SERIOUS INCIDENT

Aircraft Type and Registration:	Airbus A320-232, 9H-LOZ	
No & Type of Engines:	2 IAE V2500 turbofan engines	
Year of Manufacture:	2006 (Serial no: 2838)	
Date & Time (UTC):	28 May 2021 at 0825 hrs	
Location:	London Stansted Airport, Essex	
Type of Flight:	Commercial Air Transport (Non-revenue)	
Persons on Board:	Crew - 2	Passengers - None
Injuries:	Crew - None	Passengers - N/A
Nature of Damage:	None	
Commander's Licence:	Airline Transport Pilot's Licence	
Commander's Age:	30 years	
Commander's Flying Experience:	5,290 hours (of which 5,100 were on type) Last 90 days – 25 hours Last 28 days – 6 hours	
Information Source:	Aircraft Accident Report Form submitted by the pilot

Synopsis

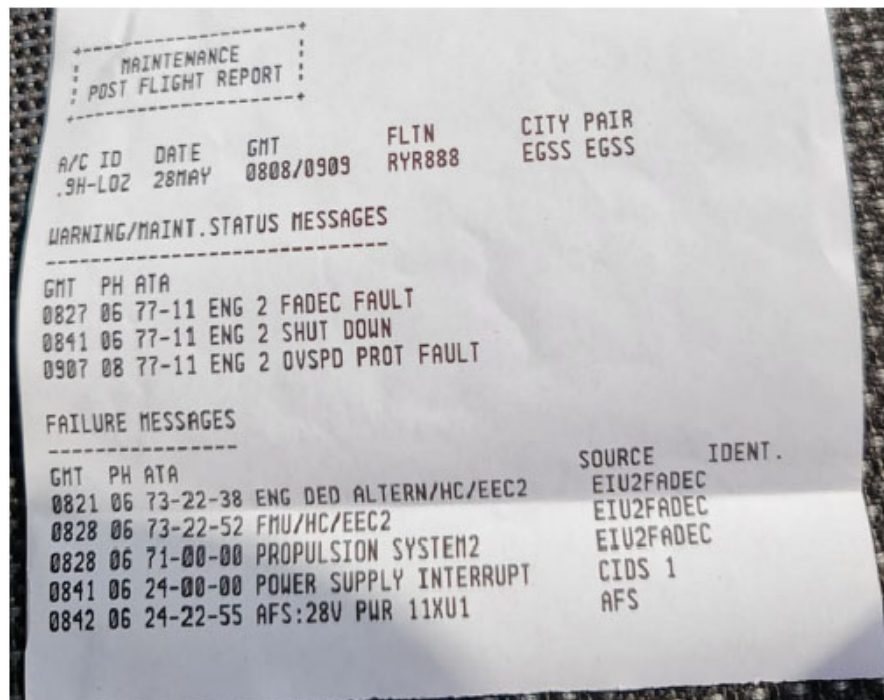
Figure 1
Post-flight Report

The post-flight report was downloaded from the aircraft (Figure 1). The Digital Flight Data Recorder (DFDR) was removed and downloaded, and the data provided to the aircraft manufacturer for further investigation. The post-flight report indicated that additional failure messages had occurred during the flight which did not have an associated ECAM warning. The first was 'ENG DED ALTERN/HC/EEC2', which indicated a failure of the Engine 2 Dedicated Alternator (EDA) or the electrical harness between the alternator and the Electronic Engine Control (EEC) unit. Additionally, 'FMU/HC/EEC2' and 'PROPULSION SYSTEM 2' faults were also recorded. The operator carried out Task 73-22-00-810-834-B *'Failure of the engine dedicated alternator stator on engine 2'* from the aircraft Troubleshooting Manual (TSM) and the EEC, EDA and the Fuel Metering Unit (FMU) from the No 2 engine were removed and sent for further investigation.

The manufacturer's assessment of the failure messages seen on the post-flight report and the ECAM warning was that they were consistent with the reduction in EPR caused by an uncommanded activation of the overspeed protection valve in the FMU. This reduced the fuel flow to the engine to a fixed level which was just below flight idle. The flight data values recorded for N1 and N2 immediately prior to this were normal and confirmed that no actual overspeed had occurred, which would have resulted in the valve correctly operating. Once activated, the fixed flow rate through the overspeed protection valve cannot be varied by any input from the throttle or the FMGC. As such, the apparently frozen parameters reported by the flight crew were an accurate indication of the engine status.

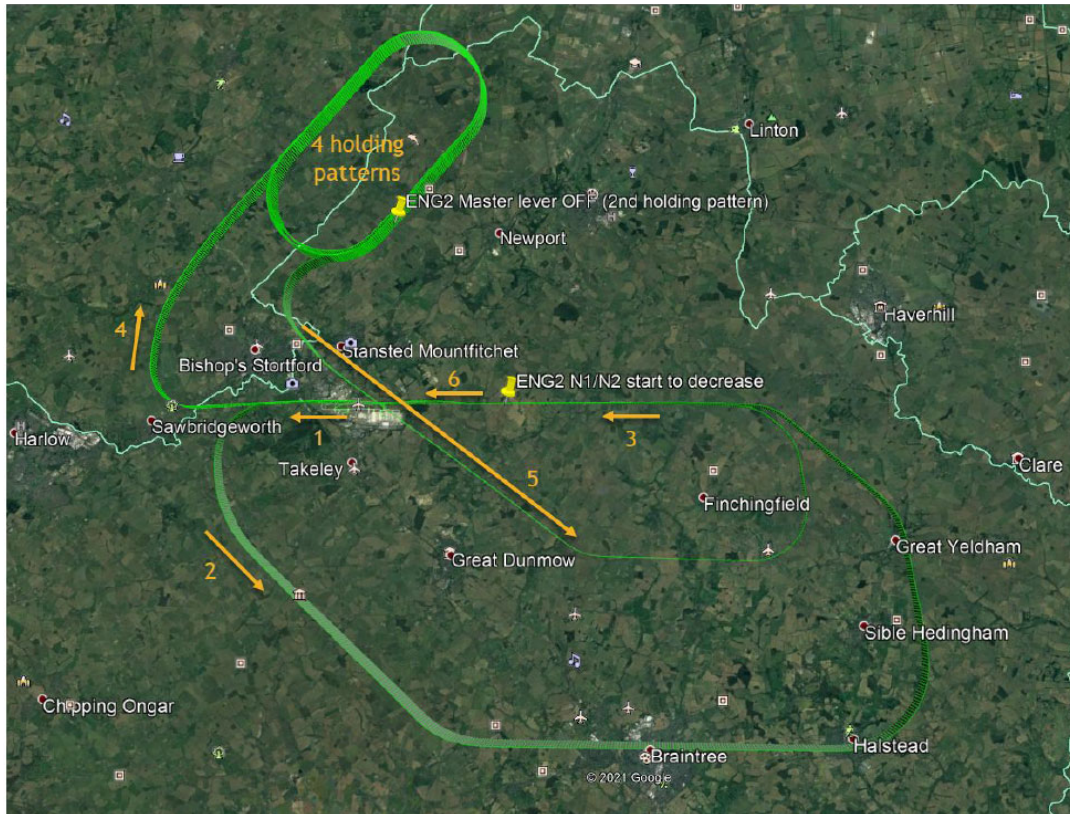
Figure 2

The aircraft manufacturer analysed the recorded flight data for the incident flight and produced a flight track which is shown in Figure 2. To assist in understanding the different phases of the flight the diagram has been annotated as follows:

- Arrow 1 – shows the initial takeoff from Stansted.
- Arrow 2 – shows the departure and climb following the SID.
- Arrow 3 – shows the first approach to land on Runway 22, with the start of the engine fault shown by the yellow pin.
- Arrow 4 – shows the go-around and missed approach route to the hold, with the engine shutdown point indicated by the yellow pin during the second circuit of the holding pattern.

- Arrow 5 – shows the re-join of the circuit at Stansted with the No 2 engine shut down.
- Arrow 6 – shows the single engine final approach and landing on Runway 22.

Recorded data showing the incident flight track

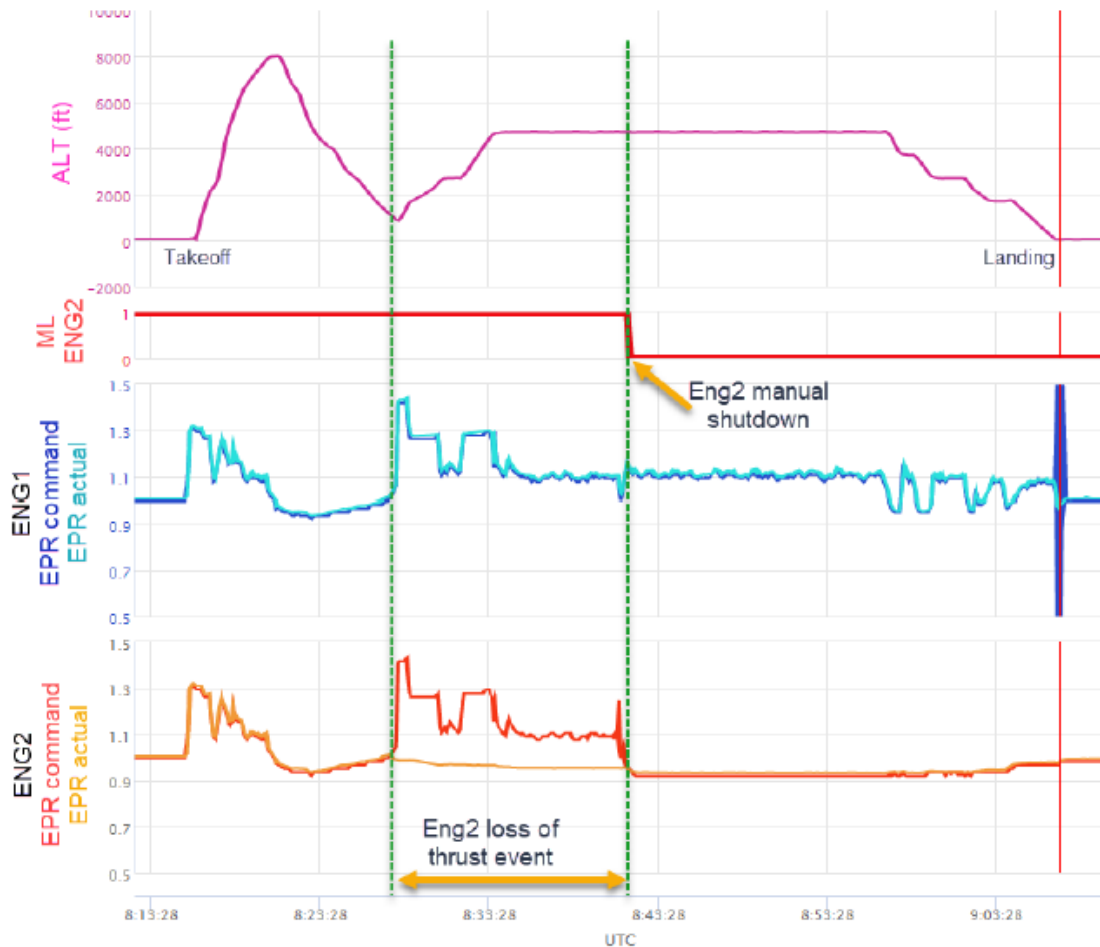
Figure 3

An overview of the relevant recorded data parameters for the incident flight, produced by the aircraft manufacturer, is shown in Figure 3. This highlights the section where the No 2 engine problem occurred. From 08:27:46 hrs the EEC commanded EPR target rapidly increased on both engines to maintain the selected aircraft autopilot airspeed. Whilst the EPR increased to match the EEC demand on engine No 1, the No 2 engine EPR began to decrease instead. The ECAM FADEC fault warning was triggered at 08:27:53 hrs and the crew reported that the engine parameters remained as figures rather than switching to amber XX. The actual engine No 2 EPR then remained at a constant value until the engine was shut down.

Relevant recorded data parameters for the incident flight
