ACCIDENT

Aircraft Type and Registration:	Tecnam P2008-JC, G-TSFC	
No & Type of Engines:	1 Rotax 912-S2 piston engine	
Year of Manufacture:	2015 (Serial no: 1047)	
Date & Time (UTC):	22 March 2021 at 1505 hrs	
Location:	Stapleford Aerodrome, Essex	
Type of Flight:	Training	
Persons on Board:	Crew - 2	Passengers - None
Injuries:	Crew - None	Passengers - N/A
Nature of Damage:	Right main landing gear collapsed	
Commander's Licence:	Commercial Pilot's Licence	
Commander's Age:	45 years	
Commander's Flying Experience:	481 hours (of which 6 were on type) Last 90 days - 6 hours Last 28 days - 6 hours	
Information Source:	Aircraft Accident Report Form submitted by the pilot

Synopsis

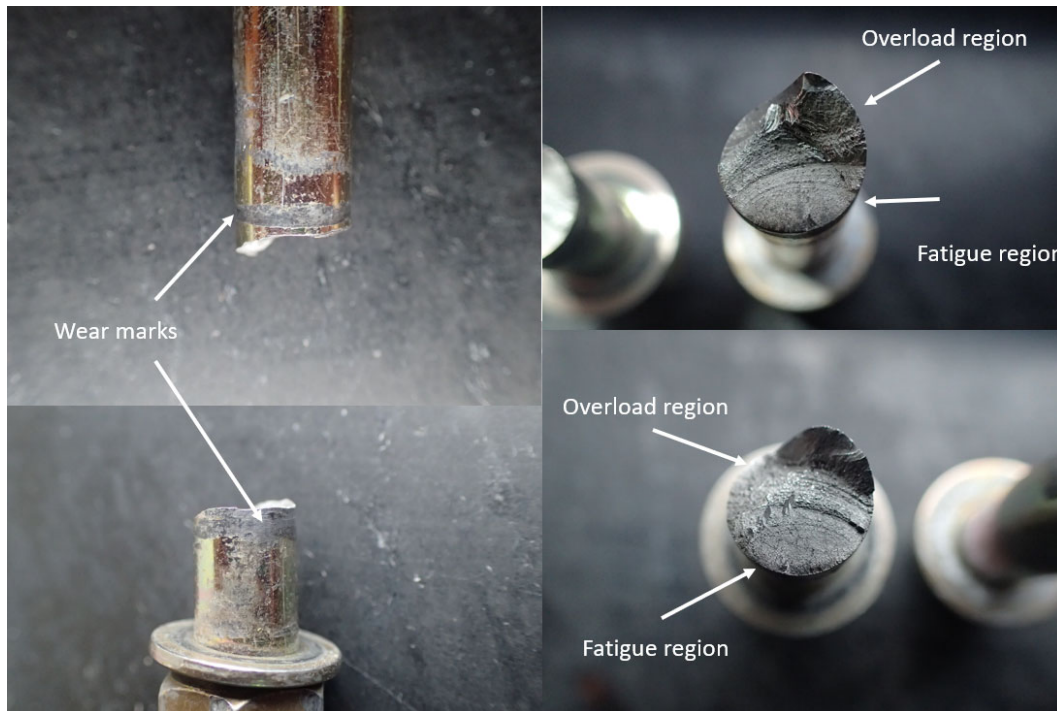
After a normal landing the right main landing gear collapsed as the aircraft taxied clear of the runway. Examination identified that the bolt securing the inboard end of the landing gear leg had failed in fatigue, (Figures 1 and 2). Wear and damage to the surface protection

was likely to be the initiation of the fatigue crack. The wear indicated that the bolt had been moving in its bushings.

Figure 2
Detail showing wear marks and fracture surfaces of the failed bolt

Inspect nose and main gear attachments, bolts and bushings for condition and security. Check especially for cracks, corrosion, and damaged surface protection. Inspect for looseness, condition and security of mounting points.’

The operator’s maintenance organisation has stated that, additionally, they will check the torque of the bolts every 50 hours and intend to replace them every 200 to 300 hours.
