# Rail Accident Report

## Runaway of a road-rail vehicle at Belle Isle Junction 16 May 2021

Report 04/2022  
May 2022

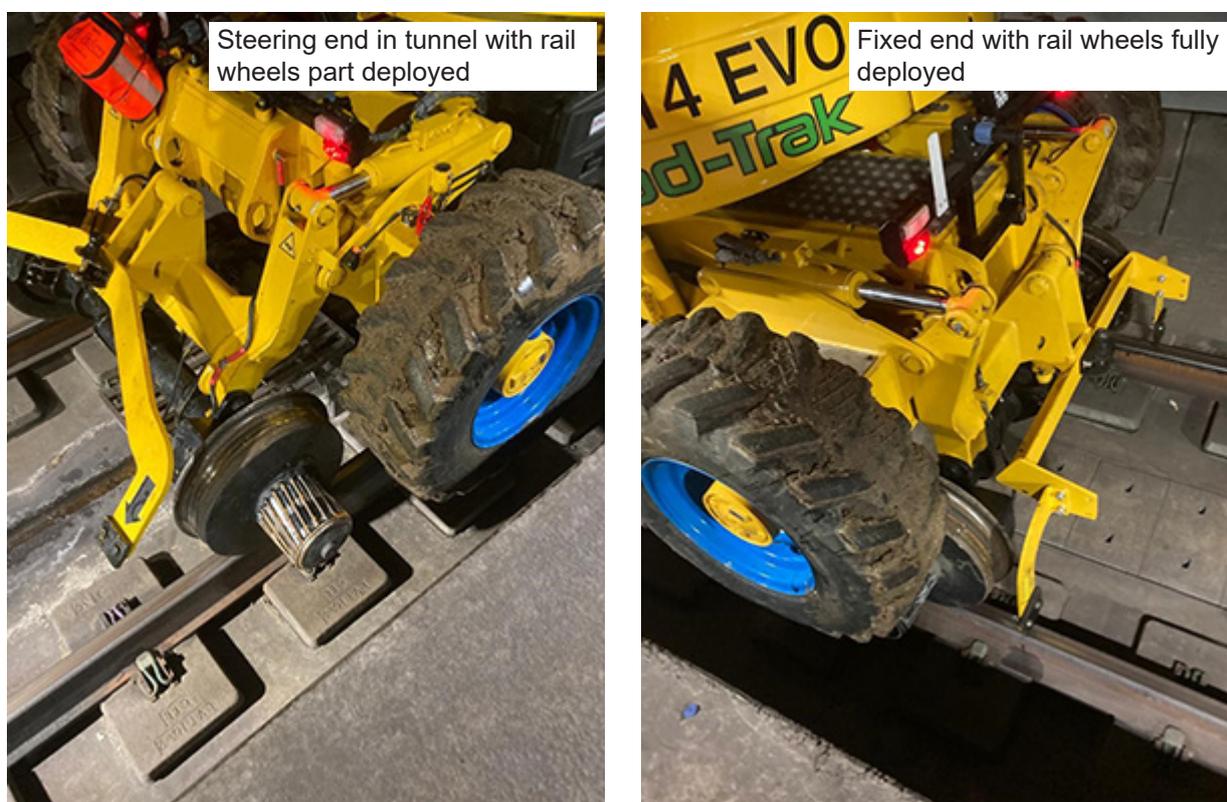
Figure 5: The position of the rail axles when the MEWP came to rest (images courtesy of Network Rail)

- 30 The incident was reported to a signaller at Three Bridges Rail Operating Centre at 03:35 hrs. Staff subsequently entered the tunnel and located the MEWP, which was stationary and with its engine still running. Photographs taken in the tunnel show that the rail axle at the fixed end was fully deployed, but the rail axle at the steering end was only partially deployed. The rail wheels at the steering end were in firm contact with the railhead and supporting the weight of the MEWP, but the road wheel tyres at this end were not in contact with the rail-axle stubs (figure 5).

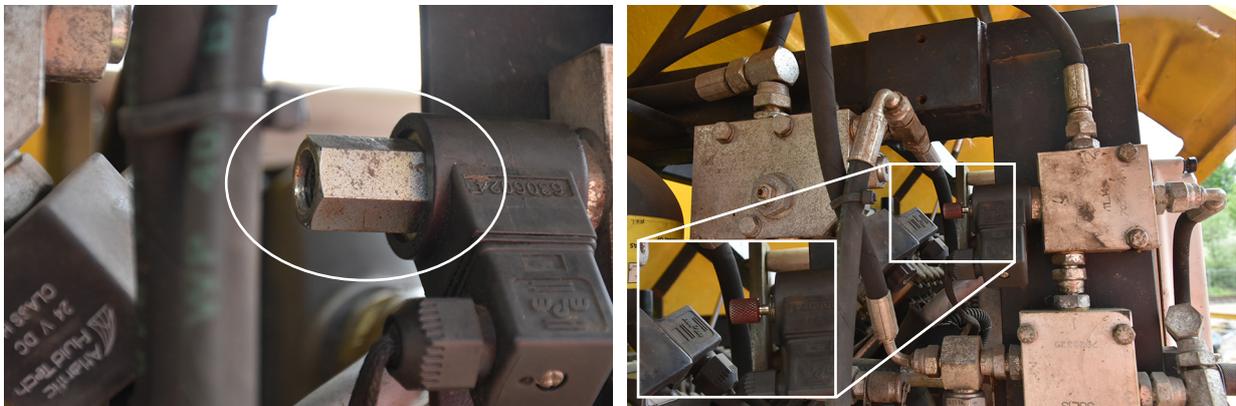
Figure 7: the park brake valve with barrel nut fitted (left) and removed, exposing the knurled knob (right)

- 42 If the park brake valve is open, the rail wheel brakes will be held off whenever the MEWP's hydraulic system is pressurised, and not just when movement is demanded. During on-tracking the operator is continually commanding the machine to either move, steer or lower the rail axles. This means that an open park brake valve will cause the brake callipers to be pressurised, and the rail-wheel brakes to be held off, when any of these activities are commanded. The hydraulic accumulator arrangement means that the callipers will remain pressurised, and the brakes held off, even after the circuit is no longer commanded to be pressurised, until the pressure in the accumulator decays sufficiently for the springs to re-apply the brakes.

- 43 An examination of the MEWP after the incident showed that the park brake valve had been left open. Testing confirmed that, with the valve in that position, whenever the MEWP was commanded to move, steer or actuate the rail axles, pressurised hydraulic fluid was admitted to the brake callipers and the rail-wheel brake callipers were held off. If the MEWP was left idle, the brakes would remain held off until the hydraulic pressure decayed sufficiently from the accumulators (paragraph 35) to allow the springs to reapply the brakes.

- 61 The MEWP entered service with ineffective direct rail wheel brakes because a valve in the DRWB system had been left open following maintenance.**
- 62 During maintenance to compensate for brake pad wear, fitters are required to manually open the park brake valve (paragraph 39). It is this valve that was found open following the incident (paragraph 43).

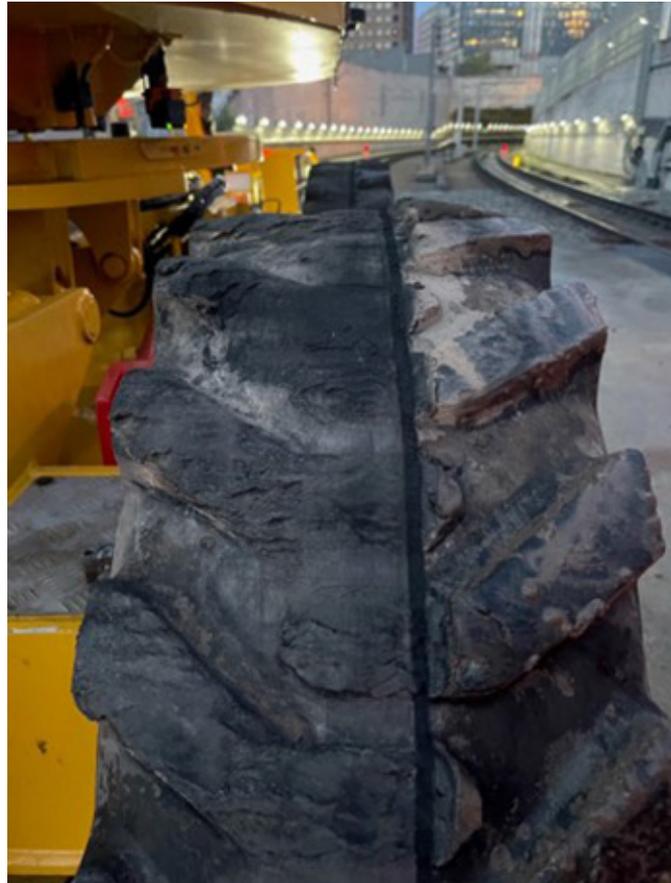
Figure 8: Road tyre wear profile

- 59 Additionally, the contact between the road wheel tyres and the rail-axle stubs had worn a distinct profile across the wheel tread (figure 8). Whilst this wear is difficult to measure, RAIB found that it was around the limit defined by ProMax in its operating and maintenance manual (PAMP011RC). This wear would have further reduced the brake force from the fixed end road wheel tyres. The steering end rail wheels were not engaged with the road tyres, and the road tyres were off the ground at the time of the runaway, as the operator was in the process of lowering them (paragraph 26).

- 60 The combined effect of the wet mud and wear reduced the brake force to such a degree that the road wheel brakes at the fixed end were unable to hold the MEWP on the gradient. However, with the rail wheels in contact with the rail, the DRWB should be sufficient to maintain the MEWP in a safe condition and any braking effort from the hydrostatic road-wheel braking system should not be necessary to prevent movement.
