# ***AAIB Bulletin***

***6/2022***

Published 9 June 2022

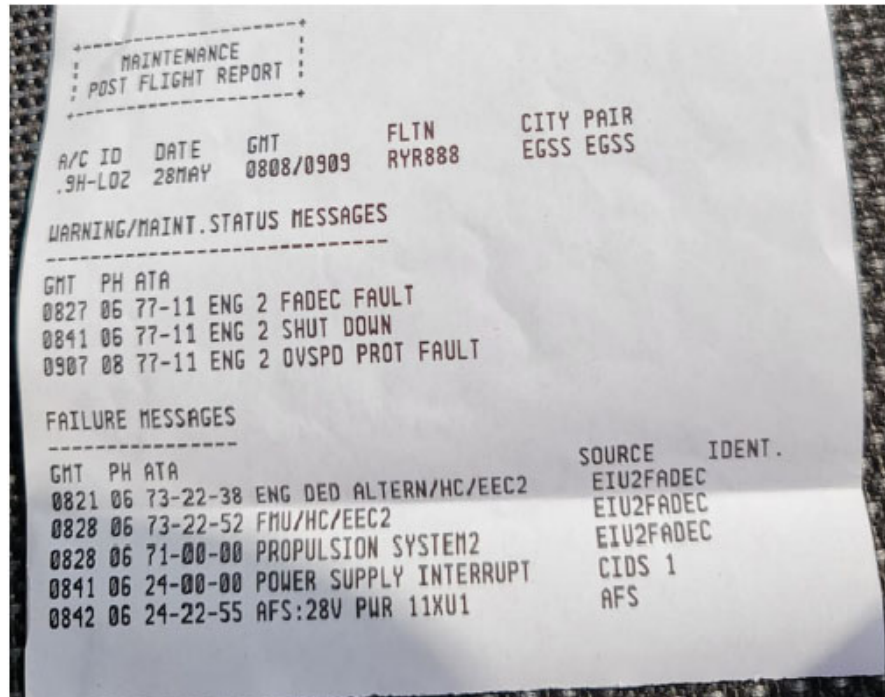
**Figure 1**  
Post-flight Report

The post-flight report was downloaded from the aircraft (Figure 1). The Digital Flight Data Recorder (DFDR) was removed and downloaded, and the data provided to the aircraft manufacturer for further investigation. The post-flight report indicated that additional failure messages had occurred during the flight which did not have an associated ECAM warning. The first was 'ENG DED ALTERN/HC/EEC2', which indicated a failure of the Engine 2 Dedicated Alternator (EDA) or the electrical harness between the alternator and the Electronic Engine Control (EEC) unit. Additionally, 'FMU/HC/EEC2' and 'PROPULSION SYSTEM 2' faults were also recorded. The operator carried out Task 73-22-00-810-834-B *'Failure of the engine dedicated alternator stator on engine 2'* from the aircraft Troubleshooting Manual (TSM) and the EEC, EDA and the Fuel Metering Unit (FMU) from the No 2 engine were removed and sent for further investigation.

The manufacturer's assessment of the failure messages seen on the post-flight report and the ECAM warning was that they were consistent with the reduction in EPR caused by an uncommanded activation of the overspeed protection valve in the FMU. This reduced the fuel flow to the engine to a fixed level which was just below flight idle. The flight data values recorded for N1 and N2 immediately prior to this were normal and confirmed that no actual overspeed had occurred, which would have resulted in the valve correctly operating. Once activated, the fixed flow rate through the overspeed protection valve cannot be varied by any input from the throttle or the FMGC. As such, the apparently frozen parameters reported by the flight crew were an accurate indication of the engine status.

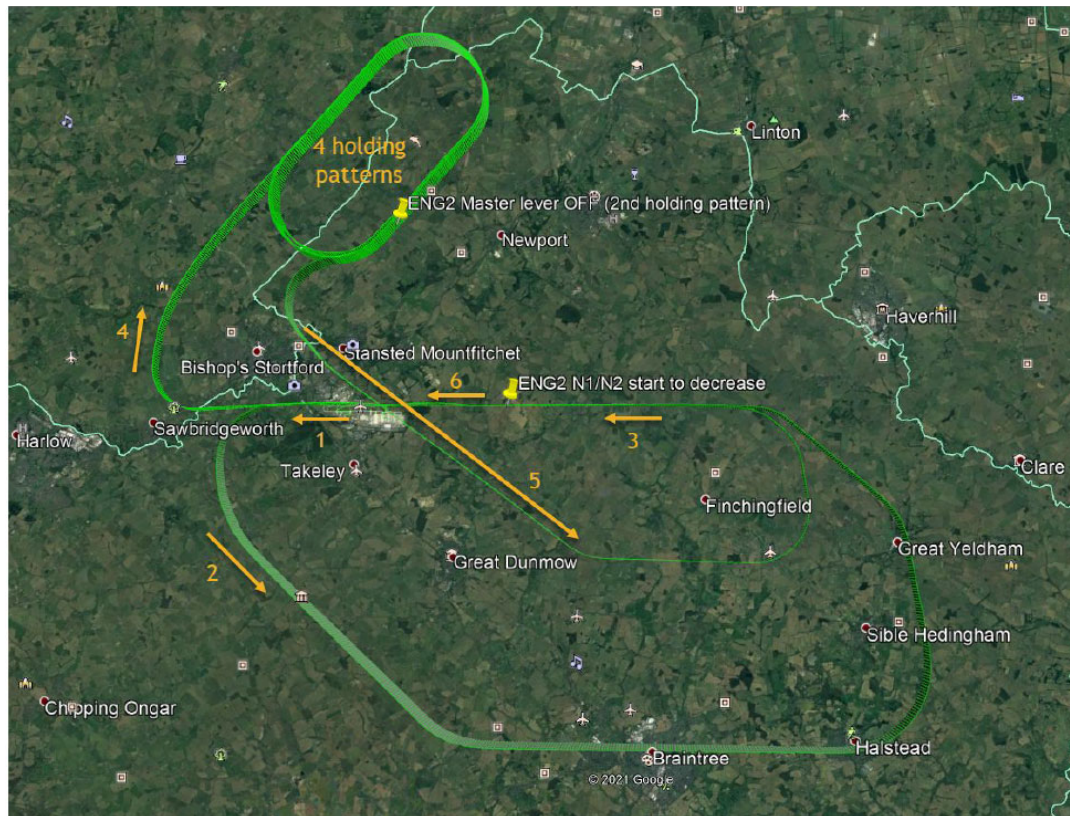
**Figure 2**

- Arrow 1 – shows the initial takeoff from Stansted.
- Arrow 2 – shows the departure and climb following the SID.
- Arrow 3 – shows the first approach to land on Runway 22, with the start of the engine fault shown by the yellow pin.
- Arrow 4 – shows the go-around and missed approach route to the hold, with the engine shutdown point indicated by the yellow pin during the second circuit of the holding pattern.

- Arrow 5 – shows the re-join of the circuit at Stansted with the No 2 engine shut down.
- Arrow 6 – shows the single engine final approach and landing on Runway 22.

Recorded data showing the incident flight track

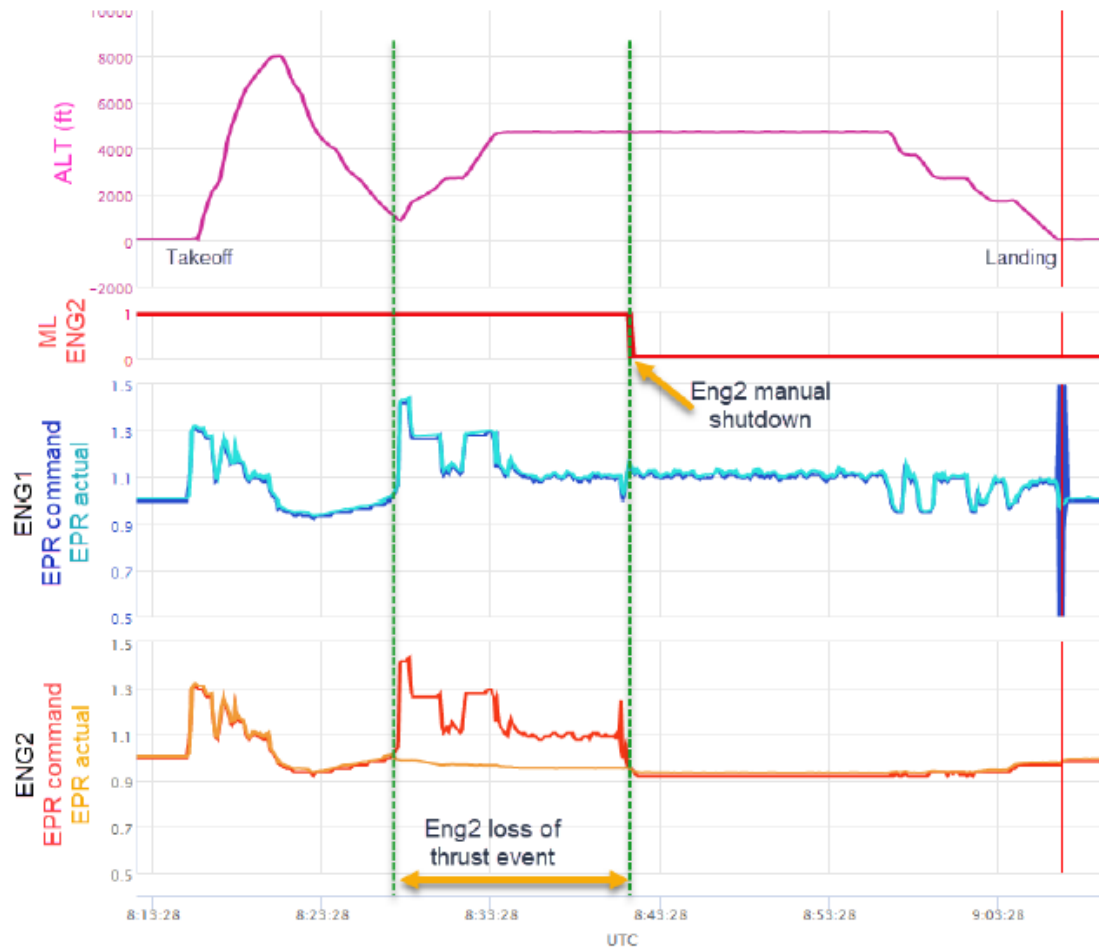
**Figure 3**

An overview of the relevant recorded data parameters for the incident flight, produced by the aircraft manufacturer, is shown in Figure 3. This highlights the section where the No 2 engine problem occurred. From 08:27:46 hrs the EEC commanded EPR target rapidly increased on both engines to maintain the selected aircraft autopilot airspeed. Whilst the EPR increased to match the EEC demand on engine No 1, the No 2 engine EPR began to decrease instead. The ECAM FADEC fault warning was triggered at 08:27:53 hrs and the crew reported that the engine parameters remained as figures rather than switching to amber XX. The actual engine No 2 EPR then remained at a constant value until the engine was shut down.

Relevant recorded data parameters for the incident flight

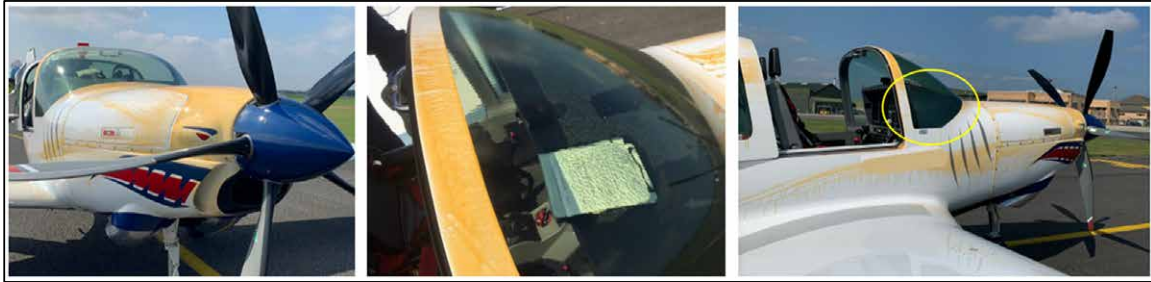
**Figure 1**

The pilot in the left seat, was undertaking a training flight under the supervision of an instructor in the right seat who was the PIC. The weather was good, and the flight was uneventful until the PIC noticed the visibility through the windscreen was deteriorating. He thought it was ice forming and elected to take control of the aircraft. The pilot flying was surprised as he was unaware of a reason for the PIC to take control; shortly afterwards his forward visibility was also obscured with what both pilots identified as engine oil (Figure 1 centre).

Oil contamination post flight

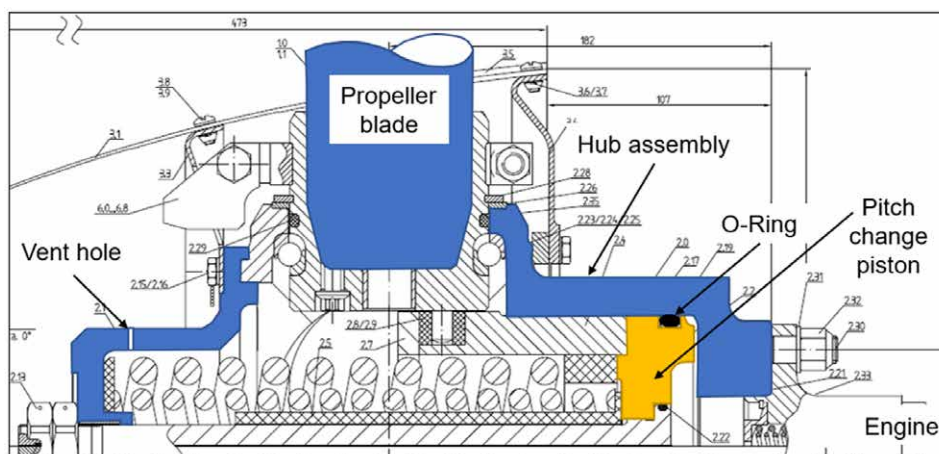
**Figure 2**

Cross-section through the propeller showing the piston O-ring

The aircraft manufacturer stated that they were aware of two incidents where the pitch change piston O-ring failed resulting in oil leaking from the vent hole in the forward part of the hub. The propeller manufacturer attributed these failures to a compatibility issue

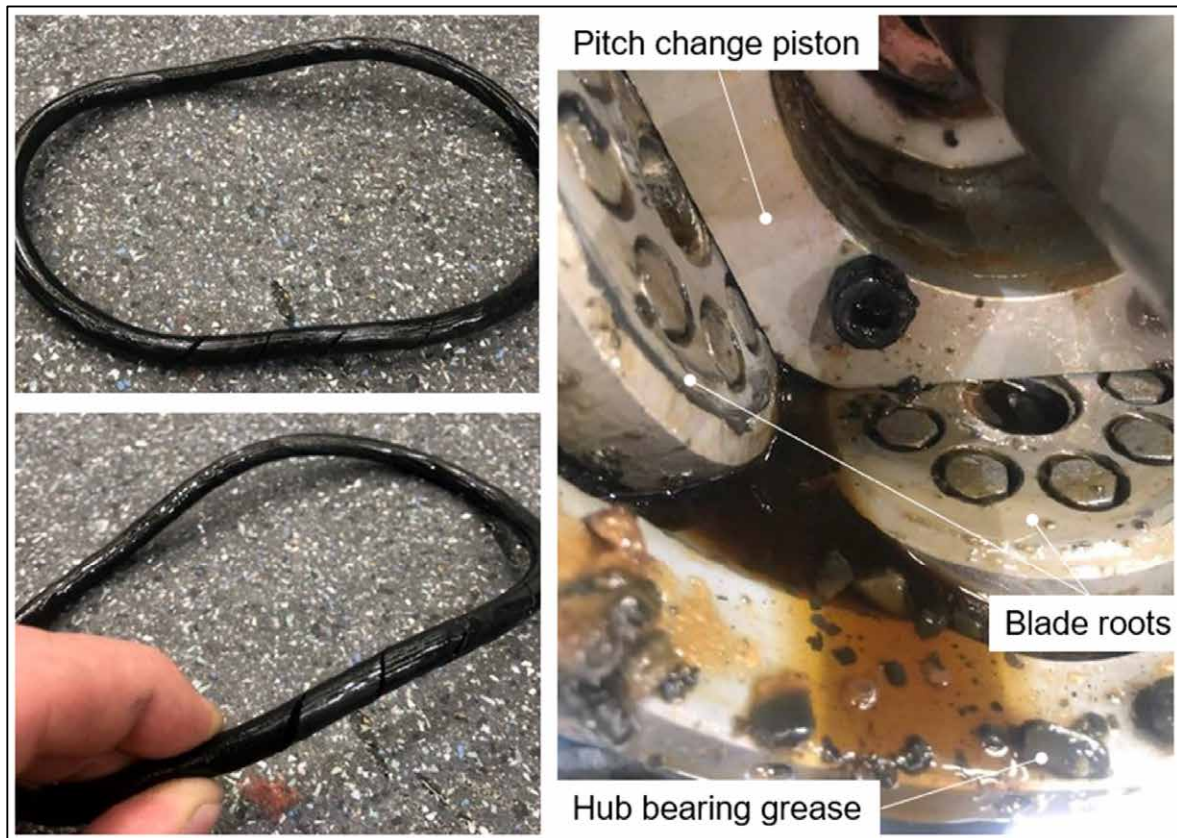
**Figure 3**

The propeller was removed and examined at an authorised overhaul facility. The piston O-ring was found to have multiple cuts and widespread surface damage (Figure 3) allowing oil to pass into the hub, causing a breakdown of the hub bearing grease. The O-ring had part number C-047-135. The propeller manufacturer stated that the damage was a result of the O-ring swelling due to high engine oil temperature and contact with a non-compatible engine oil. The size increase of the O-ring due to swelling, caused it to stick and roll as the piston moved, rather than slide. The surface was then damaged with cuts and tears.

O-ring damage (left), hub interior (right)

An investigation by the propeller manufacturer determined that there was a compatibility issue between the propeller piston O-ring and the engine oil resulting in softening and damage to the O-ring, which allowed oil to pass the seal. Furthermore, there was evidence that the O-ring was possibly damaged during installation which might also have resulted in an oil leak.

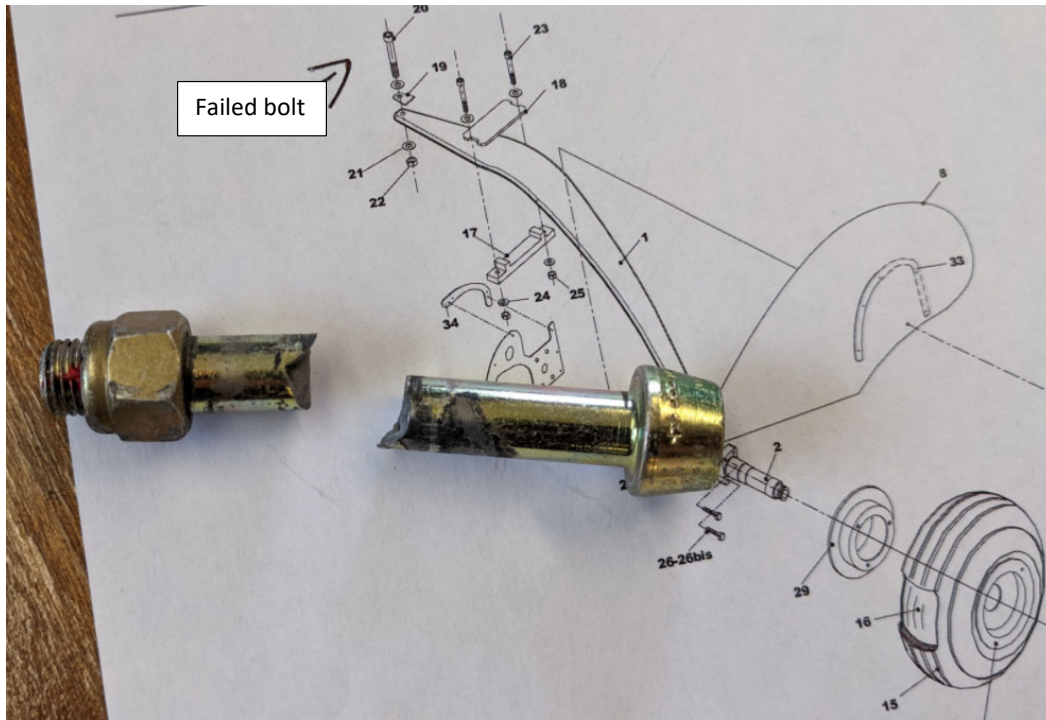
**Figure 1**  
Failed bolt and diagram showing its location

After a normal landing the right main landing gear collapsed as the aircraft taxied clear of the runway. Examination identified that the bolt securing the inboard end of the landing gear leg had failed in fatigue, (Figures 1 and 2). Wear and damage to the surface protection

was likely to be the initiation of the fatigue crack. The wear indicated that the bolt had been moving in its bushings.

The operator’s maintenance organisation has stated that, additionally, they will check the torque of the bolts every 50 hours and intend to replace them every 200 to 300 hours.

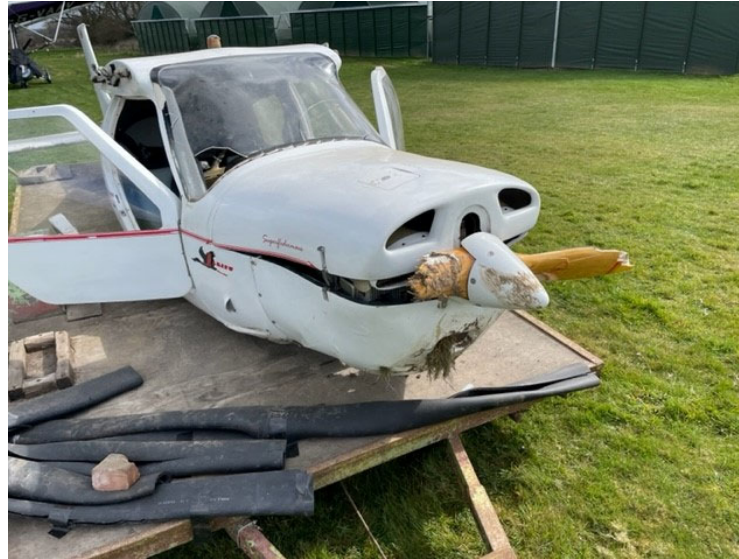
**Figure 1**

The aircraft was severely damaged. The first impact was on the nose undercarriage leg, which sheared off, followed by the main undercarriage legs, which failed at some point. The aircraft came to rest on its fuselage the right way up, and the starboard wing was dislodged and only held on by the trailing edge bolt.

G-CBGR after recovery from the accident site (used with permission)

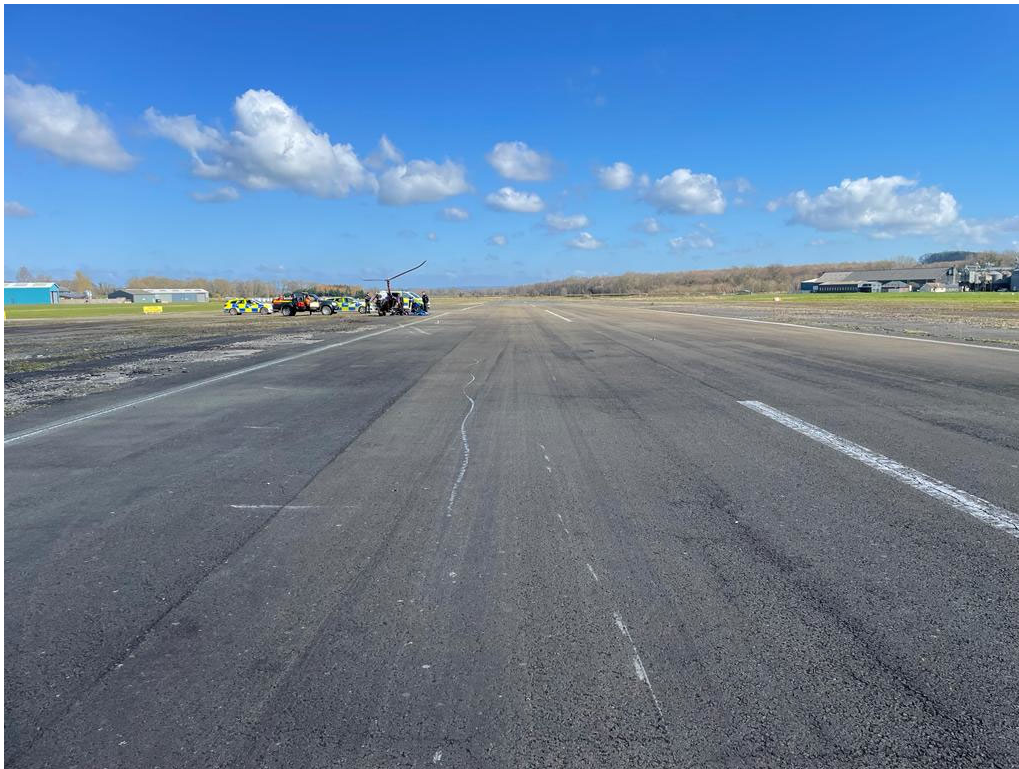
**Figure 1**

The gyroplane fell onto its side and slid along the runway, coming to a stop on the left side of the runway (Figure 1 and 2). The occupants were trapped and could smell fuel. Airfield personnel were on scene quickly and were able to right the gyroplane and extract the occupants. The instructor was uninjured; the student had chest pains and later discovered he had broken a bone in his back.

Marks on the runway with accident site in the distance

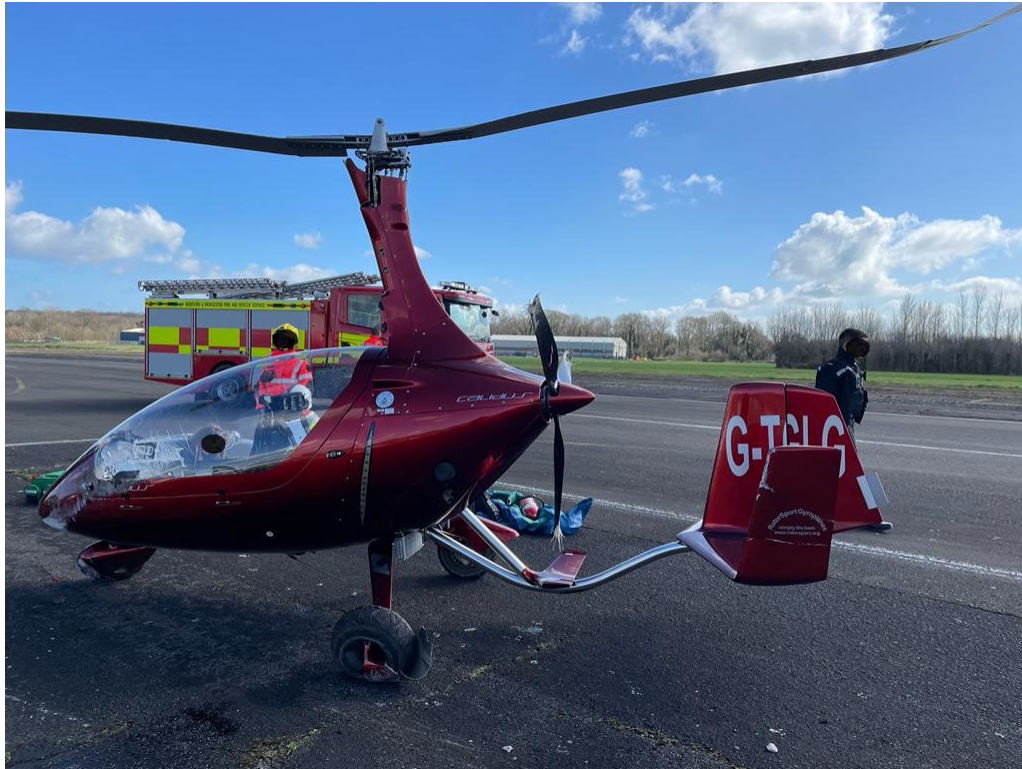
**Figure 2**

G-TGLG after righting by emergency services
