AAIB Bulletin S1/2022

SPECIAL

ACCIDENT

Aircraft Type and Registration:	Piper PA-28R-200-2, G-EGVA	
No & Type of Engines:	1 Lycoming IO-360-C1C piston engine	
Year of Manufacture:	1976 (Serial no: 28R-7635229)	
Date & Time (UTC):	2 April 2022 at 0920 hrs	
Location:	Approximately 20 nm west of Le Touquet	
Type of Flight:	Private	
Persons on Board:	Crew - 1	Passengers - 1
Injuries:	Crew - 1 (missing)	Passengers - 1 (missing)
Nature of Damage:	Aircraft missing	
Commander's Licence:	Private Pilot's Licence	
Commander's Age:	69 years	
Commander's Flying Experience:	200 hours (of which 4.7 were on type) Last 90 days - 1.3 hours Last 28 days - 0.7 hours	
Information Source:	AAIB Field Investigation

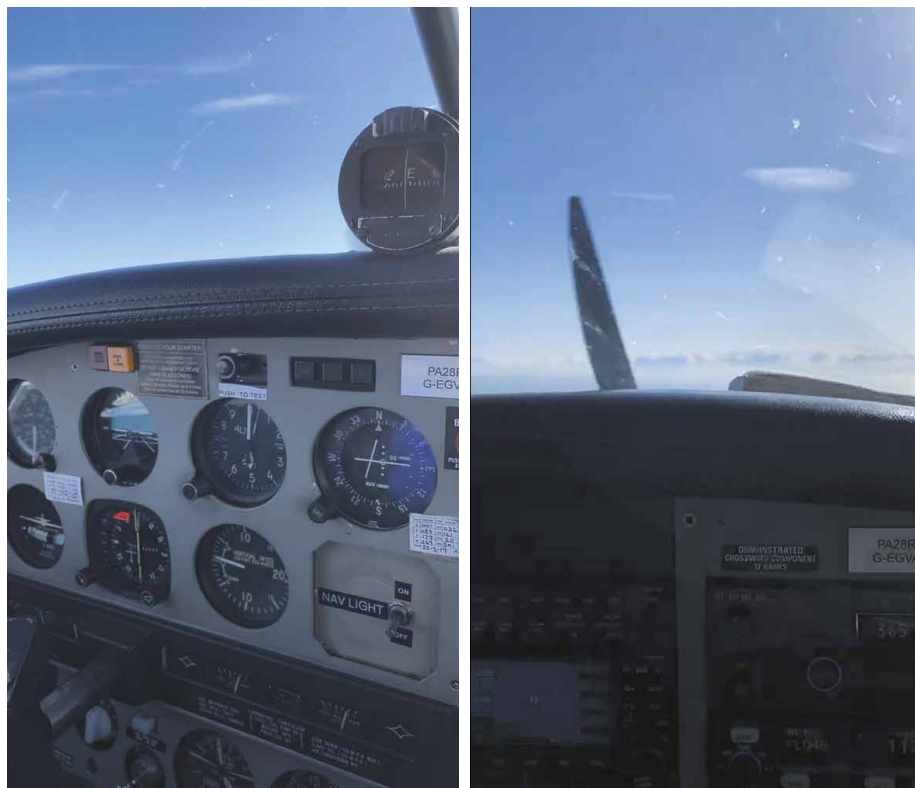
**Figure 2**

At 0846 hrs a video was posted online by the right seat pilot of G-EGVA. Extracts from the video are shown in Figure 2. The video showed the aircraft in flight passing abeam Shoreham with the flight appearing to proceed normally. The aircraft's altimeter showed 5,000 ft, the heading was approximately 090° and the airspeed indicator showed approximately 115 kt. The autopilot did not appear to be engaged and the engine and fuel indications, which were visible, appeared normal. Cumulus cloud could be seen in the distance ahead of the aircraft. Both occupants were wearing lifejackets with their shoulder harnesses worn under their lifejackets.

Extract from the video posted at 0846 hrs showing the instrument panel and the cloud ahead of G-EGVA

The video posted on social media by the right seat pilot of G-EGVA showed the aircraft at 5,000 ft with cumulus cloud visible ahead. Radar recordings show that after this time the aircraft descended to approximately 3,000 ft then climbed to above 7,000 ft whilst continuing on a constant heading towards the cloud. It is not possible to know the pilots' intentions but these changes in altitude might have been an attempt to avoid cloud. Once reaching 7,000 ft they were unable to climb any higher due to the controlled airspace above.

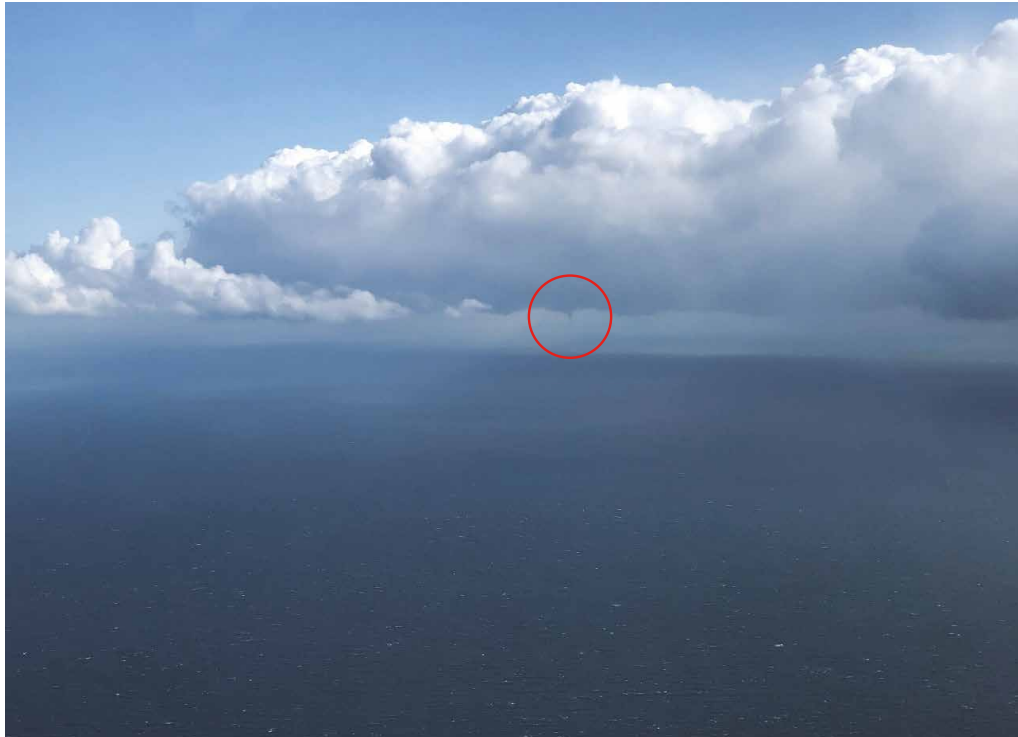
Figure 3

Photograph taken at 0918 hrs showing the cloud mid Channel
(waterspout circled in red)

Met Office weather radar data from the time of the accident confirmed heavy precipitation in the Channel suggesting a highly active convective area. Photographs taken by other aircraft in the area at the time showed waterspouts descending from the cloud and cloud down to the surface, again confirming a highly active convective area.

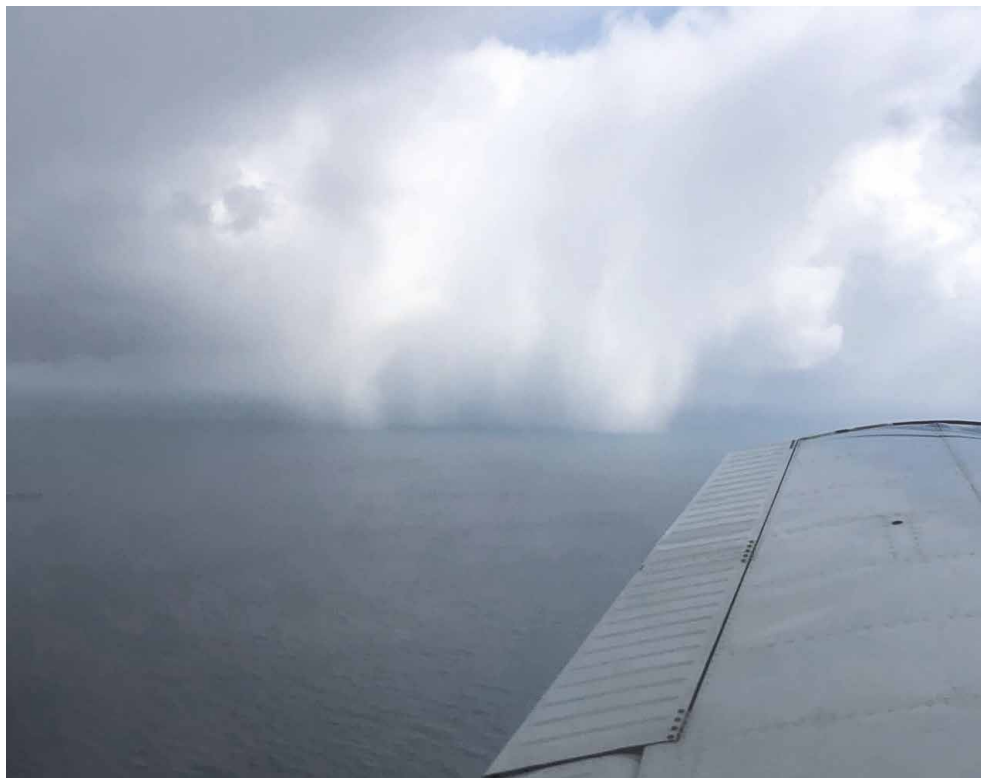
Figure 4

Photograph taken at 0924 hrs showing cloud to the surface

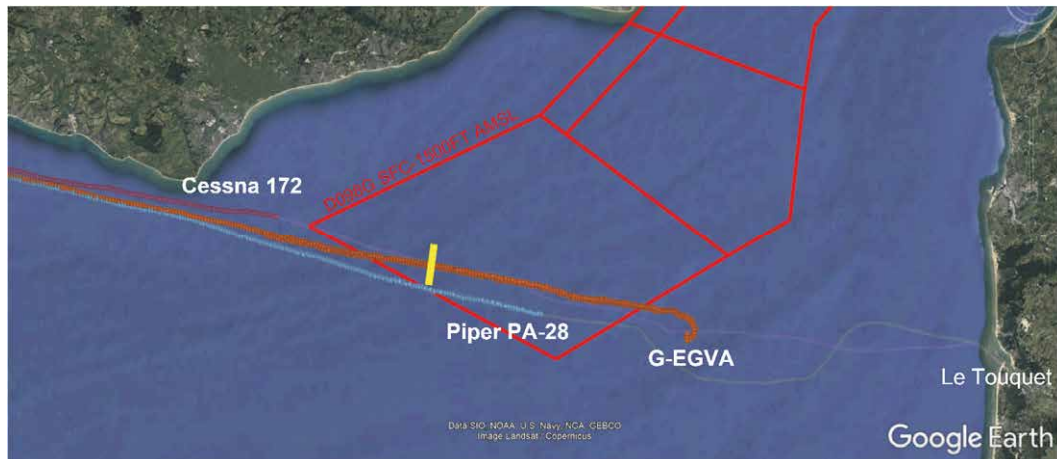
Secondary surveillance radar data for G-EGVA and the nearest two aircraft of the 'fly-out' is shown in Figures 6 and 7. Figure 6 shows part of the ground track of these aircraft to the point when radar contact was lost with G-EGVA at 0916:31 hrs. Figure 7 shows the reported altitudes for these aircraft, corrected for the QNH of 1022 hPA. Indicated on both these figures is the point at which G-EGVA descended from its cruise altitude of about 5,000 ft amsl, and on Figure 7 the corresponding time when the two following aircraft were abeam this point.

Radar track of G-EGVA up to the last known position at 0916 hrs with the location of two of the following aircraft shown. The yellow line on the G-EGVA's track is the point at which G-EGVA descended from its cruise altitude

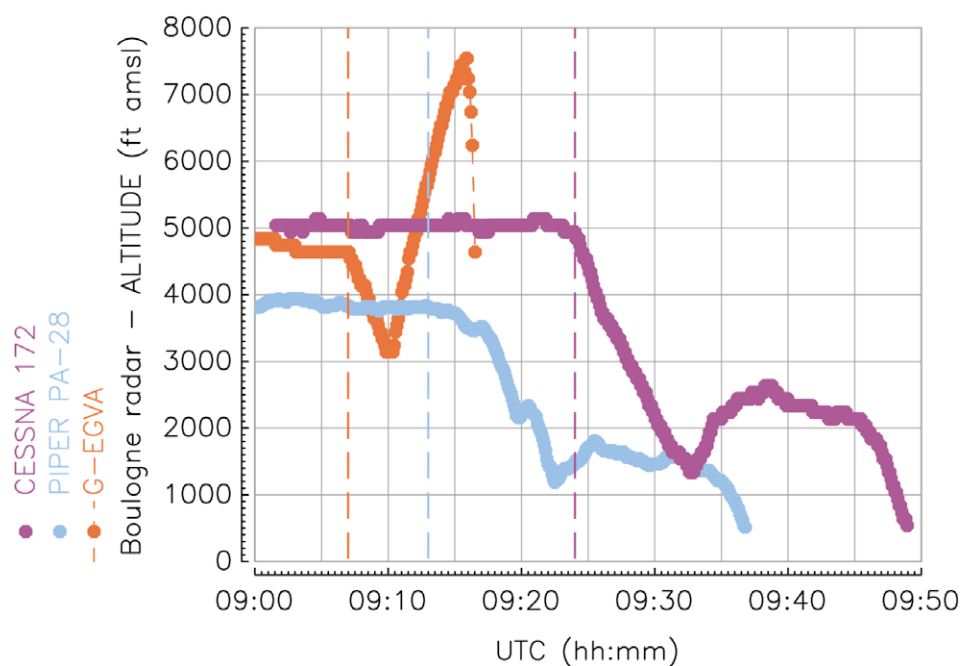
Figure 7

Altitude trace of G-EGVA and the following aircraft from 0900 hrs. The dashed line for G-EGVA shows when it descended from its cruise altitude – the corresponding dashed lines for the other aircraft show when they were abeam this point

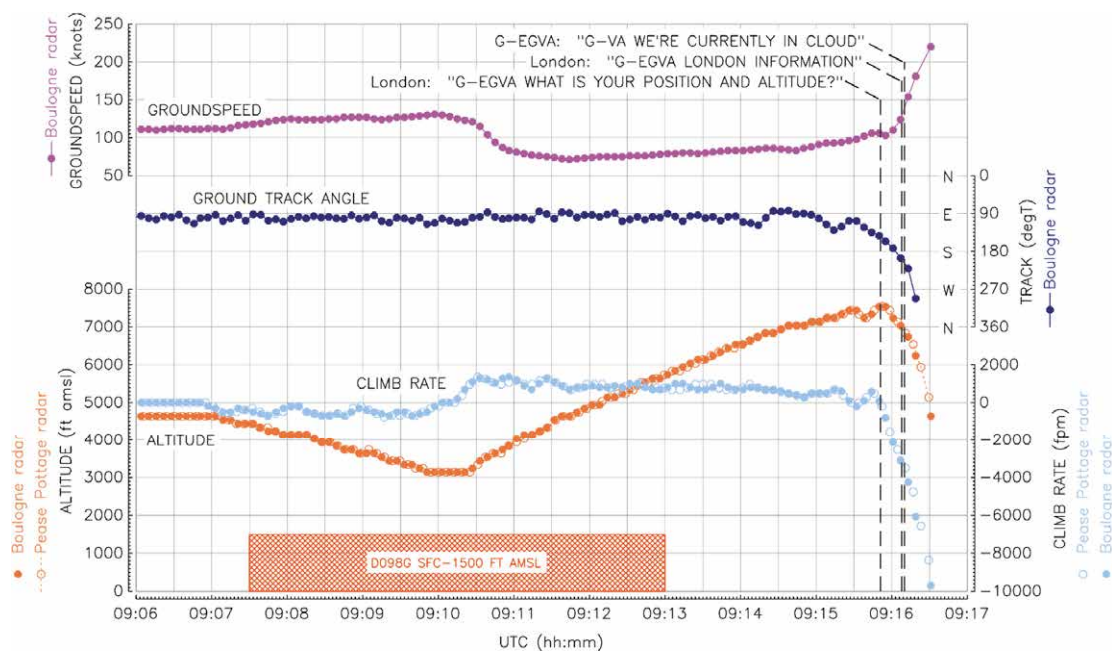
Figure 8 is a plot of the altitude and radar-derived data for G-EGVA starting just before the descent from the cruise altitude. The plot shows that the aircraft descended to about 3,000 ft at approximately 500 fpm, where it remained for 30 seconds before climbing to over 7,000 ft at about 1,000 fpm, while maintaining an easterly track. Over the next 50 seconds the aircraft climbed 400 ft, descended 200 ft, and then climbed 300 ft, and at the same time

turned right, left, and right again through a total of 50°. The aircraft then continued to turn to the right in a descent. Radar contact was lost 40 seconds later as the aircraft descended through 4,600 ft with a calculated descent rate of just under 10,000 fpm. The last recorded position was 50°34'23.49" N 001°04'11.23" E at 0916:31 hrs.

Figure 8 also shows when the last radio transmissions between London Information and G-EGVA were made. G-EGVA was descending through 7,000 ft at about 3,000 fpm and accelerating during its final transmission.

Altitude and radar-derived data for G-EGVA

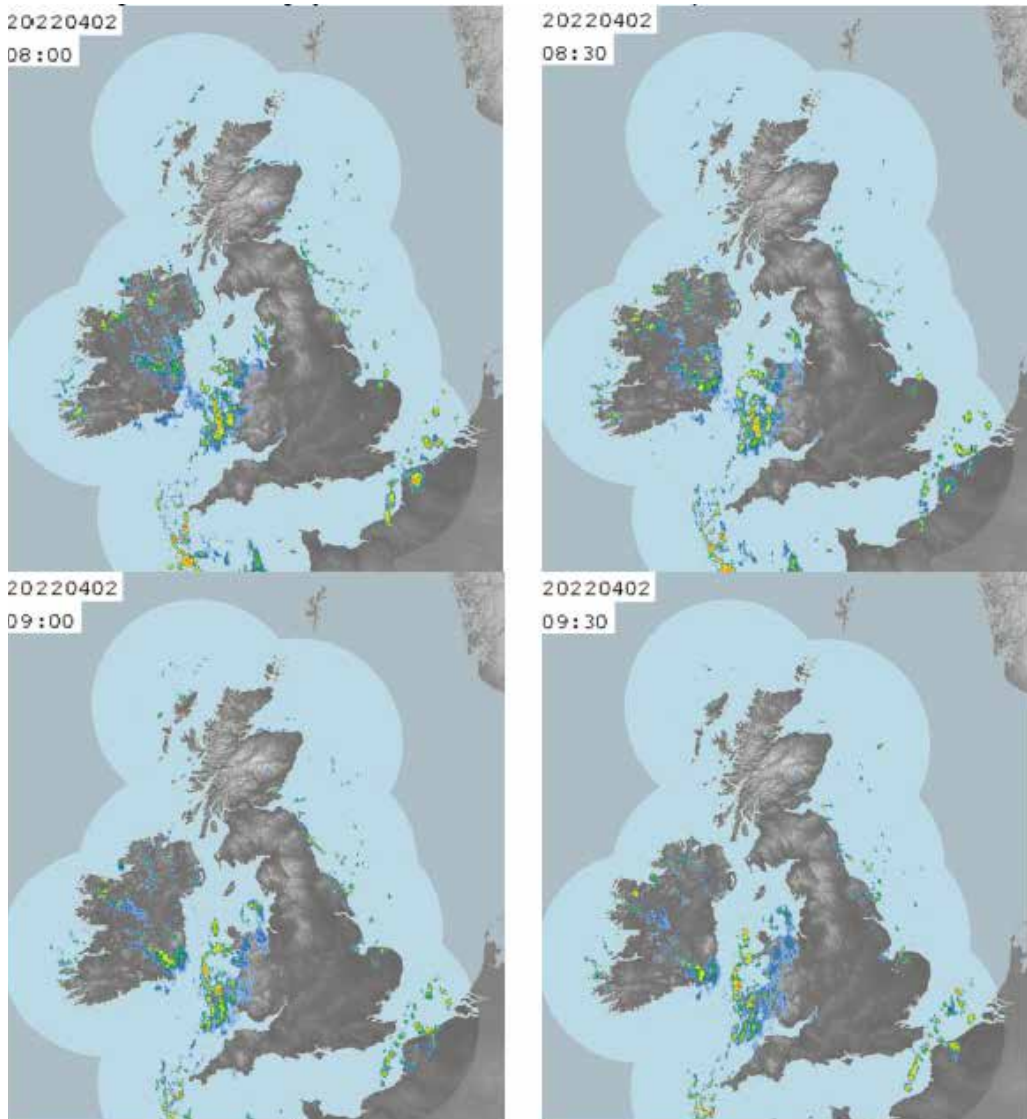
Figure 11 shows four radar images between 0800 hrs and 0930 hrs on 2 April 2022. These show dry conditions across central and southern England. A band of showers is shown lying through the Dover Strait, which ties in with the cloud structure observed in satellite imagery. The colouring of the radar returns suggests some heavy precipitation to the west of Le Touquet around 0900 hrs.

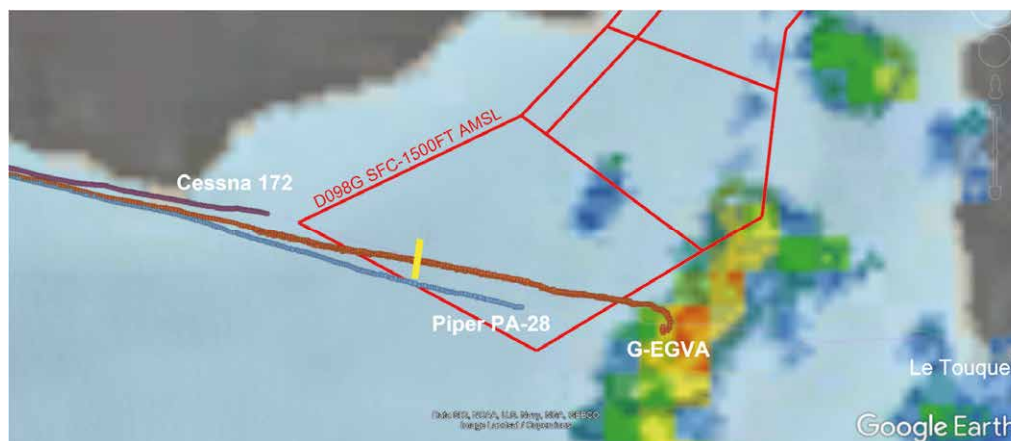
Figure 12 shows the radar track of G-EGVA and the two following aircraft overlaid on the 0900 hrs weather radar image.

Aircraft tracks at 0916 hrs overlaid on the 0900 hrs weather radar image (the Danger Area described in the NOTAM is shown in red outline)

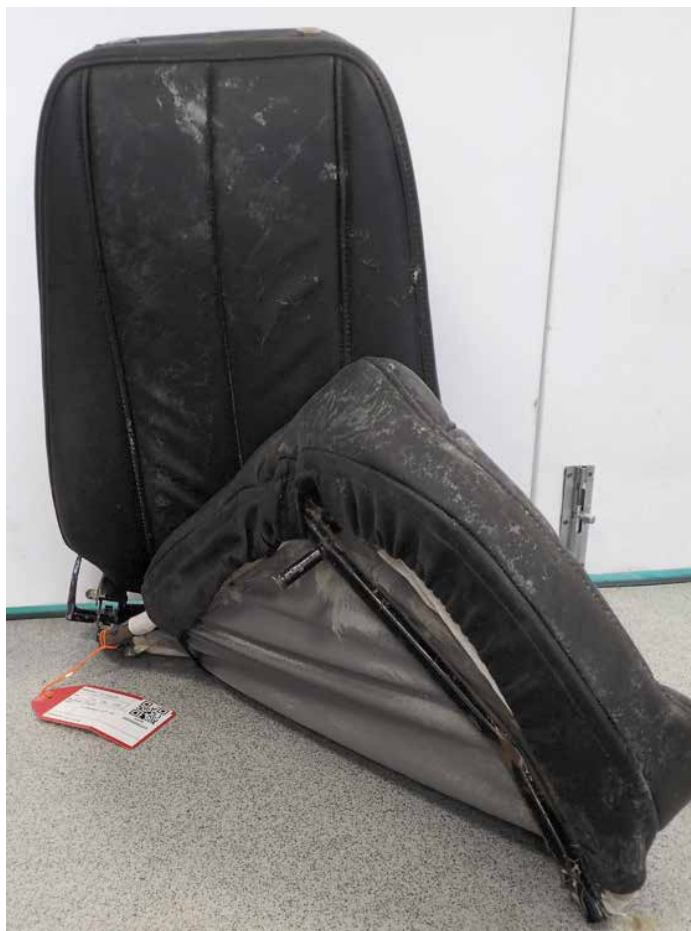
Figure 13

The seat recovered from the French coast (Figure 13) was examined at the AAIB. No part number or serial numbers were evident on the seat, but the style and branding of the seat covers matched those of the new leather seat covers that had recently been fitted to G-EGVA. It was identified as being one of the rear seats.

The seat cover exhibited minor scuffing and several small tears but was otherwise in good condition. The lower seat frame was severely distorted, and the forward left mounting point had separated from the frame.

Seat recovered from G-EGVA

Initial assessment indicated that the damage sustained by the seat recovered from G-EGVA and its liberation from the aircraft were consistent with the airframe having been subject to considerable forces and substantial disruption.
