# Near miss with track workers and collision with a tree on the line at Uphill Junction, near Weston-super-Mare, Somerset, 14 January 2022

## Summary of the incident

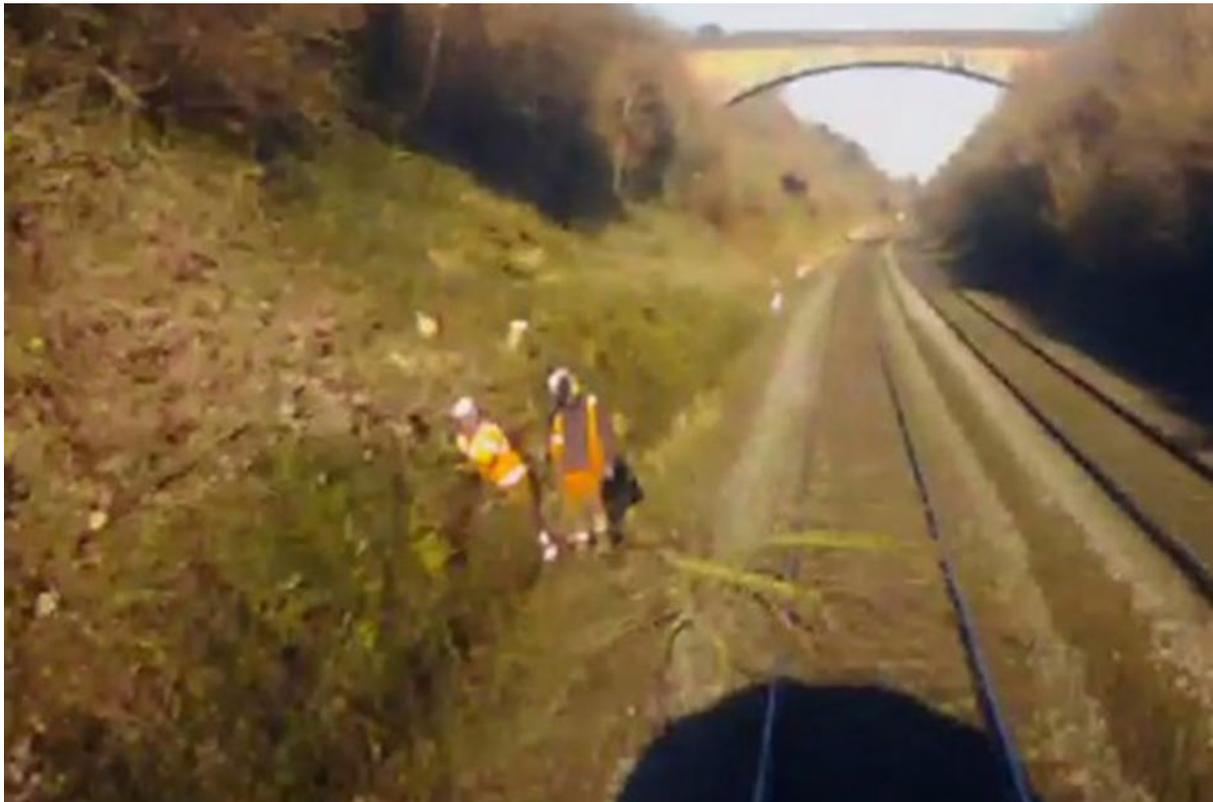
The train involved left Taunton at 12:54 hrs and was travelling near to the 100 mph (160 km/h) maximum permitted line speed when the driver observed track workers on the line ahead. The driver sounded the train's horn approximately 10 seconds before reaching the track workers with the expectation that they would move to a position of safety, where it would be safe to stand as the train passed. The track workers, however, did not acknowledge the warning, or move off the line, so the driver sounded the horn for a second time and applied the train's brakes. The track workers became aware of the presence of the train after warnings being shouted by the Controller of Site Safety (COSS), who stated that he had been attempting to call the signaller when the train approached. The track workers moved to the cess and clear of the line approximately 2 seconds before the arrival of the train, which then struck the tree. Although the track workers were close to the tree at the time of collision, nobody was injured.

Still image taken from the train's forward-facing CCTV showing the position of the track workers and the tree foul of the line shortly before the train struck the tree (image courtesy of CrossCountry).

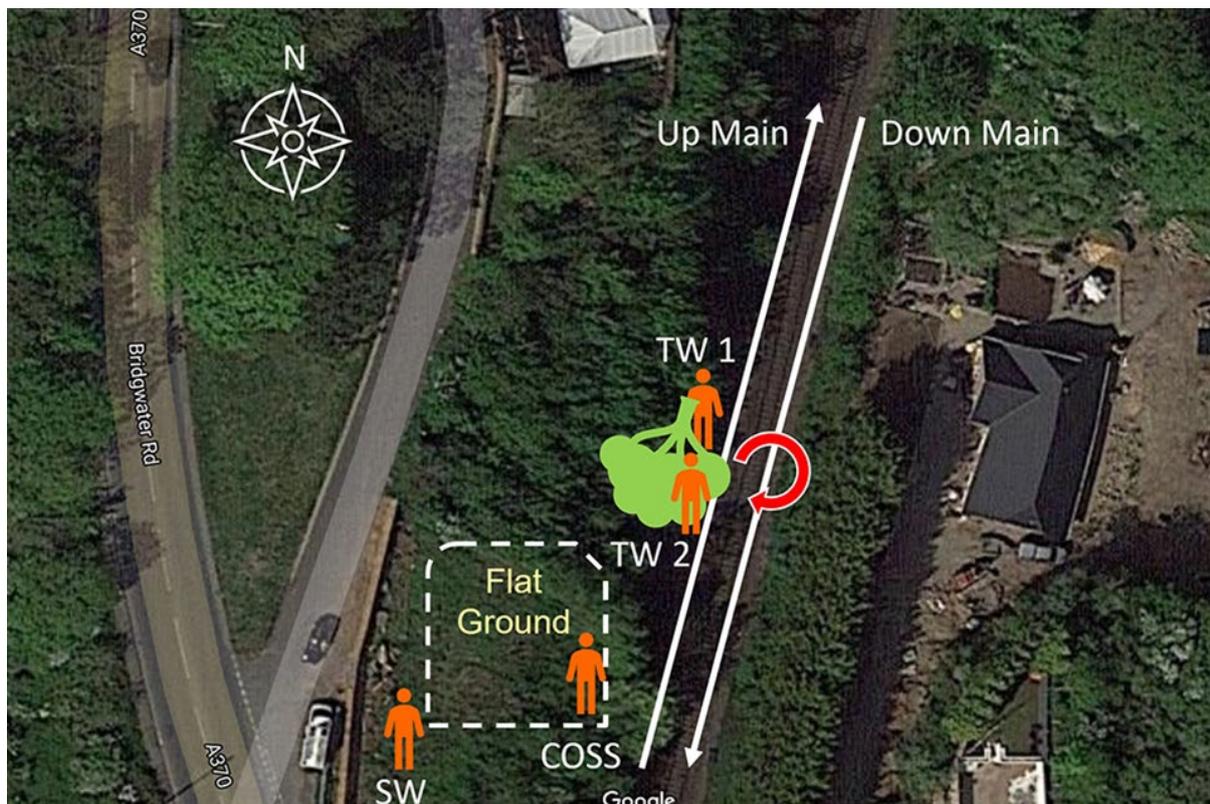
Witness evidence and forward-facing CCTV images suggest that it was mainly the upper branches of the tree which were foul of the line when it first landed in the cess. However, on arriving in the cess the track workers decided to turn the tree, so the stump was facing south. They did this so that they could pull the tree along the cess to an area where it could be cut up and disposed of safely. Turning the tree in this way, however, pulled its stump into the four-foot of the running line, just as the train was approaching. Alerted by the shouted warnings from the COSS and site warden, who had now returned to the team, the track workers pushed the stump back towards the bottom of the slope before getting clear of the line.

Site plan showing the track workers' intent to rotate the tree to allow it to be dragged to the area where the cutting flattened (not to scale)
