Defence  
Infrastructure  
Organisation

# Safety Alert Part A, B, & C

**Subject: Falling Overhead Gas Radiant Tube Heater Fan Assembly Component (Ambi-Rad model 1979 - 1995)**

**Number: SA 2021/04**

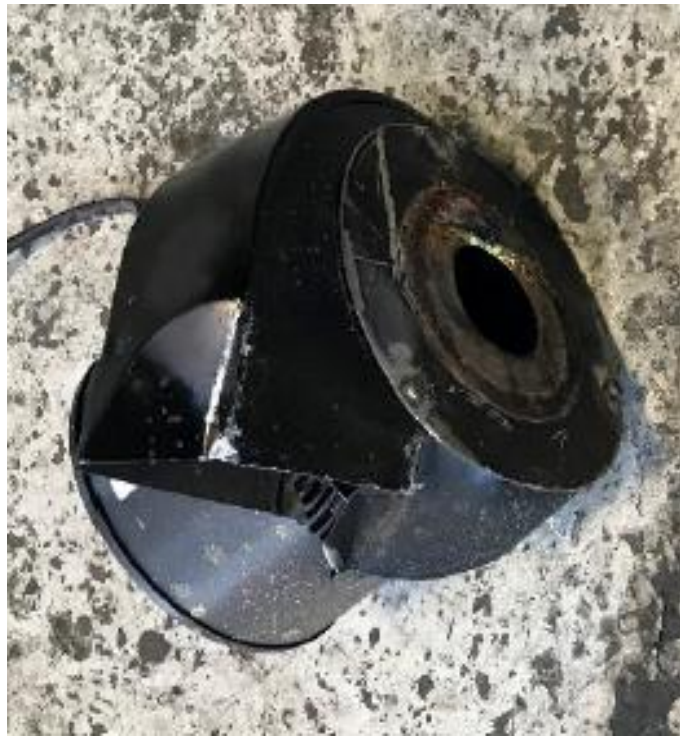
9. Investigation of the incident identified the failure of the fan assembly was due to slow deterioration of the spot welds securing the spinning plate spigot to the emitter heating tubes. This resulted in the detachment of the component part which then fell from height to the garage floor.

Photograph 1: Fan motor assembly with missing spigot that locates onto the radiator heat emitter tube pipe (see Photograph 3)

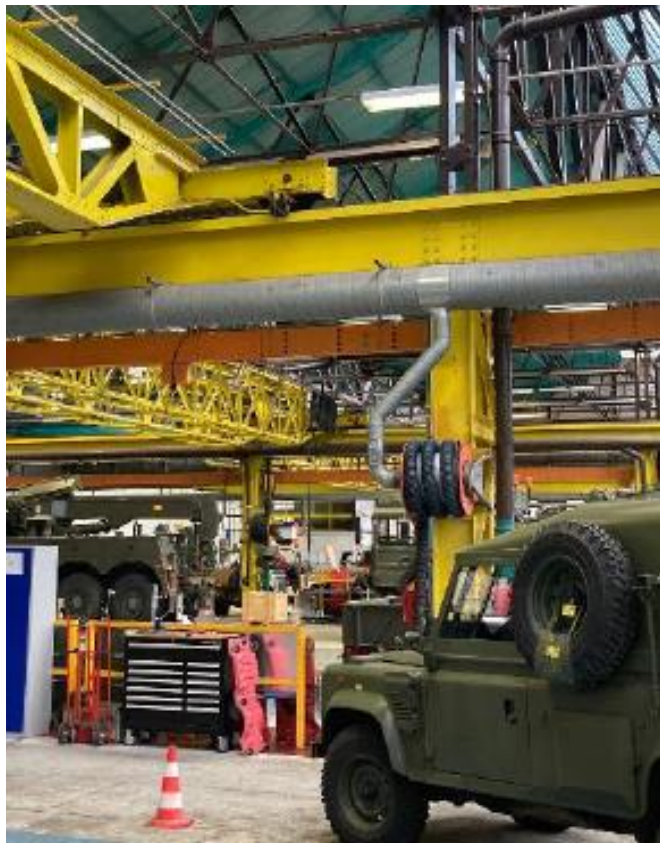
Photograph 2: Fan motor assembly and motor was found on the workshop floor where the cone is placed.

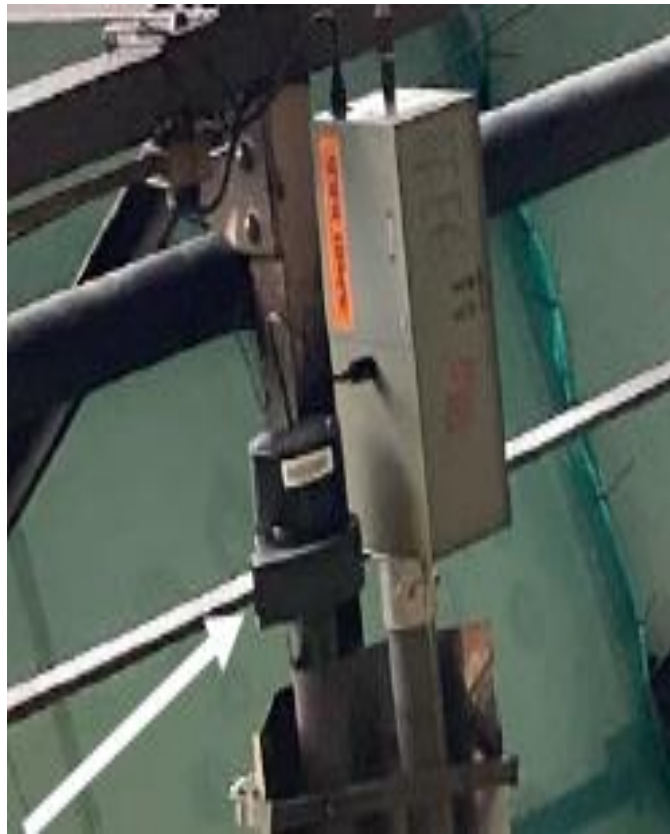
Photograph 3: Fan motor assembly fell from the gas radiant tube heater shown by arrow point

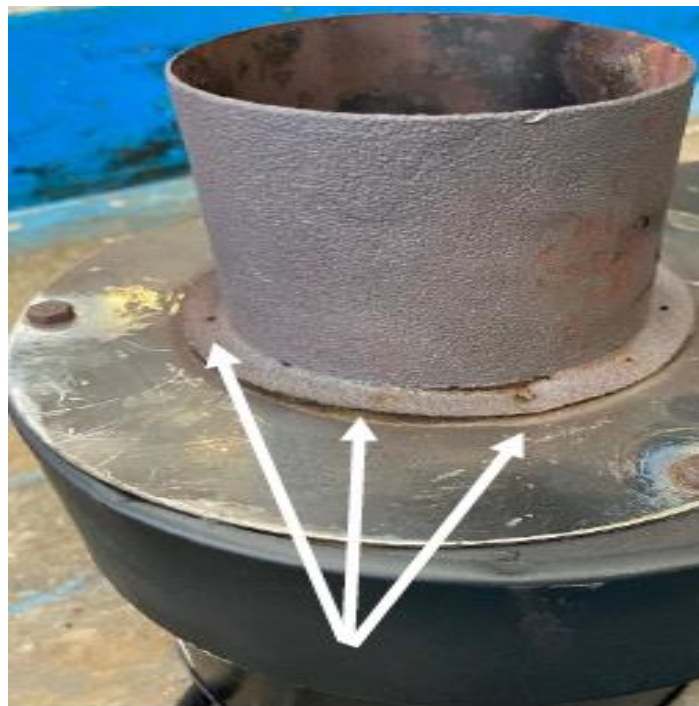
Photograph 4: Fan motor assembly fixing plate and spot-welding points on the spigot that locates onto the radiant tube emitter pipe spot welding is in poor condition, not suitable for further service. A further 60 Fan motor assembly and spigots were checked with a further five been removed due to signs of failure on the spot welding within this establishment gas radiant heater systems.

20. Any Gas Radiant Tube heaters isolated under **Part A** of this Safety Alert are not to be returned to service until it has been subject to appropriate maintenance, testing and inspection and **ALL** remedials identified are completed with emphasis on ensuring that the fan motor assembly fixing plate and spot-welding points spigot that locates onto the radiator emitter pipe are in good condition suitable for further service.
21. On completion of any necessary maintenance, inspection and testing and any remedial work the units can be returned to service.
