# Safety Alert

**Subject: Closed Water System Fluid Release  
from Failed Expansion Bellows Seal (Pipework  
System Component)**

**Number: SA 2021/05**

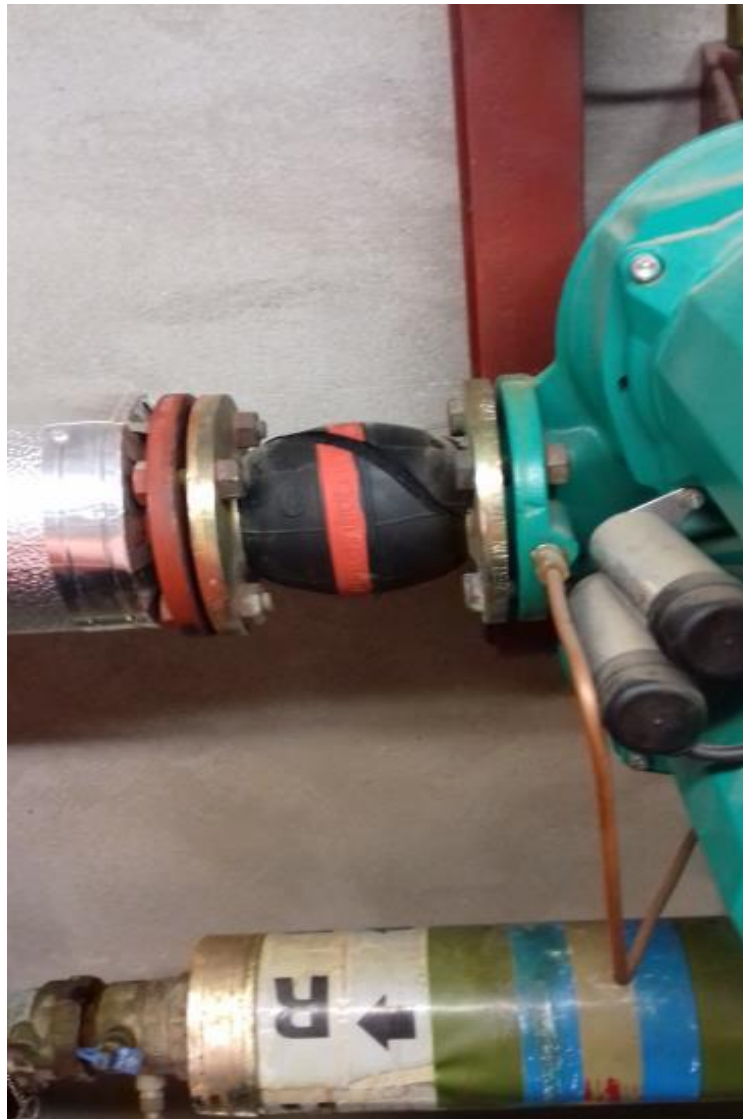
8. This Safety Alert follows the investigation of a recent incident whereby personal injury occurred following servicing and reinstatement of a low temperature hot water (LTHW) boiler to normal operations conditions. The pump expansion bellows seal split releasing hot water that subsequently covered a maintenance operative. The Injured person was wearing 5-point PPE and was able to quickly move away from the affected area, thus avoiding a serious injury from the release. The primary cause of the incident was the failing of a low temperature hot water expansion bellows fitted to the CT pumps sets. (See photograph 1)

Photograph 1 failed and rubber split bellows seal

9. The investigation identified that improvements are required in the planned preventive maintenance task schedules to include expansion bellow seals components to assure the safety of these components on all connected pipe work systems. Where the condition of some of the bellows seals components could have deteriorated further inspection is required to determine if they suitable for further service.
