## ACCIDENT

<b>Aircraft Type and Registration:</b>	Hawker Sea Fury T Mk 20, G-RNHF	
<b>No &amp; Type of Engines:</b>	1 Bristol Centaurus XVIII piston engine	
<b>Year of Manufacture:</b>	1949 (Serial no: ES3615)	
<b>Date &amp; Time (UTC):</b>	28 April 2021 at 1315 hrs	
<b>Location:</b>	Approximately 0.5 nm from Runway 04, RNAS Yeovilton, Somerset	
<b>Type of Flight:</b>	Private	
<b>Persons on Board:</b>	Crew - 1	Passengers - 1
<b>Injuries:</b>	Crew - 1	Passengers - 1 (Minor)
<b>Nature of Damage:</b>	Aircraft destroyed	
<b>Commander's Licence:</b>	Airline Transport Pilot's Licence	
<b>Commander's Age:</b>	60 years	
<b>Commander's Flying Experience:</b>	11,550 hours (of which 36 were on type) Last 90 days - 146 hours Last 28 days - 55 hours	
<b>Information Source:</b>	AAIB Field Investigation

## Synopsis

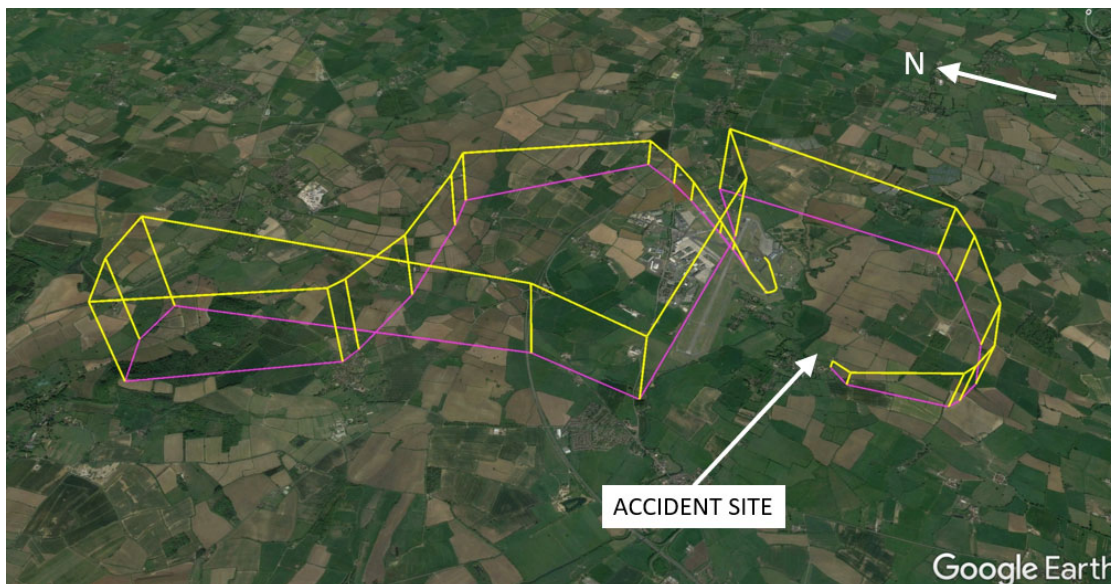
**Figure 1**

Accident flightpath (Image Landsat/Copernicus © 2022 Google)

The flight time between the start of the takeoff roll and the last recorded position was 5 minutes 30 seconds. It is estimated that the rate of descent, during the glide once the engine had seized, was between 7,000 and 10,000 fpm.

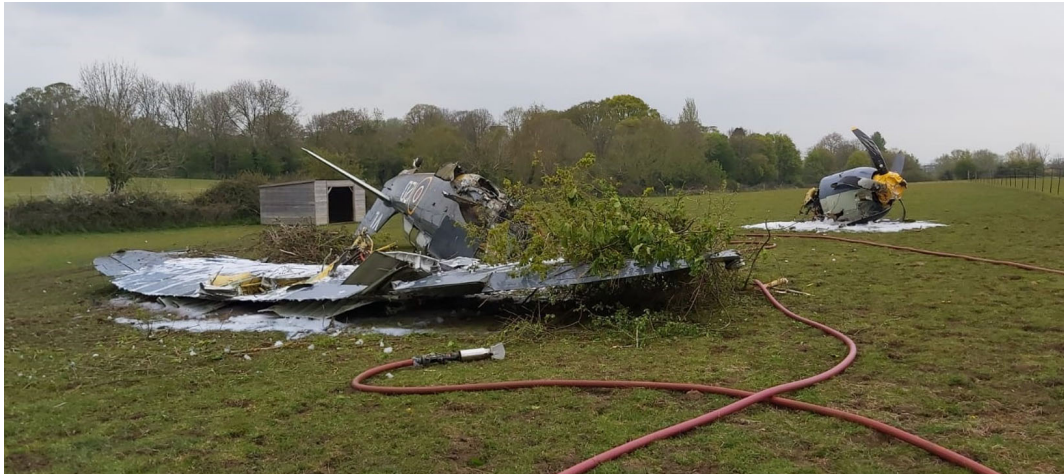
**Figure 2**

The aircraft initially struck a telegraph pole, having cleared the roof of a nearby house by approximately 6 m, before it then struck the ground in a level attitude in an area of paddocks. Ground marks showed that the right main landing gear and tailwheel were extended when the aircraft touched down, however the right mainwheel then separated from the leg, which folded rearwards underneath the wing. The left main landing gear was found retracted in the wing. The aircraft slid across the surface of the paddock before striking a hedge which covered a shallow earth berm, causing the wing and engine to separate from the fuselage (Figure 2). The length of the wreckage trail from the first ground scar to the engine, which had travelled beyond the fuselage, was 95 m.

The fuselage came to rest inverted, supported by the fin and the right tailplane. It was covered in a light sheen of engine oil, which was described as normal for the type by a maintenance engineer familiar with the aircraft. No fire had occurred. The propeller was in fine pitch and all five blades were folded rearwards due to ground contact.

Accident site (courtesy of Defence Accident Investigation Branch)

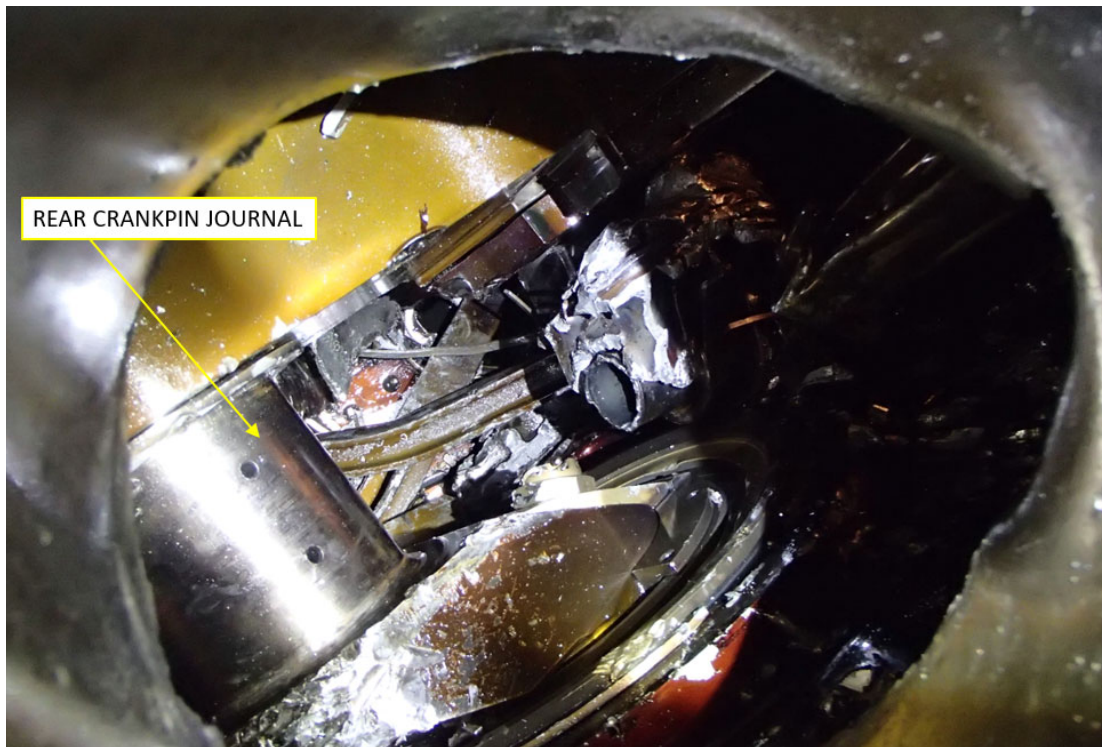
**Figure 8**

The propeller and engine cowlings were removed along with three cylinders from the rear row which revealed that the master rod and crankpin bearing had broken up, leaving the rear crankpin journal exposed (Figure 8). The remains of fractured articulated rods and pistons were visible in the bottom of the rear crankcase.

View inside the rear crankcase, looking down the No 17 cylinder

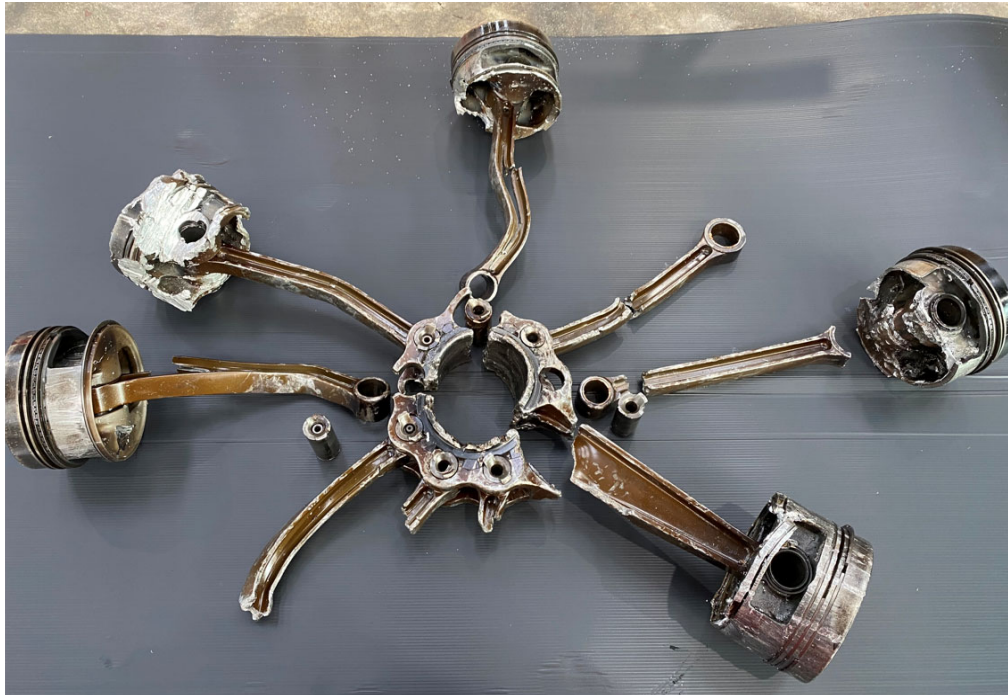
**Figure 9**

The engine was disassembled which showed that the front row components were largely intact, with only minor impact damage evident from debris liberated by the rear row that had entered the front row through the crankcase lightening holes. The rear master rod and articulated rods were fractured in multiple locations (Figure 9).

Front view of reassembled components of the rear row master and articulated rod assembly

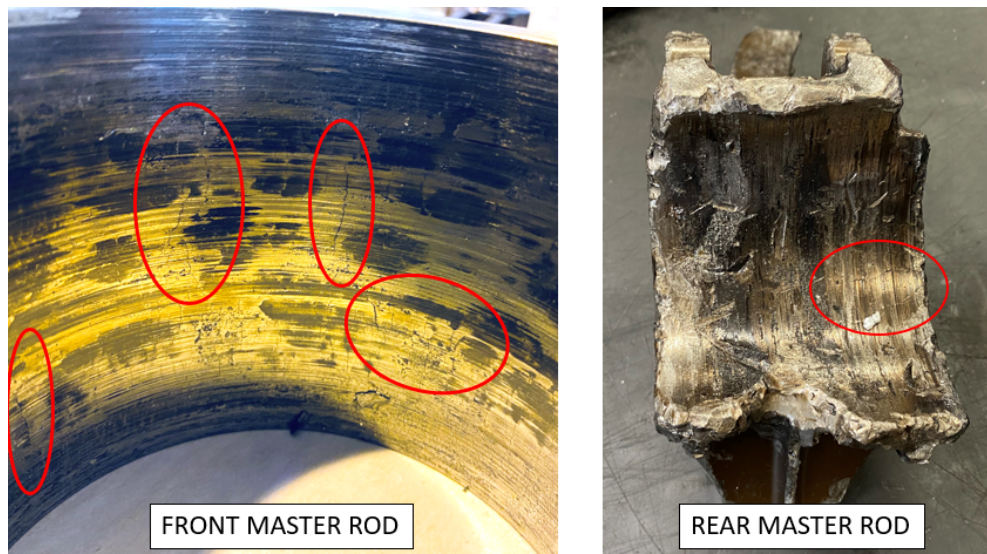
**Figure 10**

The fractured sections of the master rod big end showed evidence of overheating and a large number of cracks were present on the face of the master rod big end bore (Figure 10). The front master rod bore exhibited similar cracking. Examination of the cracks in the rear master rod bore showed that they were intergranular, following grain boundaries, and were coated with tin. Metallurgical assessment of the cracks noted that they were likely caused by liquid metal embrittlement (LME) of the master rod steel material with molten tin from the crankpin sleeve bearing. Three conditions are required for rapid crack propagation in steel due to LME with tin; the steel must be in a state of tension, with the steel surface free of oxidation and the liquid tin must intimately wet the steel surface. All three conditions were present in the master rod big end bores during the engine failure.

Cracks (circled) in the front and rear master rod big end bores

The failure of the rear master rod resulted from overheating of the rear crankpin bearing, which caused its white metal bearing layer to melt. Increased friction between the crankpin bearing and the master rod bore was sufficient to shear the bearing sleeve's dogs, allowing the sleeve to spin on the crankpin journal. The molten tin liberated from the overheated bearing caused LME of the rear master rod big end. This promoted rapid crack propagation in the big end, leading to its eventual fracture into three main sections under the high loads imposed on it whilst the engine was running.

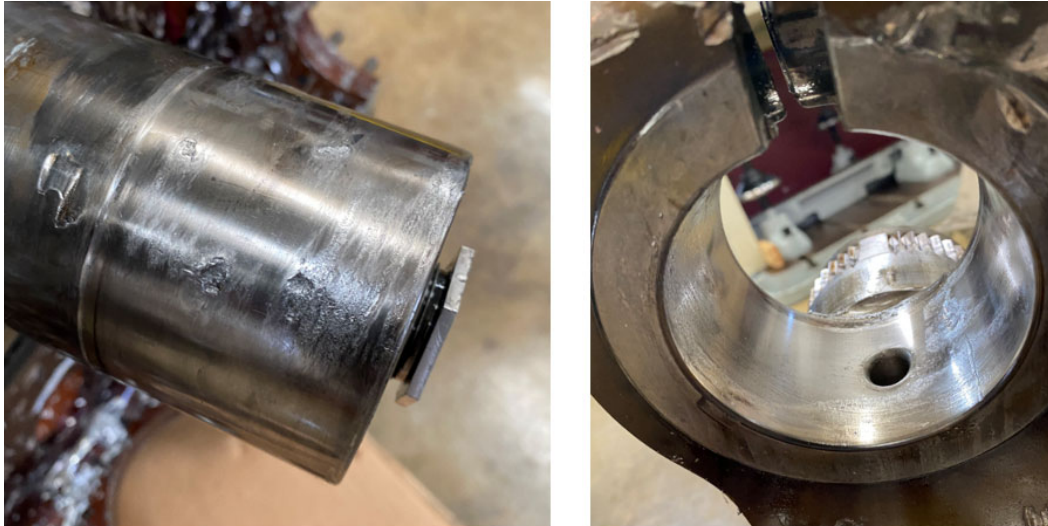
**Figure 11**

The rear half of the crankshaft was bent and the rear maneton joint had slipped, opposite to the direction of crankshaft rotation, due to contact between the rear counterweight and debris within the rear crankcase liberated during the engine failure. Fretting marks were present on the mating surfaces of the rear maneton joint (Figure 11). The crankshaft rear main roller bearing had failed in overload.

Fretting damage to the rear maneton joint

Both rear maneton bolts were mechanically damaged due to impacts. The degree of stretch present in the rear maneton bolts was measured during disassembly and found to be 0.009" for the rearmost bolt and 0.004" for the adjacent bolt. This was lower than the specified range of 0.013" - 0.015", which was recorded as being applied to both rear maneton bolts in the engine overhaul records. The elemental composition and hardness of the maneton bolts were analysed, which showed that they were manufactured from BS S97 steel rather than BS S65 steel as specified on the bolt's part drawing. BS S97 has similar mechanical properties to BS S65. The bolts were found to geometrically conform to drawing requirements.

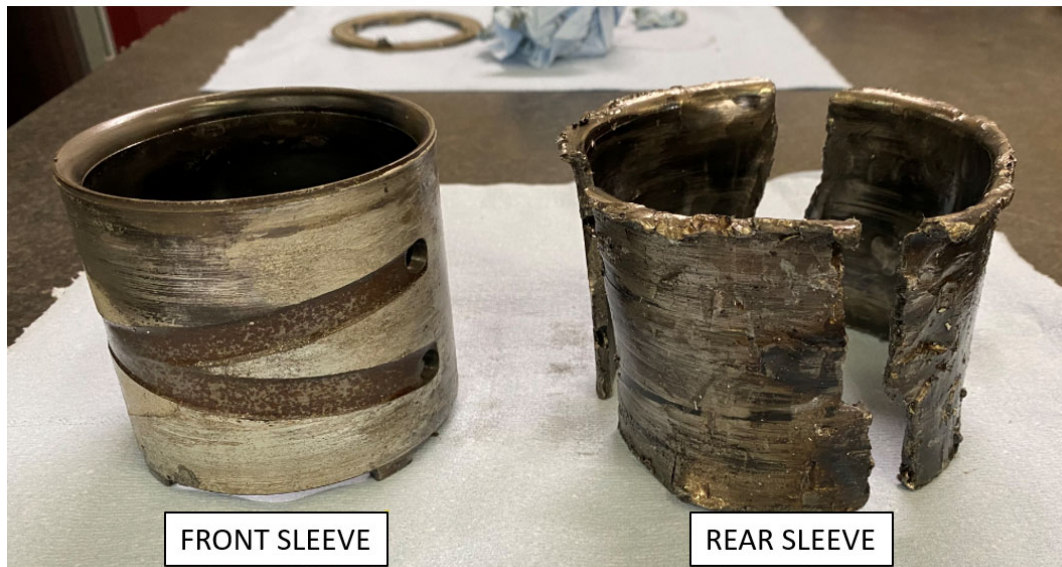
**Figure 12**

The rear crankpin sleeve bearing was broken into three pieces (Figure 12). The sleeve's locating dogs were sheared off and it had spun on the crankpin. The sleeve had overheated, causing the white metal bearing layer to melt and little bearing material was left on the sleeve.

Metallurgical analysis of the rear crankpin bearing confirmed the elemental composition of the white metal bearing material, along with lead bromide deposits, which are formed during the combustion of avgas fuel containing tetraethyl lead. The examination also revealed a small deposit of cadmium that had melted and resolidified on the bearing's surface, indicating that the bearing temperature exceeded 321°C during the engine failure. The source of the cadmium was considered to be a fragment of cadmium plating from elsewhere within the engine, liberated during the failure sequence.

Front and rear crankpin sleeve bearings

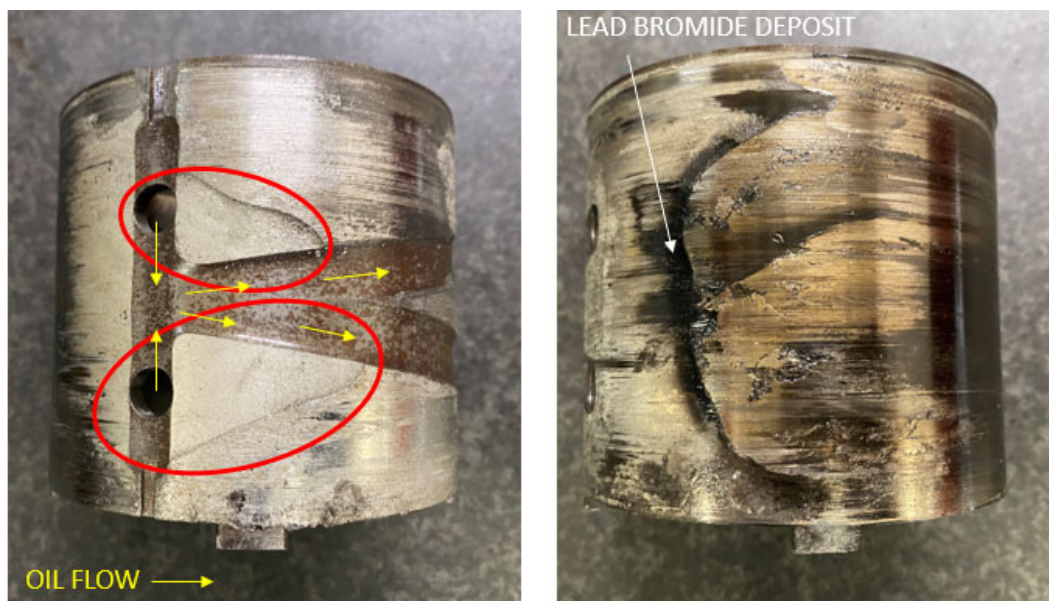
**Figure 13**

The front crankpin bearing had missing regions of white metal bearing material adjacent to the oil entry holes (Figure 13). Examination of the missing bearing material under a scanning electron microscope showed that an antimony-tin phase of the white metal had melted due to contact with oil in excess of 232°C, leaving behind a copper-tin phase of the material which remained due to it having a higher melting point of 344°C. Some of the bearing material had been smeared, due to contact with the master rod bore once the lubricating oil-film was lost. The sleeve's locating dogs were intact and it had not rotated on the front crankpin.

Front crankpin sleeve bearing, with missing bearing material circled

The damage sustained by the front crankpin bearing was caused by excessively hot oil flowing to it through the rear crankshaft, which had been heated by the failed rear crankpin bearing. This shows that some oil was still circulating within the high-pressure oil system whilst the rear crankpin bearing failure was underway. The overheated oil caused the partial melting of the front crankpin bearing, leading to similar LME-cracking of the front

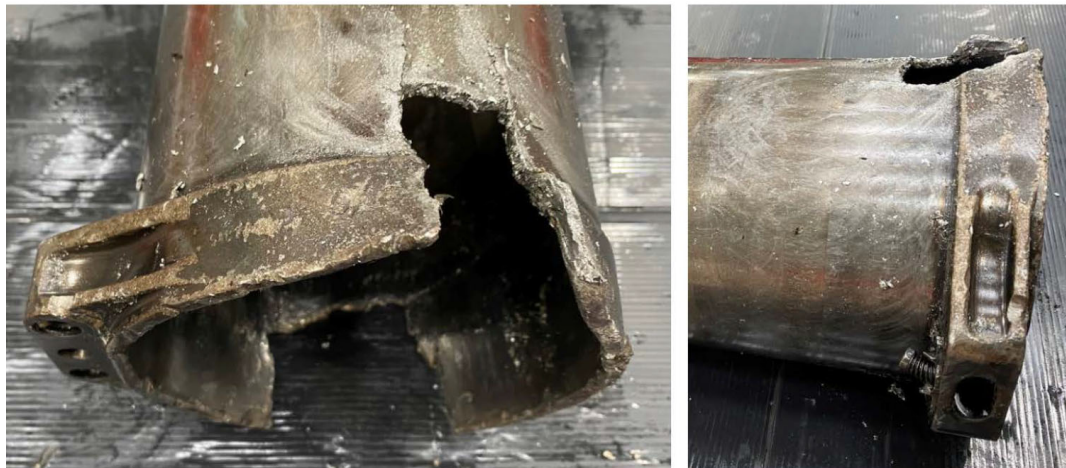
**Figure 14**

The rear row sleeves were all damaged at their bottom ends due to impacts received during the engine failure (Figure 14). The sleeve drives for cylinders 3, 5 and 9 had failed in shear overload and 11 had failed in bending due to an impact. The front row sleeves were largely undamaged apart from cylinders 6, 12 and 14 which had received light impact damage at their bases. The sleeve drives for cylinders 10 and 14 had failed in shear overload. All of the sleeves in both rows of cylinders exhibited elliptical scoring marks on their outer surfaces, indicating that they were all being driven normally whilst metallic debris was circulating in the engine oil system. No significant corrosion was observed on any of the engine components.

Typical impact damage to bottom end of a rear row sleeve (No 7 shown)

Despite the re-nitriding of the rear row's number 7 sleeve, which was not permitted under modification E.3338, there was no evidence to suggest that this contributed to the rear crankpin bearing failure. The sleeve had not seized in the cylinder bore and the lug at the base of the sleeve remained attached to its sleeve crank drive. All sleeves within the engine exhibited similar elliptical surface scoring due to contact with metallic debris in the engine oil whilst the sleeves were moving through their normal range of movement. Therefore the initiating event in the engine failure sequence preceded any subsequent failure of the rear row sleeves.

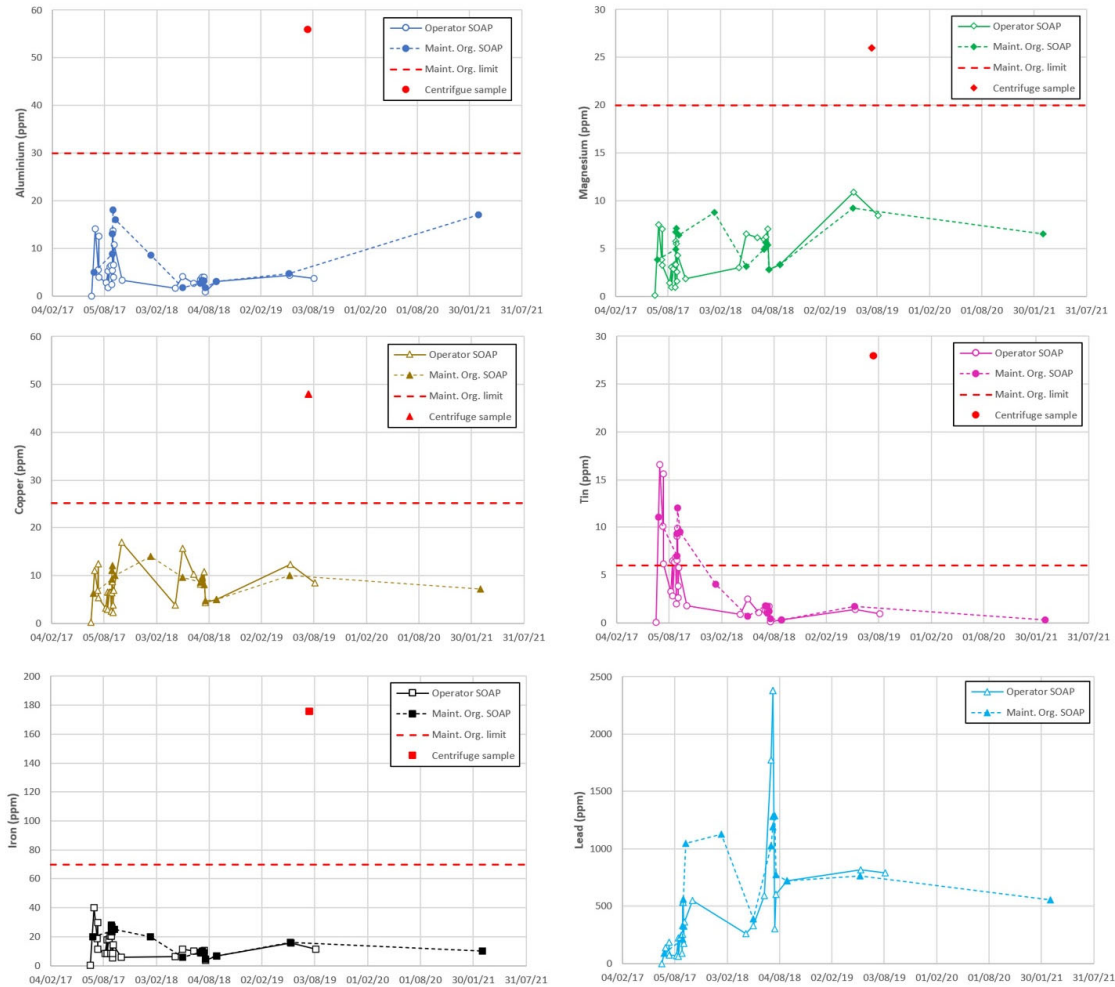
**Figure 15**

The oil analysis results were monitored by the maintenance organisation and did not give cause for any unscheduled maintenance or other investigation. Levels of tin above the warning level were ascribed to 'bedding in' of the sleeve-drive gears, which had been tin-plated during the engine overhaul. Relatively high levels of lead in the oil, thought to originate from tetraethyl lead in the avgas fuel, were seen to reduce to normal levels following an engine oil change. No warning level had been set for lead concentration level.

Summary of SOAP programme data

No pre-accident defects were identified in the engine oil system or its associated components. An unusually large number of oil samples were analysed for the SOAP programme, however after an initial 'wear-in' period, the oil analysis did not show any adverse trend that would have prompted the maintenance organisation to carry out unplanned maintenance or investigative activity.
