## ACCIDENT

<b>Aircraft Type and Registration:</b>	Grumman AA-5, G-BBSA
<b>No &amp; Type of Engines:</b>	1 Lycoming O-320-E2G piston engine
<b>Year of Manufacture:</b>	1974 (Serial no: AA5-0472)
<b>Date &amp; Time (UTC):</b>	25 September 2021 at 0837 hrs
<b>Location:</b>	Teesside International Airport
<b>Type of Flight:</b>	Private
<b>Persons on Board:</b>	Crew - 1                      Passengers - 2
<b>Injuries:</b>	Crew - 1 (Serious)      Passengers - 2 (Serious)
<b>Nature of Damage:</b>	Aircraft destroyed
<b>Commander's Licence:</b>	Light Aircraft Pilot's Licence (A)
<b>Commander's Age:</b>	63 years
<b>Commander's Flying Experience:</b>	1,614 hours (of which 830 were on type)) Last 90 days - 79 hours Last 28 days - 29 hours
<b>Information Source:</b>	AAIB Field Investigation

## Synopsis

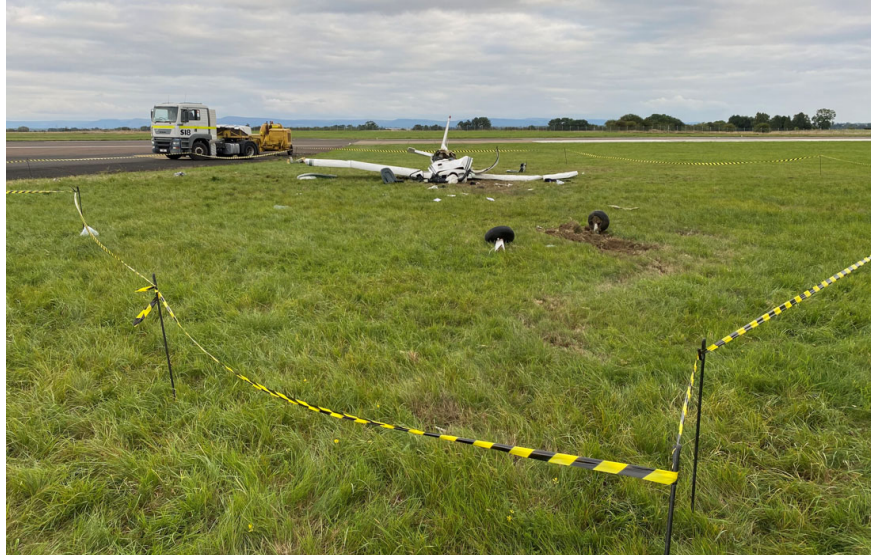
**Figure 3**

Accident site, looking south with the Runway 05 threshold behind

The aircraft had struck the ground with its left wingtip and, following a significant nose impact, had then rotated approximately 180°, coming to rest 11 m beyond the main impact ground scar. There was a strong smell of fuel at the accident site, but the RFFS had sprayed the aircraft with foam shortly after their arrival and no fire had occurred. The flaps were up.

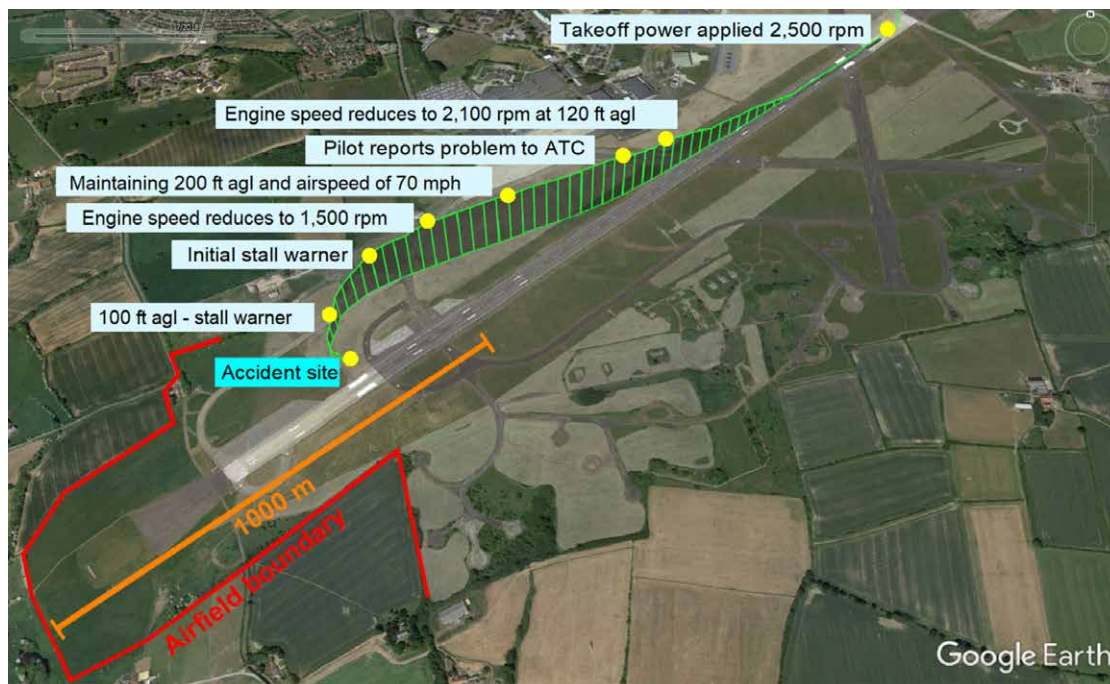
**Figure 5**

The aircraft's engine continued to operate at about 2,100 rpm for the next 10 seconds, with the airspeed and height stabilised at about 70 mph (61 kt) and 200 ft agl respectively. However, when the aircraft was almost overhead the intersection of taxiways C and D, the engine speed further reduced to about 1,500 rpm and, whilst maintaining altitude, airspeed quickly reduced to about 64 mph (56 kt). This coincided with a brief activation of the stall warner in the cockpit. The aircraft then started to turn left towards the runway whilst descending. The aircraft's bank angle continued to increase, and its descent rate reached about 1,000 fpm. As the aircraft reached a height of about 100 ft agl, the stall warner activated again, and continued to sound, until the aircraft struck the ground five seconds later. It was estimated that the aircraft's bank angle had reached about 40° during the final descent.

Aircraft flight path during the accident flight  
© 2021 Google, Image © Maxar Technologies

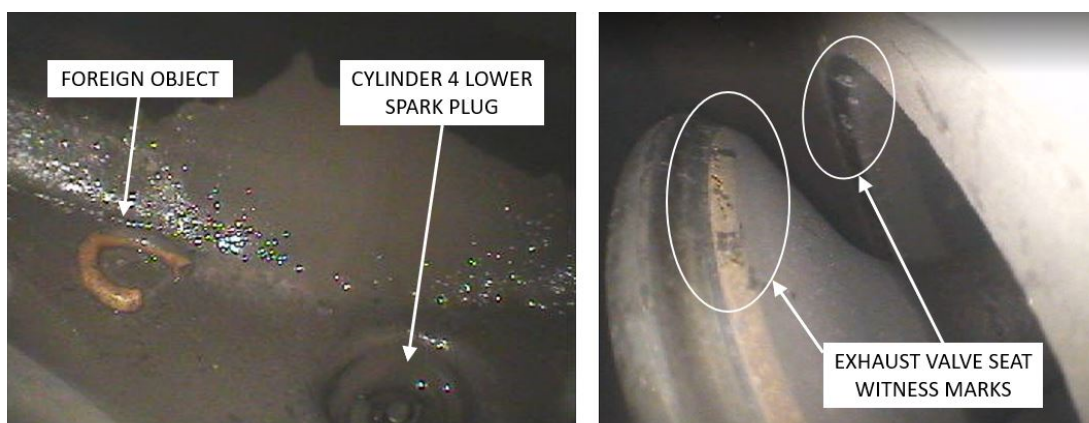
**Figure 7**

The engine basic compression test was repeated once the aircraft wreckage was recovered to the AAIB, but this time a normal degree of compression was noted on all four cylinders. Borescope inspection of cylinder No 4 revealed that a C-shaped foreign object was present in the cylinder (Figure 7). Witness marks were present on the exhaust valve seat faces caused by contact of a hard foreign object, which would have prevented the exhaust valve from closing correctly. It was considered likely that the C-shaped foreign object had been trapped beneath the exhaust valve when the engine was examined at the accident site, but that it had come loose during transportation to the AAIB.

Borescope images inside cylinder No 4

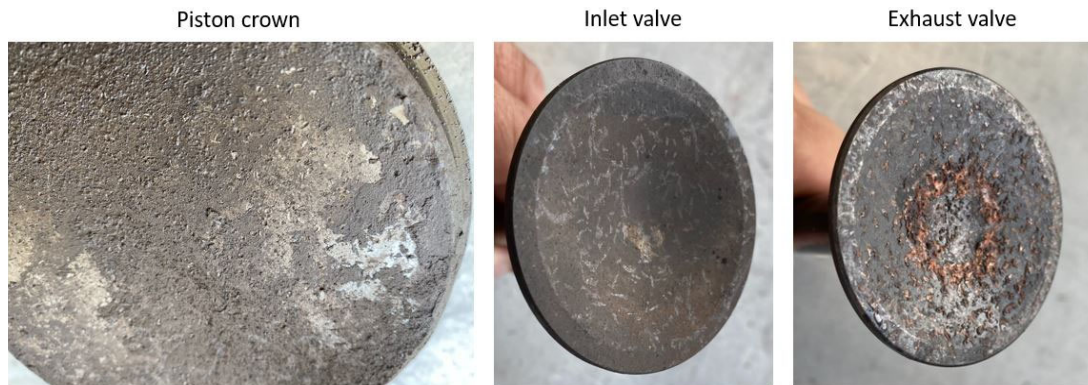
**Figure 8**

The No 4 cylinder was removed from the engine and the piston crown, inlet and exhaust valve surfaces were examined. Numerous hard-body impact marks were present on the piston crown, and the faces of the inlet and exhaust valves also showed impact marks where combustion residues had been removed from the valve faces (Figure 8). No such impact marks or foreign objects were observed in Nos 1, 2 or 3 cylinders.

Impact marks on cylinder No 4 piston crown, inlet and exhaust valves

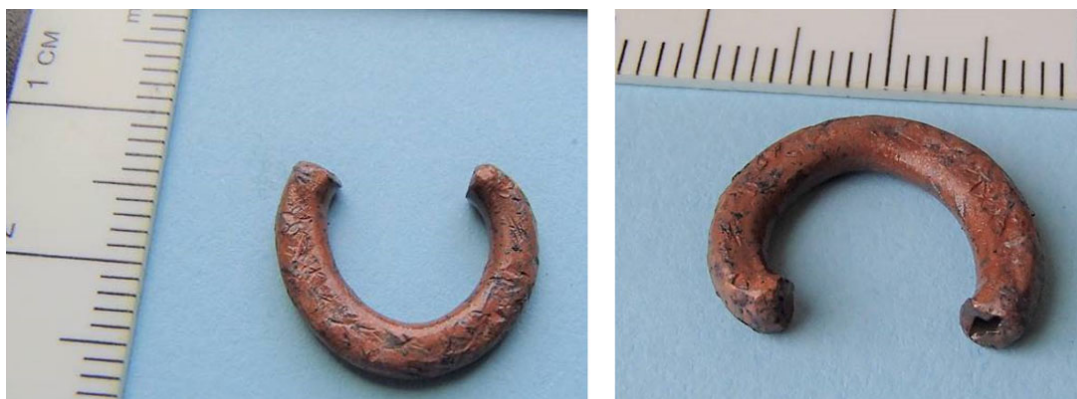
**Figure 9**

The aircraft's exhaust muffler was cut open, but no additional foreign objects were identified within. The C-shaped foreign object was of tubular cross section which had been flattened due to impacts on the tube's outer diameter (Figure 9).

Foreign object recovered from No 4 cylinder

The foreign object was examined by a metallurgist who confirmed that it was a section of brass tube, composed of 'cartridge brass'<sup>6</sup>, which the carburettor manufacturer confirmed was the same material specified for the accelerator pump discharge tube<sup>7</sup>. A section of the foreign object was subjected to a micro-hardness test, which showed an average hardness value of 95 HV<sup>8</sup>. The carburettor manufacturer stated that the hardness condition specified for the discharge tube material was ½ hard<sup>9</sup>, which equates to approximately 126 HV. The metallurgist considered that the lower measured value of 95 HV is consistent with the foreign object being stress-relieved in the elevated temperatures of the engine's No 4 cylinder.

The foreign object found in the No 4 cylinder was a portion of the accelerator pump discharge tube that had released from the carburettor and been drawn into the cylinder by the induction airflow. The discharge tube had broken up due to contact with the inlet and exhaust valves, during which the ability to seal the cylinder during the engine power stroke was lost. The engine was therefore running on only three cylinders, resulting in high vibration and a considerable loss of power.

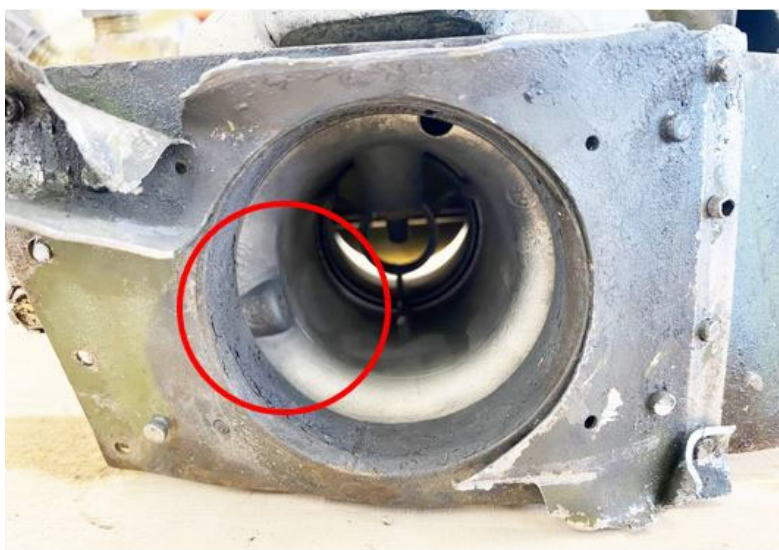
**Figure 10**

When G-BBSA's carburettor was examined, it was noted that the accelerator pump discharge tube was missing (Figure 10).

Missing accelerator pump discharge tube from G-BBSA carburettor

Although the issue of the release of the discharge tube does not appear to be a widespread problem, the CAA have agreed to discuss the airworthiness concerns relating to such events with the FAA, at their next joint Continued Operational Safety Working Group meeting. This will ensure that the FAA is aware of the findings of this investigation in their role as the regulator of the engine's Type Certificate holder.
