ACCIDENT

Aircraft Type and Registration:	Rogers Sky Prince, G-CJZU	
No & Type of Engines:	1 Continental Motors Corp O-200-A piston engine	
Year of Manufacture:	2009 (Serial no: 00118-1507)	
Date & Time (UTC):	30 June 2021 at 1536 hrs	
Location:	Near Goodwood Aerodrome, West Sussex	
Type of Flight:	Private	
Persons on Board:	Crew - 1	Passengers - 1
Injuries:	Crew - 1 (Fatal)	Passengers - 1 (Fatal)
Nature of Damage:	Aircraft destroyed	
Commander's Licence:	Private Pilot's Licence	
Commander's Age:	65 years	
Commander's Flying Experience:	706 hours (of which 16 were on type) Last 90 days - 89 hours Last 28 days - 19 hours	
Information Source:	AAIB Field Investigation

Synopsis

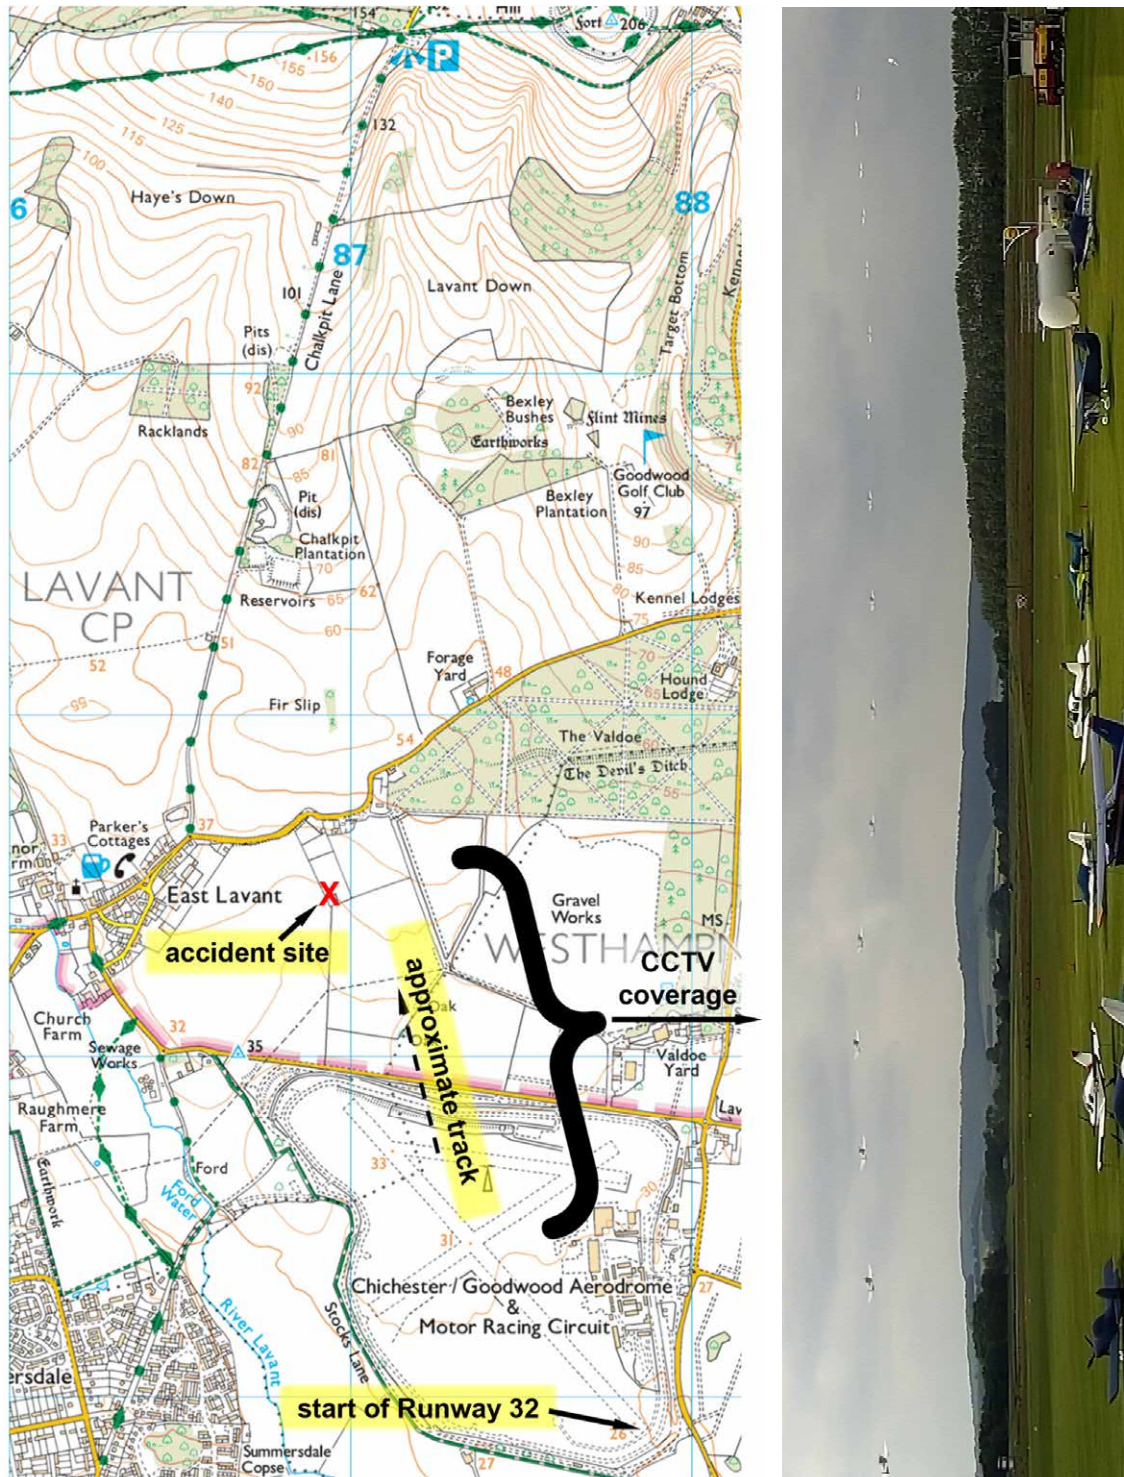
Figure 1

CCTV showed the aircraft level or begin to descend shortly after the noise abatement turn. A decrease in pitch attitude can be seen on the CCTV lasting around seven seconds before the pitch attitude increased again. Approximately 30 seconds later, the aircraft began a gentle turn to the left but rapidly became unstable with an increasing bank angle and the nose began to drop. The aircraft was last visible dropping behind a tree line with a very nose low attitude and a high bank angle. The aircraft struck the ground at 1536 hrs having turned through almost 180° to be facing the aerodrome. Both the pilot and passenger were fatally injured.

Approximate ground track (note rising ground at the top of the chart) and composite image from CCTV showing G-CJZU flightpath (two-second spacing between aircraft)

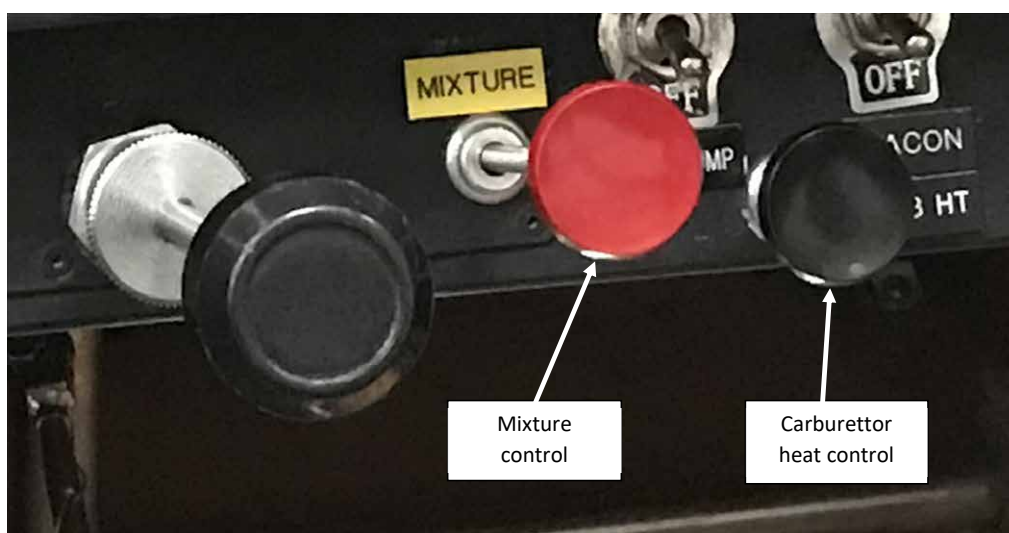
**Figure 3**

The aircraft engine mixture control was a pull/push lever with a red round knob fitted on the end. This mixture control was the same shape and had very similar dimensions as the engine carburettor heat control lever which was fitted next to it. The only difference between the two levers was the colour of the knob fitted to the end. The controls are shown in Figure 3.

Cockpit controls (used with permission)

Although it was not a requirement on G-CJZU, it is good practice that such controls have different shapes and/or movement to ensure that a pilot does not inadvertently operate the wrong control.

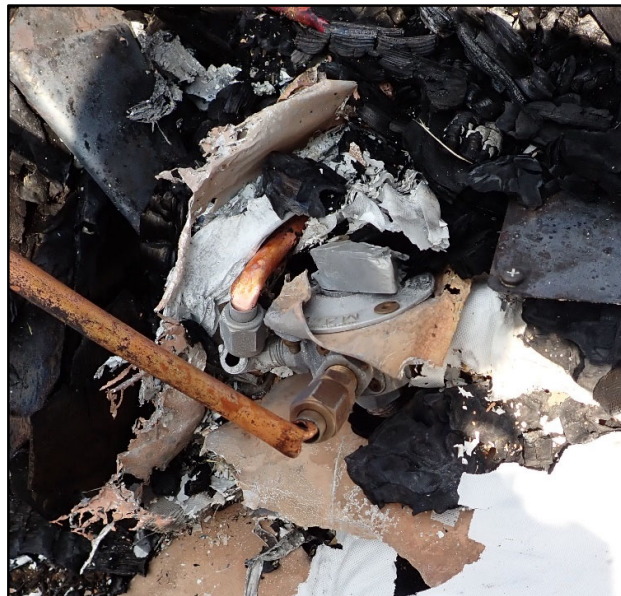
Figure 4
Fuel Selector Valve

The main aircraft structure had been severely damaged by the fire, the most significant identifiable structure were the main wing spars, but even these had been almost completely burned. Examination of the steel control lines showed no evidence of loss of integrity of the flight control system. Whilst the control surfaces which connected to the control lines had been destroyed by the fire, the steel elements of the connections were intact. Due to the angle at which the aircraft struck the ground, the cockpit was severely damaged. Electrical wiring looms had suffered extensive heat damage. The fuel system had been fragmented by the impact; the wing fuel tanks had been separated from the fuel pipes which had been distorted, bent and fractured by the impact forces. The electric fuel pump was in place, but both the inlet and outlet pipes had become separated from the pump, this was likely due to the effects of heat on the pump housing. It was not possible to obtain a fuel sample from the aircraft fuel system. The aircraft was predominantly refuelled at Goodwood, and no other aircraft reported issues with fuel supplied from the same source as G-CJZU. The main fuel selector valve was relatively undamaged (Figure 4).

The fuel selector valve was inspected, tested and disassembled at the manufacturer's facility. The valve was found to be assembled correctly and functioning satisfactorily, and the valve position correlated with the valve switch position, which was selected to the right hand tank.

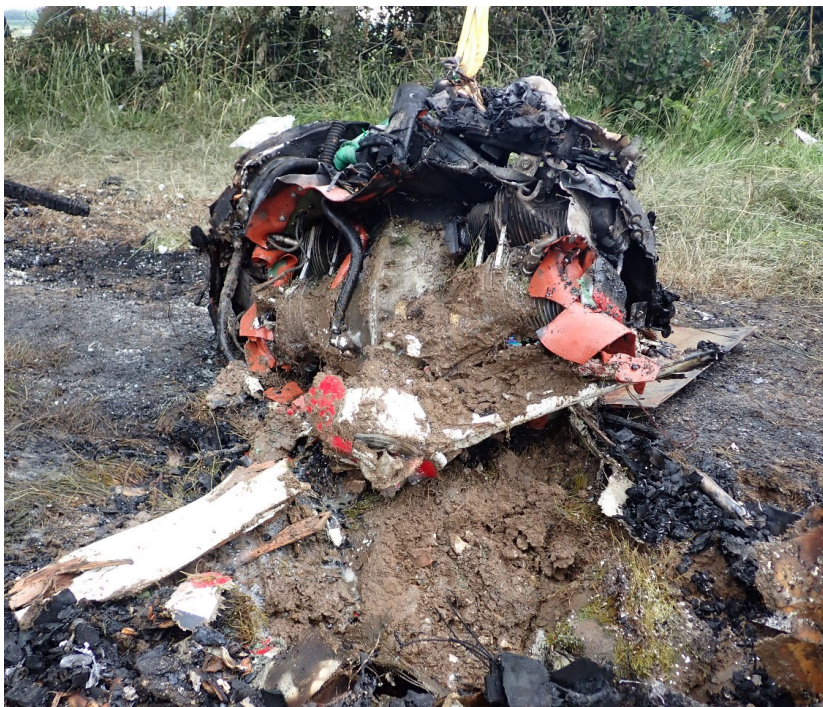
Figure 5

The engine, whilst having suffered some impact damage was relatively intact. The carburettor had been almost completely sheared off its attachment and the fuel inlet hose connector had been destroyed by the impact. The propeller had been fragmented on impact, but the propeller hub and part of the blade were still connected to the engine (Figure 5).

Engine recovered at accident site

The engine was stripped and inspected at an engine overhaul facility. This included the fuel pump, magnetos and spark plugs, carburettor, as well as the mechanical components. There was no evidence of any pre-existing defects that could not be explained by the ground impact or the post-impact fire.
