# Annual Safety Review 2021

Published 14 June 2022

Air Accidents Investigation Branch  
Farnborough House  
Berkshire Copse Road  
Aldershot  
Hampshire  
GU11 2HH.

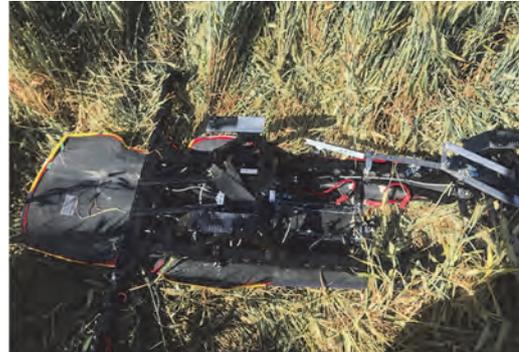
UA as found (inverted) at the accident site

The AAIB found that the Alauda Airspeeder Mk II was not designed, built or tested to any recognisable standards and that its design and build quality were of a poor standard. The operator's Operating Safety Case contained several statements that were shown to be untrue.

It is recommended that Riotplan Proprietary Limited, trading as Alauda Racing, amends its processes to ensure that it designs, builds and tests unmanned and manned aircraft in accordance with appropriate standards to ensure the safety of those who may be affected by their operation.

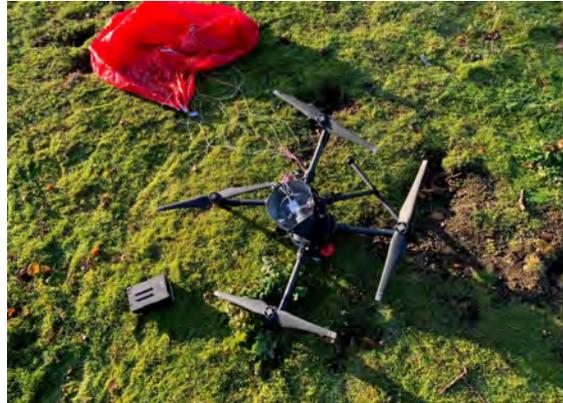
The DJI Matrice 200 Unmanned Aircraft System (UAS) was being operated on an automated flight plan to conduct an aerial survey. On the fifth flight of the day, while the aircraft was at a height of 100 m, the ballistic parachute recovery system fitted to the aircraft activated. The aircraft descended under the parachute and was subsequently found on the roof of a nearby house.

Aircraft after parachute deployment  
on 29 November 2019

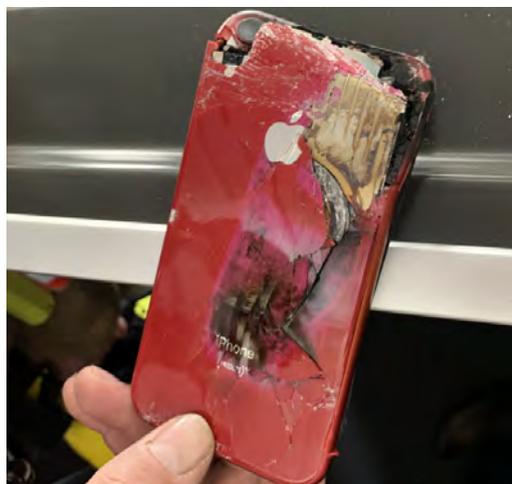
The aircraft was approaching the top of descent when the cabin crew saw smoke emanating from a passenger seat. It was discovered that a mobile phone had fallen down the side of the seat and had been crushed in the seat mechanism. The cabin crew extinguished the fire and the aircraft continued to its destination. There was no damage to the aircraft.

Mobile phone retrieved by the fire service after landing

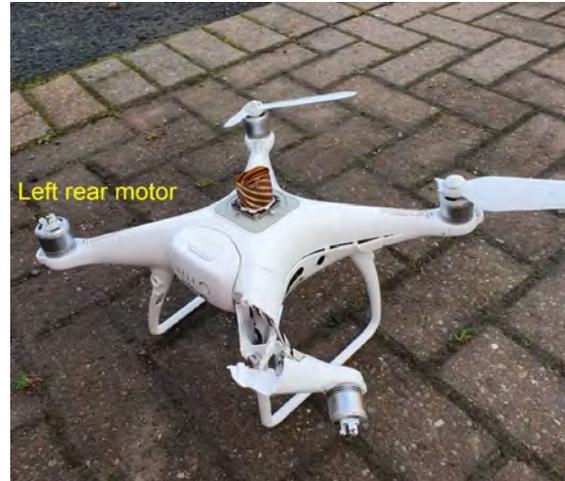
The UAS, a DJI Phantom 4 RTK, was being operated in an automated flight mode to survey a railway track and surrounding infrastructure when one of the four propellers detached whilst in-flight. The aircraft rapidly descended from a height of 70 m (230 ft) where it struck the ground in the rear garden of a house. No persons were injured.

Aircraft after being recovered from garden

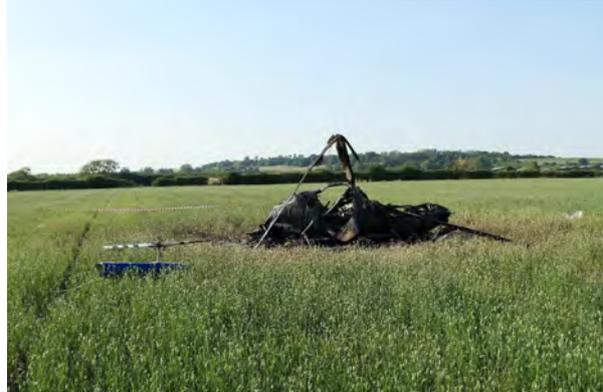
The pilot and passenger were returning to Thrupton Aerodrome following a short flight over the Malvern hills when the engine failed. The pilot executed an autorotation landing in a field near Long Marston, after which they were both able to exit the helicopter without injury. However, the tail boom was severed during the landing and the helicopter was destroyed by fire. The investigation found that the engine suffered an uncontained failure of the gas producing turbine disc due to insufficient oil reaching the bearings as a result of an oil leak. Due to the extensive damage to the helicopter it was not possible to determine the cause of the oil leak. Two Safety Recommendations were made regarding the Failure Mode and Effects Analysis for the engine, and the fire resistance and crashworthiness of aircraft components. The helicopter manufacturer undertook two Safety Actions regarding advice to pilots, and one Safety Action regarding analysis of the airframe fuel filter.

Main wreckage

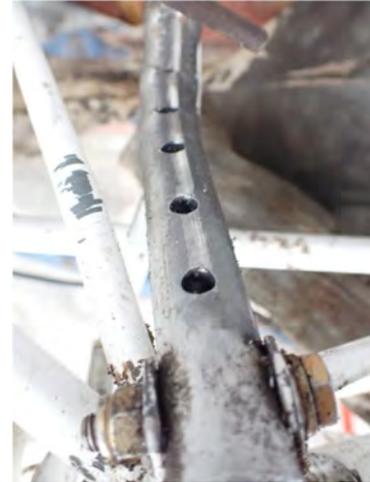
The aircraft was seen to takeoff and climb steeply while appearing to sideslip and drift off the runway centreline. It climbed to approximately 180 ft agl at which point the left wing dropped, the aircraft departed from controlled flight and it descended rapidly to the ground. The pilot was fatally injured. The evidence indicates that the seat moved rearwards leading to the pilot losing control of the aircraft. The cause of the seat movement is under investigation. Three Safety Recommendations were made.

Marks created on the pilot's seat adjustment rail by the pin

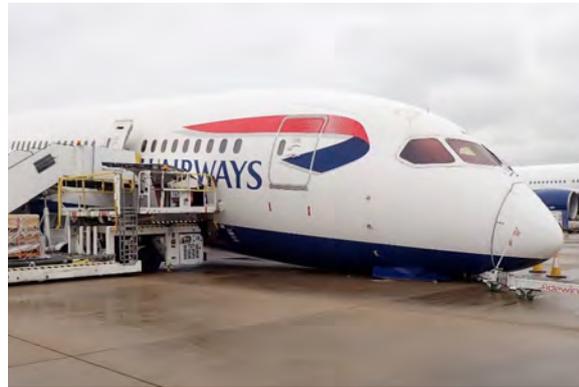
Whilst the aircraft was being loaded with cargo in preparation for a flight to Frankfurt, and whilst carrying out a Dispatch Deviation Guide (DDG) procedure to clear maintenance messages relating to an existing Acceptable Deferred Defect (ADD), the Nose Landing Gear (NLG) retracted. This caused damage to the lower nose, NLG doors and engine cowlings. Door 2 left (Door 2L) struck the top of the mobile steps which resulted in the door separating from the fuselage and one person, operating the cargo loader positioned at the forward cargo hold, received minor injuries.

Pallet cargo loader positioned at the forward cargo door

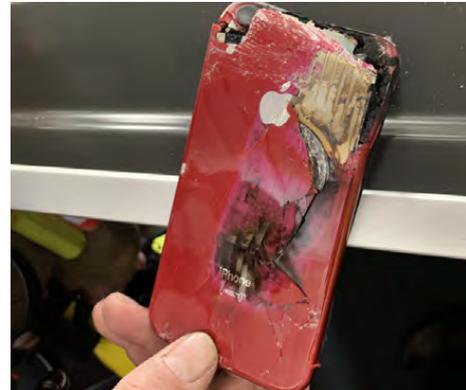
There have been several reports of similar events occurring leading to smoke in the cabin. There are currently no seat design requirements to prevent electronic devices from becoming trapped in seats. Manufacturers and regulators are aware of this issue but it has proven challenging to find a workable solution.

Mobile phone retrieved by the fire service after landing

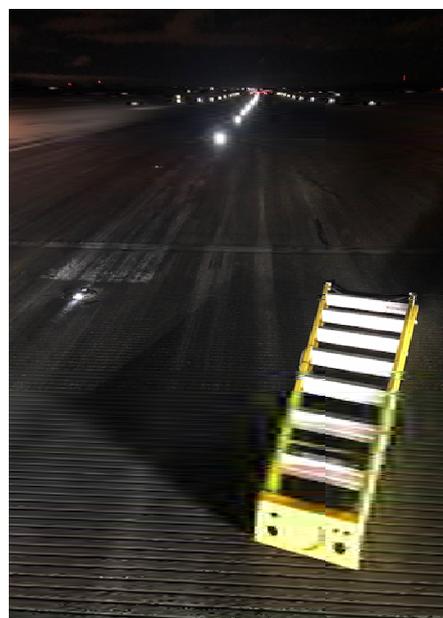
After completing some routine maintenance on the approach lights to Runway 33 at Birmingham Airport, two airport engineering services technicians drove along the runway in an airport works pickup truck en route to their next task. In the back of the pickup truck (known as Work Vehicle 4 - WV4) was a step ladder that they had been using. As they drove through the touch down zone, the ladder came out of the vehicle and came to rest just to the right of the runway centreline. Three aircraft subsequently landed on Runway 33. The first two aircraft reported that they might have seen something on the runway during landing but could not be certain that it was not paint markings. Having been informed of the reports of the two preceding aircraft, the third aircraft elected to land, following which the flight crew notified ATC that they had seen a ladder on the runway. The ladder had been on the runway for 37 minutes before it was retrieved by the airport safety team.

View up Runway 33 with the ladder in the approximate position it was found

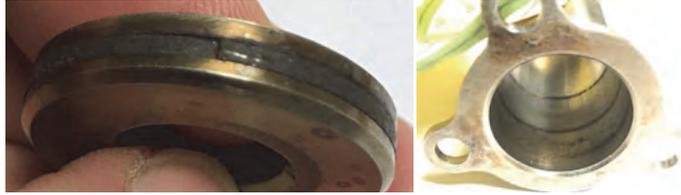
Two separate cabin smoke events were reported while starting the engines on different aircraft in the operator's fleet. The operator concluded that low utilisation of the aircraft and a high amount of airborne salinity resulted in corrosion forming on the P2.5/P3 engine air switching valve, sufficient to prevent it from fully closing. With the valve partially open, contaminated air from the engine was able to enter the cabin.

Corrosion found on piston and sleeve inner bore  
(Images used with permission of the operator)

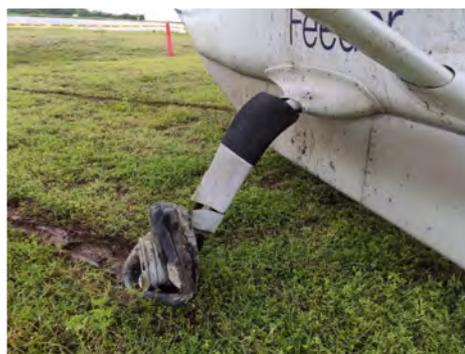
Damage to right wheel assembly

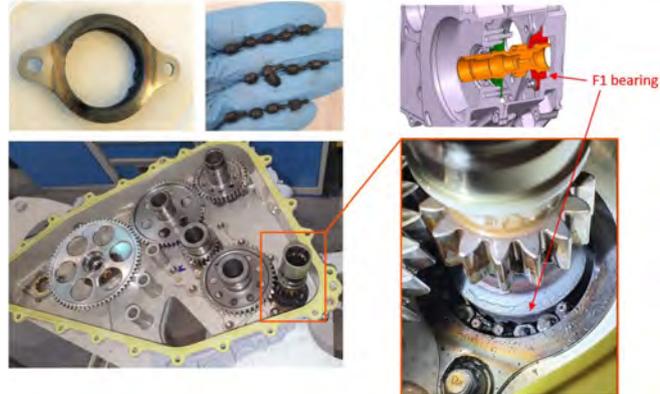
Failed F1 bearing in the LAGB  
(image used with permission of Airbus Helicopters)

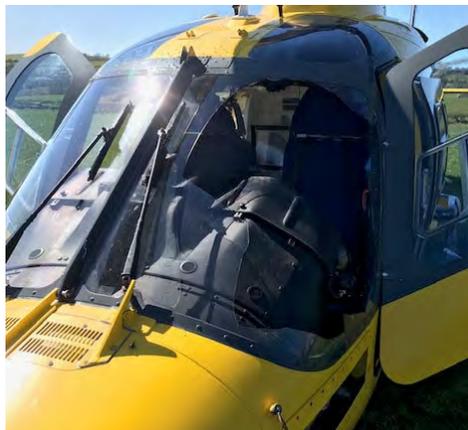
Damage to the left windshield

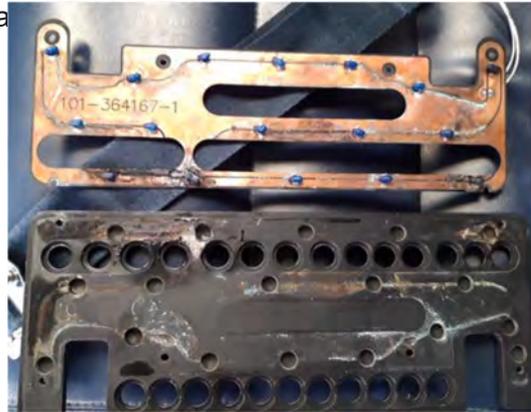
CB panel showing evidence of moisture ingress and overheating

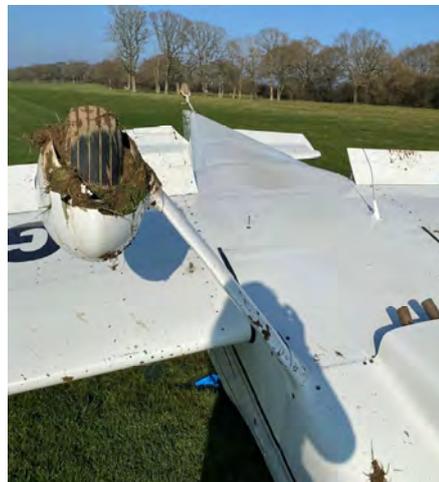
Contamination and damage to one of the wheel spats (pictures courtesy of the pilot)

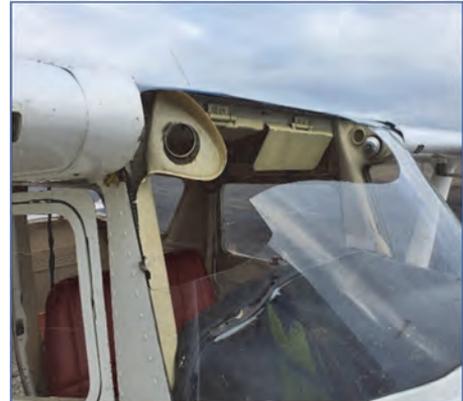
Aircraft damage caused by the impact with the ground

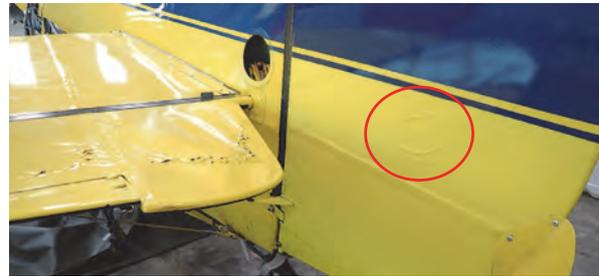
Elevator and rudder damage (circled)

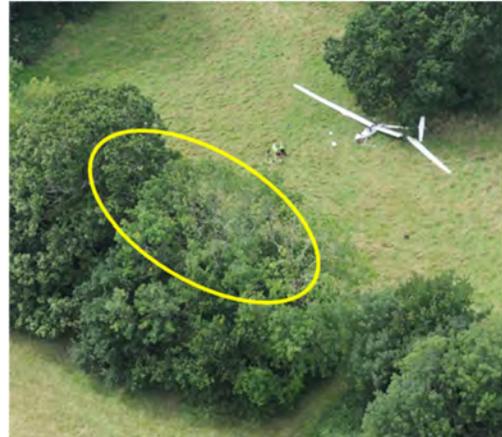
Trees struck by the right wing  
from above

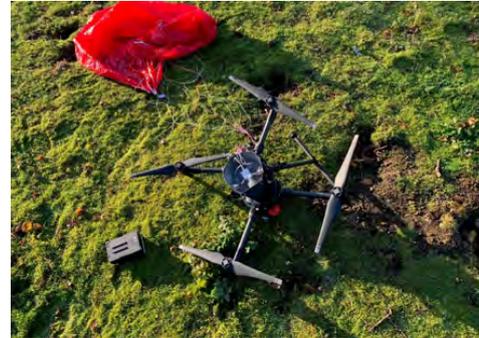
Aircraft after parachute deployment on 29 November 2019

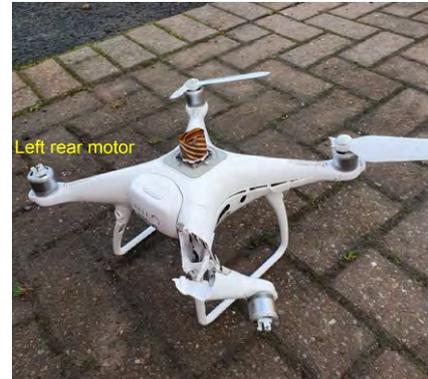
Aircraft after being recovered from garden
