**ACCIDENT**

<b>Aircraft Type and Registration:</b>	Piper PA-46-350P (Modified), G-HYZA	
<b>No &amp; Type of Engines:</b>	2 YASA electric motors (common shaft)	
<b>Year of Manufacture:</b>	1997 (Serial no: 4636130)	
<b>Date &amp; Time (UTC):</b>	29 April 2021 at 1425 hrs	
<b>Location:</b>	Near Cranfield Airport, Bedfordshire	
<b>Type of Flight:</b>	Other	
<b>Persons on Board:</b>	Crew - 2	Passengers - None
<b>Injuries:</b>	Crew - None	Passengers - N/A
<b>Nature of Damage:</b>	Left wing detached, landing gear collapsed and nose cowl distortion	
<b>Commander's Licence:</b>	Airline Transport Pilot's Licence	
<b>Commander's Age:</b>	63 years	
<b>Commander's Flying Experience:</b>	34,620 hours (of which 1,588 were on the basic type, 12 were on the modified electric variant) Last 90 days - 59 hours Last 28 days - 19 hours	
<b>Information Source:</b>	AAIB Field Investigation

**Synopsis**

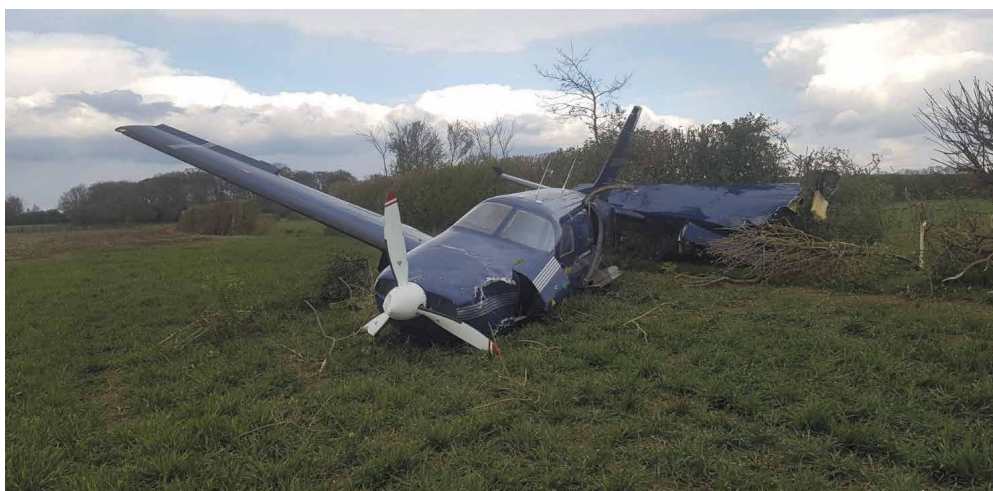
**Figure 6**  
G-HYZA accident site

The aircraft landed in a field which was 210 m wide, approximately 445 m in length, corner to corner, and bounded by a road and hedges. It touched down approximately one third along the length of the field and after 290 m struck a hedge where the left wing detached from the fuselage and the nose landing gear collapsed. The propeller, nose cowling and tailplane were also damaged (Figure 6). The aircraft remained upright, leaning to its left side sufficient to prevent the lower step section of the cabin door from fully opening. There was no fire.

- The nose landing gear had been forced upwards into the nose area and caused bending and displacement of the motor and HFC mounting frame by approximately 25 mm.
- The nose structure showed no other damage except for the pulling through of a fastener holding the coolant header tank, which was still attached and free from leakage. All the other components remained attached and in place with the mounting frame displacement being taken up by the flexing of the wiring and non-rigid pipework.
- The HV battery contactor box, also located in the nose area, was crushed such that the insulation within the cover was touching the top of some of the contactor terminals.
- There was no evidence of leakage from the motor cooling oil and inverter / HFC cooling systems.

- The hydrogen storage tanks, regulator and distribution systems were visually undamaged and there was no leakage. This was confirmed by the fact that the hydrogen detectors did not trigger.
- The cabin mounting structure for the hydrogen storage tanks and HV battery showed no signs of movement or damage, and all the attached items were retained in their original position.
- The egress path between the cockpit and the cabin exit door remained clear.

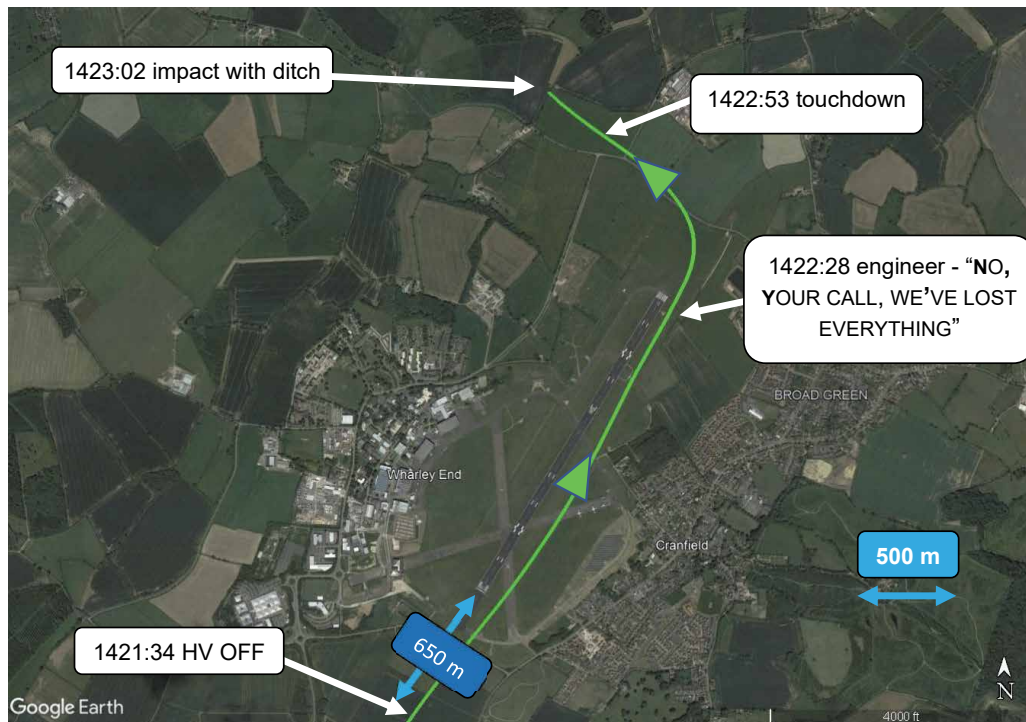
**Figure 9**  
G-HYZA track

The pilot transmitted a MAYDAY call stating that they had "LOST POWER AND COMING BACK TO TRY TO GET ON TO TWO-ONE" while commencing a turn to the left. This was followed with a transmission stating that they were landing in a field.

The pilot lowered the flaps and landing gear, touching down in a field at a groundspeed of 87 kt, 23 seconds after the MAYDAY call. Touchdown occurred approximately one third into the field with the aircraft eventually impacting the ditch and hedge at the far end at a groundspeed of 45 kt.

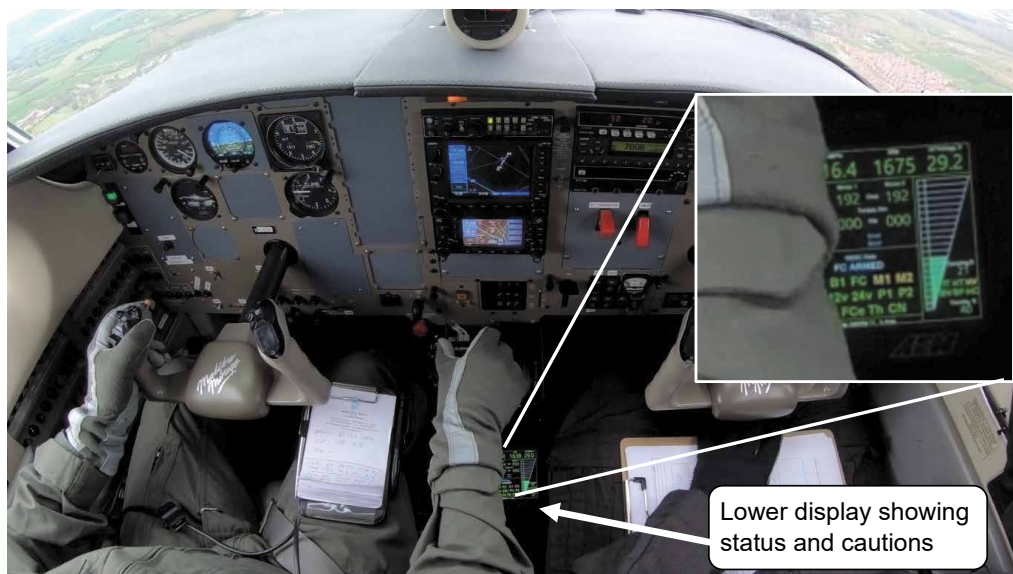
**Figure 10**  
G-HYZA cockpit camera view, just after HV selected OFF,  
showing zoom of lower display

The on-board camera showed that immediately after the HV battery was selected OFF, the displays showed M1 and M2 initially in red, then amber, representing motor fault conditions. Four seconds later, the pilot noted the loss of power. Five seconds after this, the observer stated, "YOU'VE LOST THE INVERTER, PUSH THE BUTTON".

The pilot pushed the fault clear button with the recorded power lever position still at 41%. This successfully reset the inverter; however, as the power lever was not at idle, the step demand for power after the reset could not be provided by the HFC leading to a voltage drop. This was detected by the inverter as an undervoltage and caused an additional lockout.

The observer instructed the pilot to select HV battery ON which was successful. However, due to the combination of an increased HFC voltage and continued windmilling action of the propeller, the inverters detected further overvoltage conditions which led to further lockouts. After HV battery was selected ON, further attempts were made to restore power over the next 38 seconds with the observer acknowledging that "THE VOLTAGE IS TOO HIGH". This included resetting the HFC and HV battery supplies with the fault clear button selection at various power lever positions, with no visual reference to checklists. The troubleshooting required the pilot to look down to the power lever and display and then look up to the HFC and HV battery switches in the overhead panel. Despite these attempts, power could not be restored to the motors. Figure 11 shows these data parameters throughout the event.

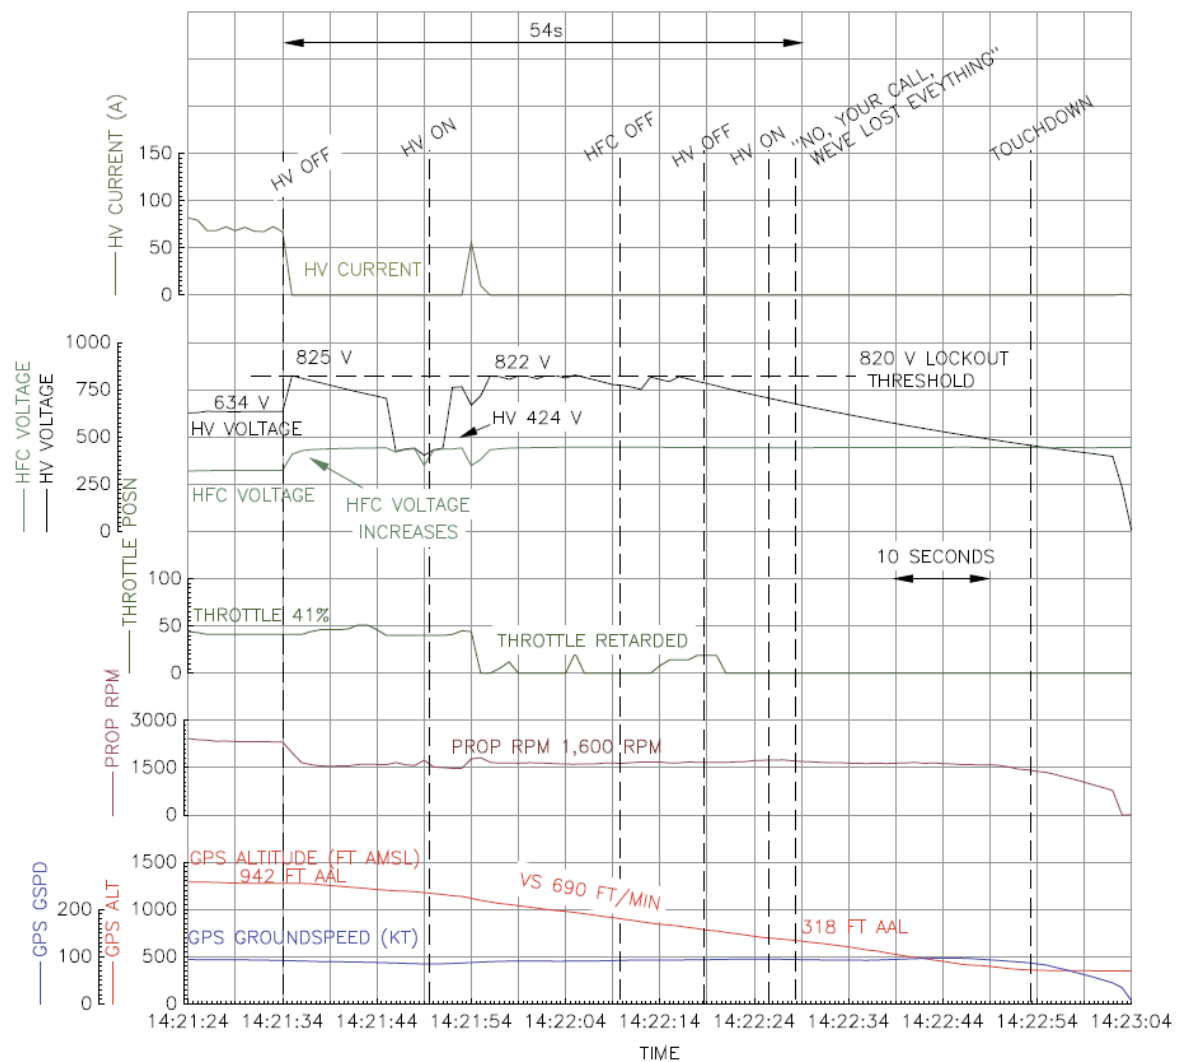
**Figure 11**  
G-HYZA flight data parameters

When the HV battery was switched off, the sequencing of the contactors, to allow the HFC alone to provide electrical power, resulted in a momentary interruption of the power supply to the motors. During this brief period the propeller was driven by the airflow which caused the motor to act as a generator. The resulting voltage was high enough to cause the inverter overvoltage protection to lockout the power supply to the motors.
