Fatal man overboard from the single-handed creel fishing vessel, *Saint Peter* (LH22) east of Torness Point, Scotland on 2 May 2021

SUMMARY

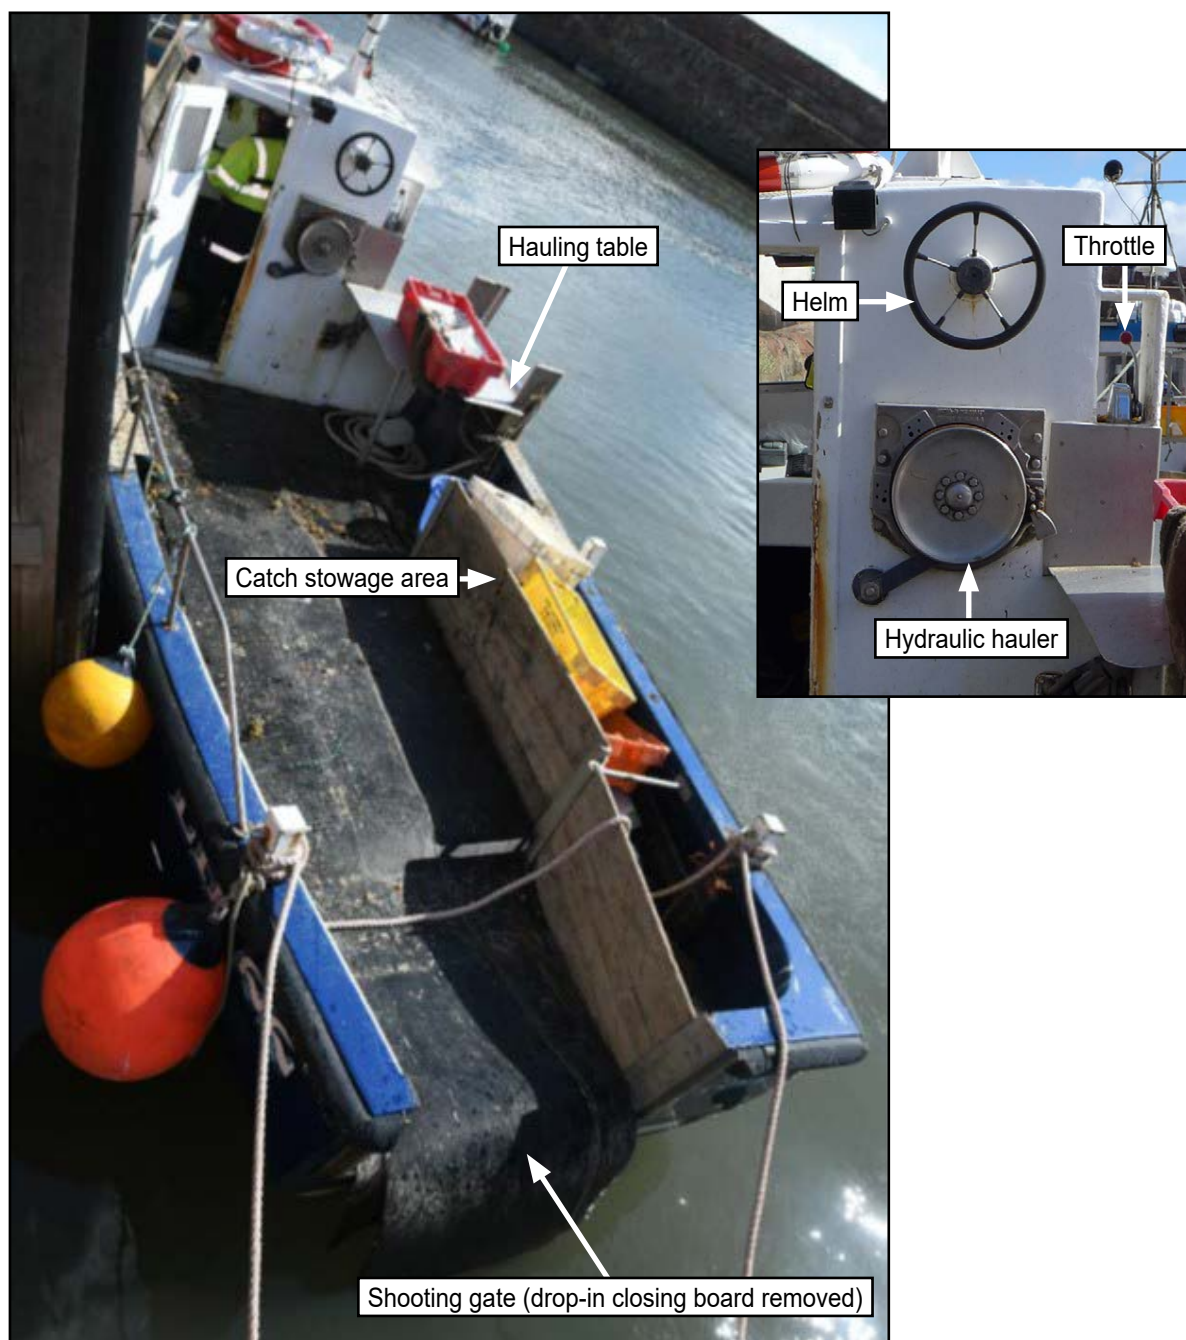
Figure 3: *Saint Peter* aft deck arrangement

Saint Peter was a 7.8m glass reinforced plastic fishing vessel built by the skipper in 1993. The vessel had an enclosed wheelhouse; an open aft deck fitted with a hydraulic hauler, hauling table, and catch stowage area; and there was a shooting gate in the transom, which had a drop-in closing board (**Figure 3**). The wheelhouse was fitted with a global positioning system (GPS) receiver, chart plotter and

Saint Peter's working deck was cluttered with creels and rope when shooting, making it difficult for the skipper to stay safely separated from the moving fishing gear, especially if the gear became tangled and required manual intervention. An alternative deck layout and fishing gear configuration, possibly with a reduced number of creels, and deck dividers or pound boards could have kept the skipper clear of the running back rope. This would have enabled him to throw the marker buoy and end stone overboard and, if necessary, deal with tangled creels without the risk of standing on the back rope.

- The skipper was not wearing a PLB or other means of raising an alarm.
- The risk of becoming tangled in the fishing gear was increased while shooting as there was no physical barrier to separate the skipper from the back rope.

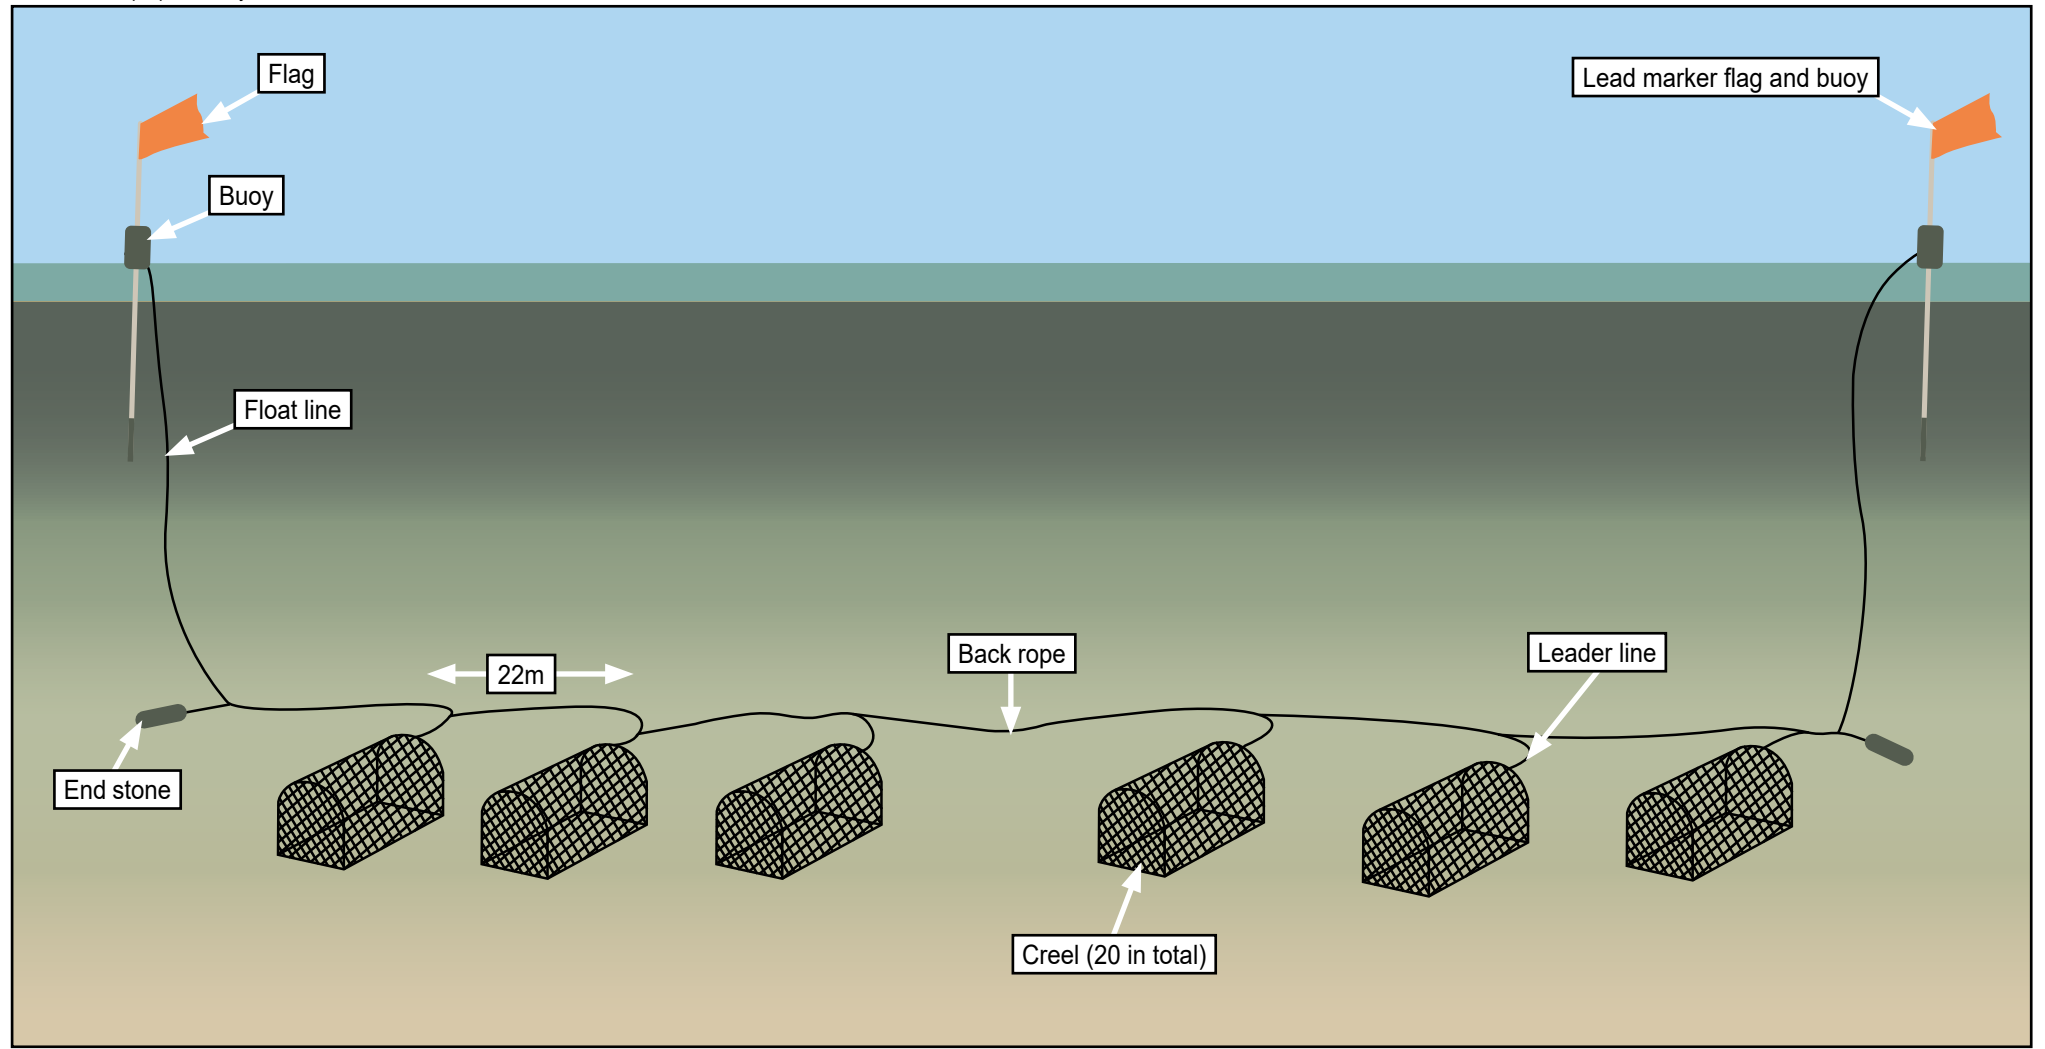
Figure 4: Saint Peter fishing arrangement

A string was recovered by bringing the marker buoy on board and heaving in first on the float line and then on the back rope using the hydraulic hauler. The creels were pulled onto the hauling table, where the catch was removed and stowed in plastic crates that were stacked in the catch stowage area. Each creel was then rebaited and stacked on the port side ready for the next shoot. It took about 40 minutes for the skipper to recover, empty, rebait and stack a string of creels.

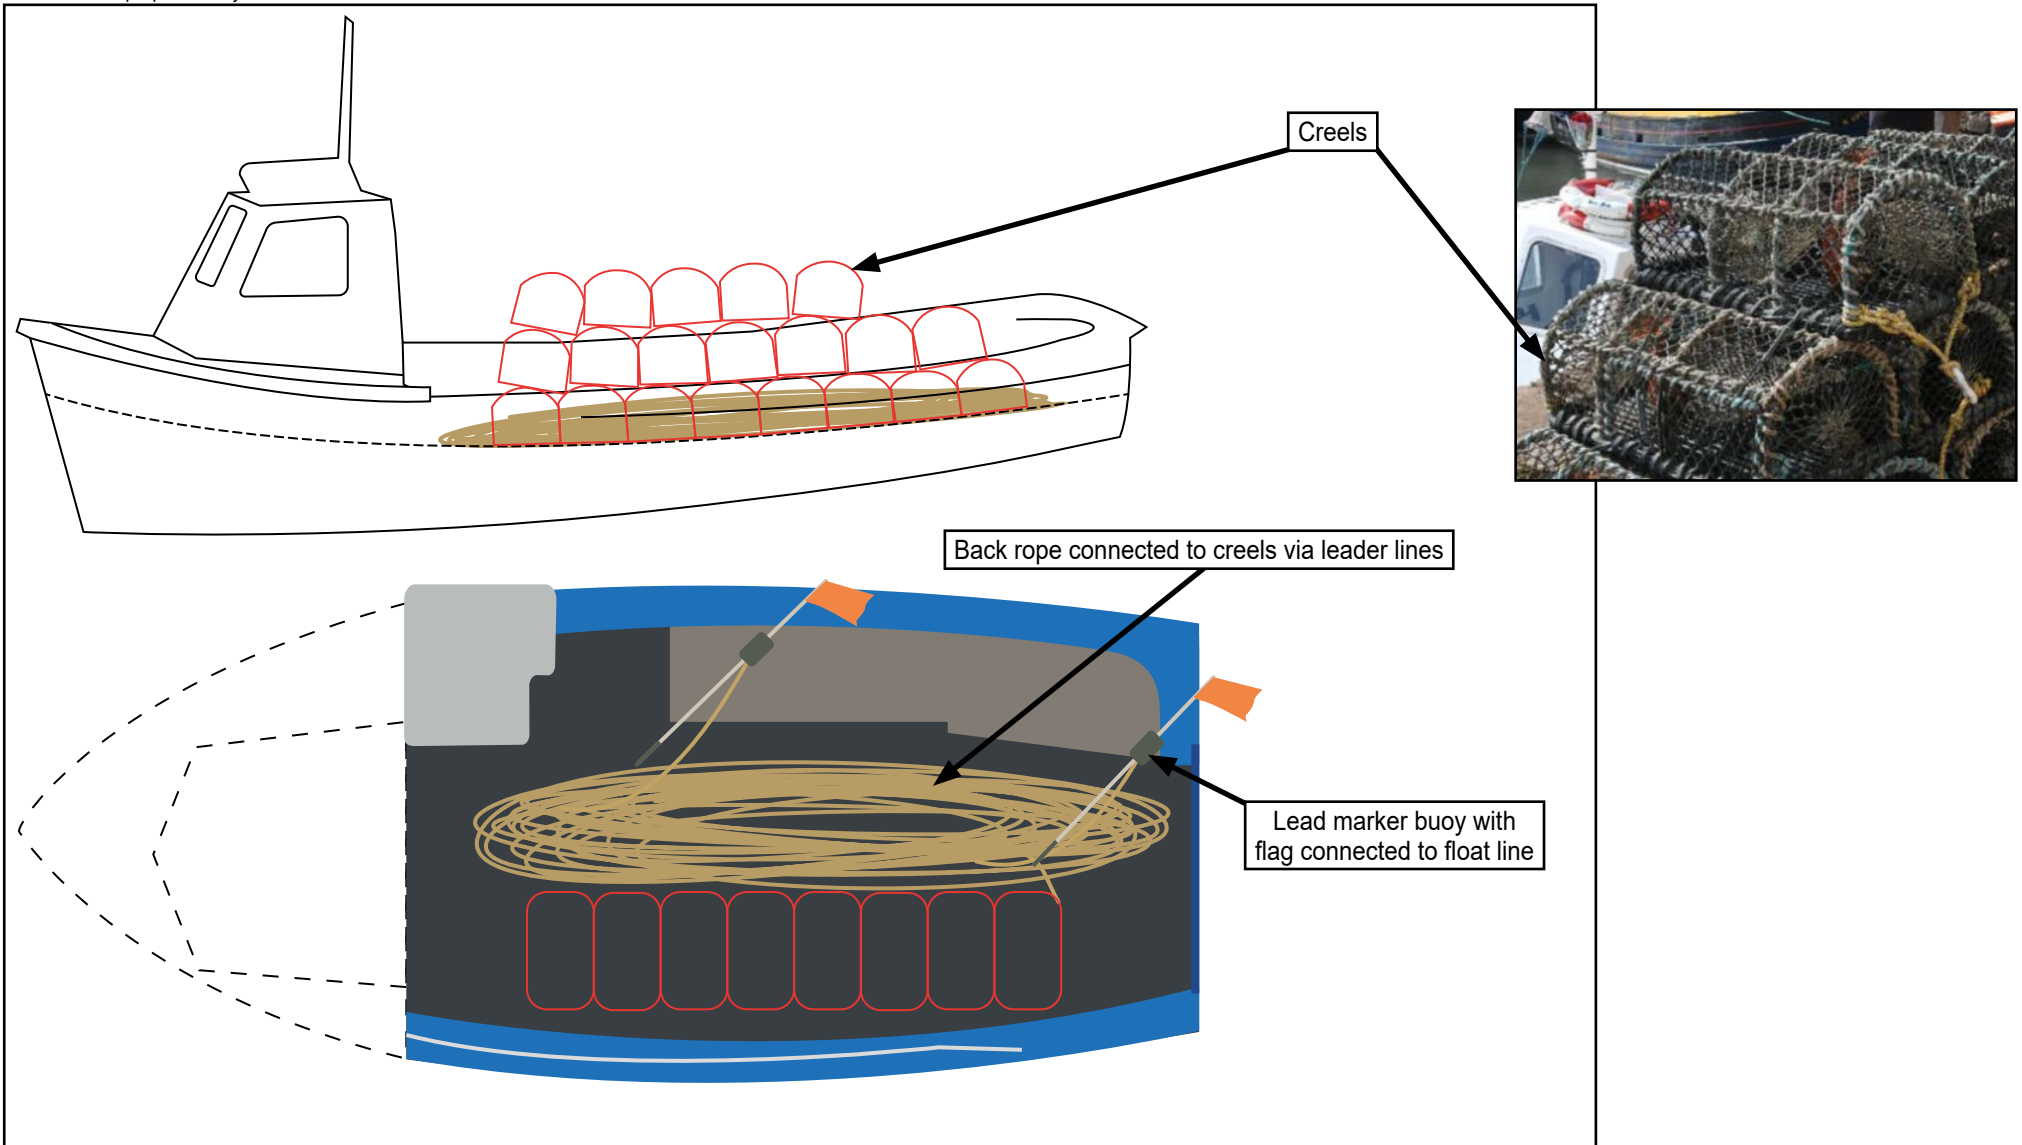
Figure 5: *Saint Peter* shooting arrangement

The skipper operated *Saint Peter* alone between high tides and caught a mixture of crab and lobster. Each string of creels consisted of 20 creels, spaced 22m apart and connected by short leader lines to a 14mm back rope. Cast iron anchor weights, known as end stones, and float lines with buoys and marker flags were connected to each end of the 535m back rope (**Figure 4**). Before shooting, the creels were stacked on the port side of the main deck with the back rope laid out next to them (**Figure 5**).

The skipper's routine for shooting a string of creels was to throw the lead marker buoy and end stone overboard with the vessel driving ahead so that the stack of creels was automatically pulled overboard through the transom gate. It took about 5 minutes to shoot one string of creels.

- It is highly likely that the skipper moved aft on the deck to untangle some creels that had become snagged while shooting, and his leg became caught in the back rope and he was dragged overboard.
