Report on the investigation of  
the foundering of the whelk potter

***Nicola Faith (BS58)***

resulting in three fatalities  
in Colwyn Bay, North Wales

REPORT NO 8/2022

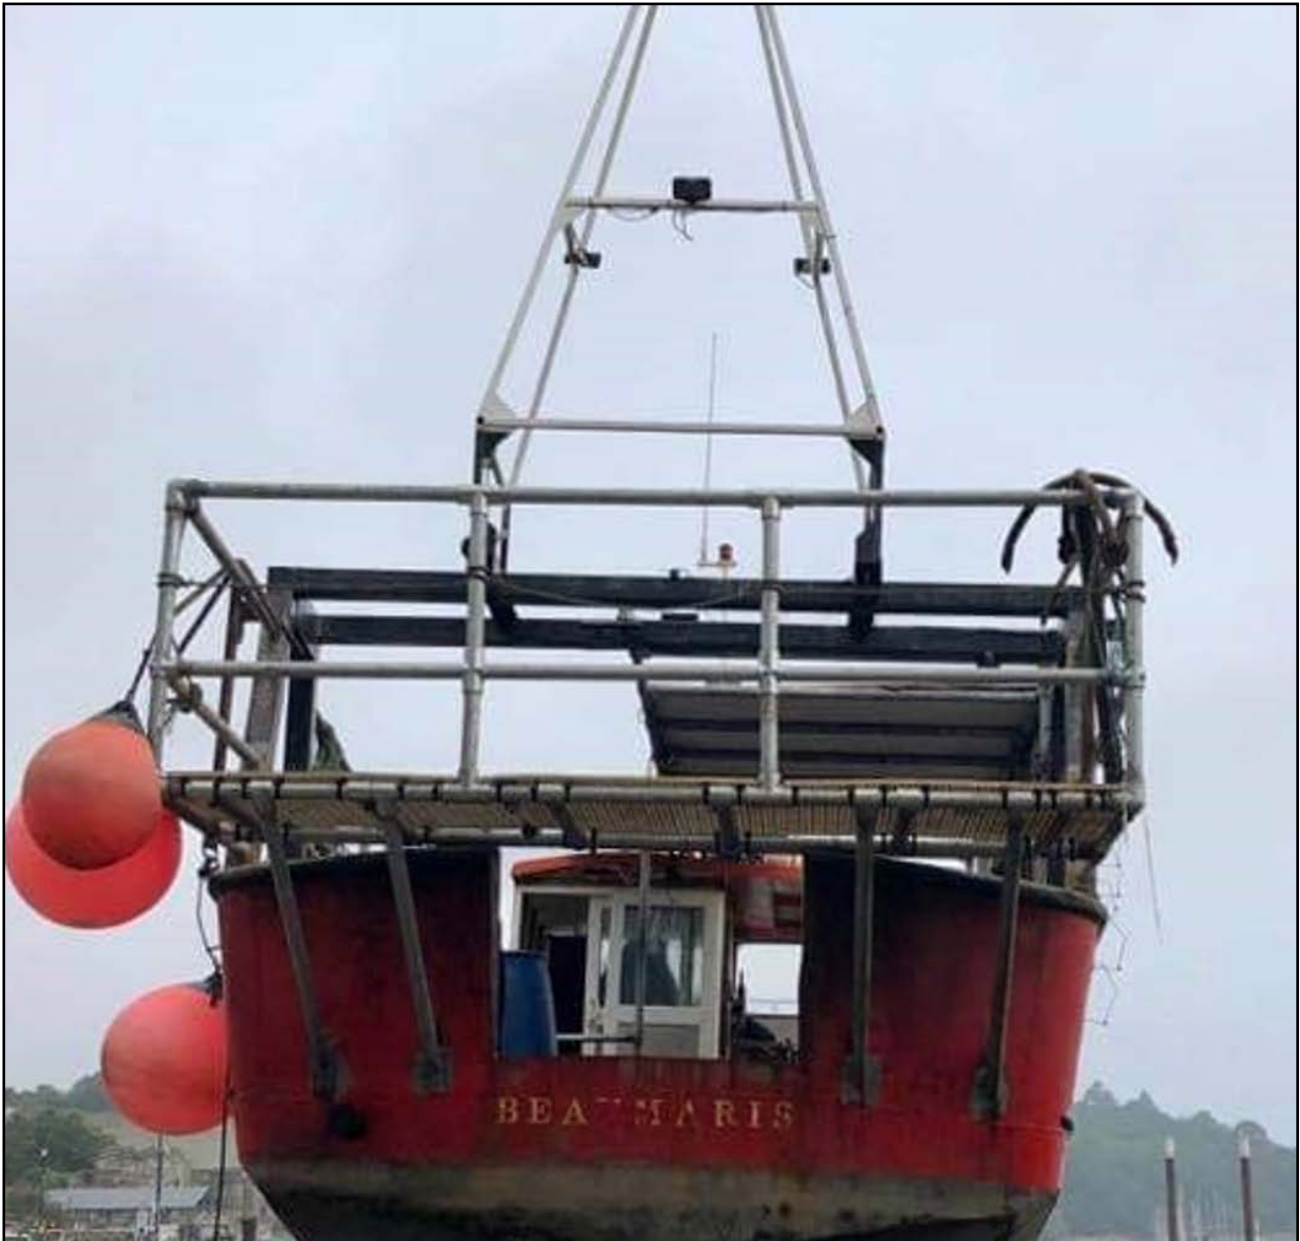
**Figure 7:** Large cat catcher fitted to *Nicola Faith*'s stern

On 5 May 2019, an unannounced inspection of *Nicola Faith* was carried out by an MCA surveyor following several engine breakdowns that had required the RNLI to tow the vessel into port. The MCA surveyor noted that the larger cat catcher had been fitted and reminded the skipper that significant modifications should be discussed and approved by the MCA before being made.

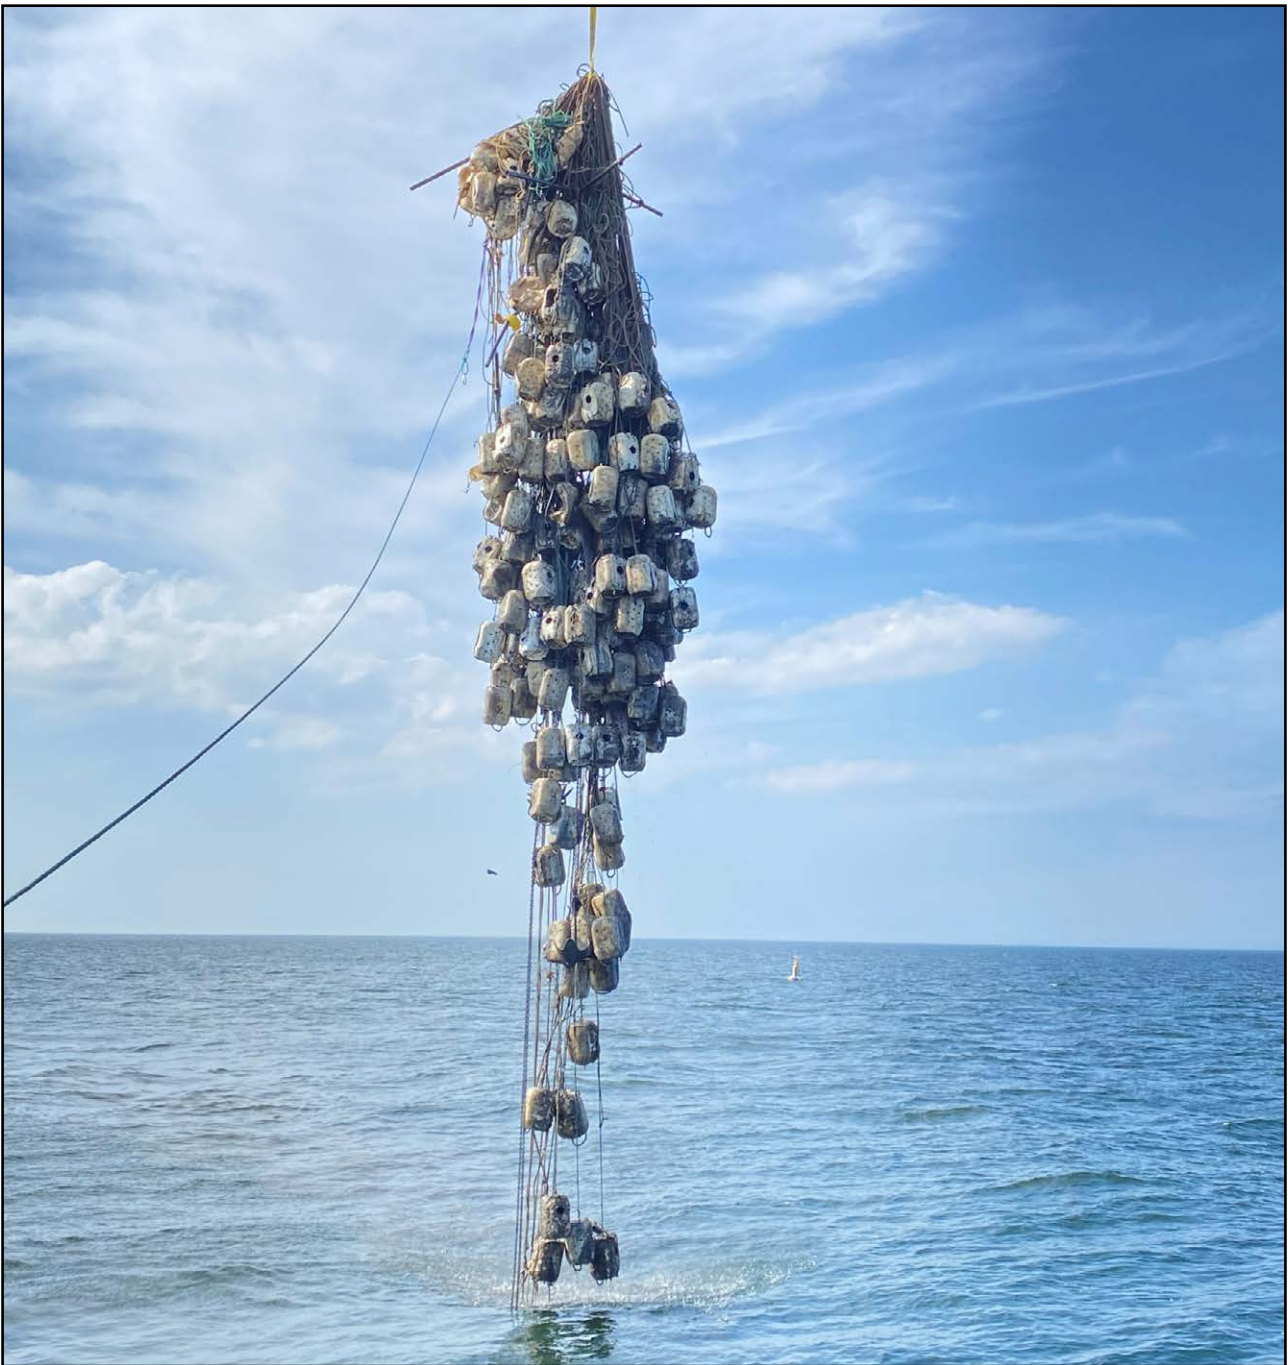
The wreck of *Nicola Faith* was recovered with 223 whelk pots (**Figure 14**). The associated gear found with the pots included hundreds of metres of leaded polypropylene rope, 11 anchors, and several pot marker buoys.

A calibrated load cell was used to weigh the equipment: the pots, rope and anchors weighed 2436kg; a large quantity of tools and spare gear found in the forward cabin area weighed 1100kg.

**Figure 14:** Whelk pots and associated gear being recovered from the seabed

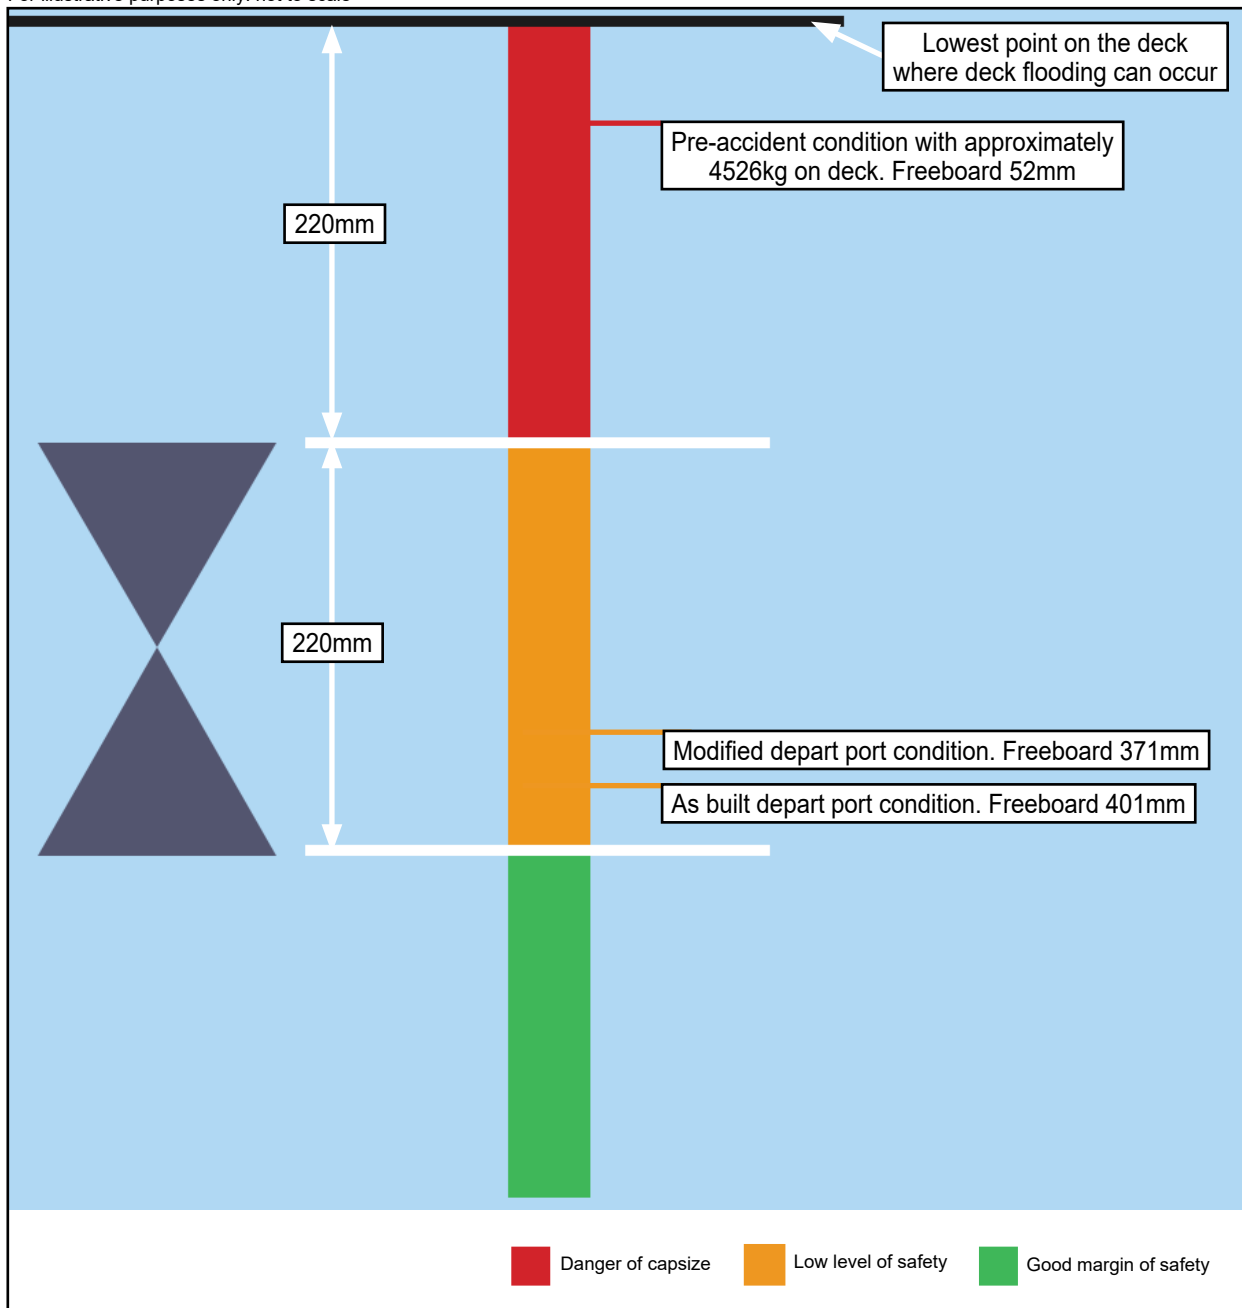
- In its as-built condition, in which the vessel passed full stability criteria, the freeboard was in the amber zone of the guidance mark under all loading conditions, indicating a low safety level of stability.
- In its modified state under condition No.2, depart port with 100% consumables on board, and condition No.6, depart grounds with 1000kg of catch stowed on deck, the Wolfson calculation indicated the freeboard to be in the amber zone.
- In the accident condition, the freeboard reduced into the red zone of the guidance mark.

Figure 19: Wolfson Stability Guidance Method guidance mark for *Nicola Faith*

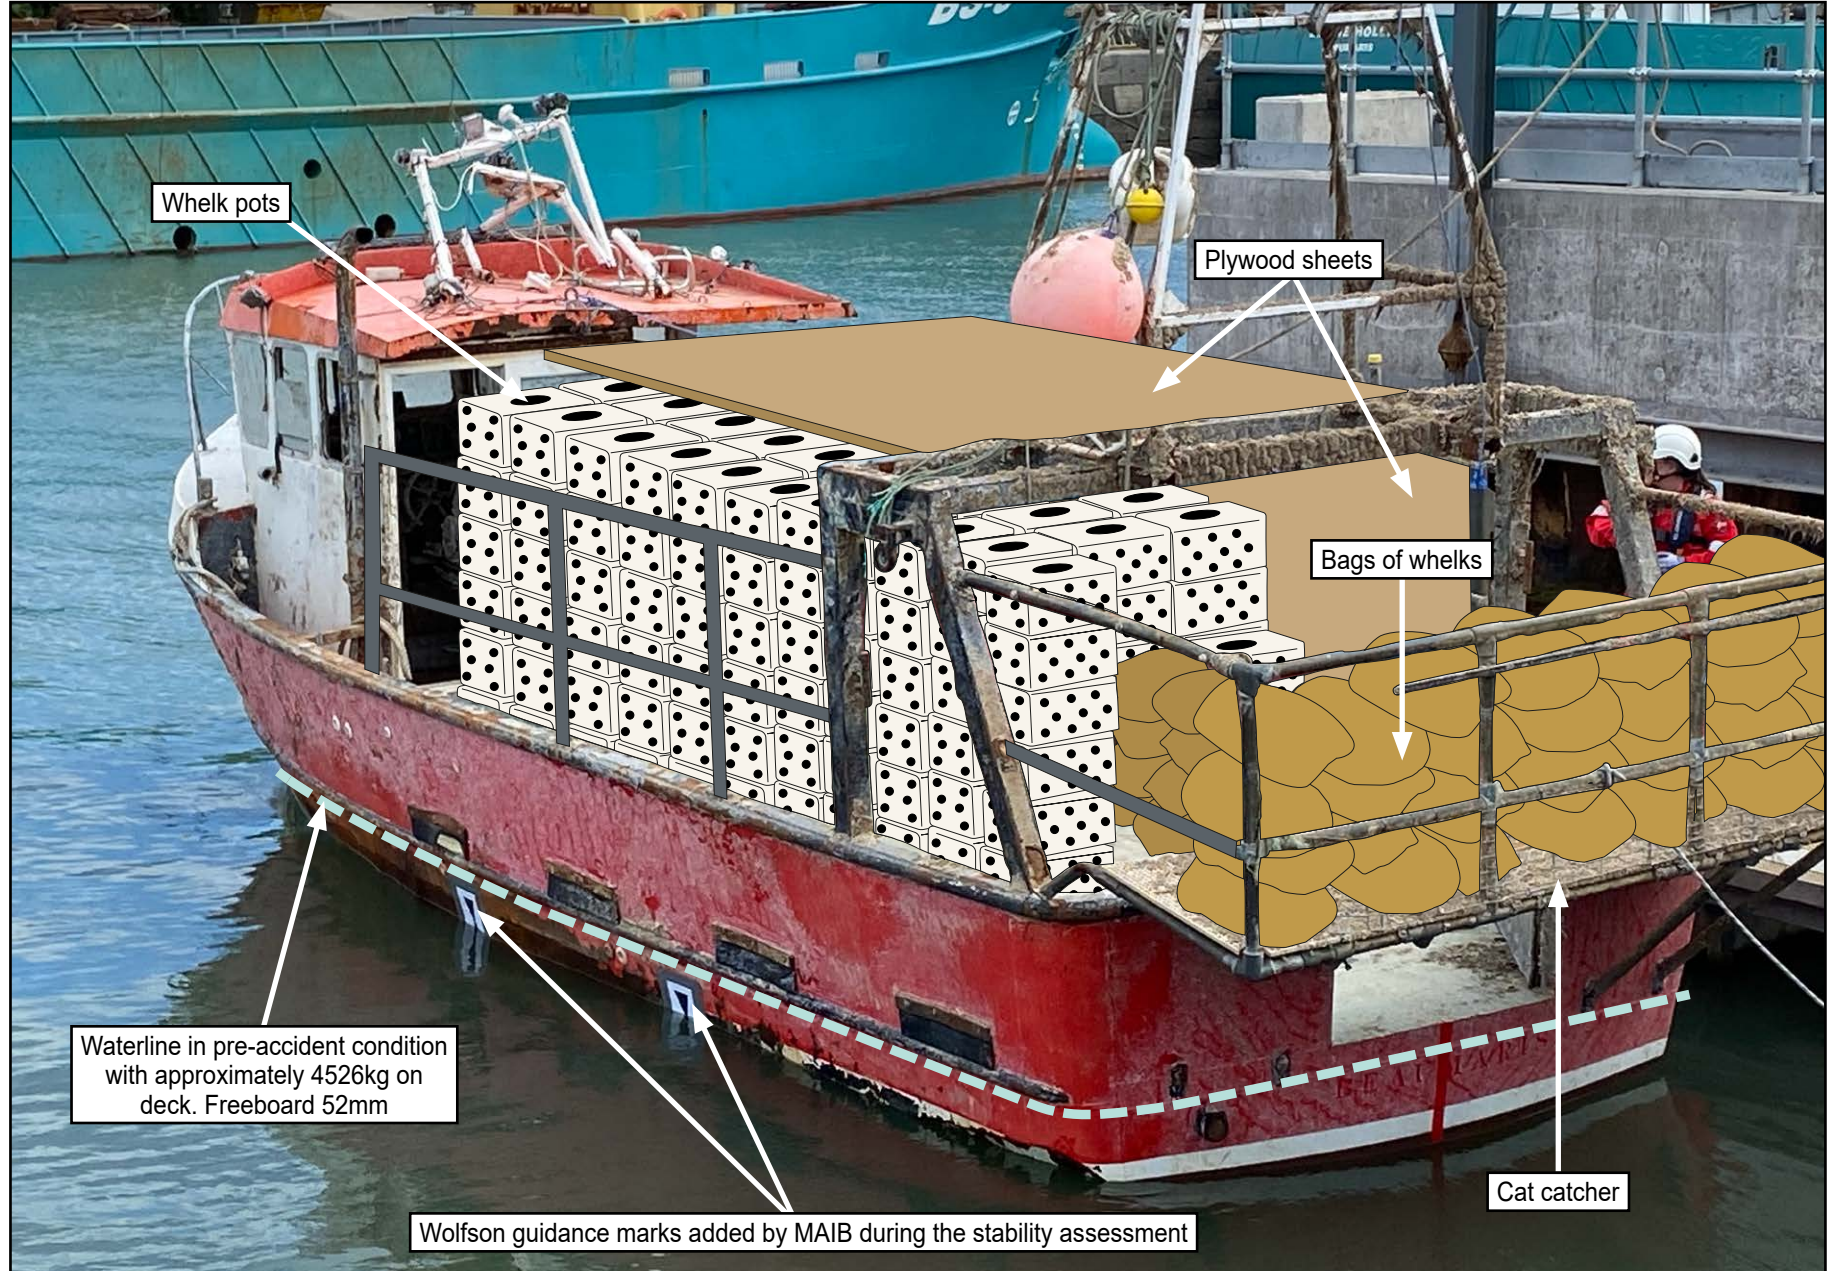
**Figure 20:** Possible loading condition of *Nicola Faith* before the accident
