**ACCIDENT**

| <b>Aircraft Type and Registration:</b> | Glasair II-S RG, G-IIRG | |

**Synopsis**

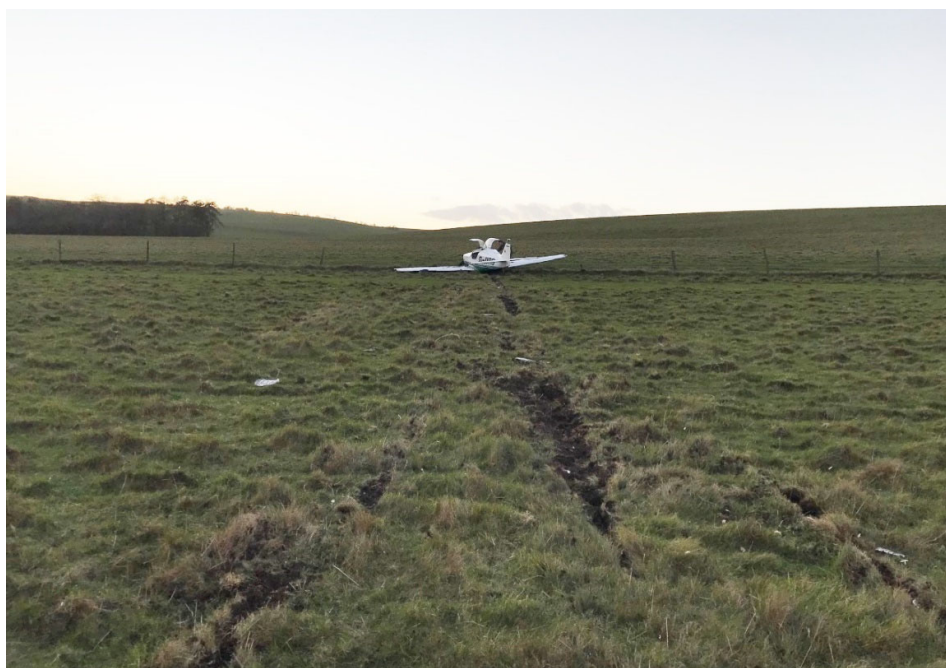
**Figure 1**

| <b>Nature of Damage:</b> | Landing gear collapsed, damage to wings, lower surface of the fuselage, propeller and engine shock-loaded | |

The pilot stated that rather than attempting to further troubleshoot the loss of engine power, he prioritised selecting a suitable landing site and having made a MAYDAY call, carried out preparations for a forced landing. He selected a grass field that was into wind and had an upslope. The aircraft landed heavily in the field, forcing the landing gear to retract and partially push the main landing gear legs through the upper wing skins. The aircraft slid on its belly before striking a post and wire fence, which brought the aircraft to a halt (Figure 1). Neither the pilot nor his passenger were injured in the accident.

Accident site
