**ACCIDENT**

| <b>Aircraft Type and Registration:</b> | Zenair CH 750, G-CIJZ | |
| <b>Location:</b> | 2 miles west of Wideford Hill, Orkney | |

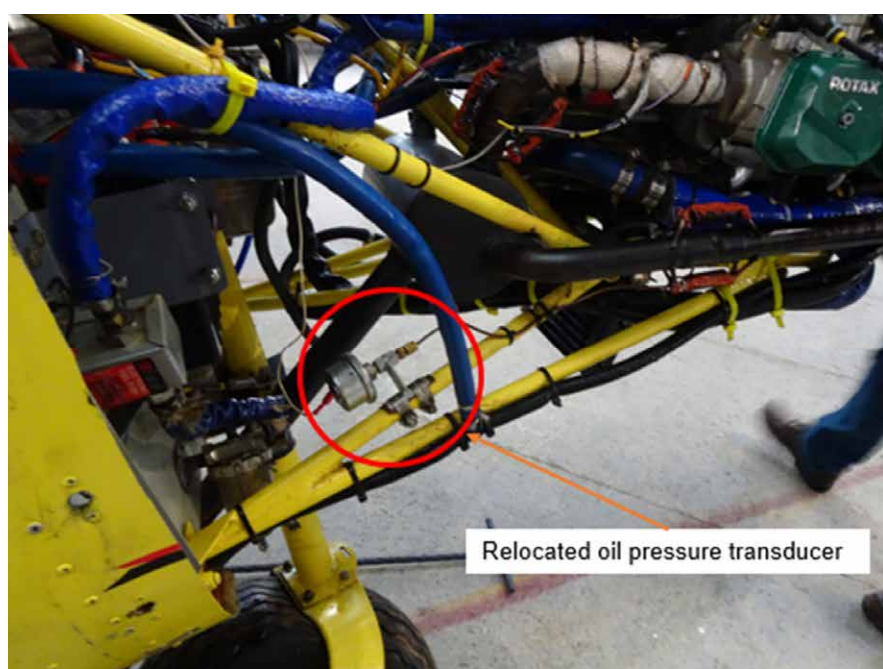
**Figure 1**

Inspection of the engine found that a brass pipe connecting the oil pressure transducer to the engine had failed causing loss of oil from the engine. Normally the oil pressure transducer is mounted directly on to the front right hand side of the crankcase. At some point in the aircraft's history the oil pressure transducer had been relocated from the standard position to the engine frame (Figure 1).

Image showing relocated position of the oil pressure transducer

When considering the remote location of the oil pressure transducer, the relative movement between the engine and transducer needs to be factored into the modification. The LAA have recently highlighted<sup>1</sup> this issue to owners and inspectors.

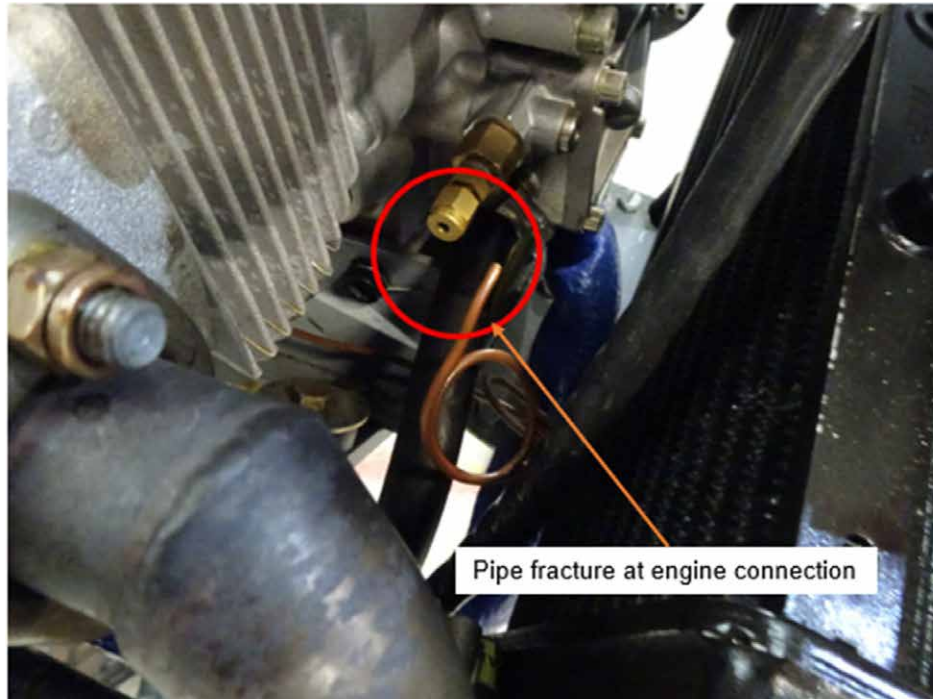
**Figure 2**

Subsequent inspection of the engine found that a brass pipe connecting the oil pressure transducer to the engine had failed in fatigue causing loss of oil from the engine. At some point in the aircraft's history the oil pressure transducer had been relocated from the standard position to the engine frame which increased relative movement of the pipe in flight.

It is not uncommon to see oil pressure transducers on Rotax 91x Series engines remotely mounted as there is a perception that it reduces fluctuating oil pressure readings. The standard Rotax installation is for the oil pressure transducer to be mounted directly on the crankcase. If relocated it is more normal to see a flexible hose between the engine oil pressure outlet fitting and the transducer. The brass pipe used to connect the transducer on G-CIJZ had failed at the engine fitting (Figure 2), most likely due to fatigue exacerbated by the relative movement between the engine and the frame the transducer had been mounted on.

Image showing location of pipe fracture
