# Guidance to spillway failure mechanisms

## FCERM Research & Development Programme Research report

Date: June 2022

Version: FRS20238/R2

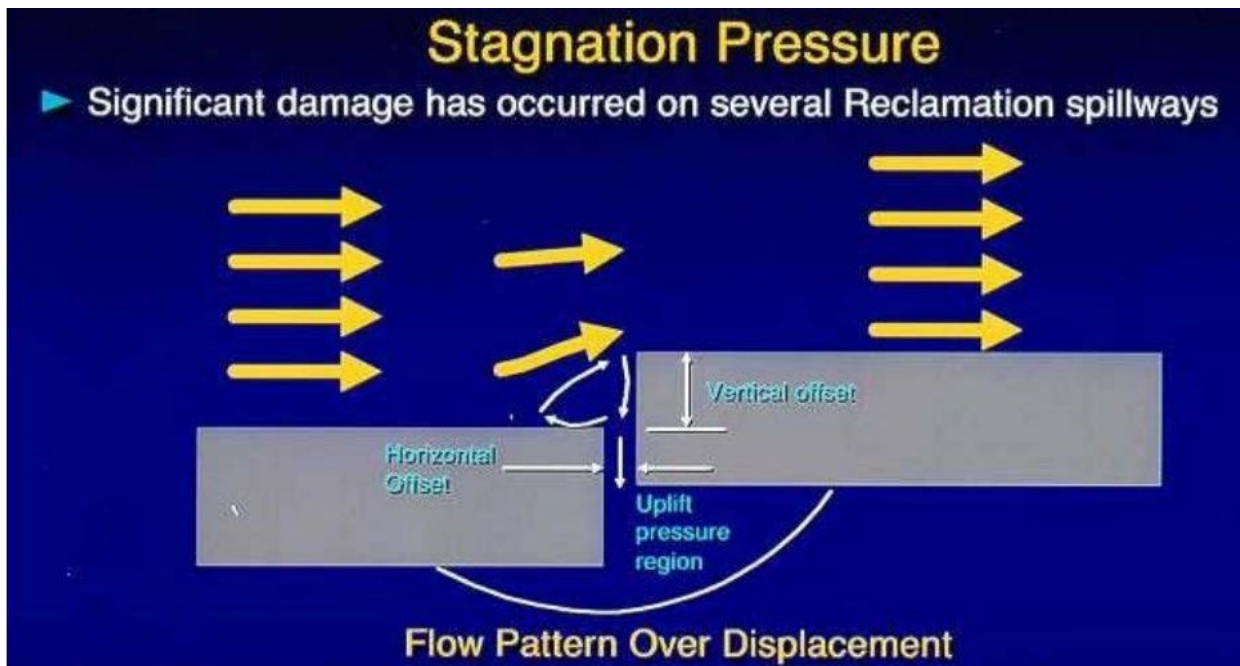
The document provides, among other things, a description of the hydraulic failure mechanism associated with stagnation pressures developing where unfavourable conditions at joints or cracks exist (refer to Figure 1).

**Figure 1: Stagnation pressure development (USBR & USACE, 2019)**

“Cracking occurred in the chute slabs due to excessive water and ice pressures along the foundation-concrete slab interface and some of the slabs heaved and were displaced off the foundation, creating offsets into the flow. The spillway operated from 1957 to 1983 without incident, but a chute floor slab failed in June 1983, due to uplift pressures from flows of 400ft<sup>3</sup>/s. Calculations were performed to confirm that the failure was the result of stagnation pressures being generated under the chute slab. The calculations also showed that with anchor bars fully effective, the slab would not have failed. From observations after the failure, it was observed that the anchor bars exposed beneath the slab were not coated with grout, indicating that the anchor bar capacity was not fully developed.”

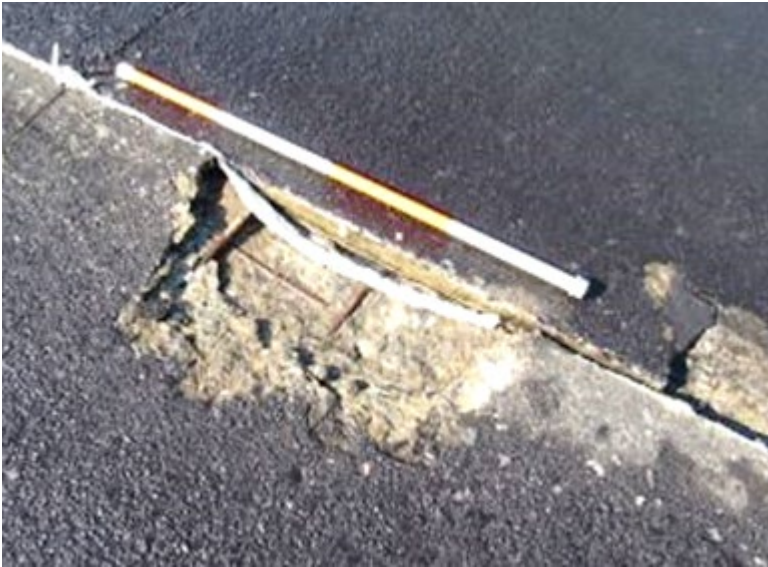
The paper provides an event tree and sequence of events for stagnation pressures developing at unfavourably oriented vertical offsets at joints and cracks leading to lifting of the spillway slabs. The authors show an example figure of a deteriorated transverse joint and state that “similar concrete deterioration is what likely initiated the failure of the Oroville spillway chute.” (refer to Figure 2).

**Figure 2: Transverse joint damage (Schweiger and others, 2019).**

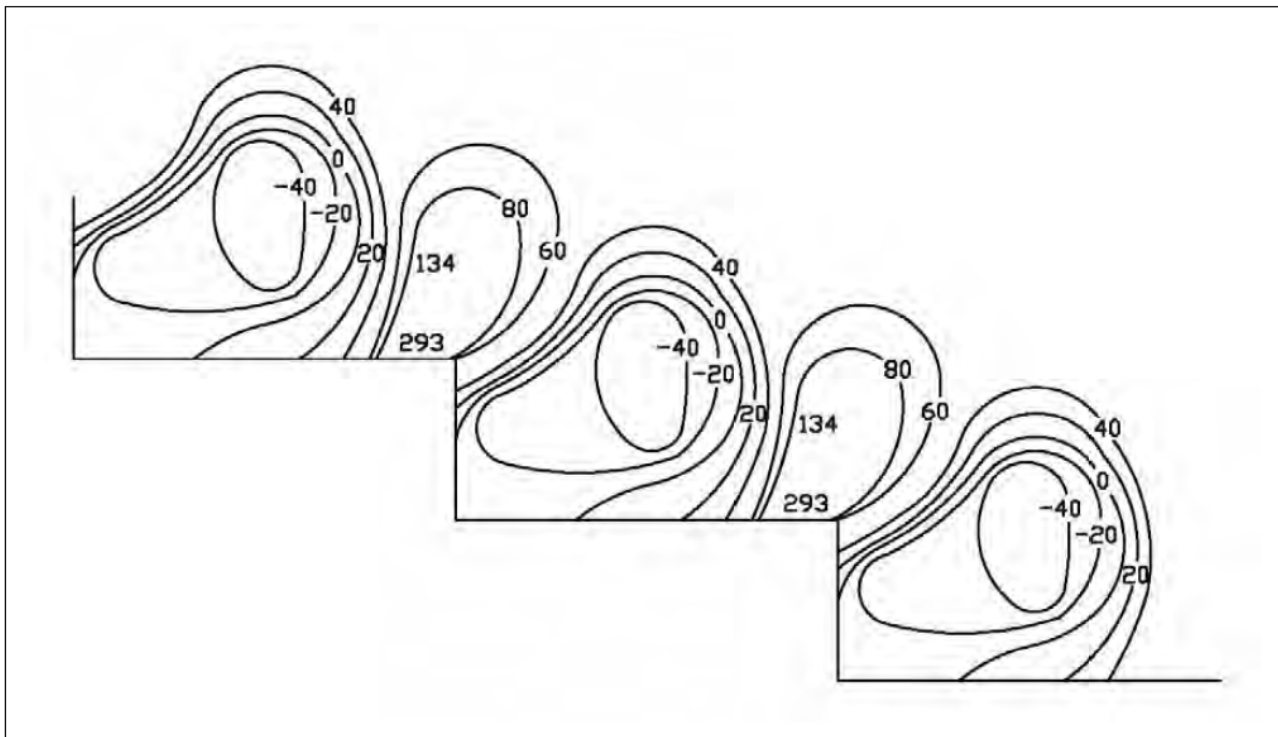
The document also discusses the distribution of the dynamic pressures acting on the inverts and walls of stepped spillways (refer to Figure 3):

**Figure 3: Mean pressure [kPa] contour plot for flow over a set of steps (Winter and others, 2010)**

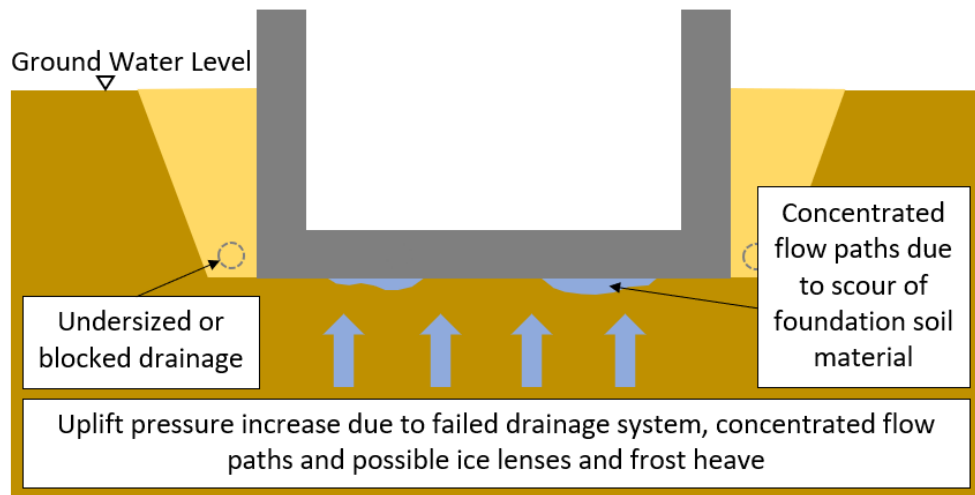
a.

- increased seepage of water due to internal erosion and concentrated flow paths (refer to Figure 4a)
- failure of the drainage system to control ground water level (inadequate design, monitoring or maintenance) (refer to Figure 4a)

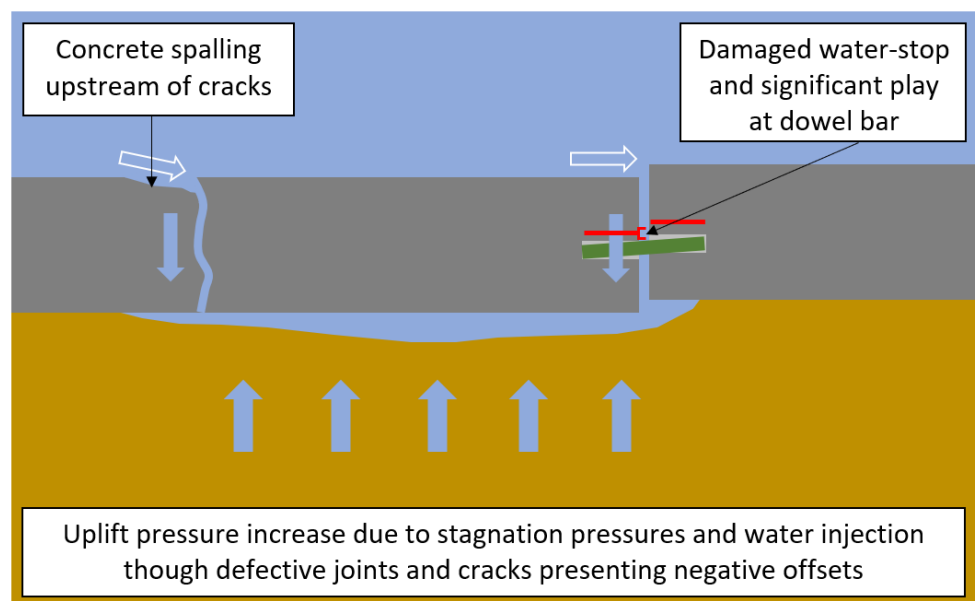
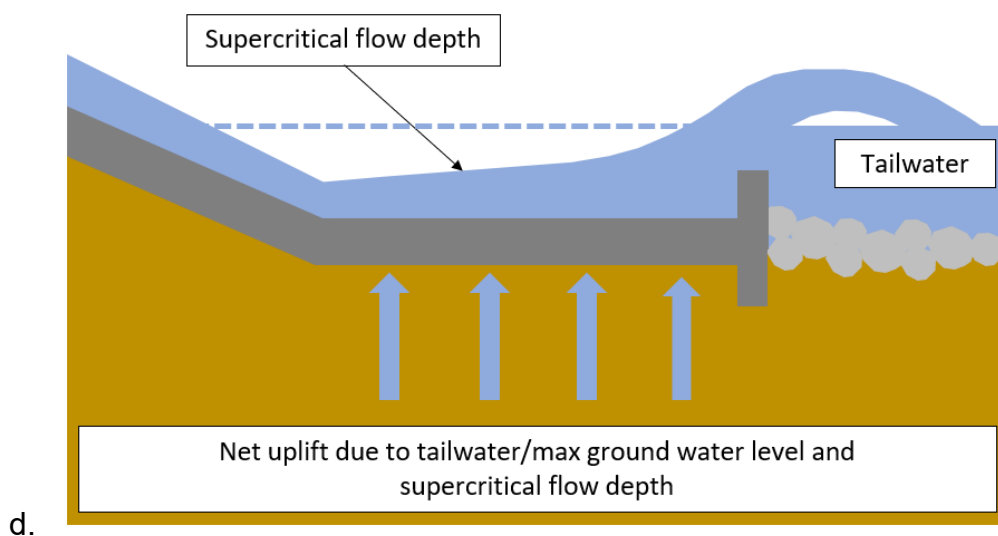
**Figure 4: Structural failure due to excessive uplift pressure**

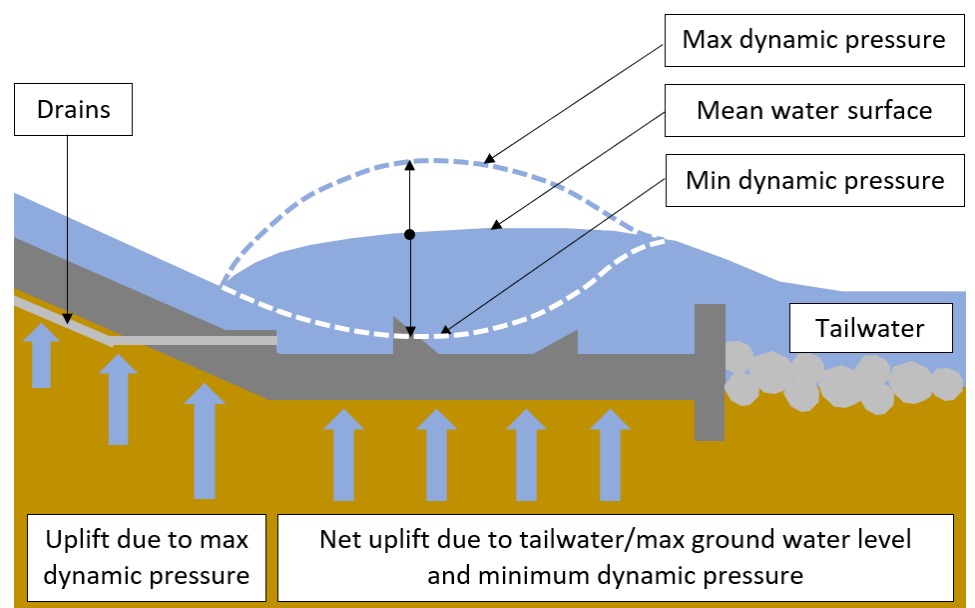
c.

- severe pressure fluctuations within stilling basins due to turbulence in the hydraulic jump, causing water under pressure to enter under the slabs through any underdrain outlets located in this area or through any unsealed or defective joints or cracks. (refer to Figure 4c)

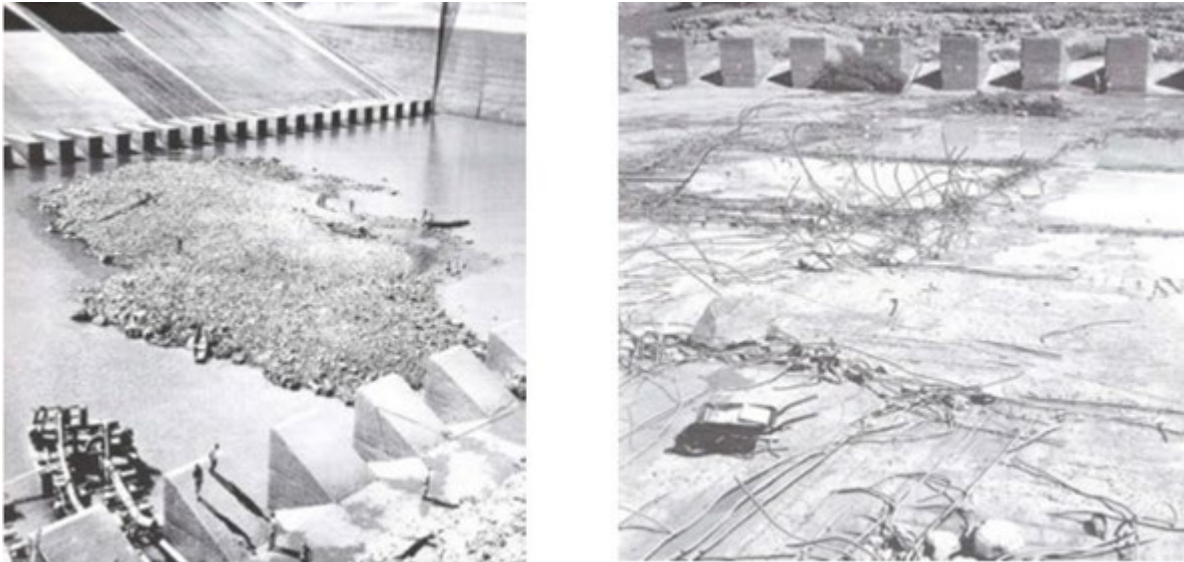
“the integrity of the basin may also be affected by fluctuating uplift forces whose peaks overcome the weight of the concrete slab and the resistance of the steel anchors that are provided to incorporate the weight of the underlying rock. Examples of serious accidents caused by these fluctuating forces are Malpaso, Mexico (Sanches-Briebesca and Viscaino, 1973) and Karnafuli, Bangladesh (Bowers and Toso, 1988). The effect of these fluctuating uplift forces results from the transfer of dynamic pressures generated by the turbulent hydraulic jump to the underside of the basin slabs, through joints and drainage system pipes.” (refer to Figure 5 ).

**Figure 5: Marimbondo Spillway stilling basin damages from asymmetric operation (ICOLD, 2016).**

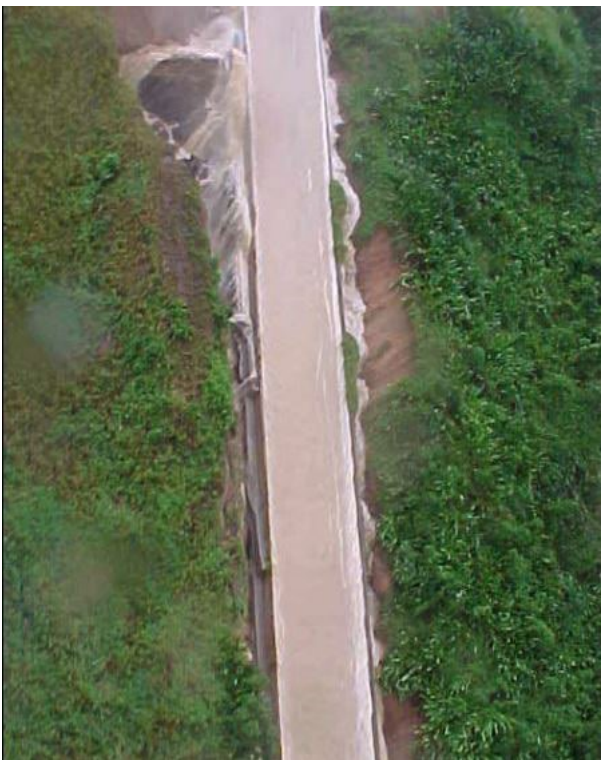
“Overtopping of the spillway chute walls initiated erosion of backfill behind chute walls and undermining and failure of spillway chute. Head cutting progressed upstream and lead to reservoir breach.” (refer to Figure 6).

**Figure 6: Overtopping of chute walls of El Guapo dam (USBR & USCE, 2019)**

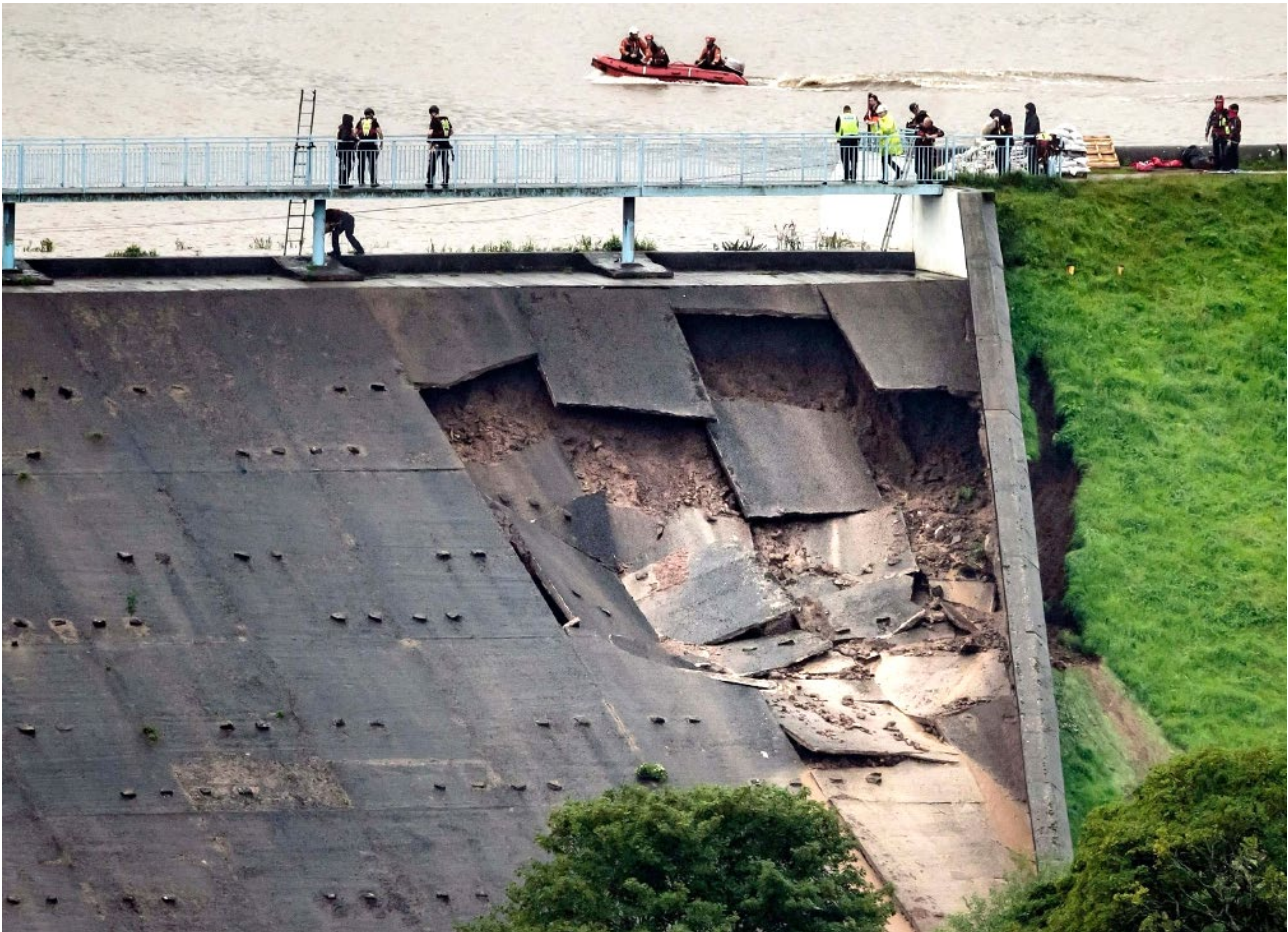
“The lack of an effective cut-off between the spillway crest and the impermeable core of the dam would have allowed water to pass into the embankment fill under the spillway chute. While some of this will have drained downwards through the permeable fill, it is likely that some will have flowed beneath the slabs of the spillway chute causing erosion of its foundation.”

The author then goes further into the physics of the failure. He postulates crack injection as being responsible for seepage of water under the spillway slabs that caused the large void into which the slabs subsequently collapsed (refer to Figure 7):

**Figure 7: Spillway chute panels collapse into a void at Toddbrook Reservoir (Balmforth, 2020)**

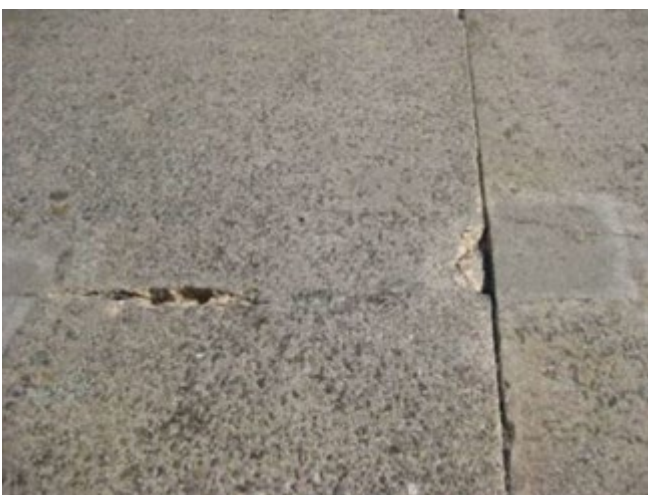
“Spalling occurred almost entirely in delaminated concrete at joints and cracks and at patches from previous repairs, generally in the concrete above the level of the reinforcing steel and dowels. Delamination led to spalling of the slabs near the joints and cracks. The spalling exposed reinforcing steel in the chute slabs and dowel bars at the joints to corrosion, leading to bar failure.” (see Figure 8).

**Figure 8: Concrete spalling at Oroville Dam Spillway (France and others, 2018).**

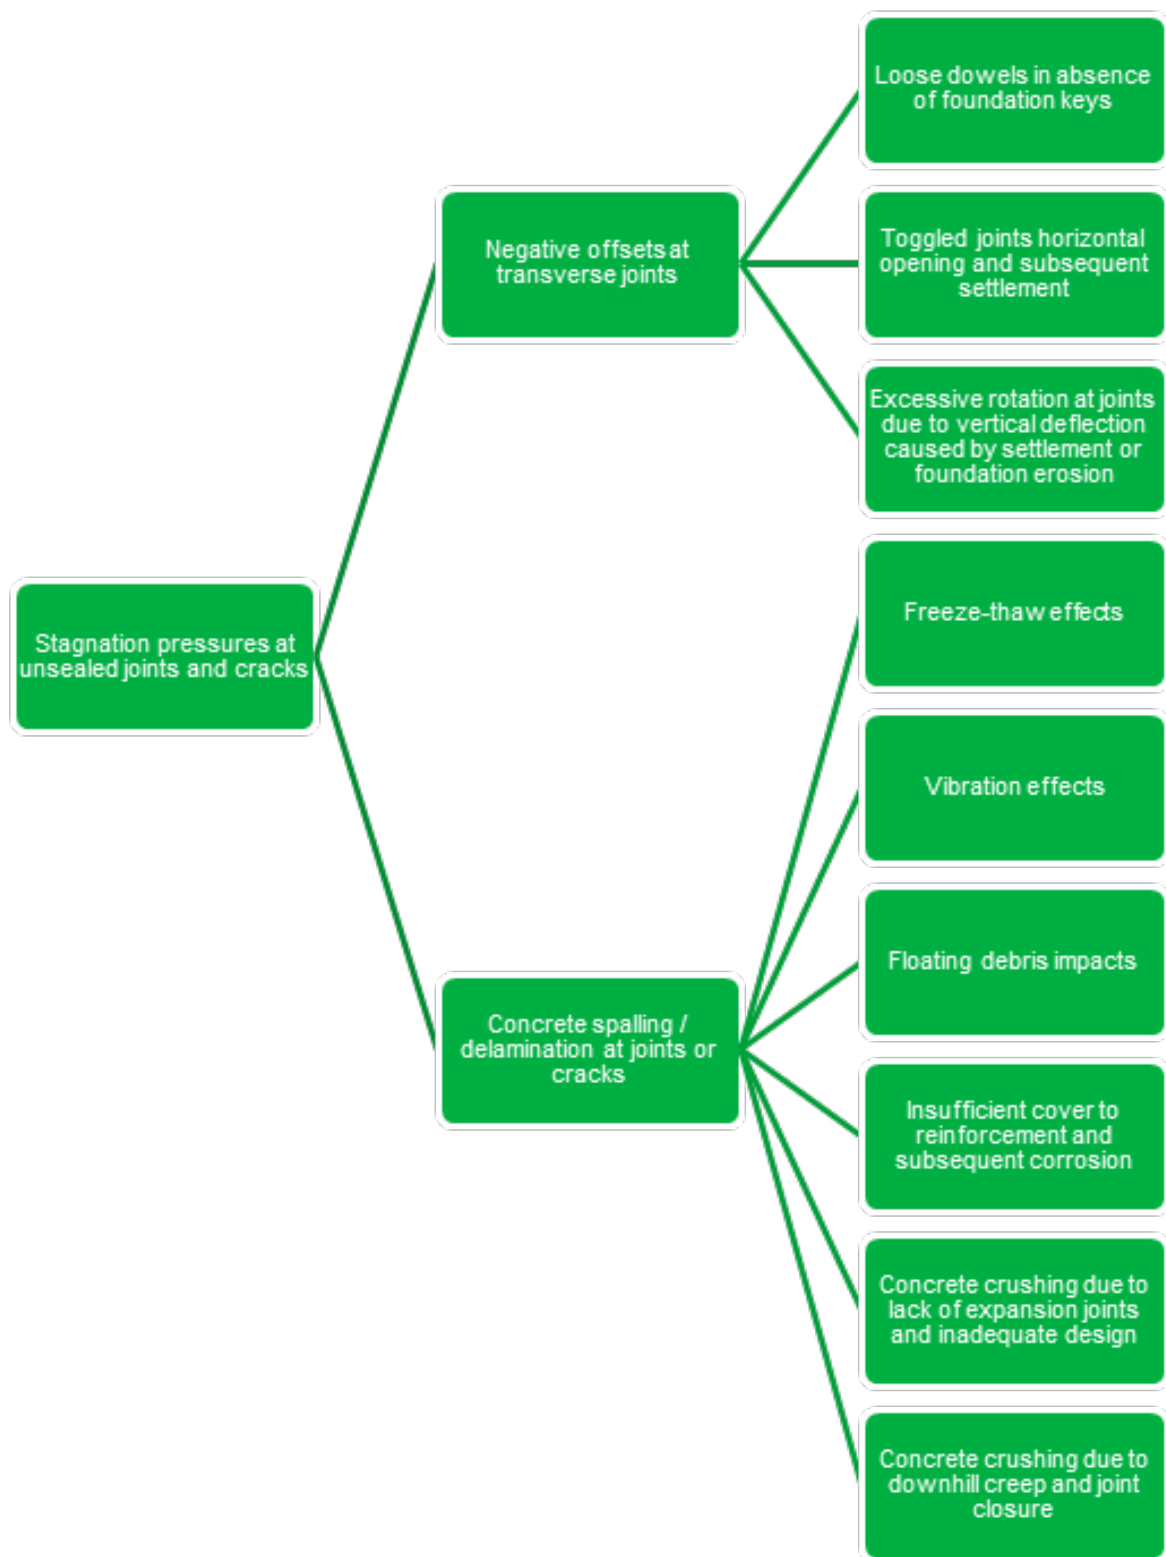
Stagnation pressures could develop at unsealed transverse joints and cracks where negative offsets have the potential to form. This root cause diagram below illustrates some of the possible reasons for the formation of such offsets.

**Root cause diagram for water injection through unsealed cracks or joints**
