AAIB Bulletin

7/2022

Published 14 July 2022

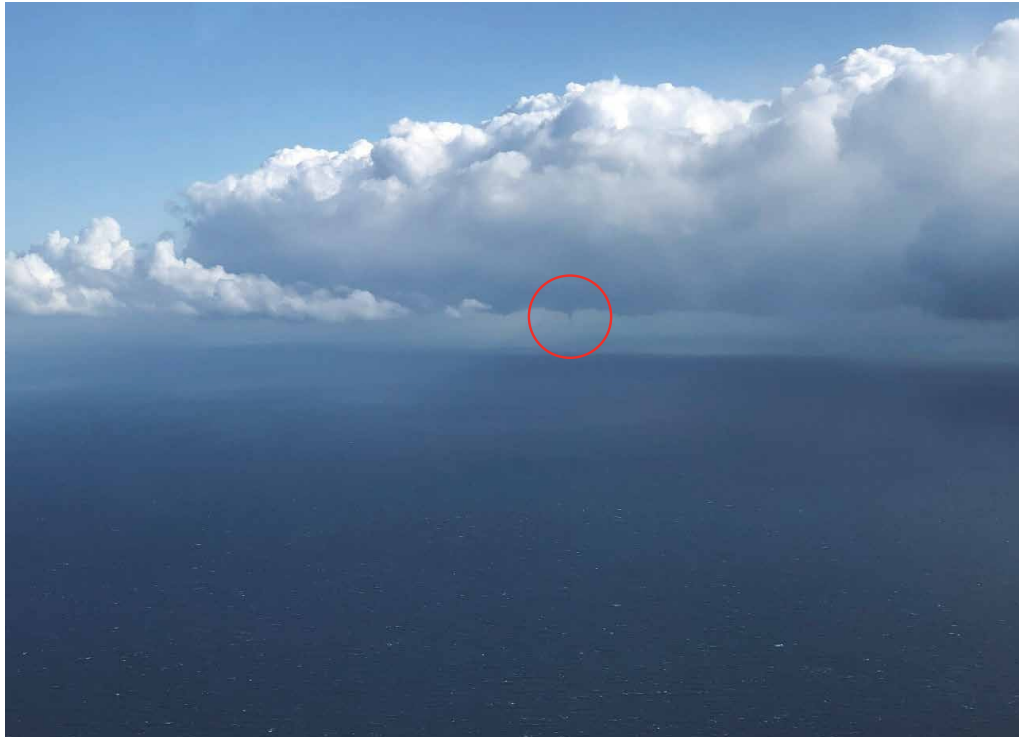
Figure 3

Photograph taken at 0918 hrs showing the cloud mid Channel (waterspout circled in red)

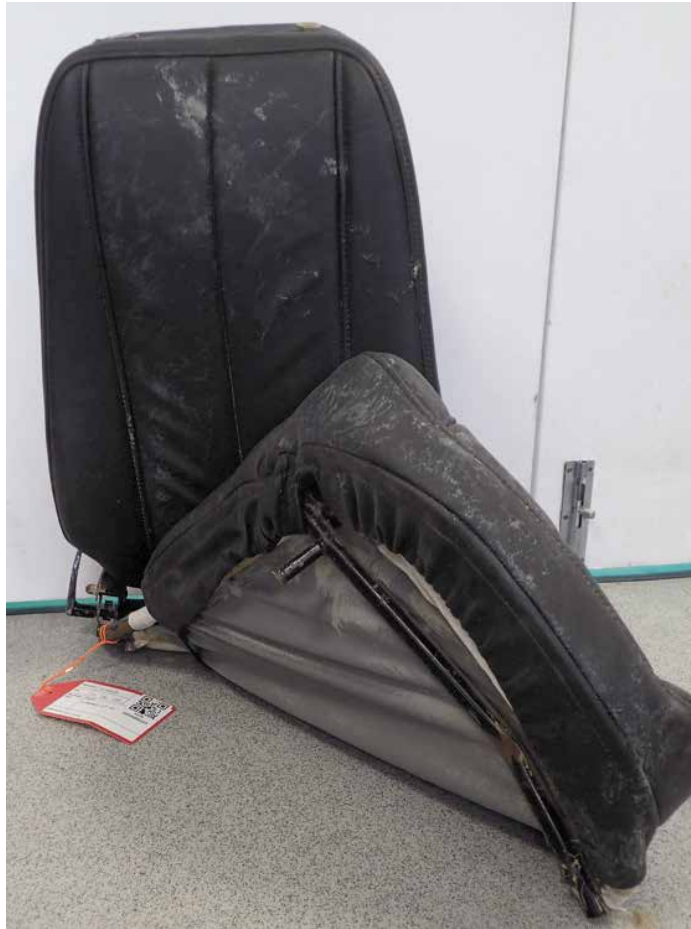
Figure 13

The seat cover exhibited minor scuffing and several small tears but was otherwise in good condition. The lower seat frame was severely distorted, and the forward left mounting point had separated from the frame.

Initial assessment indicated that the damage sustained by the seat recovered from G-EGVA and its liberation from the aircraft were consistent with the airframe having been subject to considerable forces and substantial disruption.

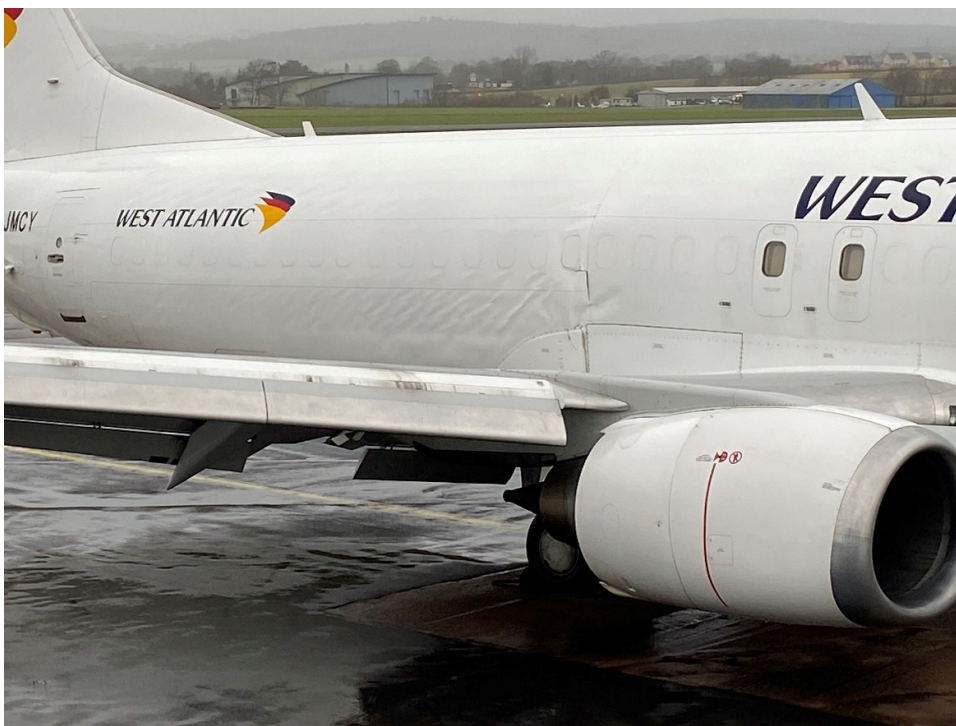
Figure 5

The fuselage skin aft of the wings was cracked and buckled, and the rear fuselage was distorted downward, Figure 5. The crown skin was creased and rippled along most of the fuselage.

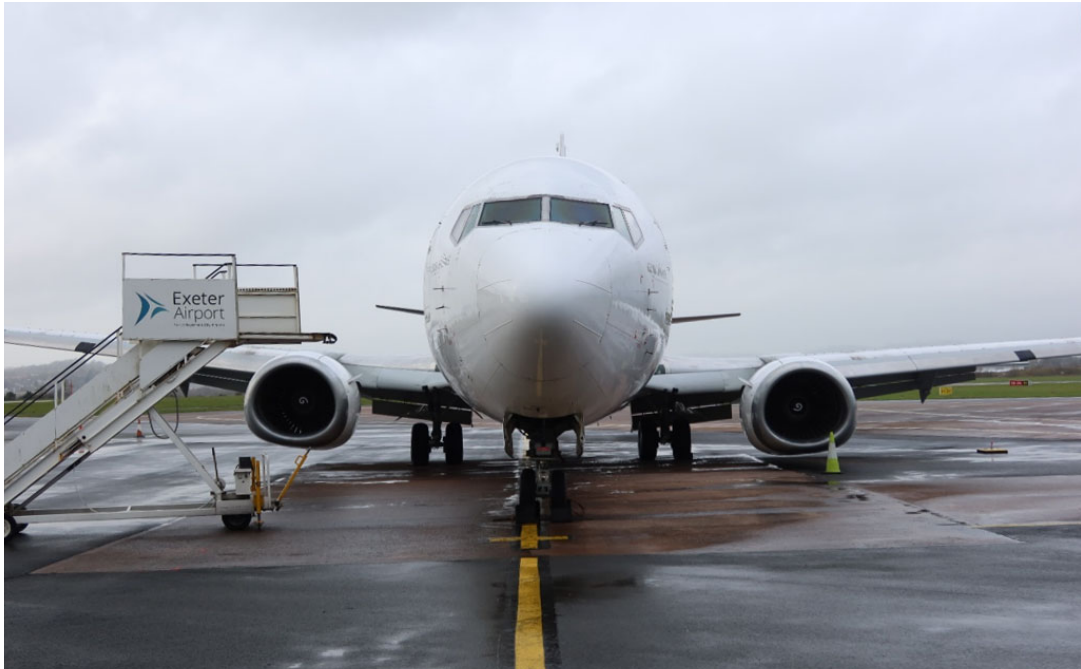
Figure 6

Residual hydraulic oil was dripping from several areas but there were no indications of a fuel leak. Both main landing gear shock absorbers were found to be bottomed, and the left main landing gear beam was distorted upwards such that the aircraft was approximately 2° left-wing low (Figure 6).

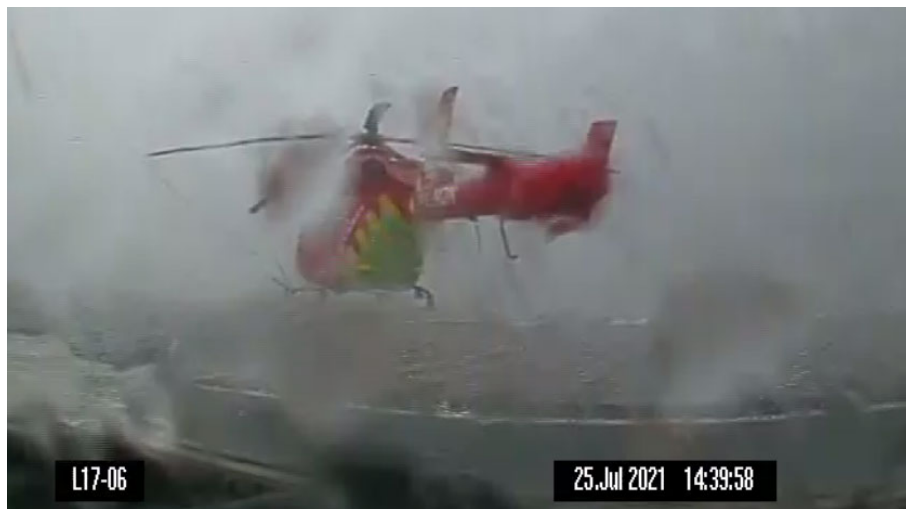
Figure 1

G-LNDN on the helipad at RLH during heavy rainfall

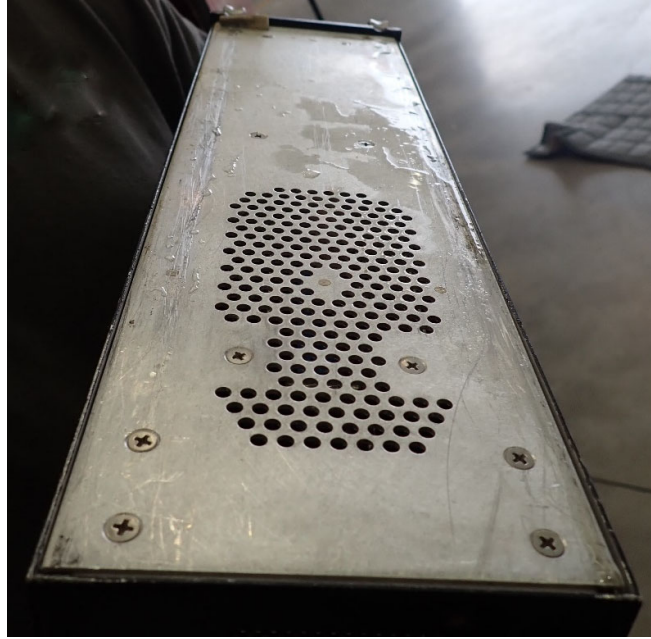
Figure 11

The right EEC, which is positioned inboard of the Symbol Generator, showed evidence of having been in contact with water. The unit is mounted horizontally in the helicopter and accessed by removing the rear mounts and then lowering it, hinging around the forward mounts. As the unit was lowered, water was seen dripping from the ambient pressure tapping on the rear of the unit (Figure 12). Water was also found accumulated within the JI connector when it was disconnected.

Underside of Symbol Generator when removed from G-LNDN

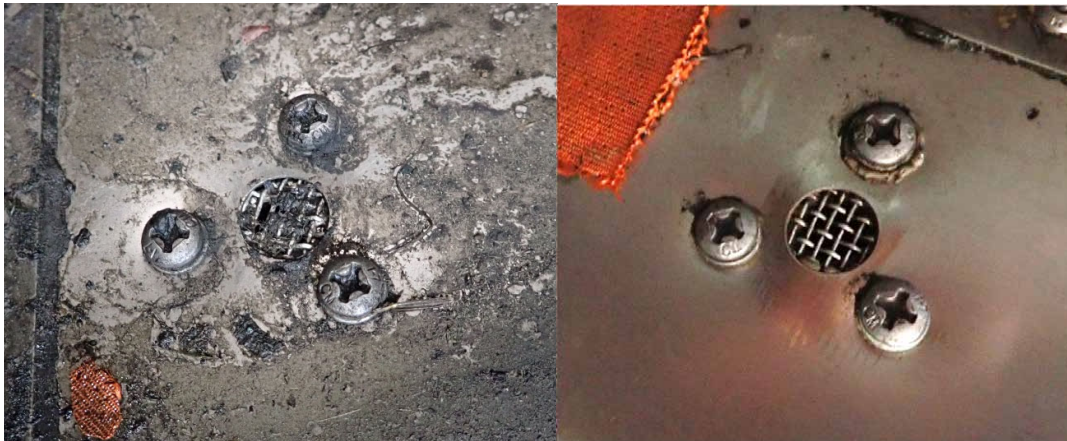
Figure 13

The right engine cowling was removed allowing access to the engine bay. With the thermal blankets removed it was possible to see that the rear bay drain hole was partially blocked with debris; the forward drain was clear (Figure 13). Both drains were functionally tested and showed that they could both pass fluid to the overboard drain outlets.
