Defence  
Infrastructure  
Organisation

# Safety Alert Part A, B & C

## Subject: Failure of Bulk Fuel Installation Pipework

### Number: SA 2019/02

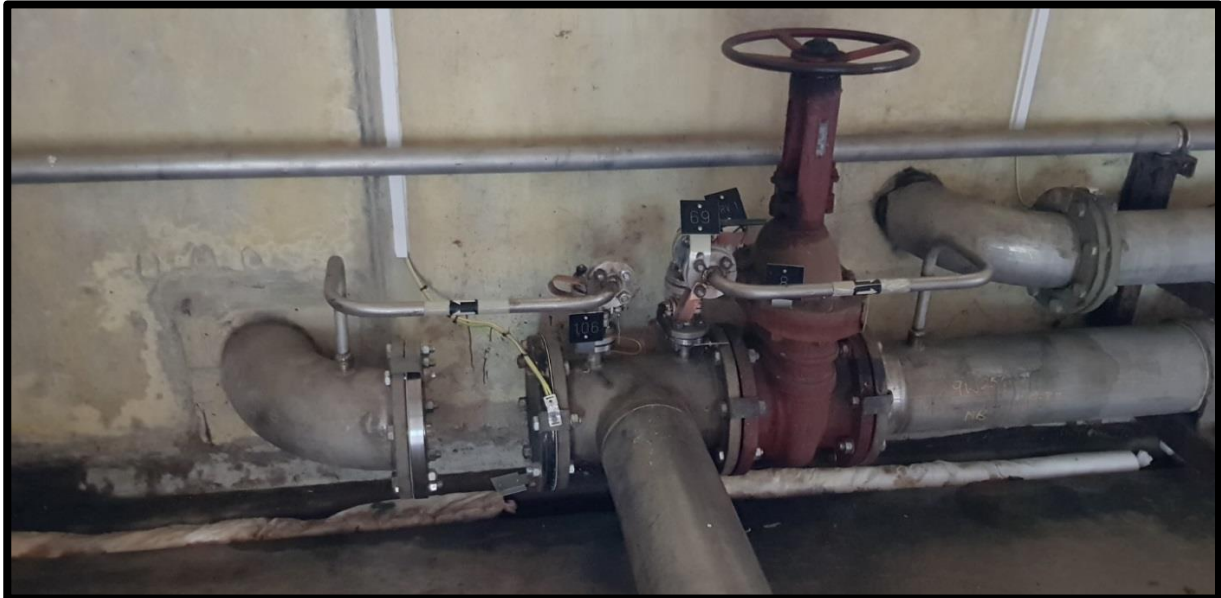
7. Further investigation included pressure testing of the pipework within the BFI pump room; one pipeline failed the test. The failed pipeline was one of two dead legs that terminated within the earth mound covering the fuel tank. It is believed these pipelines were installed as part of the design to enable the future connection of an additional storage tank within the BFI should the storage demand need to be increased. The previously unidentified surface water drainage pipe traversing the BFI was found to have failed thus allowing fuel contamination into the drainage system and surrounding earth mound.

8. Due to their location the fuel pipelines had not been identified on any maintenance regime, but the valves (although not in service) on the pipework which were located within the pump room had received operational attention (opening and closing) along with all the in-service valves. This activity had seen the pipelines remain pressurised with fuel. The lack of inspection and testing of these pipelines had seen them deteriorate over time with one eventually failing; this failure was undetected due to lack of maintenance and inspection. The operational activity to the valves continued on the failed pipeline causing contamination of the surrounding area compounded by failed surface water drainage pipe providing a pathway to the drainage system.

Photograph showing one of the pipelines isolated in the BFI pump room

18. If where identified, a dead leg pipeline has been deemed as no longer required, the pipework should be drained and physically isolated from the existing system by fitting a suitable blank. Once the pipework has been isolated the surrounding area should be investigated/tested for evidence of hydrocarbon contamination.
