**ACCIDENT**

<b>Aircraft Type and Registration:</b>	Rotorway Executive 162F, G-JDHN	
<b>No &amp; Type of Engines:</b>	1 Rotorway RI 162F piston engine	
<b>Year of Manufacture:</b>	1998 (Serial no: 6324)	
<b>Date &amp; Time (UTC):</b>	2 April 2021 at 1500 hrs	
<b>Location:</b>	Near Ledbury, Herefordshire	
<b>Type of Flight:</b>	Private	
<b>Persons on Board:</b>	Crew - 1	Passengers - 1
<b>Injuries:</b>	Crew - 1 (Minor)	Passengers - 1 (Minor)
<b>Nature of Damage:</b>	Helicopter damaged beyond repair	
<b>Commander's Licence:</b>	Private Pilot's Licence	
<b>Commander's Age:</b>	54 years	
<b>Commander's Flying Experience:</b>	Approximately 300 hours (of which 80 were on type) Last 90 days - not declared Last 28 days - not declared	
<b>Information Source:</b>	AAIB Field Investigation

**Synopsis**

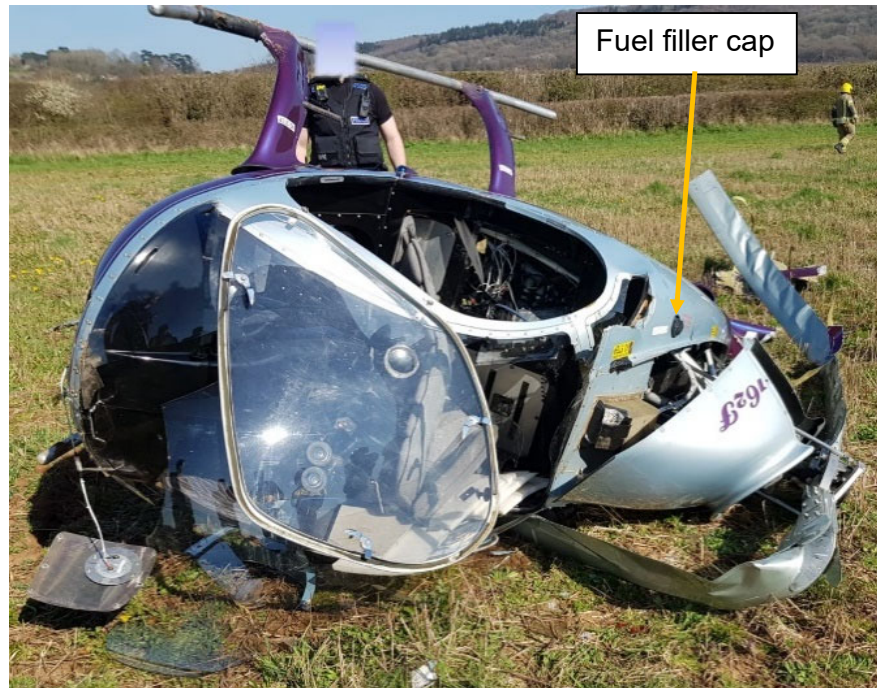
**Figure 2**

G-JDHN at the accident site (used with permission)

The accident site was in a fallow field approximately two miles to the north of Ledbury. The grass was short, but the ground was uneven with some holes. The helicopter was lying on its left side with the tail structure broken in several pieces, although the tail rotor section was still attached by a control cable. Various loose bits of tail structure, including sections of drive belt, were scattered a short distance to the south of the fuselage. The helicopter remained on its left side for approximately two hours until it was recovered back to the pilot's private helipad.

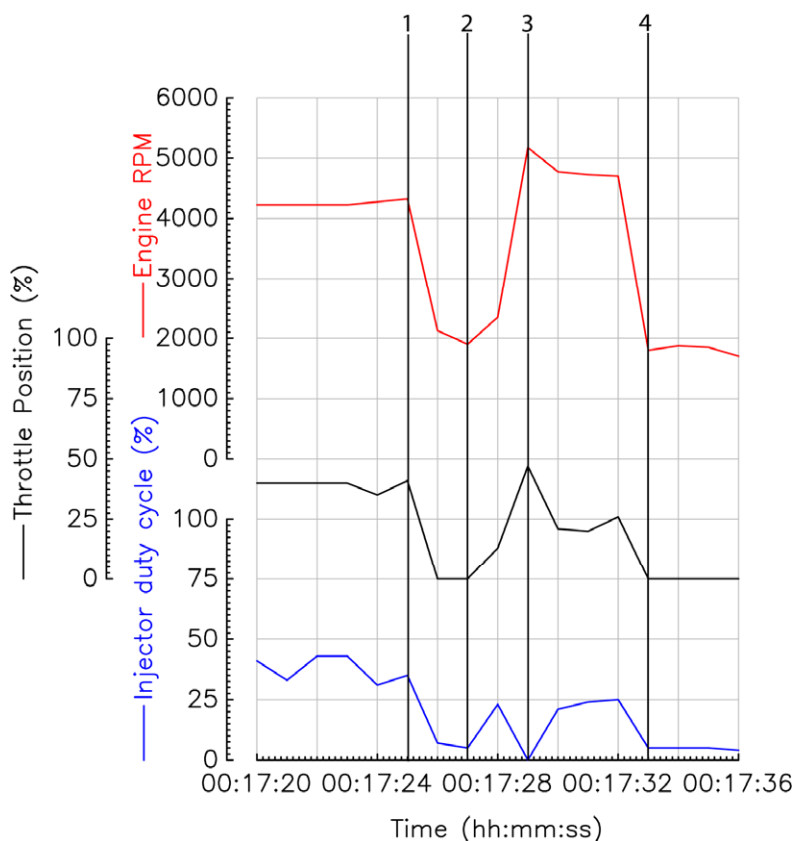
**Figure 3**

Primary DECU download of the significant parameters

The helicopter was in the cruise with all parameters stable up until 00:17:25 where it is considered that the bang occurred (1). Two seconds later the throttle was closed to zero and the engine speed reduced accordingly (2). A further two seconds later the throttle was opened to just above cruise setting, but the engine speed reached 110% (5,175 rpm) and the engine limiter initiated by cutting the injector duty cycle to zero (3). Over the next four seconds the throttle was adjusted and eventually closed (4), and it remained in that position until the fuel was shut off and the engine stopped several seconds before the landing.

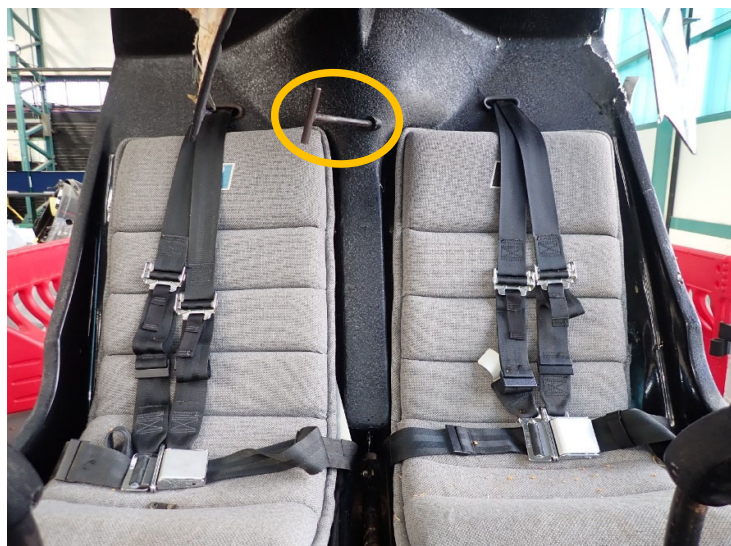
**Figure 6**

Cockpit looking aft with clutch lever disengaged

When the helicopter rolled over at the end of the ground run, the passenger in the right seat was injured on the left shoulder by the clutch lever. With the clutch disengaged, the 5 mm diameter steel lever protruded approximately 200 mm into the cabin and was angled towards the passenger side (Figure 6). It could not be determined why the clutch disengaged.

A modification is available to replace the lever and over centre linkage with an electro-mechanical actuator to operate the clutch system.

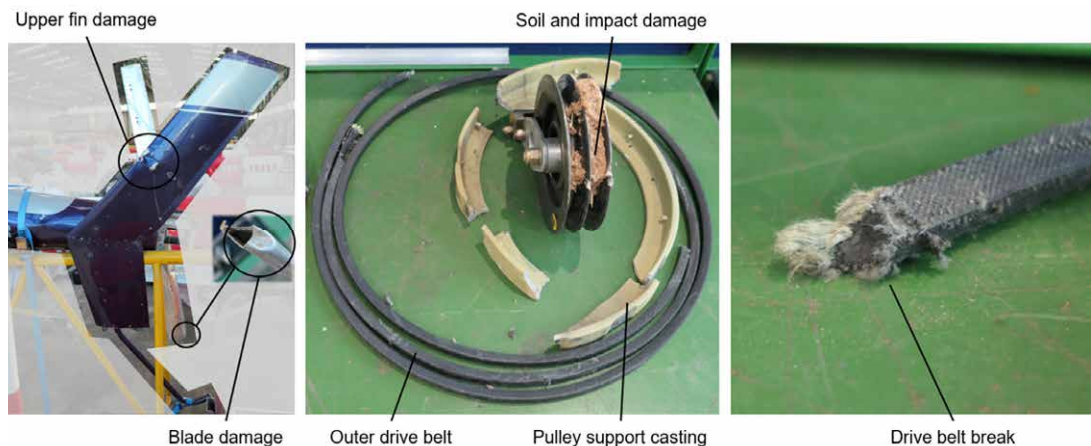
**Figure 8**

The tail boom structure was badly damaged with the tail rotor assembly and vertical fin having broken off as one piece (Figure 8 left), leaving approximately 30 cm attached to the fuselage structure. The lower skid and the upper vertical fin of the tail rotor assembly showed signs of impact with the ground, and there was minor damage to the tail rotor blades from ground contact including the loss of a blade end cap. The rest of the structure had broken into many smaller pieces including the two aluminium castings that supported the intermediate pulleys (Figure 8 middle). On both intermediate pulley wheels there were impact marks and soil lodged into the V grooves. The temperature stickers on the pulleys had not recorded an increase in temperature during operation. All three tail rotor belts had been damaged and the third (nearest the tail rotor) was in two pieces. The belts were examined and were in good condition with no indications that the belts had been slipping or of any other defects. The damage to the ends of the belts was consistent with overload failure (Figure 8 right).

Tail rotor, intermediate pulley and drive belt damage

The investigation considered the possibility of a tail rotor drive belt failure but concluded it was unlikely as all three drive belts showed evidence of the same overload failure mechanism. All three belts were in good condition and there was no evidence of the effects of incorrect belt tension which often precedes a belt failure. The belts were new, the tension had been checked recently by the maintenance and repair organisation and the pilot prior to the flight, and the temperature indicators on the pulleys did not show elevated temperatures. It was considered that an inflight failure of the drive belts would not have produced a noise consistent with the description by the pilot and the witnesses on the ground. The increase in tail thrust and inability to apply enough left pedal further suggests the tail rotor was still operational throughout the flight.

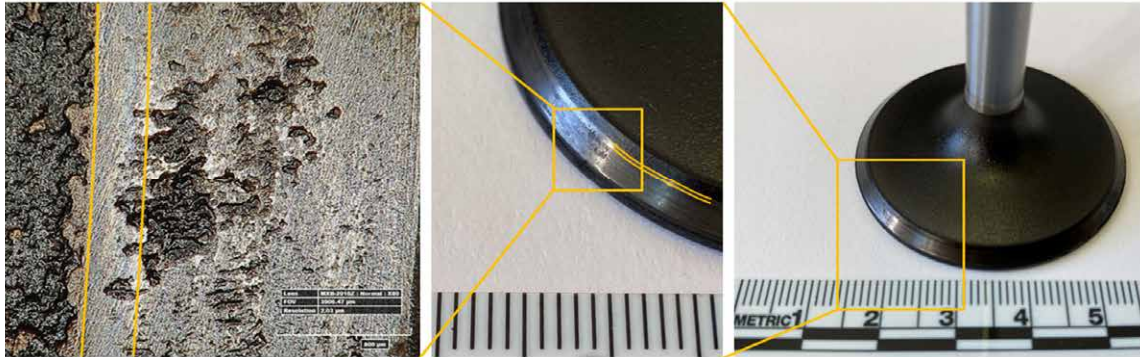
**Figure 9**

The width of the contact area between the inlet valve and the seat is approximately 400  $\mu\text{m}$  and the largest surface defect was 640  $\mu\text{m}$  wide, which crossed into the contact area.

Cylinder 2 inlet valve surface defect, valve seat contact area highlighted

During the engine examination oil was found in the inlet plenum, and two cylinders leaked air during a leak test. After the helicopter rolled over, it was lying on its left side with cylinders 1 and 2 lowest. The helicopter remained in this attitude for approximately two hours before it was righted and lifted onto a vehicle for recovery. Hot engine oil could have passed the piston rings (a labyrinth seal) and into the cylinder head during this time. The defects in the sealing of the inlet valve in cylinder 2 could have resulted in the oil slowly seeping past the valve and into the inlet manifold and plenum.

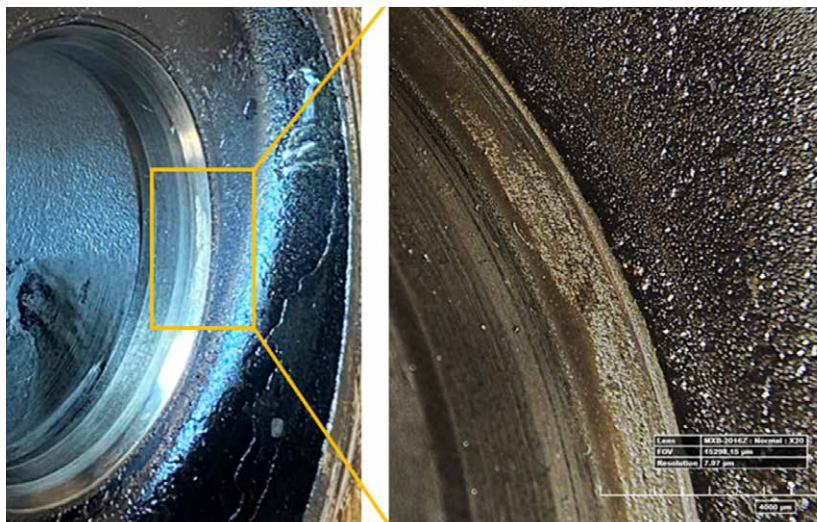
**Figure 10**

Cylinder 2 inlet valve seat surface defects

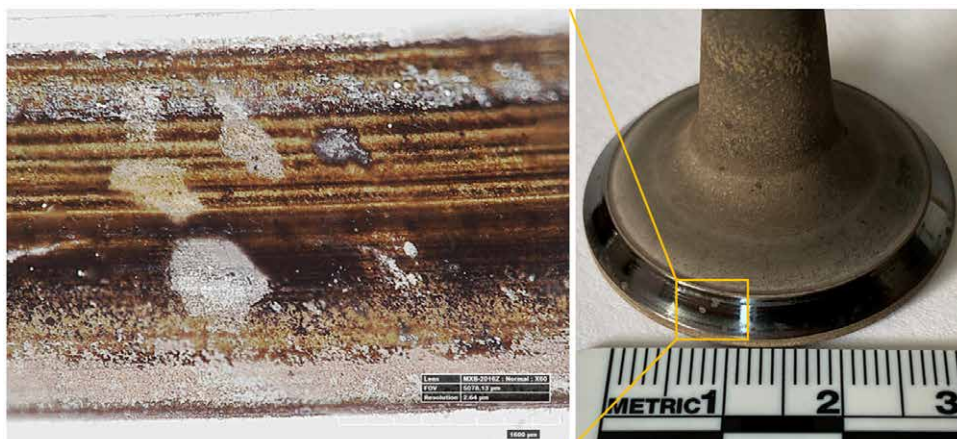
**Figure 11**

Cylinder 3 exhaust valve surface defects

The defects observed in the sealing faces of the exhaust valve in cylinder 3 may have allowed unburnt fuel to pass the valve and enter the exhaust system during the accident flight. This unburnt fuel would have accumulated in the exhaust until it was ignited by the exhaust gases and caused an explosion or after fire in the exhaust system. This could have produced a loud noise similar to that described by the pilot and reported by the witnesses on the ground. The after fire would have caused an increase in the internal pressure of the exhaust system which would have momentarily restricted the flow of exhaust from the other cylinders. This restriction would have resulted in a hesitation in power output from the engine.

The cylinder 2 inlet valve and cylinder 3 exhaust valve were in poor condition considering the engine had completed 179 hours since a cylinder head overhaul. It was considered that the defects seen were the result of normal operation of the engine over a prolonged period, where localised heating had resulted in a deterioration in the surface. The maintenance requirement to have a top end overhaul every 500 hours would be to rework any damage before it affected engine performance. It was not possible to obtain the records of the top end overhaul at 497 hours and therefore to determine if any work had been carried out on these valves.

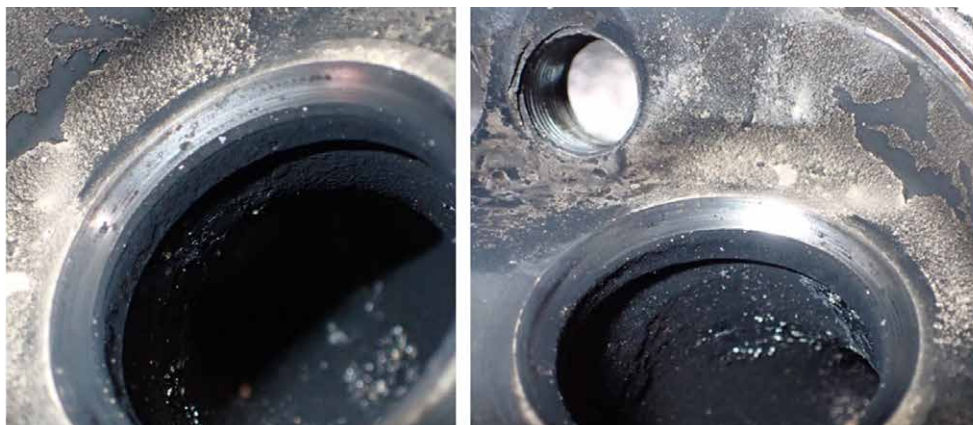
**Figure 12**

Cylinder 3 exhaust valve seat surface defects
