ACCIDENT REPORT

REPORT NO 9/2022

Moorings deck accident on board the cargo vessel *Teal Bay* resulting in one fatality at Kavkaz South anchorage, Russia on 30 August 2021

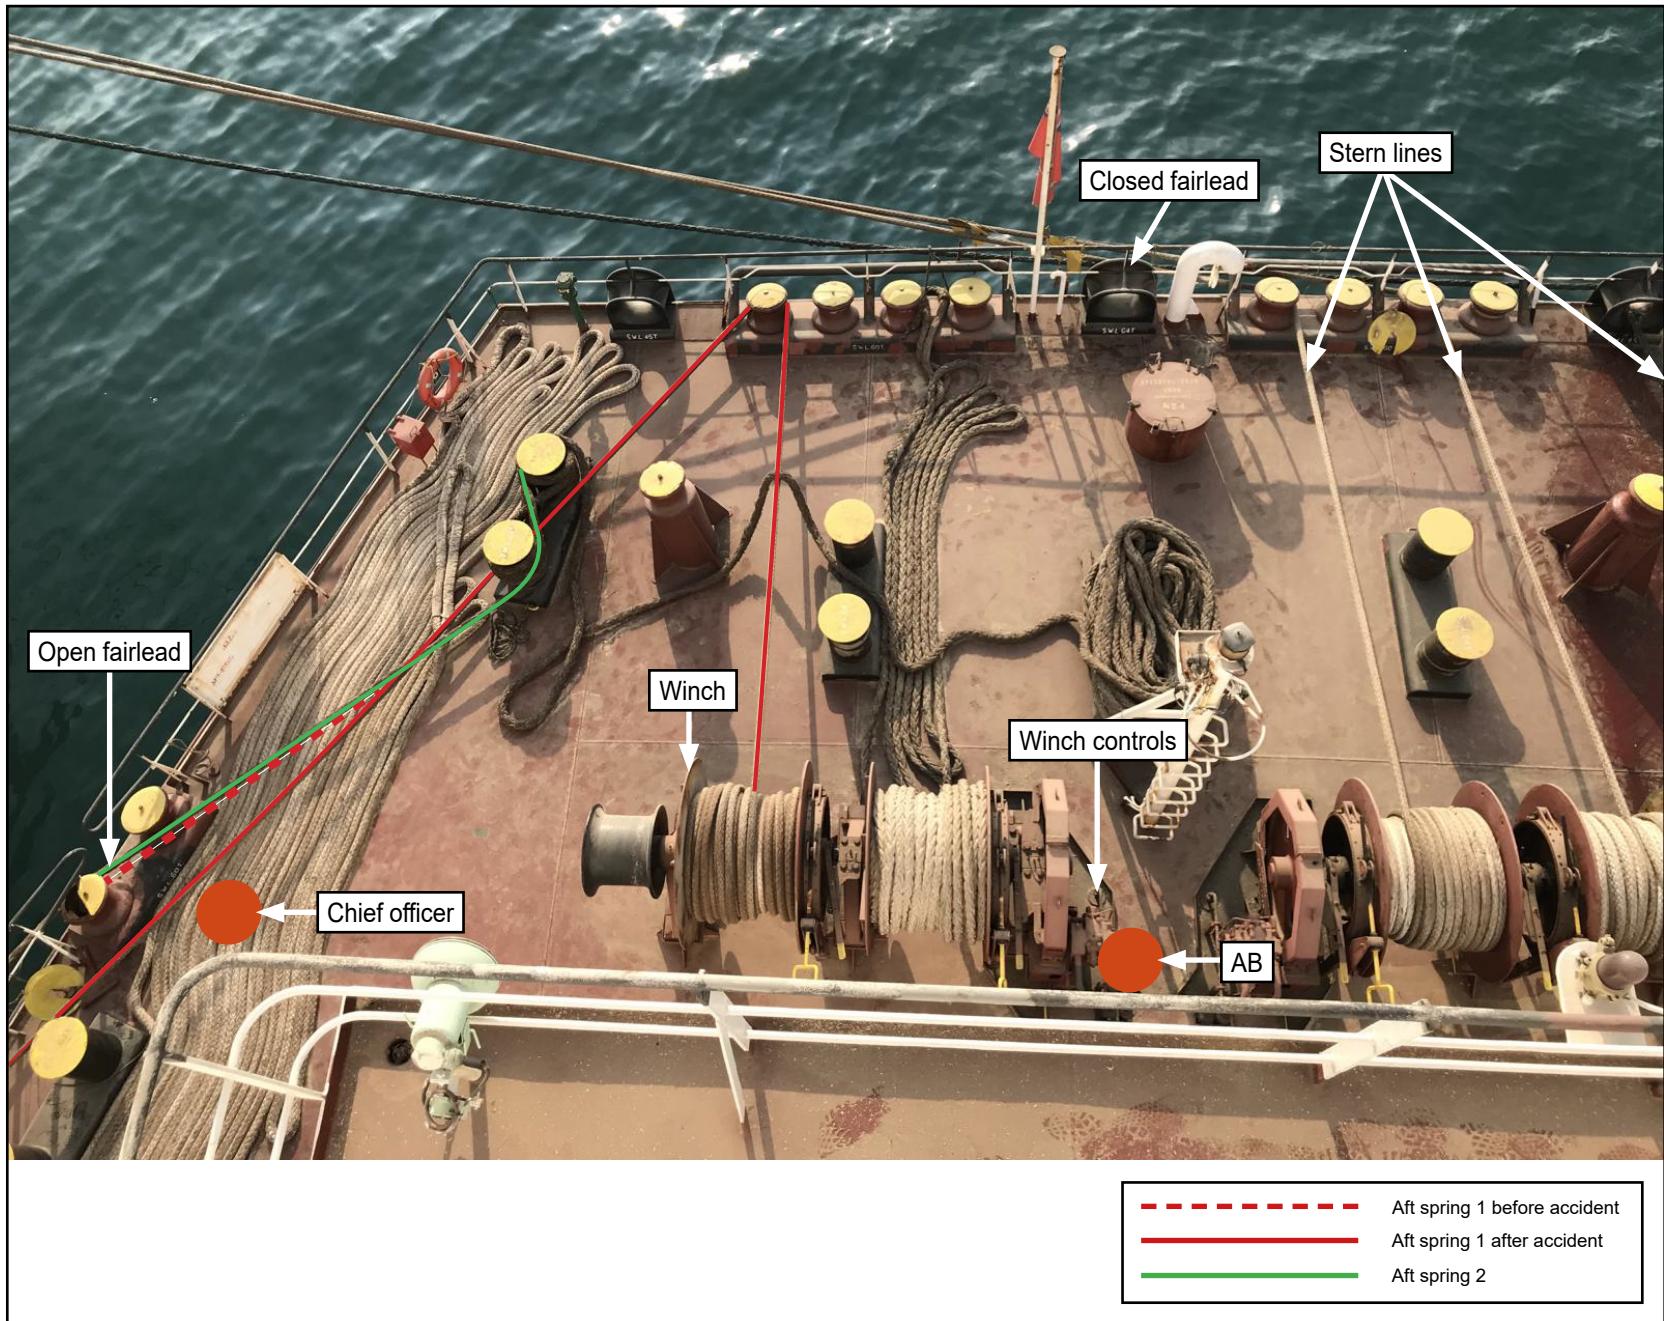
Figure 1: *Teal Bay's* aft mooring arrangement (dotted line indicates position of aft spring 1 before the accident)

The aft spring lines were rigged from the starboard side of the aft mooring deck. One (aft spring 1) was attached to the starboard mooring winch outer drum and led around an open roller fairlead at the stern, back through a set of double bitts and then forward through an open roller fairlead on the outer edge of the mooring deck. The second aft spring (aft spring 2) was secured above aft spring 1 on the double bitts and led forward through the same open roller fairlead (**Figure 1**). Both springs passed through the same closed fairlead on *Kavkaz V*'s main deck.

The decision to lead two lines through the same roller fairlead was unsafe and the presence of a second line restricted the available space and limited the fairlead's containment ability, almost certainly contributing to the aft (upper) spring 1 jumping out under tension.

- Leading two lines through the same fairlead restricted the space available and almost certainly contributed to the loss of spring line 1 containment.

- Conducted additional safety training with *Teal Bay*'s crew, including modules on safe mooring operations and STS.
- Issued a work instruction setting out a plan to remove open fairleads from the fleet and replace them with a closed type or universal type of fairlead and directed managers to make allowance for this within the dry dock specification for vessels scheduled to dry dock.

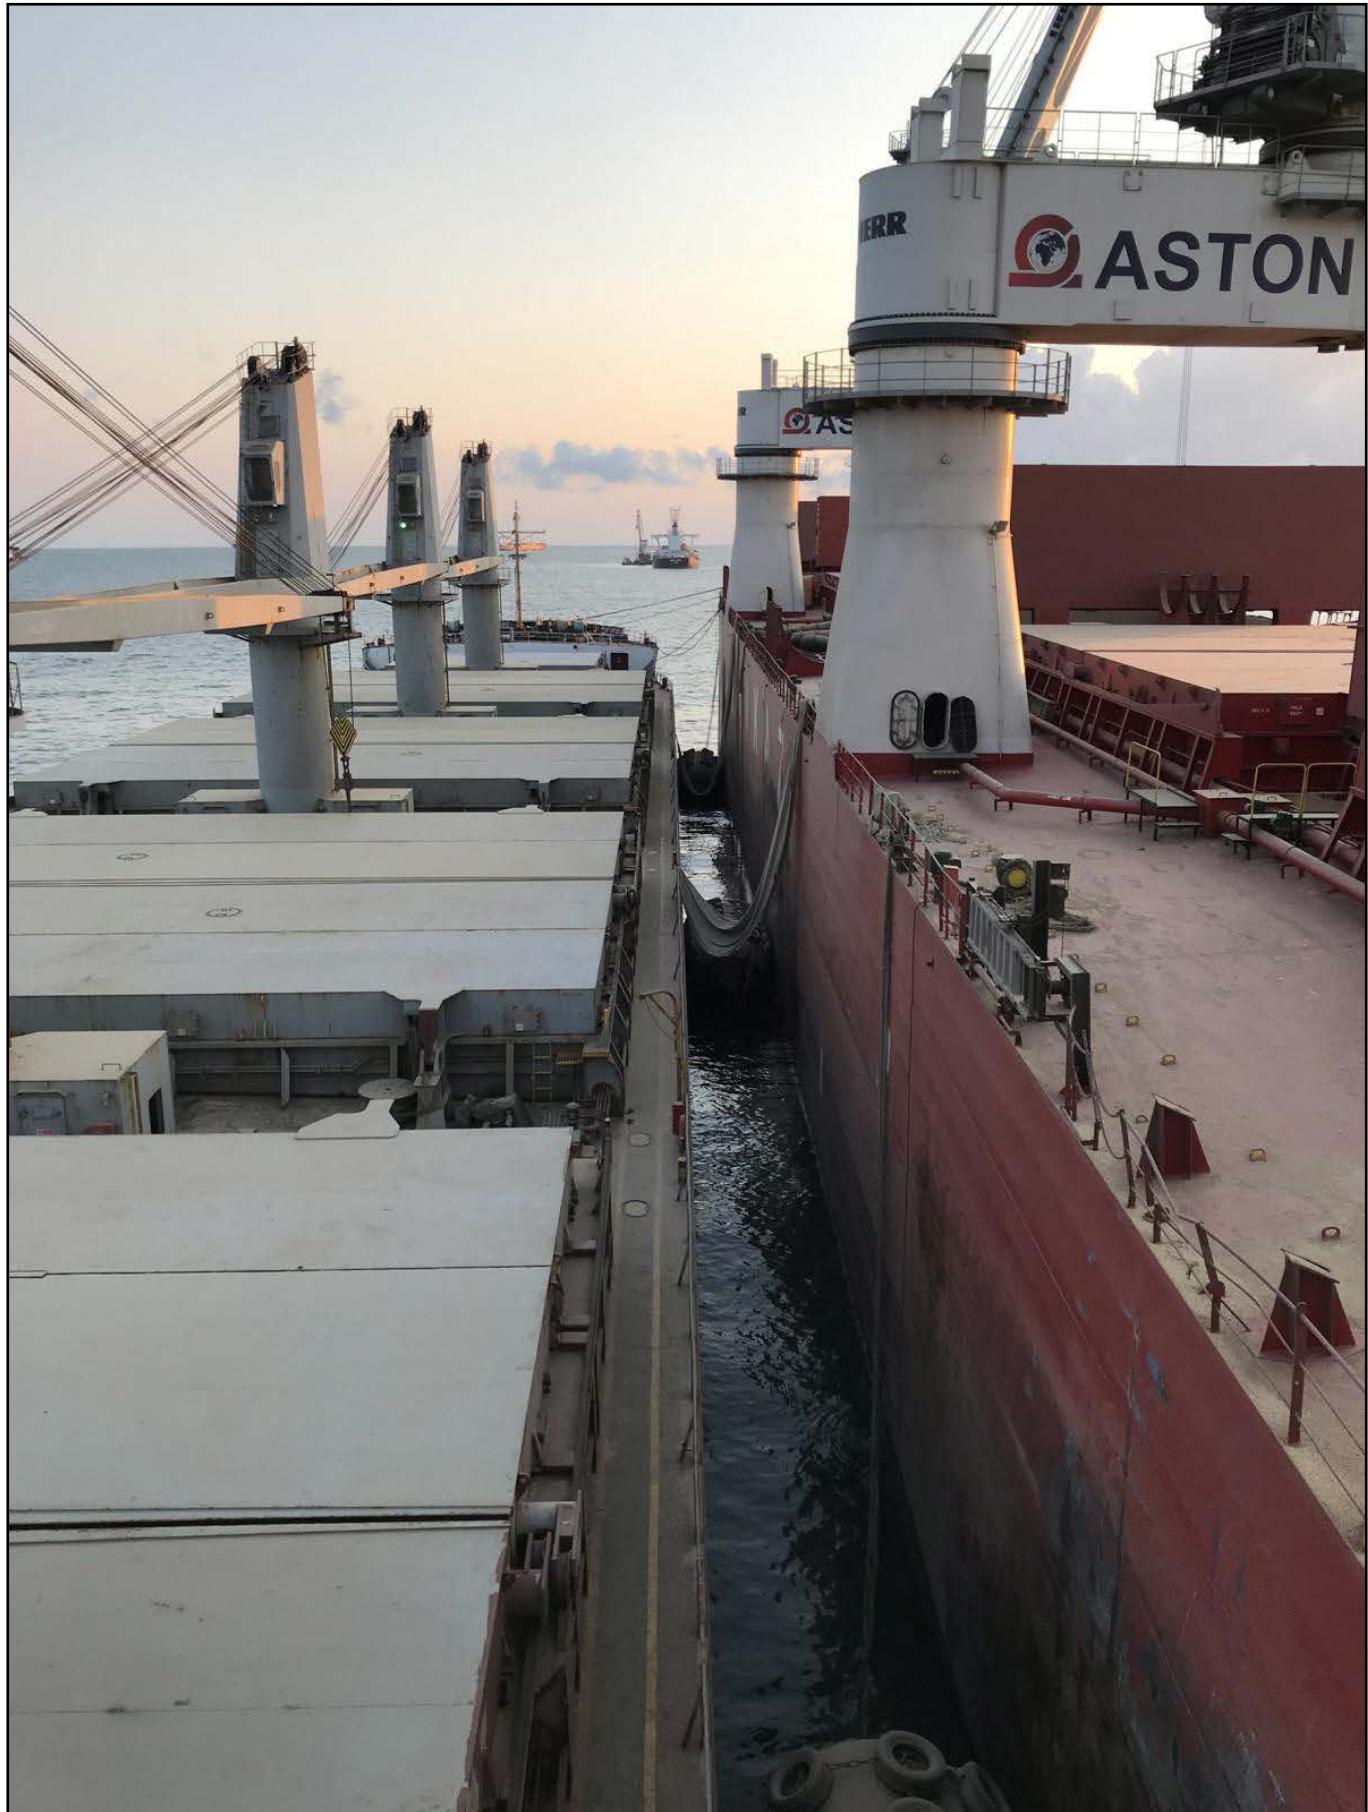
Teal Bay was moored starboard side to alongside *Kavkaz V* (**Figure 2**). The three stern lines were rigged from the port side of the aft mooring deck. Two were attached to the port mooring winch drums and led through open roller fairleads at the stern; the third was secured to a set of double bitts and led through a closed fairlead (**Figure 1**). All three stern lines were led through a single closed fairlead on the port side of *Kavkaz V*'s aft mooring deck and placed over bitts.

Figure 2: Teal Bay (left) moored alongside Kavkaz V (right)

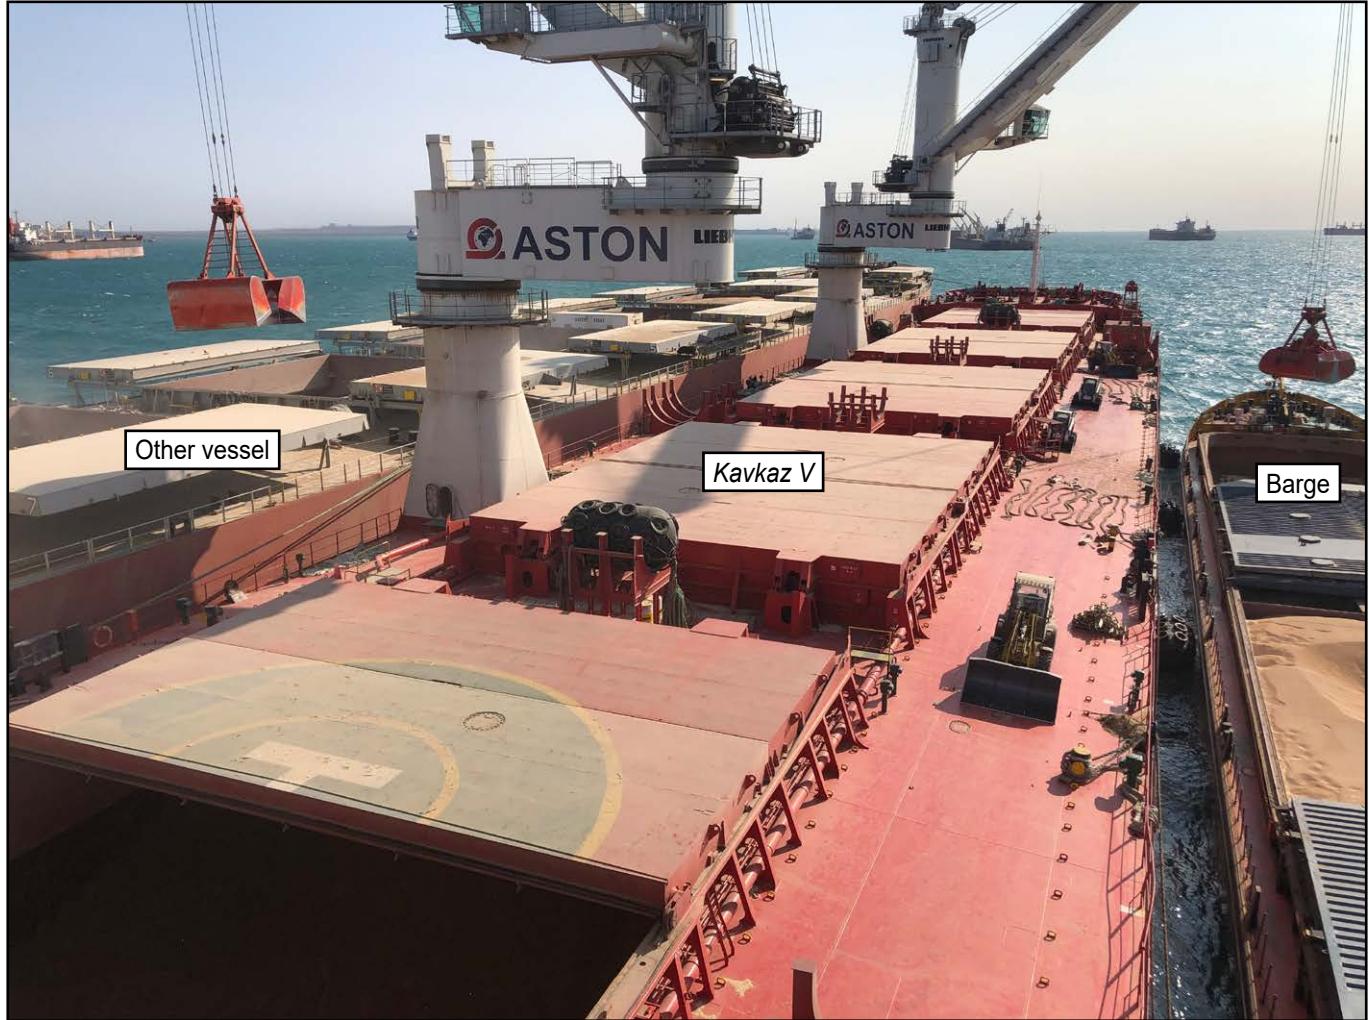
When acting as a storage vessel at anchor, *Kavkaz V*'s cargo holds were loaded with grain from river barges. The grain was then discharged into other vessels moored alongside for onward transport (**Figure 3**). *Teal Bay*'s crew had not loaded cargo in this way before and, until the pilot boarded and informed him of the loading arrangements, the master was expecting to load grain directly from barges while at anchor.

Figure 3: *Kavkaz V* (centre) loading grain from a barge (right) while transferring cargo to another vessel (left)

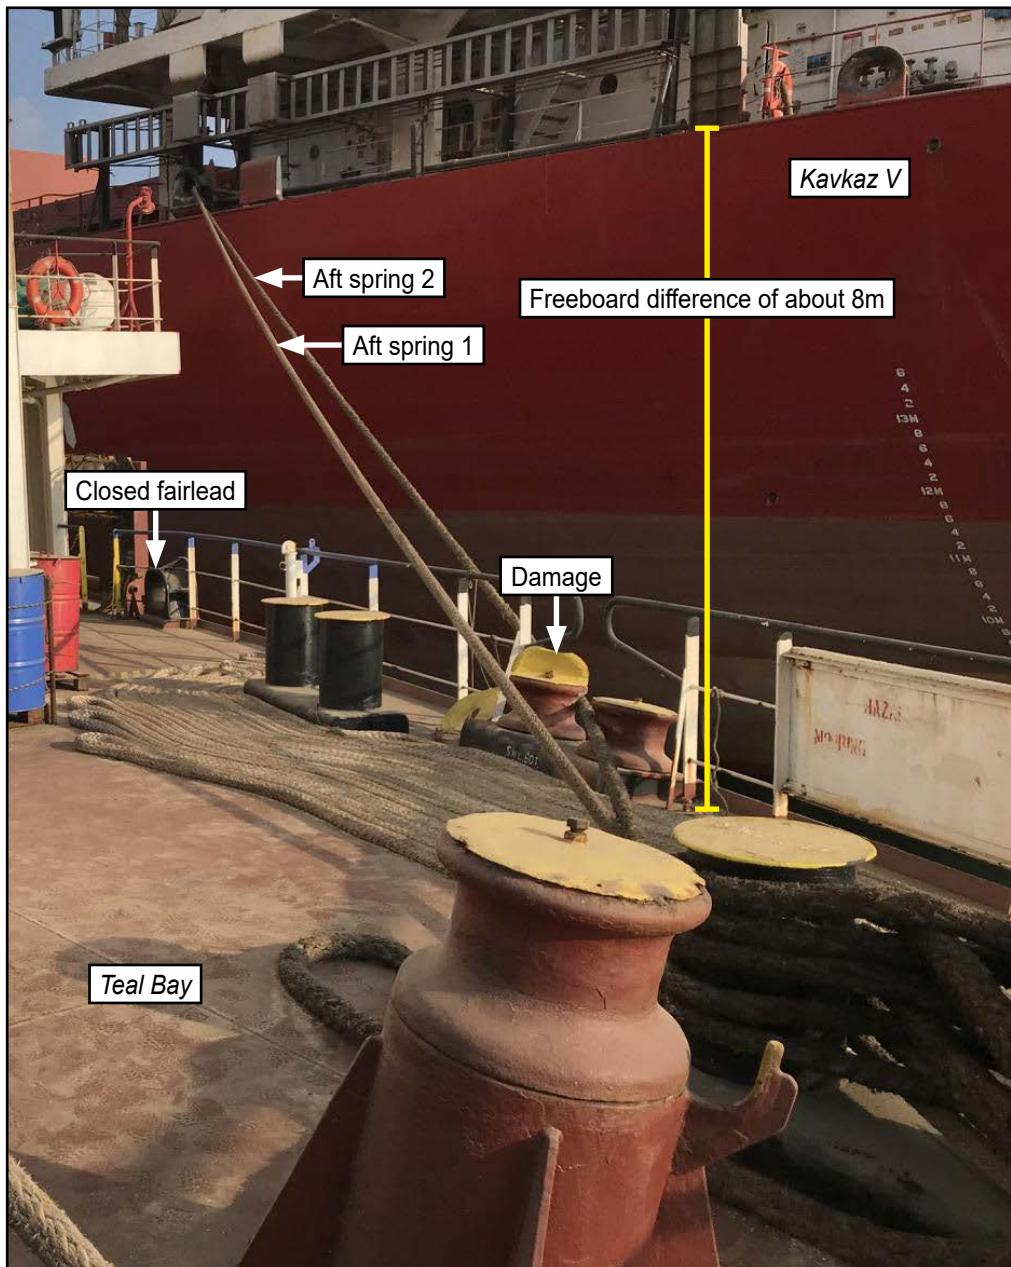
Figure 4: *Teal Bay's* aft deck, showing the nearest closed fairlead, freeboard difference, damage and location of aft spring after the accident

Although *Teal Bay*'s aft deck mooring equipment included several closed fairleads (**Figure 4**) the springs were led through an open one. This was probably because, constrained by the position of mooring equipment on both vessels, *Teal Bay*'s crew judged that the open fairlead provided the most suitable arrangement for the aft spring and had not considered the additional hazards introduced by the loading method. This lack of hazard recognition was further demonstrated by the fact that *Teal Bay*'s mooring risk assessment did not include reference to STS loading.

- *Teal Bay*'s C/O was struck on the head and fatally injured by a tensioned mooring line when it sprang out of a roller fairlead and snapped tight.
- The mooring line sprang free because the fairlead in use was open and the lines had developed a hazardous upward lead during STS cargo operations as the difference between the vessels' freeboard increased.
