Rail Accident Report

**Near miss between a rail grinding train and
an empty passenger train at Sileby Junction,
Leicestershire
5 May 2021**

Report 06/2022
July 2022

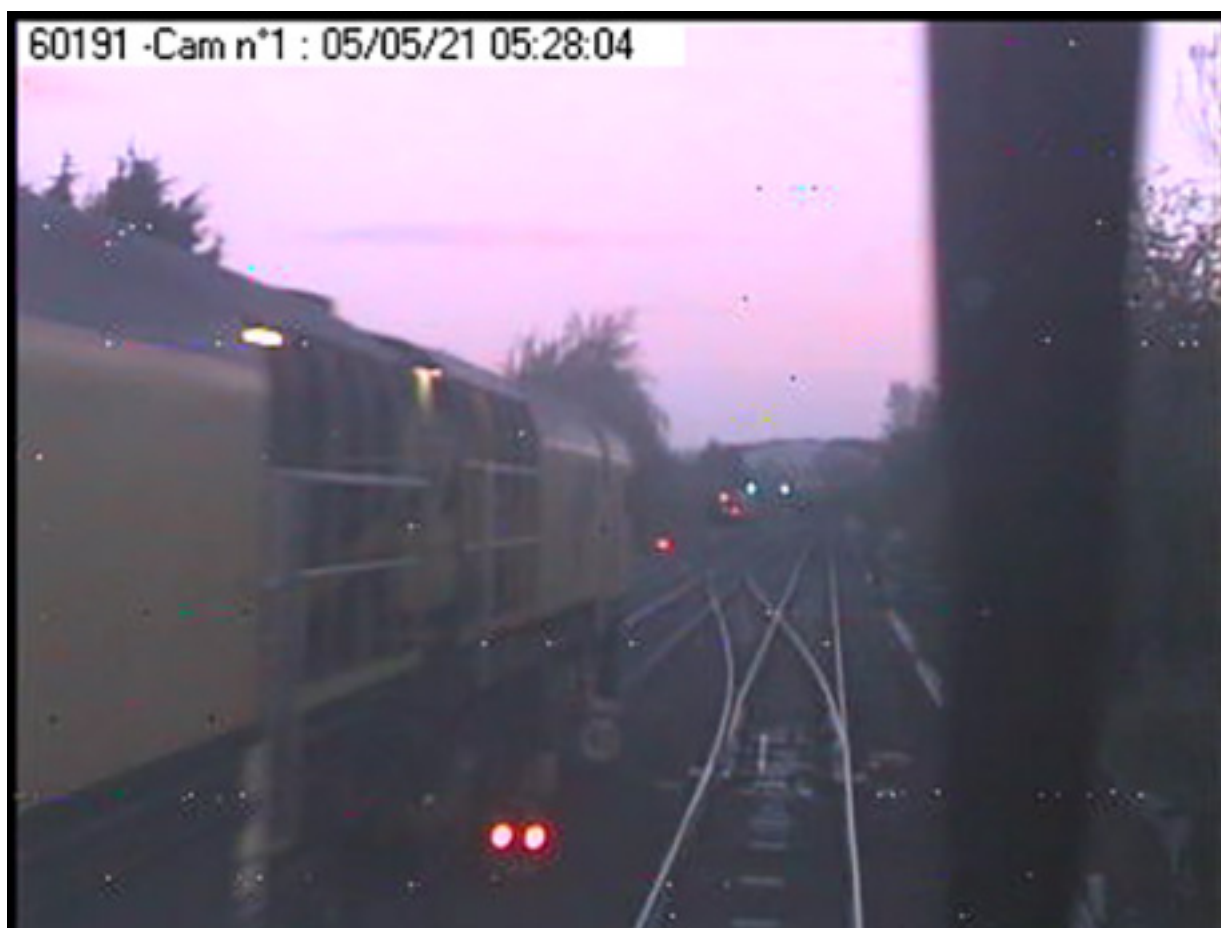
- 3 At about 05:29 hrs on Wednesday 5 May 2021, a train made up of machines used for reprofiling (grinding) rails passed signal LR477 at danger (showing a red aspect) on the down slow line at Sileby Junction, between Leicester and Loughborough (figure 1). This resulted in a near miss with an empty passenger train travelling in the opposite direction that had cleared the junction less than 10 seconds before the rail grinding train reached it (figure 2).

Figure 2: Still image from the rearward facing closed-circuit television (CCTV) of train 5P01 having just crossed over from the up fast line to the up slow line, across the path of train 6Z08; image shows the leading end of rail grinding train 6Z08 (left) shortly before it came to a stop on the down slow line (East Midlands Railway)

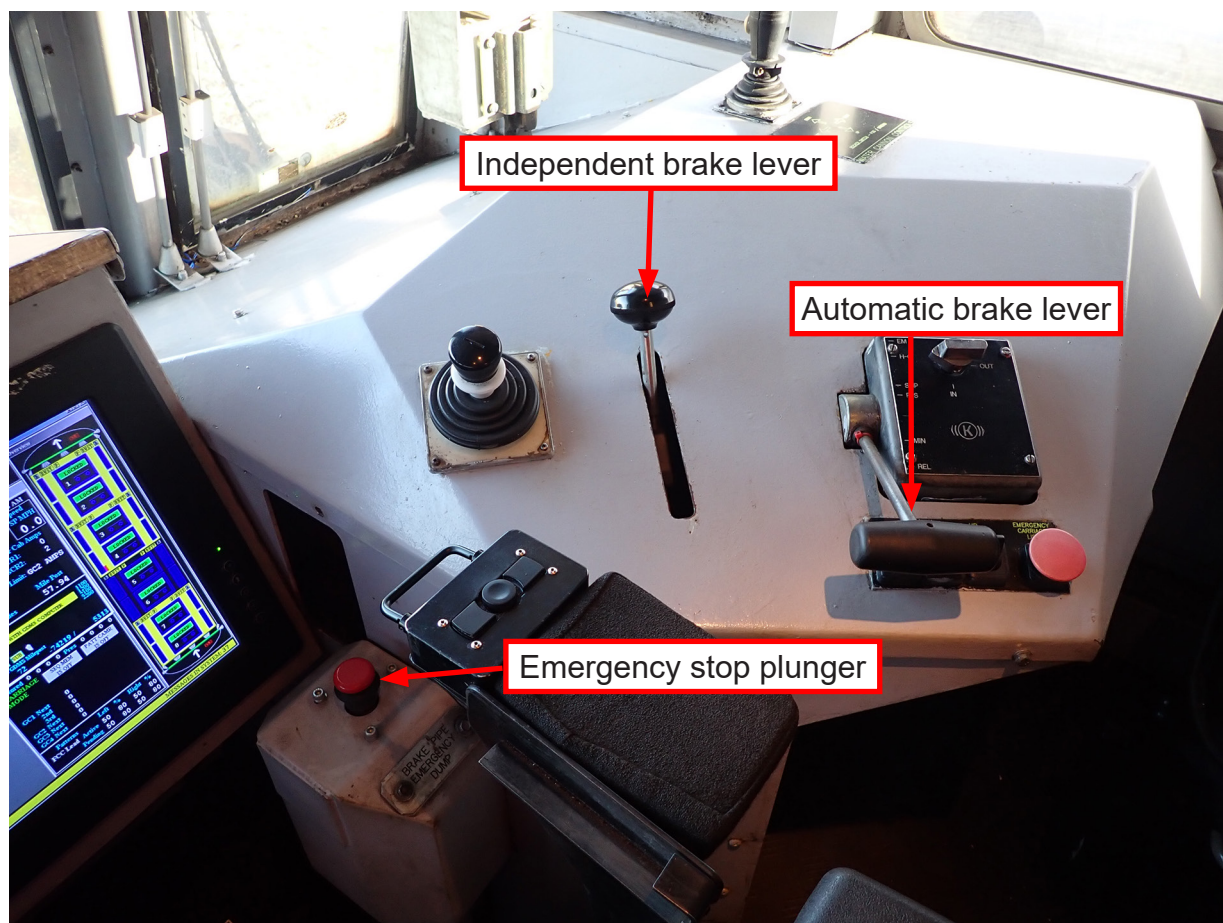
- 15 Machine C2101 is fitted with two braking systems (see figure 5). The first is a conventional 'automatic' braking system, which controls brake cylinder pressures on all the machines via the brake pipe.¹ The automatic brake applies uniform brake cylinder pressure throughout the train; as such, it is used when travelling at higher speeds outside possessions. The second system is an 'independent' (or 'direct') brake, which rapidly changes brake cylinder pressure independently of the brake pipe. The independent brake operates more quickly than the automatic brake but, consequently, can result in the wheels sliding on the rails and being damaged as a result. Therefore, the independent brake should only be used when travelling below 20 mph (32 km/h). It is primarily for controlling speed during grinding work.

Figure 5: Driver's braking controls for the rail grinding machine. These controls are situated to the right-hand side of the driving seat.

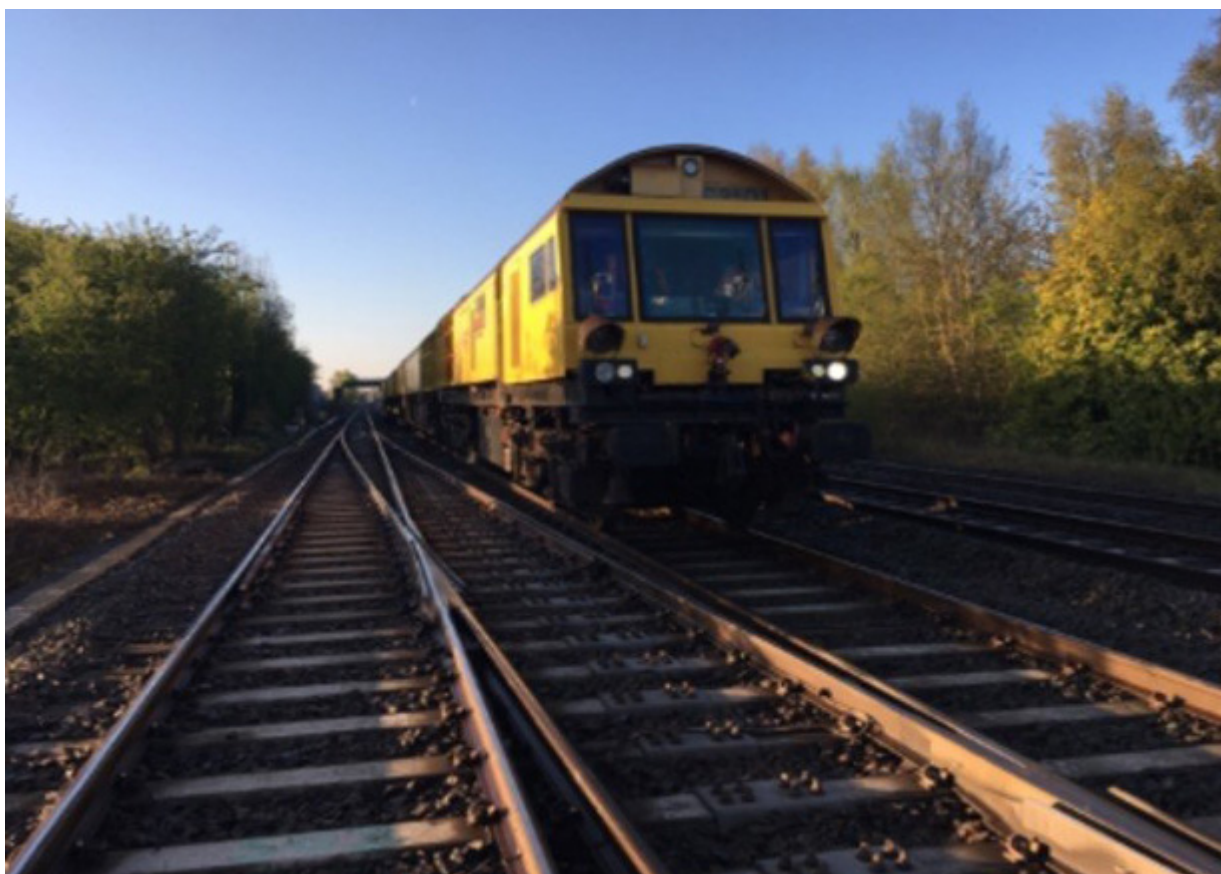
- 40 Train 6Z08 passed signal LR477 at danger at 05:29:24 hrs, while travelling at 40 mph (64 km/h). At this point, the front of train 5P01 had just traversed from the up fast onto the down slow line, before continuing its movement onto the up slow line. About 20 seconds later, the rear end of train 5P01 cleared the junction, just before train 6Z08 reached the conflict point (figure 3). Train 6Z08 stopped after a further 10 seconds, having travelled around 340 metres beyond the signal (figure 7).

Figure 7: Stopping point of the train after the incident, showing the crossover used by train 5P01 from the down slow to the up slow line (Network Rail)
