AAIB Bulletin

1/2022

Airbus Helicopters AS355 F1	G-BOSN	02-Mar-21	11
-----------------------------	--------	-----------	----

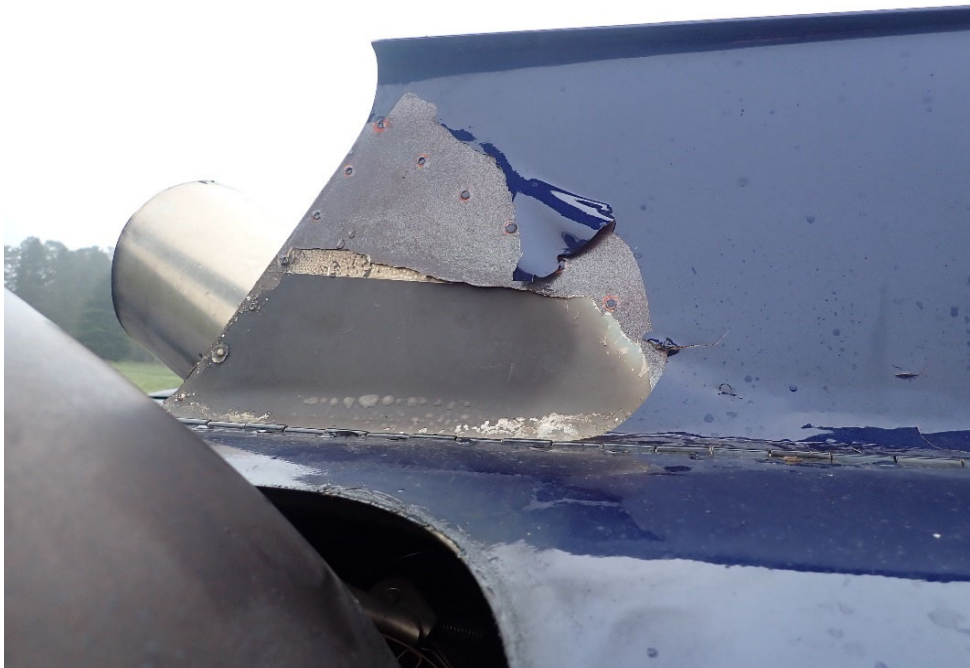
Figure 2
Paint blistering on engine cowling adjacent to right engine inboard exhaust tube

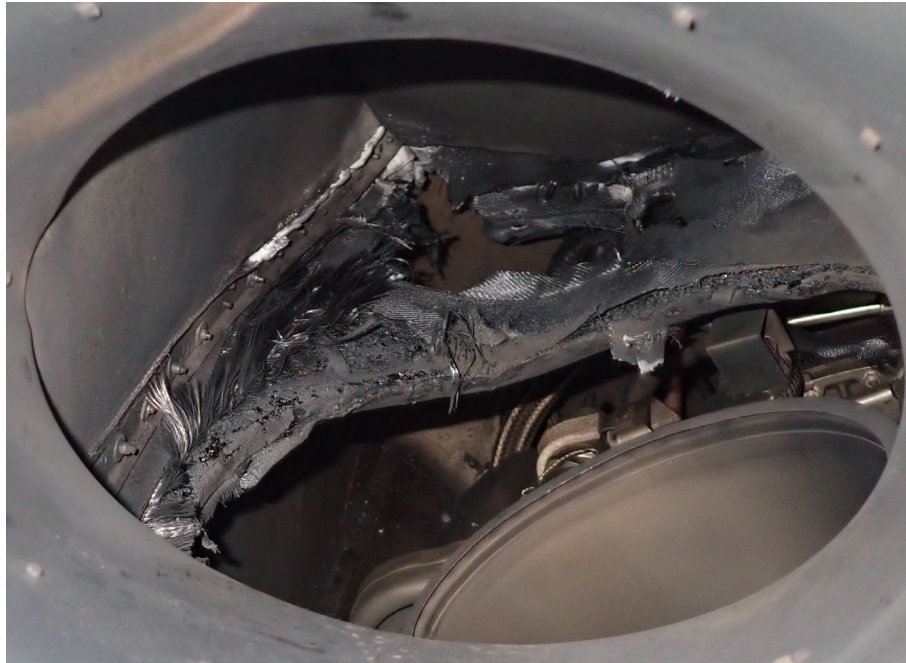
The right engine bay showed signs of elevated temperatures with melting of electrical connector back shells and harness clipping anti-fret material. The starter generator overboard duct had also deformed. The condition of the internal panel forward of the inboard exhaust outlet suggested that the panel had been on fire (Figure 3).

Evidence of fire damage on engine cowl viewed looking forward through right inboard airframe mounted exhaust duct

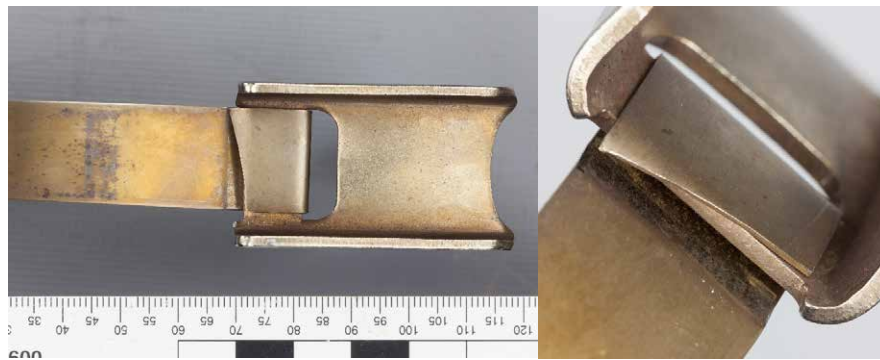
Laboratory examination of the clamp identified that the fracture occurred in the tightening band adjacent to the locking bracket (Figure 9). The fracture surface exhibited features consistent with low-load high-cycle fatigue crack propagation with the fatigue crack propagating across 97% of the width of the band. The remaining fracture surface, measuring approximately 0.5 x 0.5 mm, exhibited features associated with ductile overload (Figure 10) signifying very low load during the final rupture of the clamp.

Clamp bracket and tightening band showing location of crack initiation

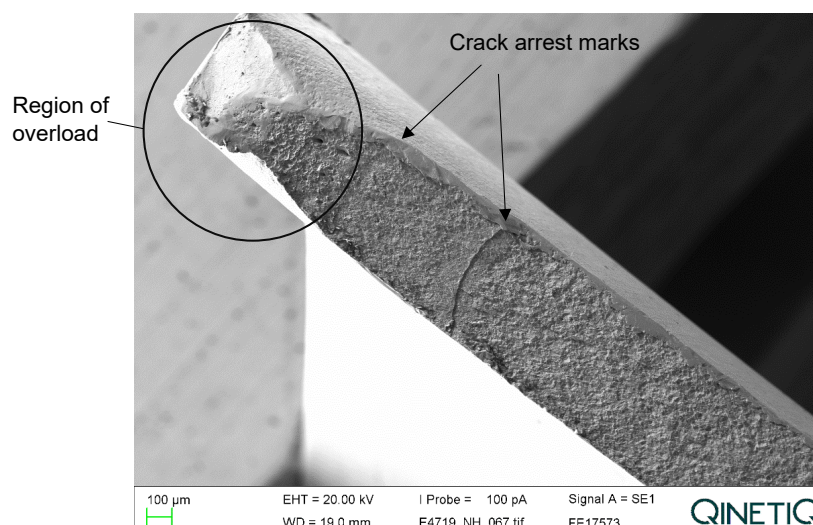
Tightening band showing area of ductile overload and crack arrest marks

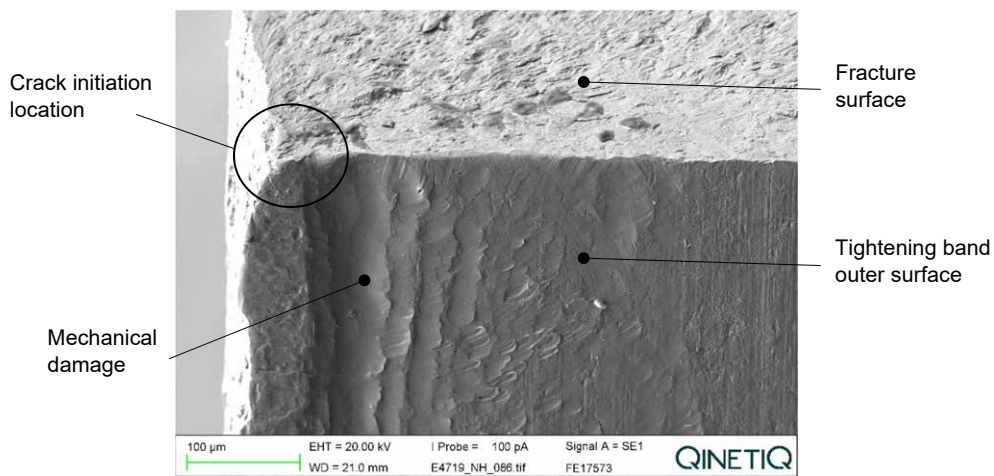
Assessment of the fatigue surface found that the crack initiated on the edge of the outer surface of the tightening band, adjacent to the edge of the locking bracket. Mechanical damage on the outer surface of the band (Figure 11) adjacent to the crack initiation location, may have acted as a stress concentration for the initiation of the fatigue crack. The cut edge of the tightening band in this area exhibited features suggesting that it had been guillotined during manufacture (Figure 12). This unfinished surface may also have influenced the initiation of the fatigue crack. Significant staining (Figure 13) at the crack initiation location indicates that the crack may have been present prior to the incident flight. The remainder of the fracture surface showed consistent colouring with very few crack arrest marks, indicating that the crack growth was likely to have occurred during recent operation. The band material was assessed to be consistent with the grade and hardness for the stainless steel specified by the manufacturer.

Edge of tightening band in the location of crack initiation

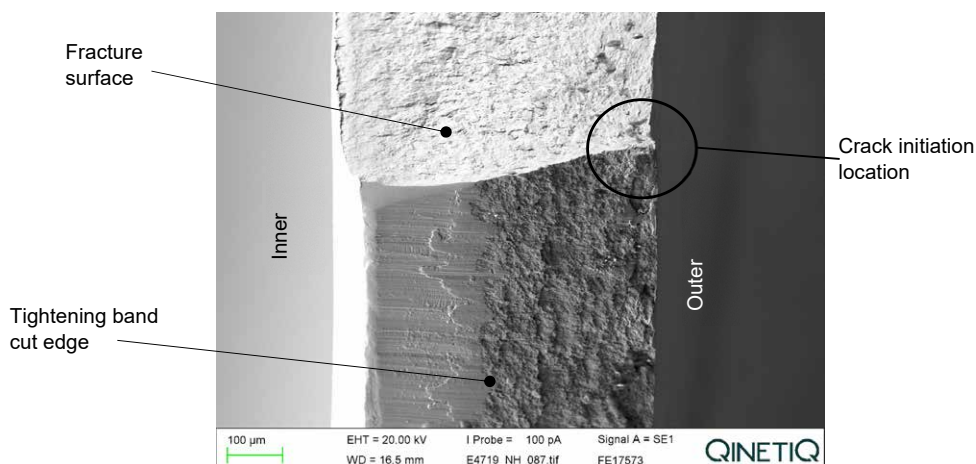
Edge of tightening band in the location of crack initiation

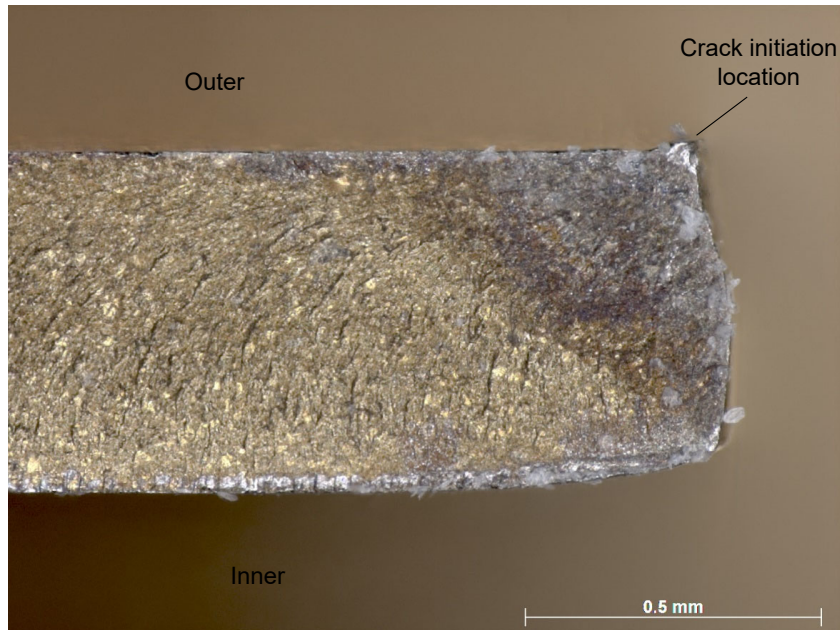
Tightening band fracture surface showing area of crack initiation staining

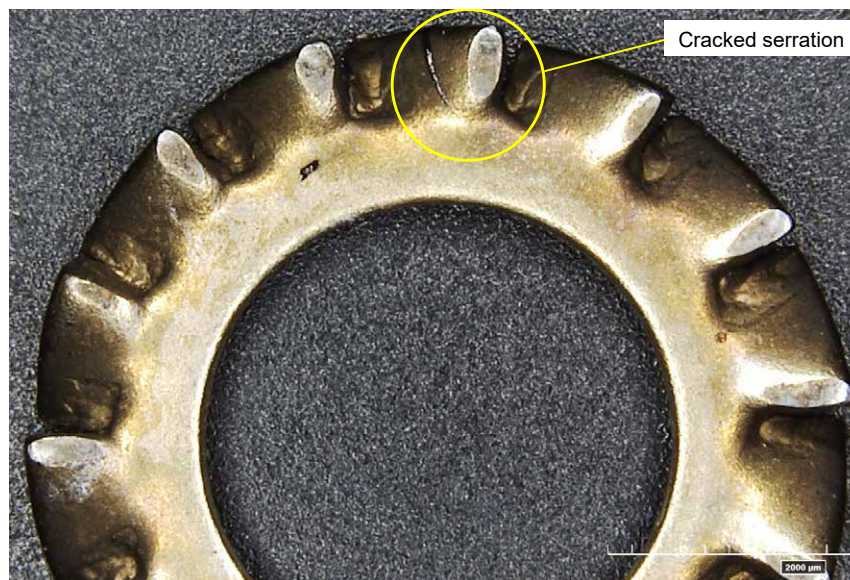
Examination of the clamp identified that it had been fitted with a serrated locking washer under the head of the locking screw. This washer was further examined and found to have evidence of gouging on all serrations and one of the serrated tabs had cracked (Figure 14). The lock washer, p/n 350A57-1058-21, was not fitted.

Serrated washer fitted to failed exhaust nozzle clamp

The clamp loosening was likely to have been associated with the incorrect locking washer being fitted. The serrated locking washer which was originally supplied with the clamp should have been removed and replaced with a tab locking washer, p/n 350A57-1058-21, before fitting the clamp. The condition of the serrated washer indicates that it had been tightened multiple times as the serrations had flattened, and one of the serrations had cracked. This will have reduced its ability to maintain the locking screw in its position.

- Check the condition of the exhaust clamp (absence of cracks, etc.)
- Check if the serrated washer delivered with the clamp is replaced by the tab washer
- Introduce an installation drawing depicting the correct installation of the clamp and its tab washer
- Check if the tab washer is properly installed and bent according to the installation drawing
- After installation, complete a ground run and then re-adjust the tightening torque to ensure correct tightness.

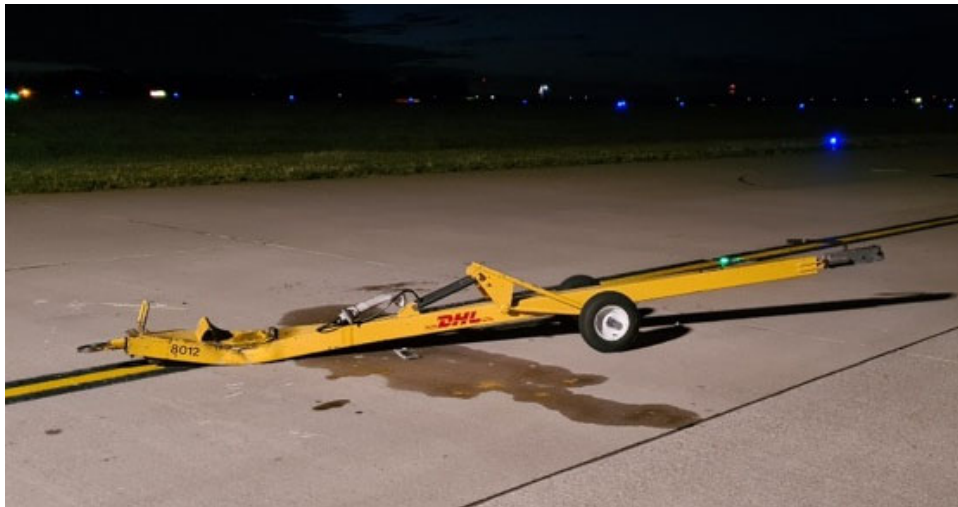
in the taxiway with damage indicating that the aircraft had taxied over it, Figure 2. The TD immediately informed ATC and his supervisor, who informed airfield operations.

Figure 2
Towbar showing damage

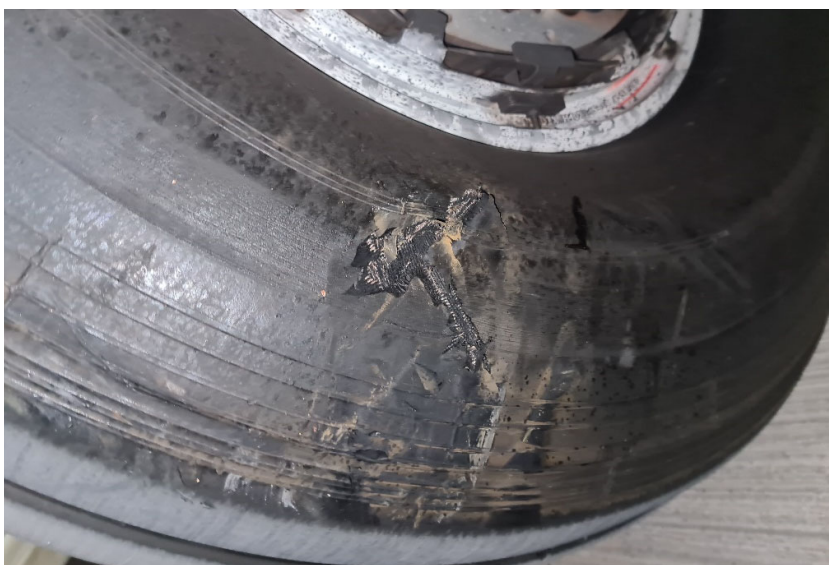
Figure 3
Damage to one of the landing gear tyres

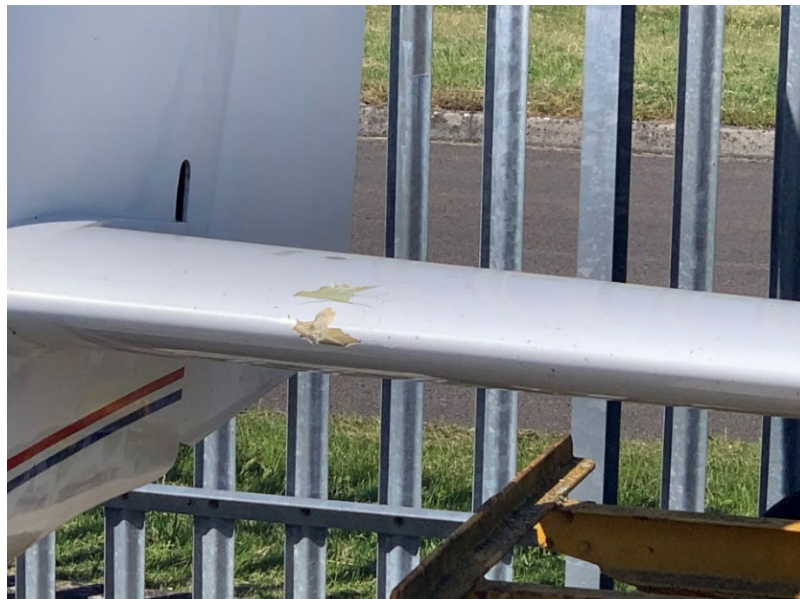
The left tailplane was subsequently found to have been damaged (Figure 1), in a manner consistent with it having been struck by the door. The door was not recovered.

Damage to G-FLOR's left tailplane

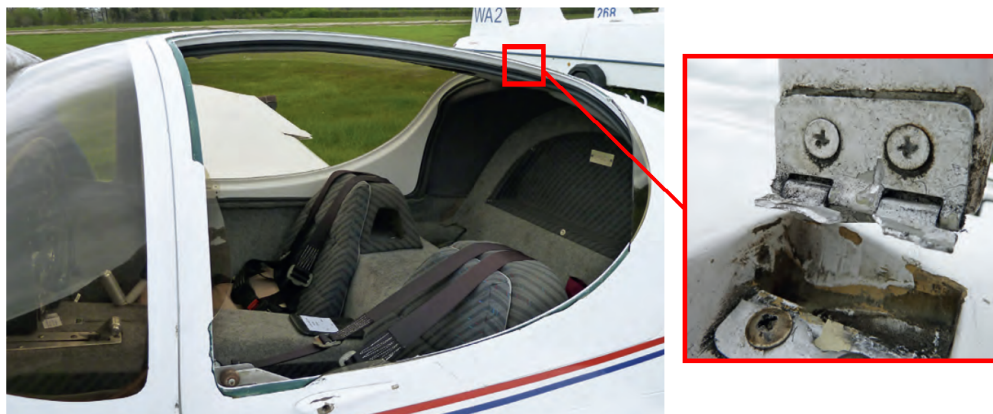
The investigation involving G-BYJI in 2012, concluded that the rear tapered shoot bolt had not been engaged into its guide prior to takeoff, and that the rear hinge had subsequently failed in overload when the door opened in flight (Figure 8).

Damage to G-BYJI

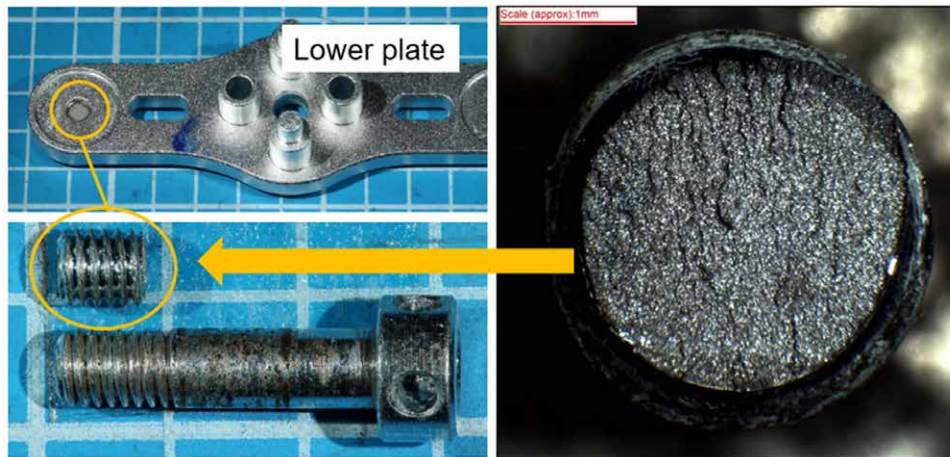
The screw had failed at the second thread from the plain diameter, (Figure 4) and the cut thread profile showed no material defects which would have initiated the failure. The fracture surface was intergranular, consistent with Stress Corrosion Cracking (SCC) with radial marks denoting the direction of crack propagation. There was light oxidation of the fracture surface, consistent with the relatively short period of service. The characteristics of the fracture face could not preclude the possibility that Hydrogen Embrittlement (HE) had also contributed to the failure mode.

Type 1 Blade attachment screw, fracture face

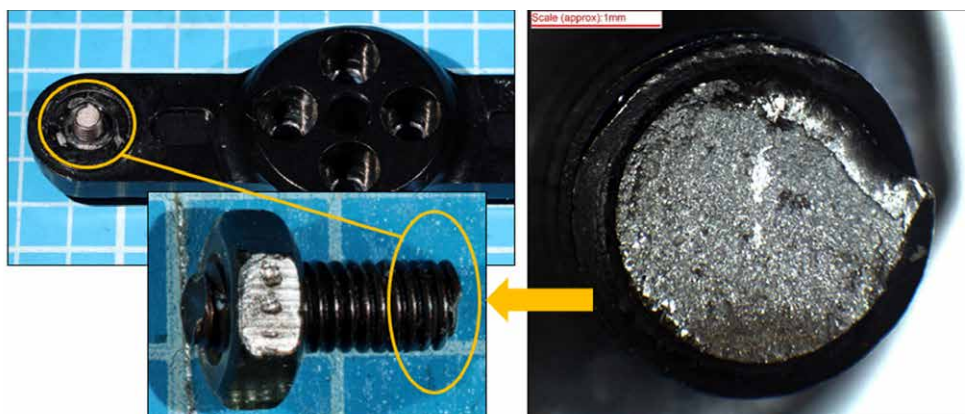
The predominant failure mode of the type 2 screw was through fatigue, which initiated from the thread root and had propagated across 90% of the cross section before final separation occurred. No initiating defect could be identified however, approximately 20% of the stable crack growth cross-section exhibited evidence of intergranular fracture, consistent with hydrogen embrittlement. The remainder being trans-granular indicative of fatigue crack growth. The level of embrittlement was determined to be insufficient to have caused the failure however, it may have reduced the threshold for crack initiation and would have accelerated the crack growth.

Type 2 Blade attachment screw, fracture face
