AAIB Bulletin

12/2021

Aircraft Type and Registration:	Cessna FRA150L, Aerobat, G-CIIR	
No & Type of Engines:	1 Rolls-Royce Continental O-240-A piston engine	
Year of Manufacture:	1973 (Serial no: 187)	
Date & Time (UTC):	11 October 2020 at 1342 hrs	
Location:	Troutbeck Airfield, Cumbria	
Type of Flight:	Private	
Persons on Board:	Crew - 1	Passengers - None
Injuries:	Crew - 1 (Fatal)	Passengers - N/A
Nature of Damage:	Destroyed	
Commander's Licence:	Private Pilot's Licence	
Commander's Age:	44 years	
Commander's Flying Experience:	69 hours (of which 52 were on type) Last 90 days - 3 hours Last 28 days - 2 hours	
Information Source:	Field Investigation

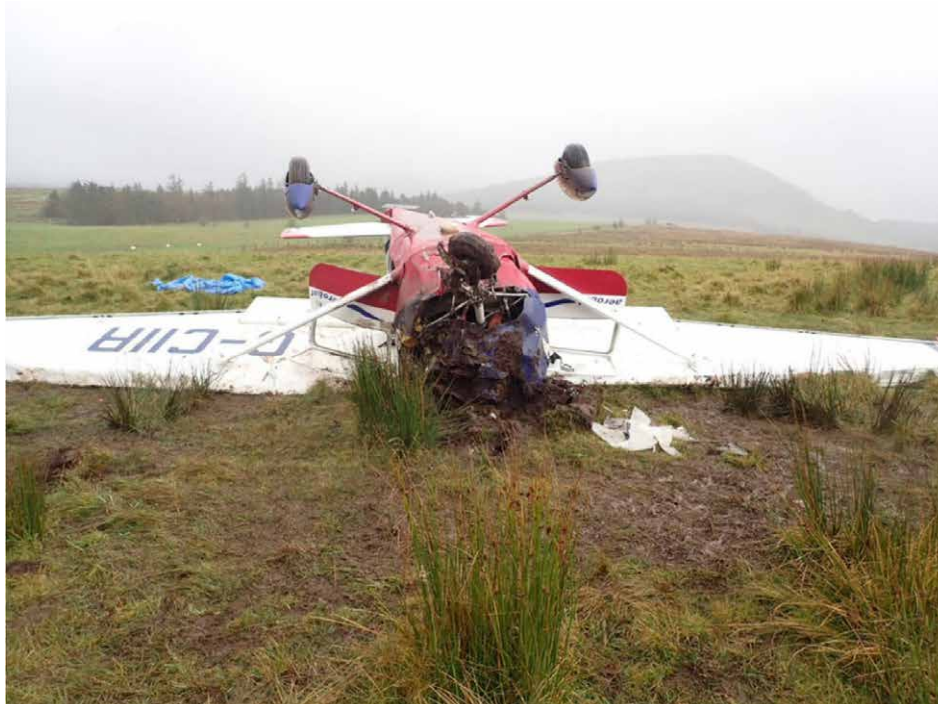
The aircraft hit waterlogged soft ground about 60 m from a conifer plantation. Marks on the ground showed that the aircraft hit the ground near vertical with the left wingtip striking the ground first. This was confirmed by the damage to the nose of the aircraft and the leading edges of the wings (Figure 2). The propeller had lifted out a divot and the spinner and engine cowl had made a hole in the soil about 0.45 m deep which had filled with water and a small amount of oil leaking from the engine.

Figure 2
G-CIIR accident site

The engine had been pushed rearwards distorting its firewall and severely disrupting the rudder pedals, instrument panel and surrounding components. The nose section of the aircraft had been shortened by approximately 0.75 m. The fuel selector was in the ON position and the battery master switch, although distorted, appeared to be in the OFF position. The cabin doors remained attached but had opened in the impact. The windscreen frame and instrument panel glare shield were severely distorted, and the windscreen and roof transparencies had fragmented. Some of the personal items within the aircraft had fallen out onto the ground. The left and right seat safety harnesses were loose; the pilot's harness was reported as being found undone by the first responders when they arrived.

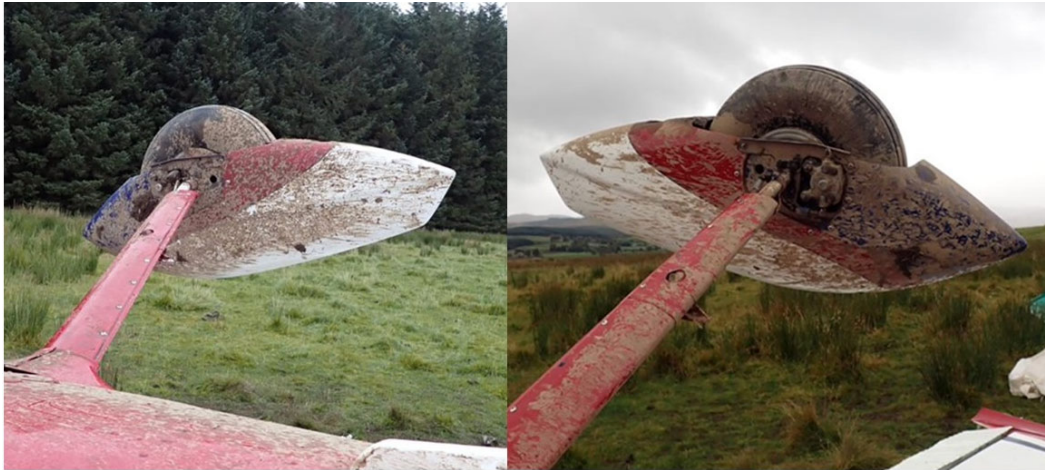
Figure 3

The nose landing gear was severely displaced and had bent rearwards, and its wheel fairing had detached. The main wheels and fairings were intact but were heavily contaminated with mud (Figure 3).

Left and right mainwheel mud contamination (aircraft inverted)

The inside of the wheel fairings was also covered in mud in the same way. At the accident site the left wheel, although stiff, could be rotated by hand whereas the right wheel was seized and could not be rotated. It was eventually freed with the application of a small amount of lubricant on the disc surfaces. Both tyres were found to be correctly inflated and the treads were well defined. The brake callipers and pads were also covered in a layer of liquified mud but underneath were generally in a good, unworn condition. Despite the mud contamination the pistons had not seized in their callipers. However, mud had been smeared onto the disc friction surfaces during wheel rotation and had accumulated on the leading face of the pad friction material.

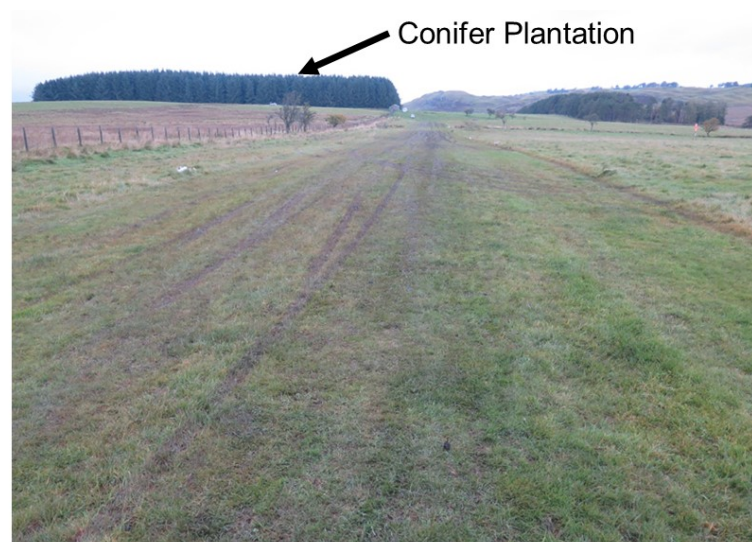
Figure 4

View down Runway 36 showing conifer plantation

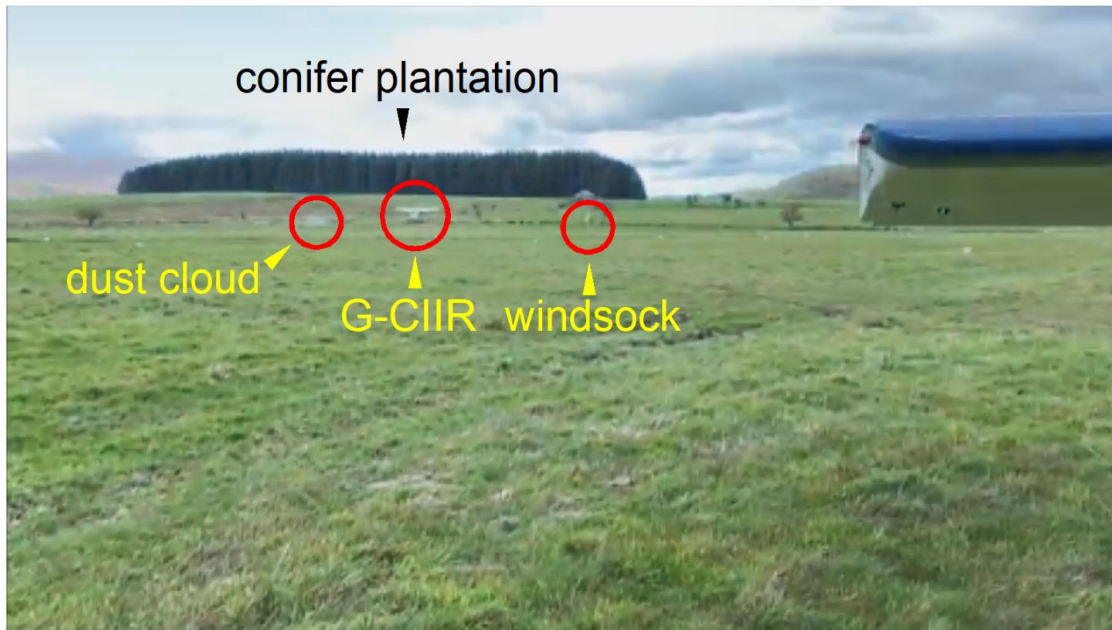
Figure 5

Image of G-CIIR shortly before takeoff

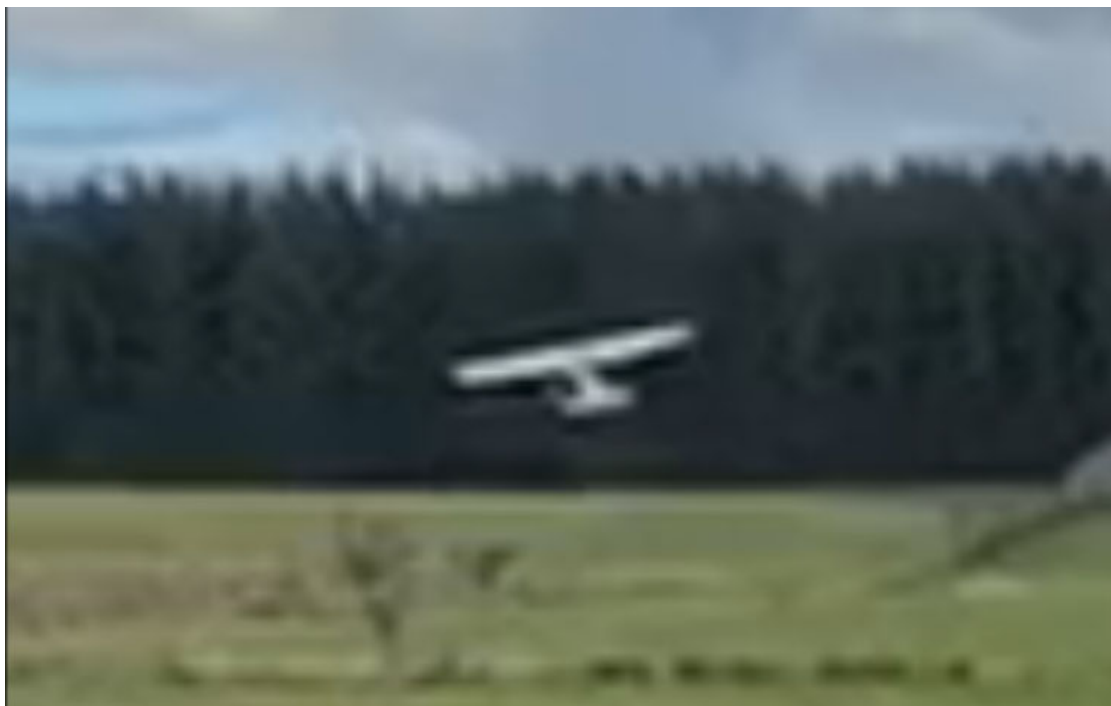
Figure 6

Aircraft yawing and turning left after takeoff

The video evidence indicated that after taking off the aircraft had some left yaw with a brief left roll component. The condition of the runway was described as sludgy and the aircraft was found with lots of mud on its underside. Additionally, the left mainwheel was free to rotate whilst the right mainwheel brake appeared to be binding. This was probably a result of the mud that was discovered on its brakes friction surfaces. With this binding brake, the right wheel would have had higher rolling resistance compared to the left, leading to a tendency for the aircraft to drift right during the takeoff. This would have required the pilot to apply left rudder on the takeoff roll to maintain the aircraft's track along the runway centre line. If the pilot maintained left rudder after the aircraft became airborne, it would have caused the left yaw and initial left roll as observed in the video.

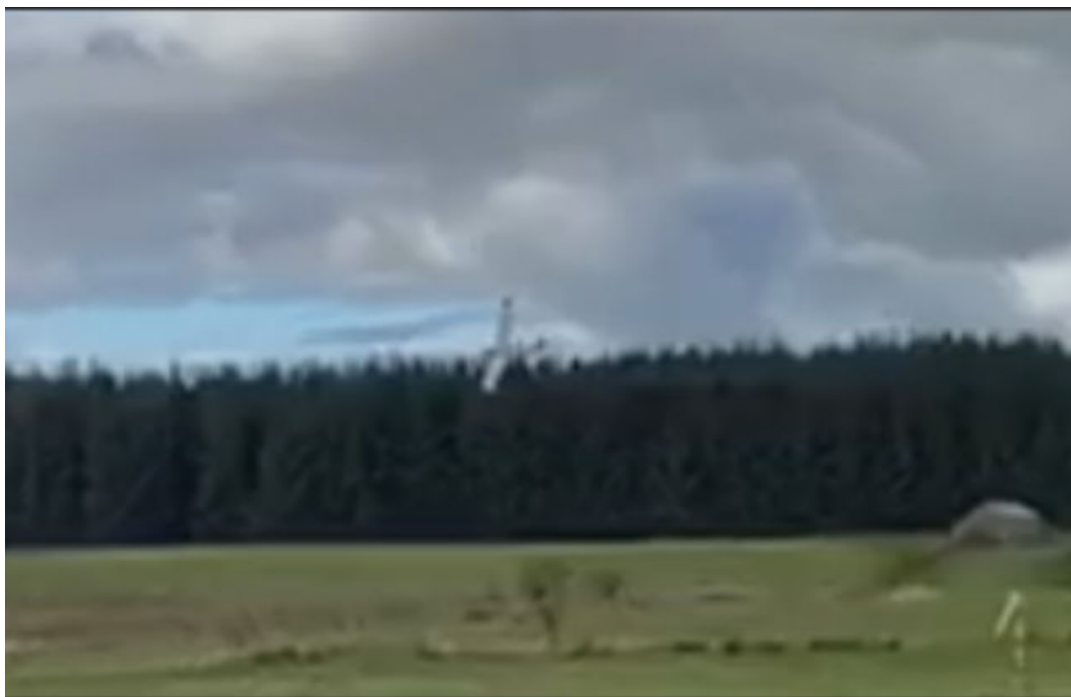
Figure 7

Aircraft banks rapidly to the left whilst starting to descend

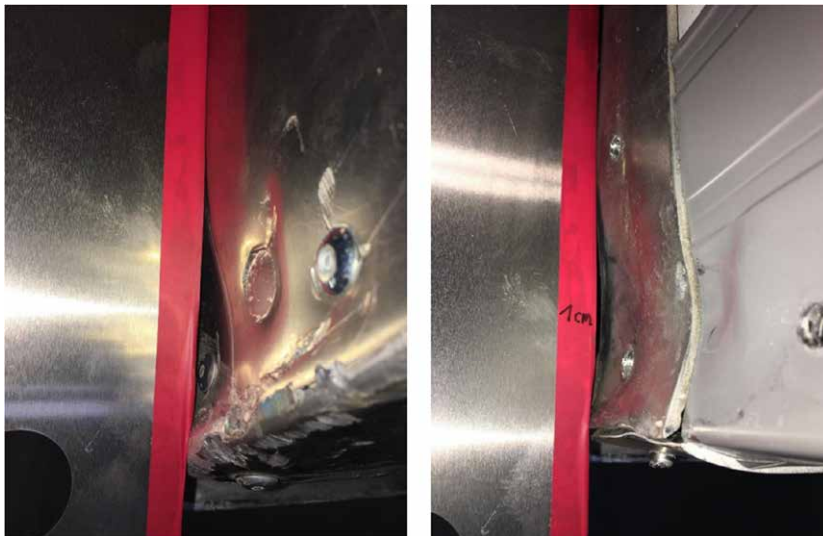
Figure 3

'the smoke was a consequence of improper handling of the container, which led to a short circuit of two of the batteries. The short circuit was caused by a significant impact/collision on the back of the container, where the affected batteries are located.'

Impact damage to container

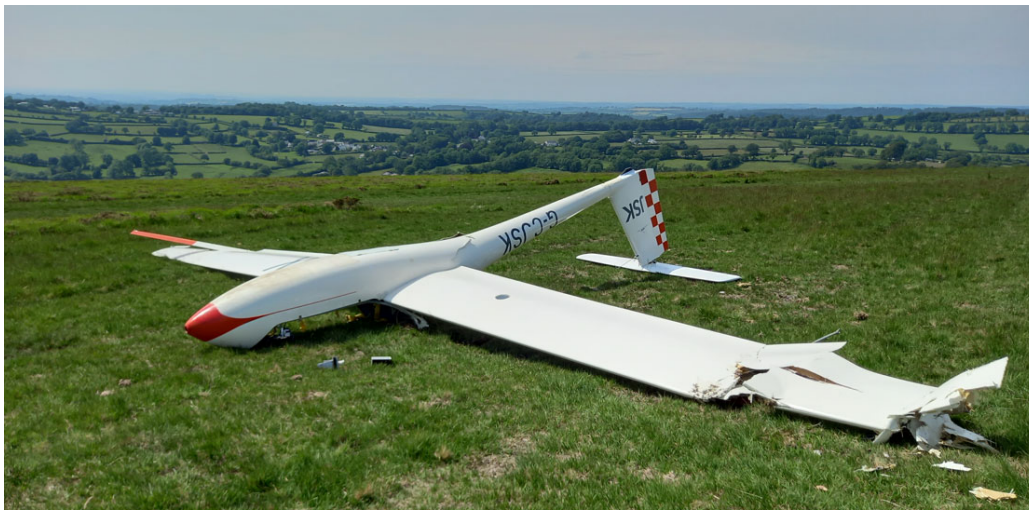
The glider came to rest in an area of open ground approximately 1 nm NNE from Brentor^a Airfield in an inverted attitude (Figure 1).

Figure 1
Accident site

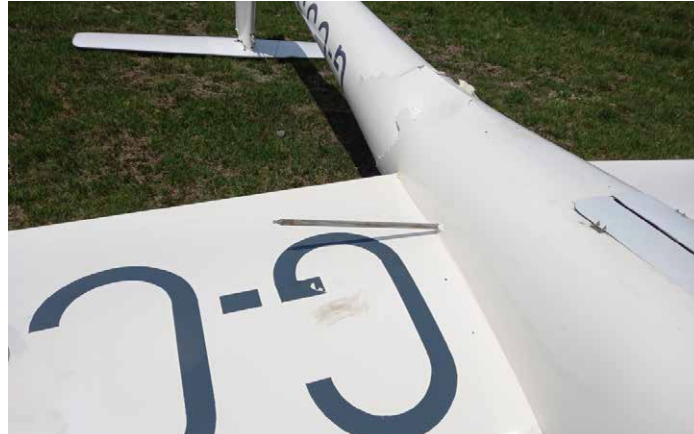
Figure 2

Examination of the wreckage revealed that the right aileron control connection in the fuselage was disconnected. The right aileron pushrod was projecting from the fuselage, having penetrated the fuselage skin during the ground impact (Figure 2). The left aileron and airbrake control connections were found to be securely connected.

Disconnected right aileron control pushrod, having penetrated the fuselage during the ground impact

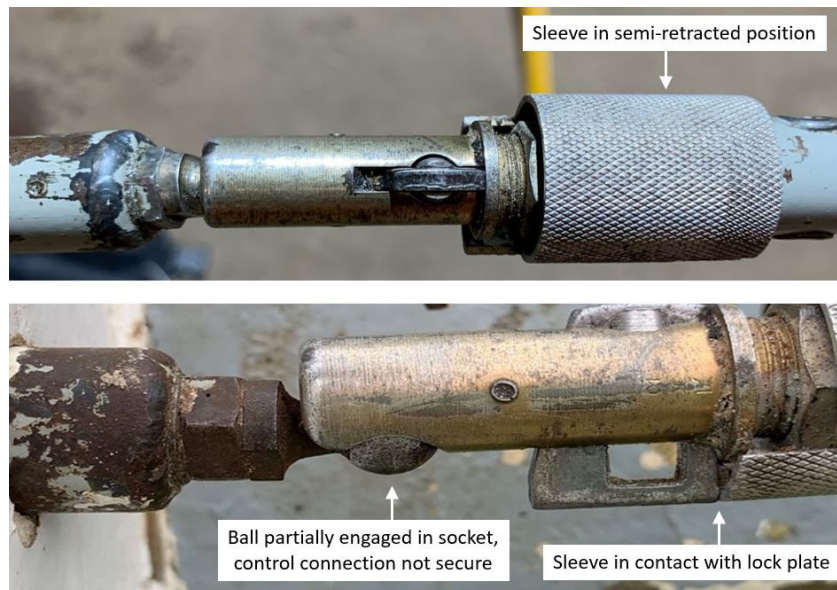
Figure 5

The right aileron L'Hotellier control connection became disconnected after approximately 50 minutes of flight leading to a reduction in the pilot's control over the glider's flightpath and for the disconnected aileron to cause wing flutter when the airspeed increased above 55 kt.

L'Hotellier control connection with the Wedekind sleeve partially engaged, control connection not secure (images courtesy of the BGA)
