ACCIDENT

Aircraft Type and Registration:	Agusta A109C, G-HBEK	
No & Type of Engines:	2 Allison 250-C20R/1 turboshaft engines	
Year of Manufacture:	1996 (Serial no: 7633)	
Date & Time (UTC):	15 July 2021 at 0730 hrs	
Location:	Organford, Dorset	
Type of Flight:	Private	
Persons on Board:	Crew - 1	Passengers - None
Injuries:	Crew - 1 (Minor)	Passengers - N/A
Nature of Damage:	Helicopter damaged beyond economic repair	
Commander's Licence:	Private Pilot's Licence	
Commander's Age:	50 years	
Commander's Flying Experience:	1,187 hours (of which 687 were on type) Last 90 days - 4 hours Last 28 days - 1 hour	
Information Source:	Aircraft Accident Report Form submitted by the pilot

Synopsis

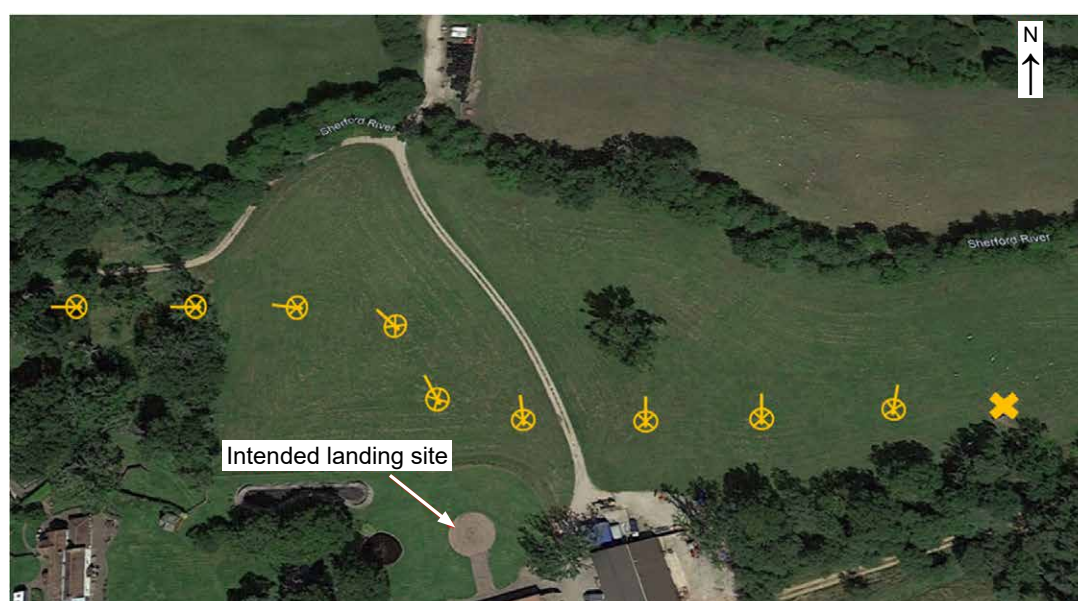
Figure 1

As the helicopter turned to head south toward the landing site, a greater amount of left pedal than usual was needed as the aircraft nose began turning to the right. The pilot increased his left pedal input until he had full left pedal applied, followed by left cyclic inputs to try to control the aircraft. At this point, the helicopter nose was still tending right but the helicopter was now drifting sideways to the left on an easterly track, whilst maintaining an approximate southerly heading (Figure 1). The pilot estimated his ground speed was approximately 15-20 kt. Additional application of the collective made the rotation to the right uncontrollable.

Approximate flight path of G-HBEK on approach to the landing site

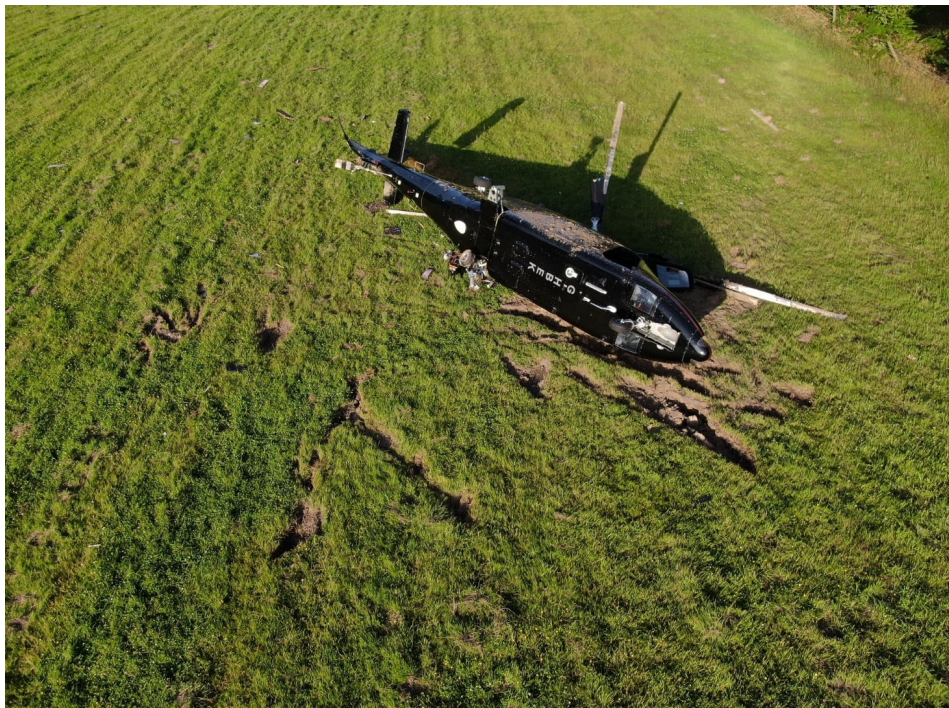
The helicopter was damaged beyond economic repair. The pilot reported that he did not sustain any visible head injuries. His loss of consciousness may have been caused by high sideways rotational accelerations of his head during the impact sequence.

The aircraft was examined by the AAIB and representatives from the aircraft manufacturer. The tail rotor blades were damaged but the tail rotor gearbox shaft rotated freely. There was sufficient oil in the tail rotor gearbox and no evidence of overheating. All tail rotor control linkages were secure and applying full left and right pedal in the cockpit produced corresponding tail rotor actuator and blade pitch changes. The tail rotor driveshaft was in good condition along the length of the tail boom. The tail rotor driveshaft had separated from the main rotor gearbox at a spline fitting. There was no damage to the splines, which indicated that the failure probably occurred as a result of the ground impact. The aircraft manufacturer's representative stated that they had only seen this type of spline separation once before and that it was the result of impact forces.

Figure 2
G-HBEK at the accident site

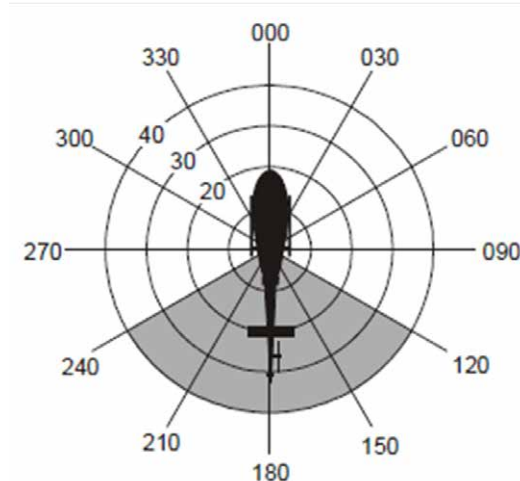
Figure 3

When the wind is from 120°- 240° relative to the helicopter at wind speeds up to 40 kt, the nose attempts to weathercock into it. This can only be stopped by pilot input on the opposite yaw pedal. If a right yaw rate develops and the relative wind is in this region (Figure 3) the yaw rate can rapidly become uncontrollable. Maintaining positive control of the yaw rate is imperative when flying downwind, particularly with high power settings and low airspeed.

Weathercock stability – relative wind from 120° to 240° from 0-40 kt

The wind at Bournemouth Airport at the time of departure was reported to be from 350° at 8 kt, which if present at the landing site would have been 170° relative to the helicopter as it took up a southerly heading. The next wind reported at 0750 hrs reported a wind of 020° at 11 kt, a relative direction of 200°. As the accident is estimated to have occurred at 0735 hrs, it is possible the relative wind was from behind the helicopter. This wind combined with the groundspeed of the helicopter as it turned towards the landing site, may have resulted in reaching the controllability limit for the helicopter for the wind conditions.
