SERIOUS INCIDENT

Aircraft Type and Registration:	Boeing 737-436, G-POWS	
No & Type of Engines:	2 CFM CFM56-3C1 turbofan engines	
Year of Manufacture:	1992 (Serial no: 25853)	
Date & Time (UTC):	18 June 2021 at 1300 hrs	
Location:	London Southend Airport	
Type of Flight:	Commercial Air Transport (Cargo)	
Persons on Board:	Crew - 2	Passengers - None
Injuries:	Crew - None	Passengers - N/A
Nature of Damage:	None	
Commander's Licence:	Airline Transport Pilot's Licence	
Commander's Age:	63 years	
Commander's Flying Experience:	9,800 hours (of which 4,900 were on type) Last 90 days - 165 hours Last 28 days - 40 hours	
Information Source:	Aircraft Accident Report Form submitted by the pilot and further enquiries by the AAIB

Synopsis

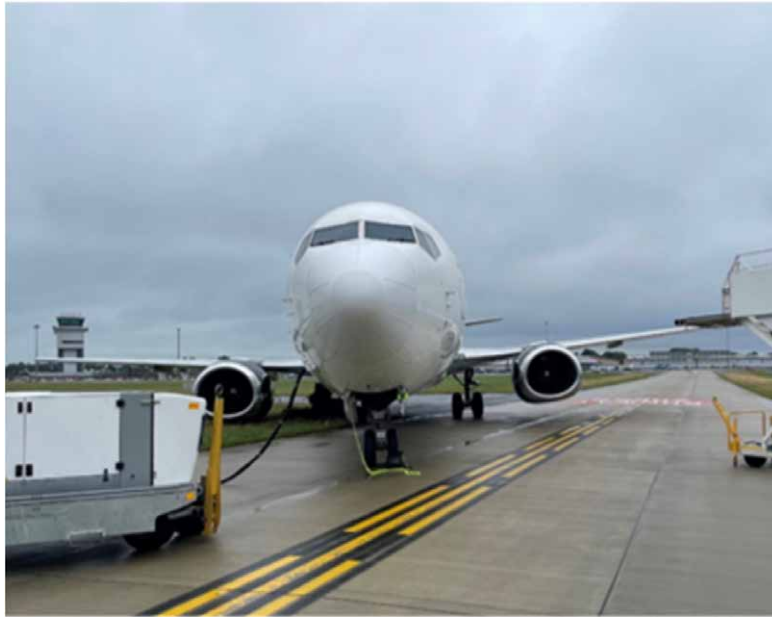
While the aircraft was in the right turn onto Taxiway B, ATC cleared it to enter and backtrack Runway 05 to vacate at D. The co-pilot then commented on the aircraft's proximity to the grass at which point the commander believes it had already left the taxiway. The commander stated that the aircraft was still moving slowly and his natural reaction was to increase power in order to return to the taxiway. Simultaneously, ATC asked whether assistance was required but received the response "*I think we can power out*". The commander reported increasing the power but, by the time the engines had spooled up, the aircraft had lost momentum and subsequently came to a stop. ATC instructed the aircraft to hold position and wait for assistance. The crew complied, shut down the engines and secured the aircraft. Figure 1 shows where the aircraft came to rest, with its nosewheel approximately 2 m right of the yellow taxi line.

Stopped position of the aircraft

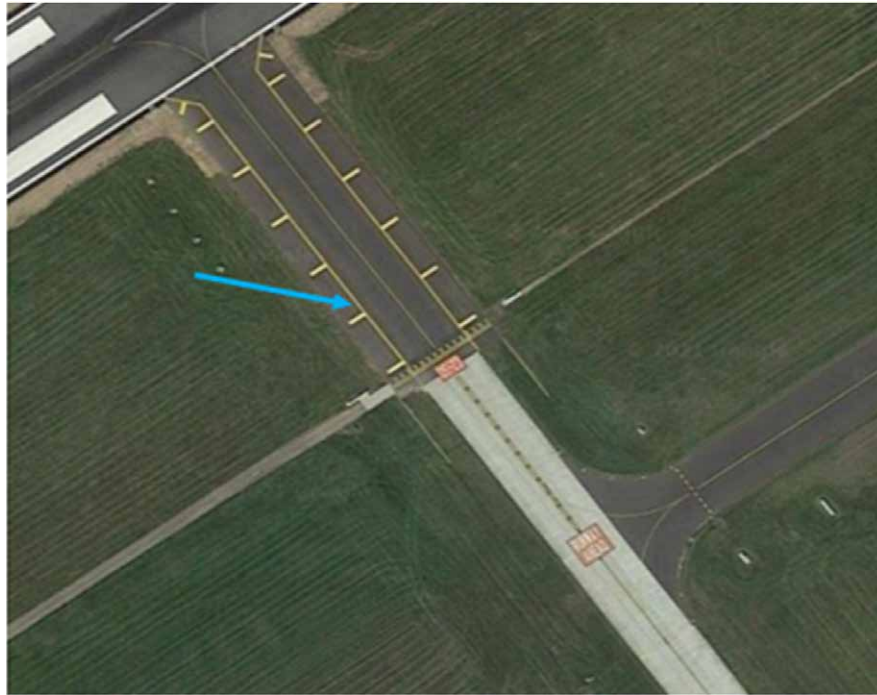
Figure 3

Aerial view of Taxiways B and Z and the representation of approved taxiway width north of B1 (Image from Google Maps)

There were several cues which led the pilots to believe the taxiway onto which they were turning was wider than it was. This included the inaccurate ground charts, the operator's briefing sheet and the colour of the taxiway surfaces. This contrasting colour of the taxiways may have exposed the pilots to the irradiation illusion⁸, where a light or bright object appears larger than it is when contrasted with a dark object of the same size. These cues were further compounded by the physical widening of the paved surface beyond the turn, which would have been visible from the flight deck when the aircraft was approaching the turn, perhaps to a greater extent than the narrower portion of Taxiway B.

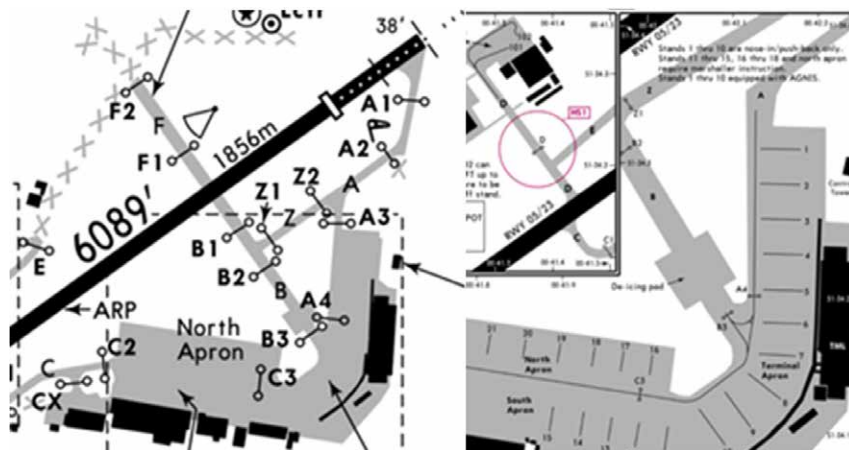
Figure 4a

Taxiway B is depicted as wider than Taxiway Z and of a constant width on both ground charts which were available to the crew (Figures 4a and 4b). However, Taxiway Z has a declared width of 15 m, which is the same as Taxiway B.

Taxiways Z and B intersection – Southend Airport Jeppesen Ground Chart (4a) and Parking Chart (4b)

The commander stated he believed Taxiway B was wider than Taxiway Z both from his assessment of the ground charts and his visual perception when taxiing.

In response to this event, the operator promulgated a memo to aircrew which contained updated text for the company briefing sheet for Southend Airport. An additional paragraph on the threat of a taxiway excursion was added to the briefing sheet, which warns crews to exercise ‘*extreme caution*’ when taxiing from Taxiway B and Taxiway Z. The memo further stated ‘*All B737 Flight Crew shall review ALL of Chapter 2.5 “Ground Operations” from the 737 Classic Flight Crew Training Manual...*’.
