SERIOUS INCIDENT

| Aircraft Type and Registration: | Boeing 737-8K5, G-TAWY | |
| Date & Time (UTC): | 9 March 2022 at 0840 hrs | |
| Location: | Manchester Airport | |

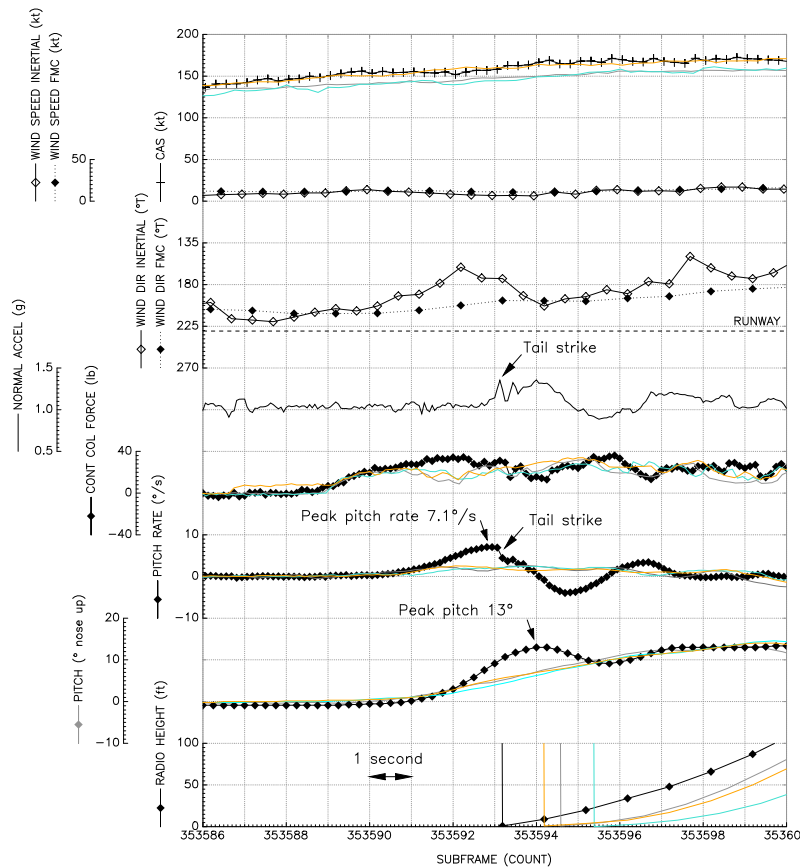
The FDR data was used to create Figure 1. The plot shows pitch attitude, pitch rate, control column force, radio altitude and airspeed during the rotation on the incident flight and the aircraft's three previous flights. The plot also shows wind speed and direction and normal acceleration for the incident flight. The data showed the pitch rate peaked at 7.1°/sec and reached a maximum pitch attitude of 13° on the incident flight⁴. Roll inputs are not shown on Figure 1 but the data showed a left roll input, sufficient to deploy the left spoilers, was made as the aircraft started to rotate⁵.

The plot shows a marked difference between the steady pitch rate and control column force on the previous flights and the increasing force and rate on the incident flight.

Takeoff plot for the incident flight (black) and the aircraft's three previous flights (grey, orange, and blue) (vertical lines on the radio height scale indicate the lift-off point)
