ACCIDENT

Aircraft Type and Registration:	Aeronca 65C, G-BTRG	
No & Type of Engines:	1 Verner Scarlett 7Hi piston engine	
Year of Manufacture:	1939 (Serial no: C4149)	
Date & Time (UTC):	21 October 2021 at 1435 hrs	
Location:	Birchwood Airfield, North Yorkshire	
Type of Flight:	Private	
Persons on Board:	Crew - 1	Passengers - 1
Injuries:	Crew - None	Passengers - None
Nature of Damage:	Aircraft extensively damaged and missing propeller	
Commander's Licence:	Private Pilot's Licence	
Commander's Age:	58 years	
Commander's Flying Experience:	568 hours (of which 387 were on type) Last 90 days - 4 hours Last 28 days - 4 hours	
Information Source:	Aircraft Accident Report Form submitted by the pilot

Synopsis

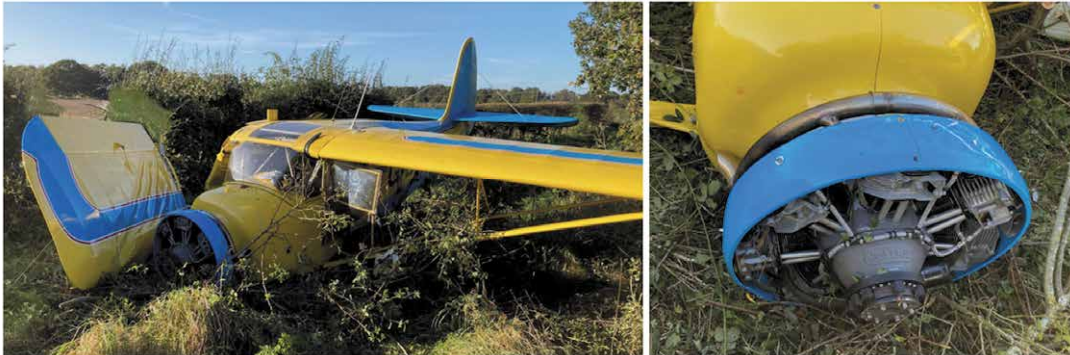
Figure 1

The aircraft, with the pilot and one passenger, took off from Runway 26 at Birchwood private airstrip for a short flight. It was the first flight after completion of a Permit-to-Fly renewal flight following annual maintenance. The aircraft climbed through 450 ft and as the pilot went to reduce the engine power, it suddenly over sped. The pilot does not recall any abnormal indications such as noises or vibration prior to the engine over speeding. The pilot immediately closed the throttle and flew the aircraft to maintain its best gliding speed of 65 to 70 mph. He evaluated possible landing sites ahead but chose to return to the airfield as he felt his options were limited. He lined up on Runway (RWY) 03 and slide slipped to lose height as he was closer than he had anticipated. The pilot felt that the aircraft was going too fast to stop on RWY 03, so realigned to RWY 08 and landed on the main wheels. Despite the use of braking, the aircraft went through a hedge at the far end

of the runway (Figure 1). The pilot turned the fuel and electrical master off and vacated through the left door with the passenger. It was then that they noticed that the propeller was missing. The propeller has not been recovered.

Accident site with close-up of propeller flange
(Photographs used with permission)

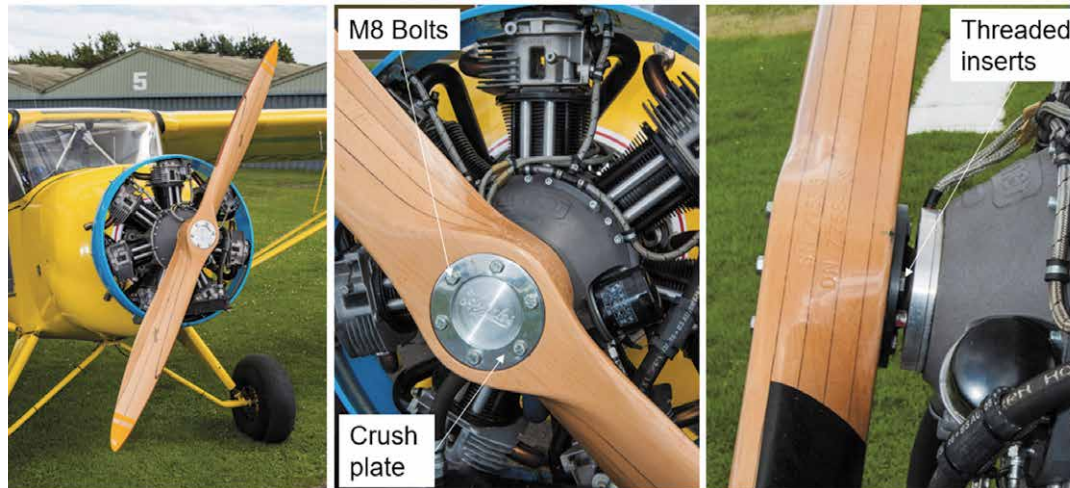
Figure 2

G-BTRG was fitted with a 76" wooden propeller (Figure 2 left) and was attached to the engine propeller flange with six M8 x 110 mm, 8.8 steel bolts. The heads were drilled, wire locked in pairs and the threaded part had been shortened. Under the head of each bolt was a plain washer and a 8 mm thick recessed crush plate (Figure 2 centre and right). The bolts thread into inserts which are press fitted into the attachment flange. The full thread started approximately 1 mm inside the insert from the propeller side.

G-BTRG with Hercules propeller (left), detail of the attachment (centre and right)
(Photograph credit: FLYER - Ed Hicks)

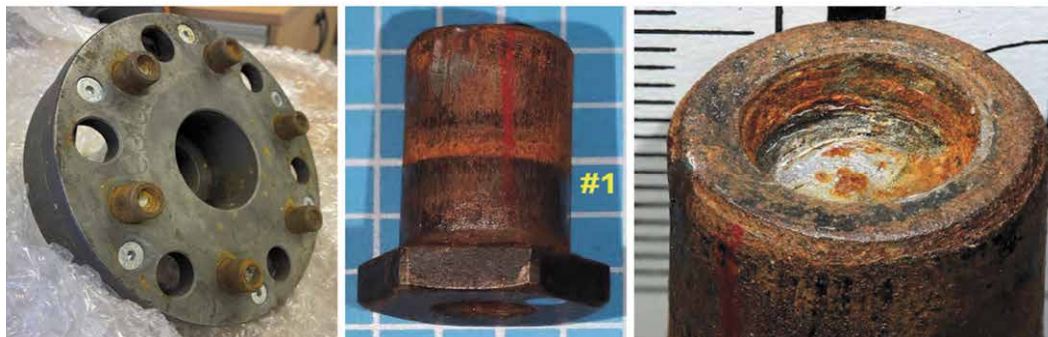
Figure 3

The propeller attachment flange was removed from the aircraft (Figure 3 left) and sent to AAIB where the threaded inserts were removed and sent for metallurgical examination (Figure 3 centre and right).

Attachment flange (left), example threaded insert removed (centre),
remaining bolt thread in the insert (right)
(Photographs used with permission)

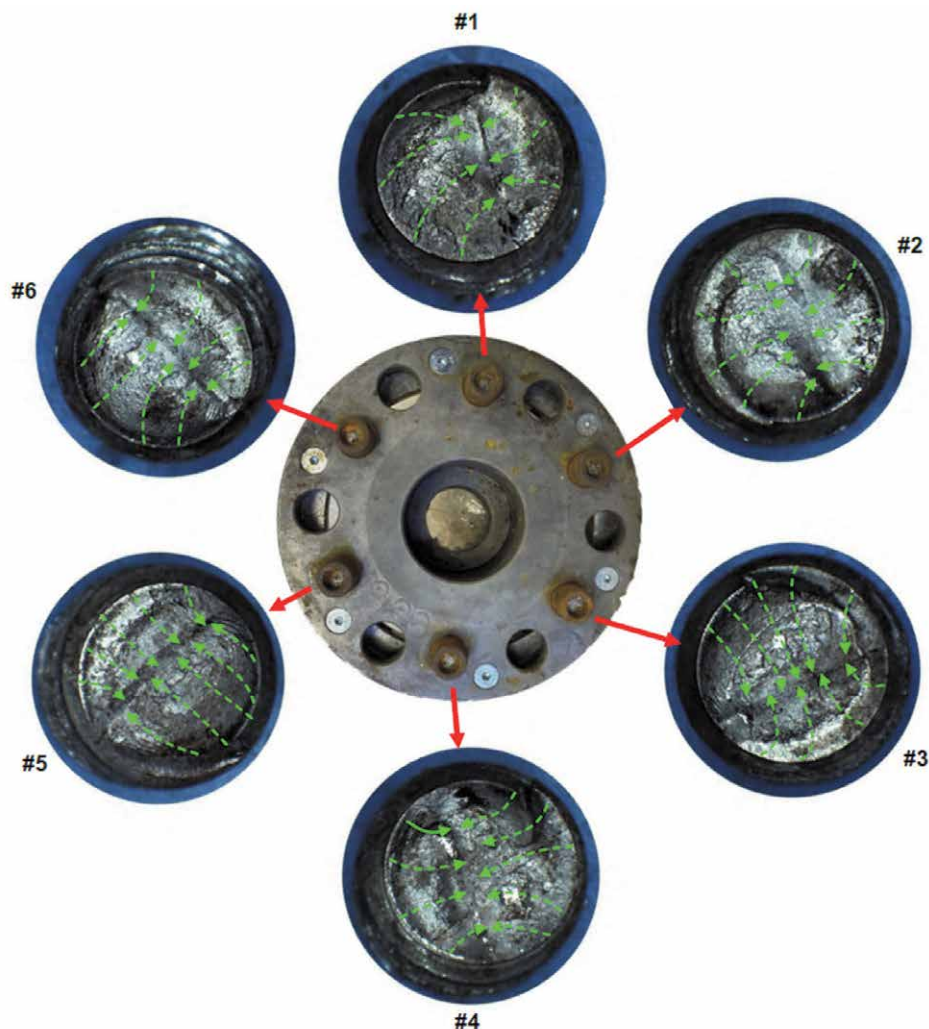
Figure 4

Examination of the fracture faces showed that all the bolts had similar characteristics of failure. Multiple fatigue cracks had propagated inwards from initiation sites around the circumference of the bolt, coalescing to form two major cracks (Figure 4). This is consistent

with reverse-bending fatigue and the fine spacing of the crack growth indicated loading under high frequency vibration. No pre-existing mechanical or material defects could be found at the initiation sites. Sample bolts were strength tested and they conformed to all specification requirements.

Fracture faces of all bolts showing propagation direction.
(Photograph used with permission)

Examination of the failed bolts revealed that they had failed from high cycle, reverse-bending fatigue. This failure is consistent with normal loads applied by the propeller to bolts which have insufficient pre-load. This loss of pre-load was possibly due to the bolts having shanked. On installation the correct torque was applied however as the bolt shank was too long no axial pre-load was applied to the bolt.

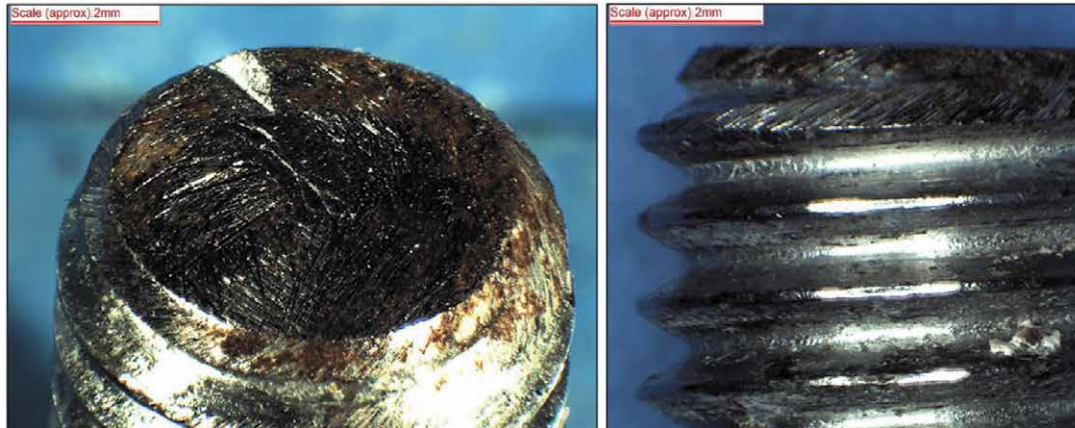
Figure 5

The tail of all the bolts showed evidence of grinding marks consistent with the bolts being shortened and chamfered (Figure 5). The bolt standard states the full thread length of the bolt is 22 mm minimum and the average length of full thread documented on the batch certificate of conformance was 23.2 mm. The thread transition was approximately 1 mm. The part of the bolt removed from the threaded insert was 18 mm and as the thread transition was visible, approximately 5 mm had been removed from the bolt tail.

Detail of the bolt tail showing grinding marks and chamfering.
(Photographs used with permission)

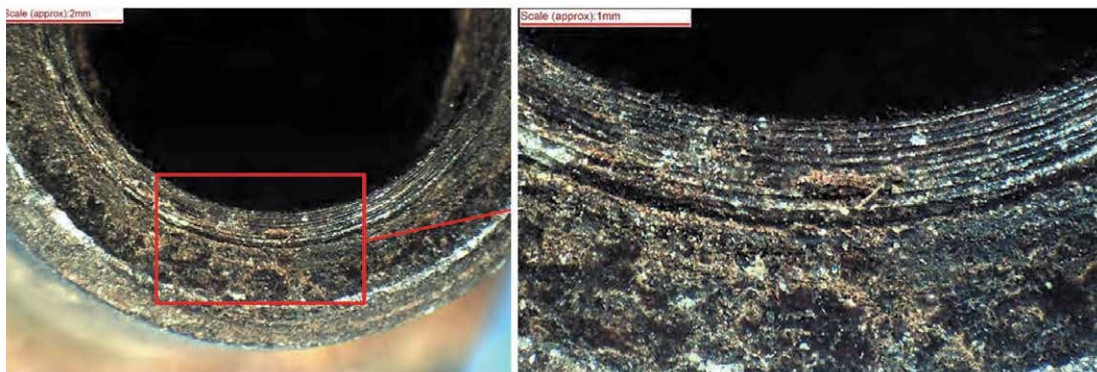
Figure 6

There was evidence on two of the threaded inserts of a circular imprint and helical machining marks on the surface on the non-flanged end, ie the end adjacent to the propeller (Figure 6). It was considered possible that these imprints were a result of the shank of the bolt having been pressed into the insert. This situation is called 'shanking', where the bolt is tightened to the specified torque but the pre-load tension in the bolt is lower than specified. Insufficient pre-load is a common cause of fatigue failure of threaded fasteners.

Detail of the circular imprint and helical machining marks on a threaded insert.
(Photographs used with permission)

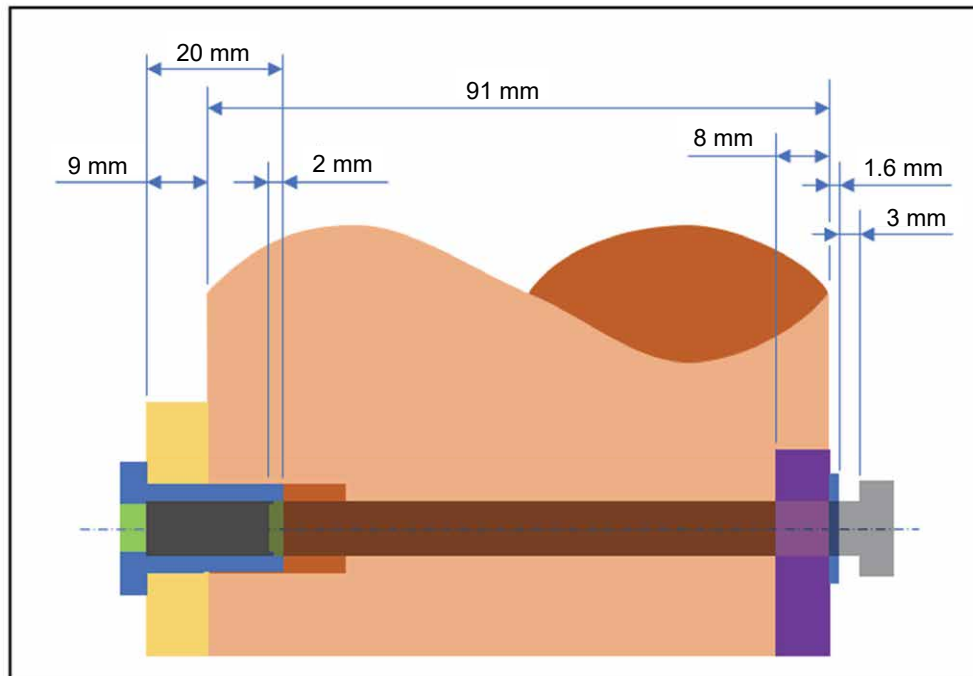
The cross section shown in Figure 7 shows the propeller, flange and threaded insert arrangement. The recessed crush plate and the washer under the head of the bolt are also included. The M8 x 110 mm bolt has a shank length of 86.6 mm ($110 - 23.2 = 86.6$ mm). It was assumed that the full thread would start 2 mm inside the insert due to the overlapping thread transitions and this was supported by the fracture faces being approximately 2 mm inside the insert (Figure 3 right).

The stack of components in the joint is 82.6 mm ($2 + 20 + 9 + 91 + 1.6 = 83.6$ mm) thereby leaving a gap of 3 mm. The installed bolt would have shanked before pre-load had been applied. The engineer stated that when the propeller was installed the crush plate “was proud by 2 to 3 millimetres” which he accepted as correct.

Cross section of the propeller to flange bolted joint

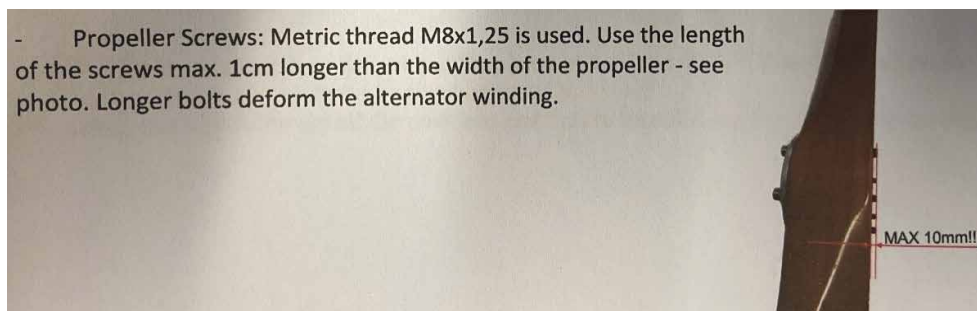
Figure 8

In the engine manufacturer’s installation documentation, there is a requirement that no more than 10 mm of bolt is to protrude through the propeller to ensure clearance of the alternator windings which are located just behind the propeller flange (Figure 8).

Engine manufacturer’s installation documentation regarding propeller bolting

It is possible that the length of bolt was chosen based upon a misinterpretation of the installation document from the engine manufacturer. A bolt length was chosen which protruded more than 10 mm and was then shortened so that just less than 10 mm protruded. This resulted in a shank length which was too long for the stack by approximately 3 mm. A 100 mm bolt would have had full thread engagement without shanking and protruded approximately 4 mm from the rear face of the propeller.

As a result of this accident the engine manufacturer has taken safety action to revise the information in the installation document to include a drawing to aid the correct length of bolt to be selected.

To revise the propeller installation document to include a drawing to aid the correct length of propeller bolt to be selected.
