## ACCIDENT

<b>Aircraft Type and Registration:</b>	CAP 231, G-IIHZ	
<b>No &amp; Type of Engines:</b>	1 Lycoming AEIO-540-L1B5D piston engine	
<b>Year of Manufacture:</b>	1988 (Serial no: 8)	
<b>Date &amp; Time (UTC):</b>	9 January 2022 at 1515 hrs	
<b>Location:</b>	Mundesley, Norfolk	
<b>Type of Flight:</b>	Private	
<b>Persons on Board:</b>	Crew - 1	Passengers - None
<b>Injuries:</b>	Crew - None	Passengers - N/A
<b>Nature of Damage:</b>	Control arm mount detached from rudder, fin stern post dis-bonded from fin structure	
<b>Commander's Licence:</b>	Private Pilot's Licence	
<b>Commander's Age:</b>	51 years	
<b>Commander's Flying Experience:</b>	359 hours (of which 200 were on type) Last 90 days - 11 hours Last 28 days - 5 hours	
<b>Information Source:</b>	Aircraft Accident Report Form submitted by the pilot and enquiries made by the AAIB

## Synopsis

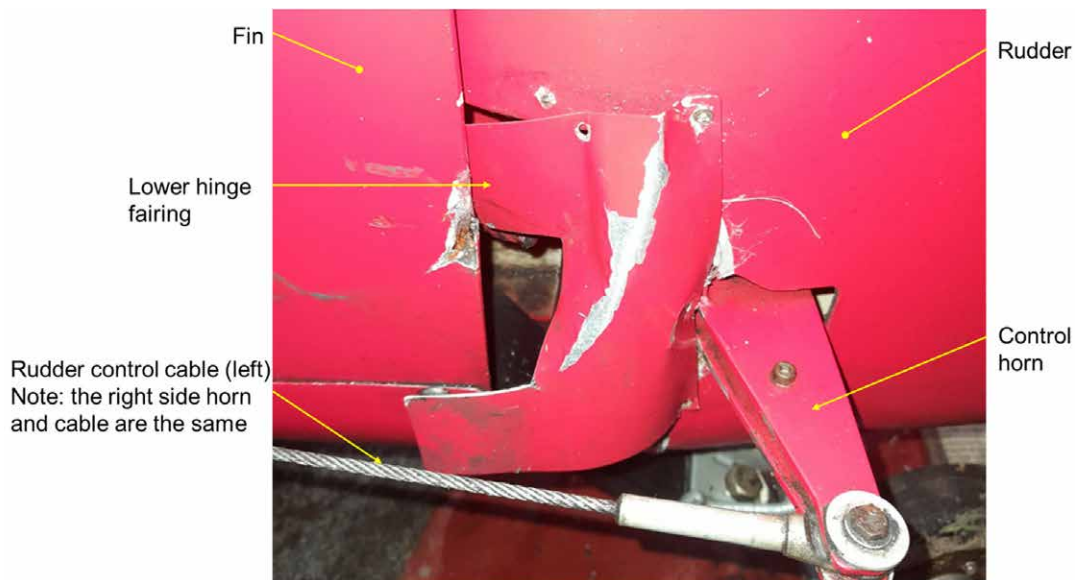
**Figure 1**

The fairing was partially attached but appears to have been trapped and crushed between the rudder fin skin edges where they overlap the stern post (Figure 1).

Rudder lower hinge fairing damage

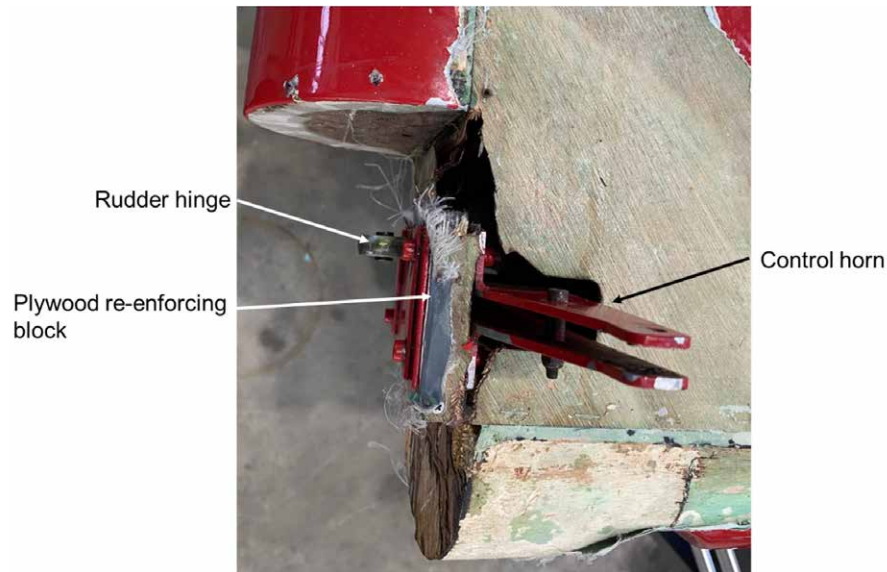
**Figure 2**

The upper and lower rudder hinge pivot brackets and surrounding structure was undamaged as were the left and right faces of the rudder. The lower hinge and control horn were correctly attached to the re-enforcing block, but this was partially detached from the rudder structure. It had broken away from the box section main spar within the rudder structure (Figure 2).

Damage to the rudder spar and lower hinge and horn mounting block  
(Fabric covering removed from the surrounding area for examination)

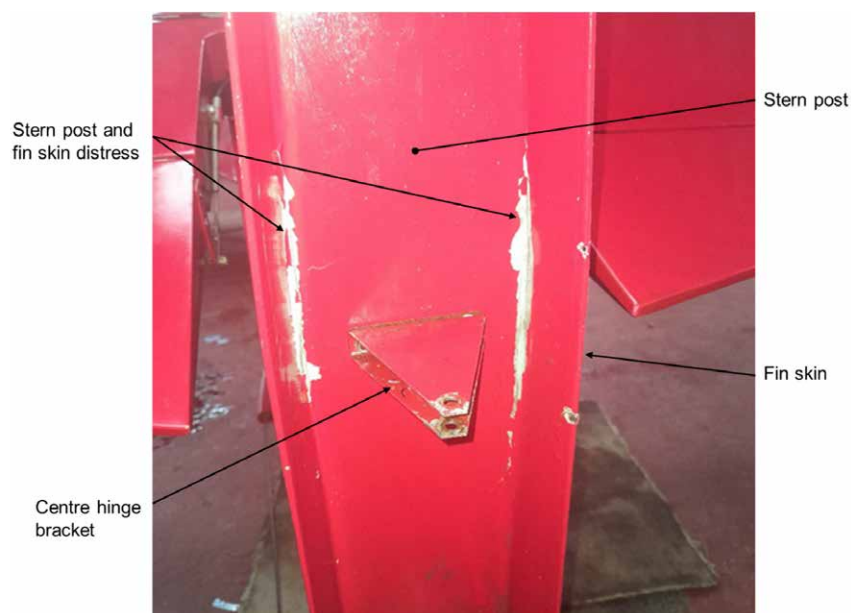
**Figure 3**

Distress between the fin skin and stern post both sides of the centre hinge

It is also possible that the stern post had dis-bonded first, which would have led to a loss of rigidity in the lower hinge bracket. This would have put abnormal loads into the centre hinge bracket hence the distress apparent where the skin meets the stern post on both sides. Additionally, this mis-location or loss of rigidity would have led to abnormal loads in the bottom hinge rudder and control horn.

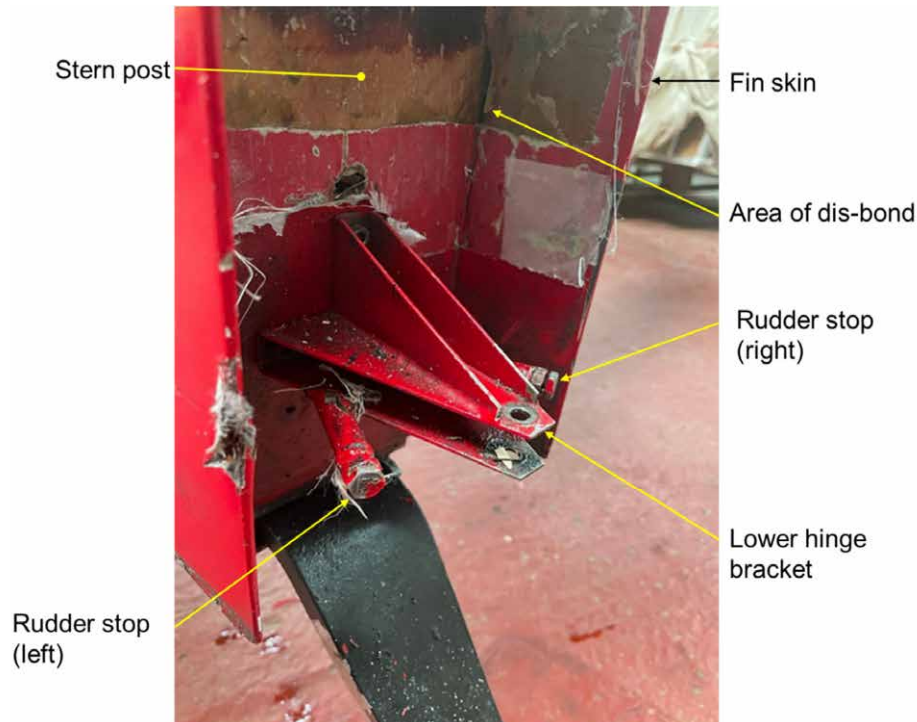
**Figure 4**

Lower hinge bracket and integrated stops showing the dis-bond.  
(Fabric covering removed in the surrounding area for examination)

Examination of the stern post attachment to the fin skins showed evidence that a repair had been carried out in the past and that the right side glued edge had parted. It was also apparent that the bond along this edge seemed to have been assembled with only a small bead of glue.
