ACCIDENT

Aircraft Type and Registration:	Cessna 120, G-OVFM	
No & Type of Engines:	1 Continental Motors Corp O-200-A piston engine	
Year of Manufacture:	1948 (Serial no: 14720)	
Date & Time (UTC):	06 December 2021 at 1530 hrs	
Location:	South Cave (Mount Airy) Airfield, Hull, East Riding of Yorkshire	
Type of Flight:	Private	
Persons on Board:	Crew - 1	Passengers - 1
Injuries:	Crew - None	Passengers - None
Nature of Damage:	Right main gear leg displaced, fuselage buckled, engine cowlings and propeller damaged	
Commander's Licence:	Private Pilot's Licence	
Commander's Age:	20 years	
Commander's Flying Experience:	192 hours (of which 35 were on type) Last 90 days - 24 hours Last 28 days - 10 hours	
Information Source:	Aircraft Accident Report Form submitted by the pilot and examination of the aircraft by the AAIB

Synopsis

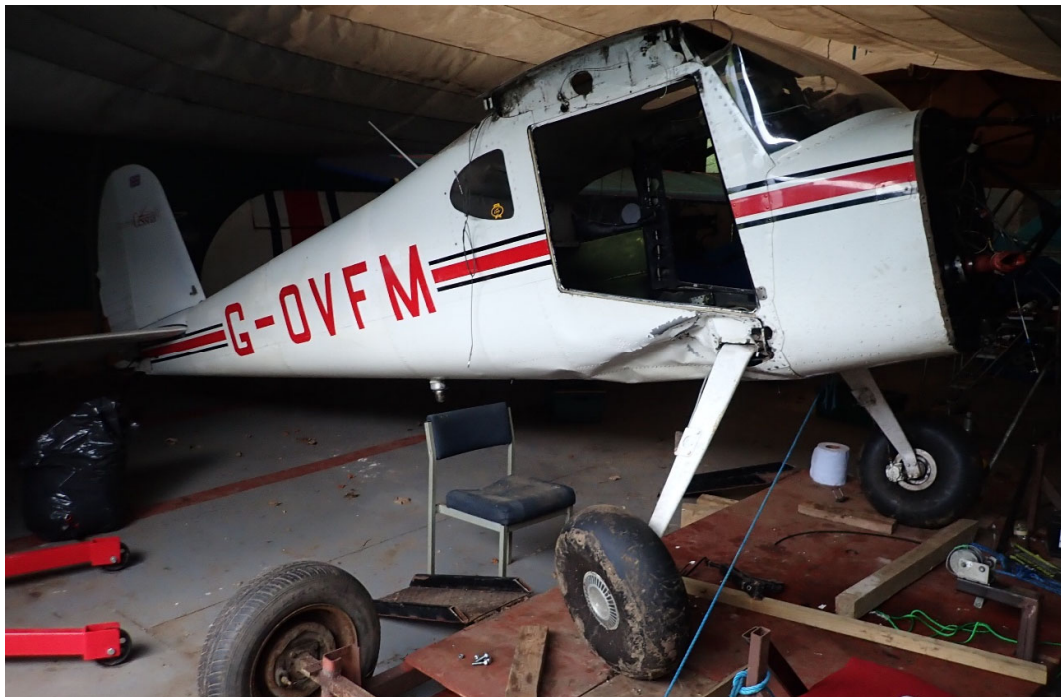
Figure 1

The damaged aircraft was recovered to a hangar and its wings and engine removed in preparation for repair. Subsequent inspection by the AAIB identified the right main landing gear leg was deflected rearwards. This resulted in buckling and twisting of the floor pan and fuselage to the rear of the landing gear mount (Figure 1). The fuselage to the rear of the left seat had buckled (Figure 2) and the right wing root had cracked (Figure 3). The engine cowls were damaged, as was the propeller.

G-OVFM showing movement of right main gear leg and damage to fuselage rear of its mounting location
