SERIOUS INCIDENT

Aircraft Type and Registration:	Grob G115B, G-BYDB	
No & Type of Engines:	1 Lycoming O-320-D3G piston engine	
Year of Manufacture:	1988 (Serial no: 8025)	
Date & Time (UTC):	17 April 2022 at 1450 hrs	
Location:	Clacton Airfield, Essex	
Type of Flight:	Private	
Persons on Board:	Crew - 1	Passengers - None
Injuries:	Crew - None	Passengers - N/A
Nature of Damage:	Damage to the leading edge of the wing and shock loading of the engine	
Commander's Licence:	Private Pilot's Licence	
Commander's Age:	52 years	
Commander's Flying Experience:	189 hours (of which 10 were on type) Last 90 days - 4 hours Last 28 days - 2 hours	
Information Source:	Aircraft Accident Report Form submitted by the pilot

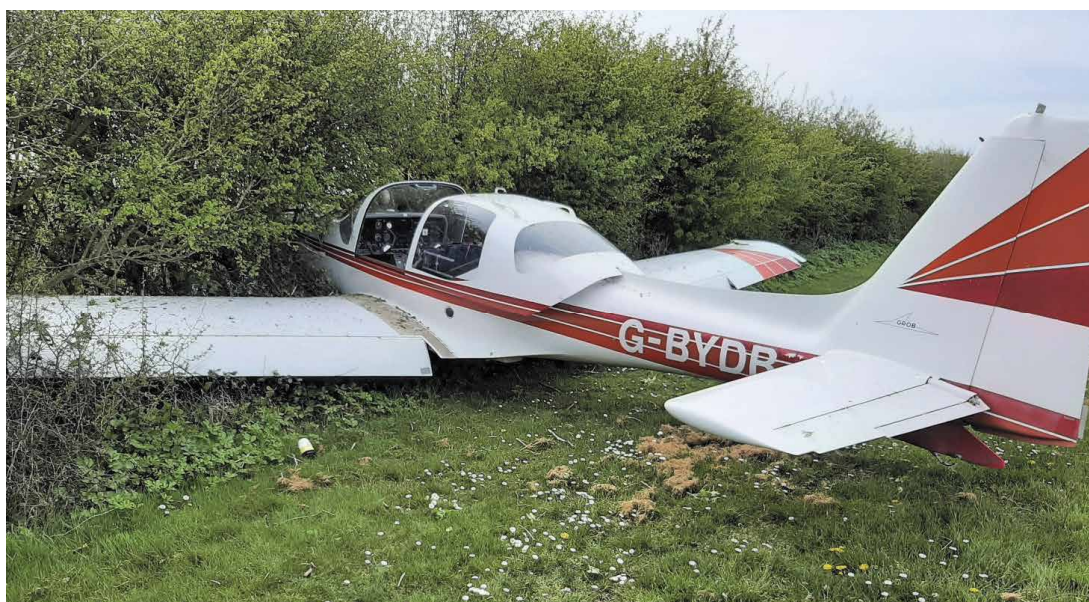
Figure 2

The pilot judged he was high on the approach and increased the aircraft's rate of descent to compensate, which probably also increased its airspeed. The aircraft touched down but, despite the use of maximum braking, overran the runway and came to an abrupt halt in the airfield's boundary hedge.

unable to stop the aircraft in the remaining distance. G-BYDB overran the runway before coming to an abrupt halt in the airfield's boundary hedge (Figure 2). Uninjured, the pilot unfastened his harness and exited the aircraft without external assistance.

The aircraft suffered damage to the wing leading edge and shock loading of the engine. During a pre-takeoff test at Fowlmere Airfield G-BYDB's brakes had worked normally, and a post-incident technical investigation found the brakes to be "fully functioning".

G-BYDB in the boundary hedge after the runway overrun

The pilot considered that it might have been better to go around when he realised he was high on the approach, especially given the short landing distance (505 m).

While previous experience is generally beneficial, making assumptions based on it can engender risk. On-the-day factors, such as aircraft performance, local weather conditions and achieved flight parameters, are key considerations in any pilot’s decision-making process, both before and during flight.
