Maritime &
Coastguard
Agency

SS Richard Montgomery: Survey Report 2021

June 2022

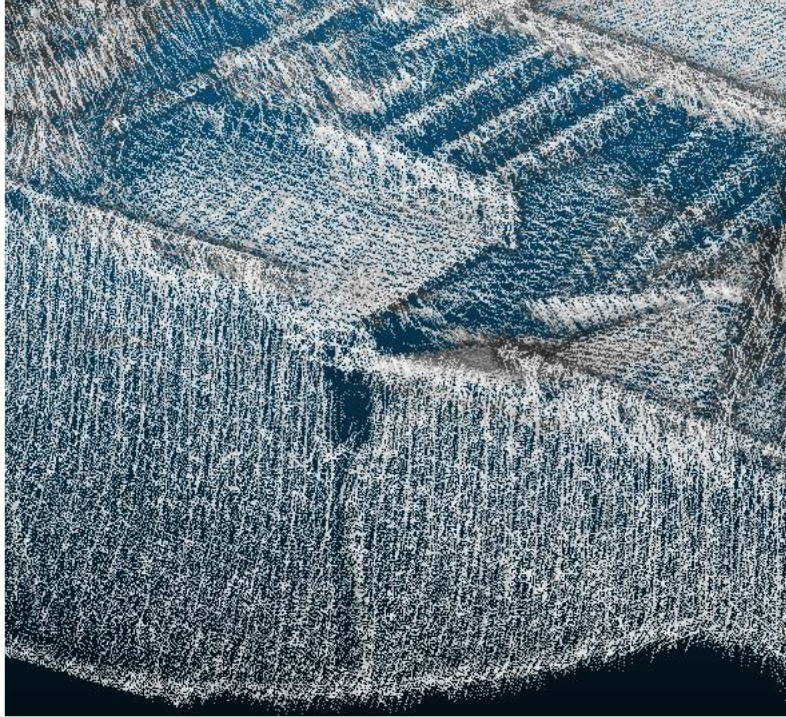
- 4.1.3** There has also been little change if any in the individual features of the wreck, discussed individually below.
- 4.1.4** Key Area 1, crack in hull (port side, forward section). *“Analysis of the large crack in the hull on the forward port side of the wreck suggests that the extent of the crack has remained static since the September 2020 survey was completed”* (Figure 7).

Figure 7 – Image of Key Area 1, crack in hull.

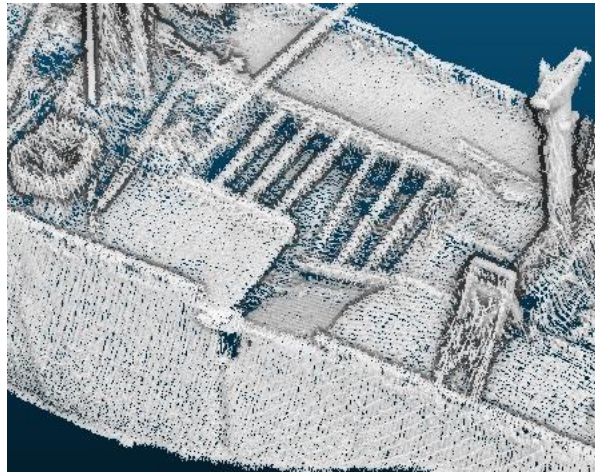
4.1.6 Key Area 2, partial collapse of cargo hold deck (port side). “No discernible differences have been seen in the initial analysis between the September 2020 and September 2021 surveys” (Figure 8).

Figure 8 – Image of Key Area 2: partial collapse of cargo hold deck (port side).

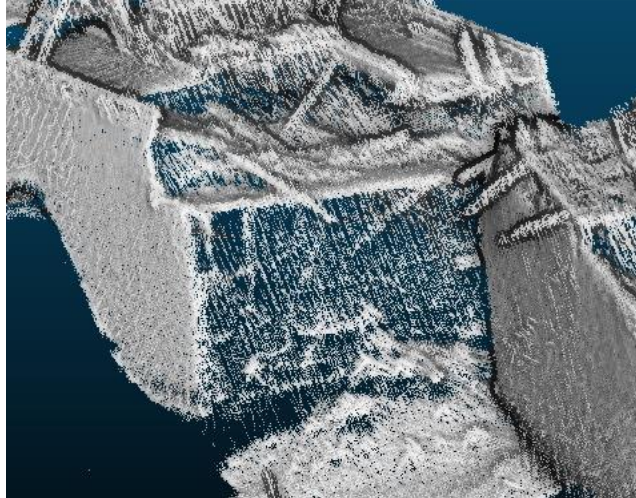
4.1.7 Key Area 3, Port Side Aperture in Aft Part of Forward Section. “Comparisons between the September 2021 and September 2020 datasets show no obvious changes in this area.” (Figure 9).

Figure 9 – Image of Key Area 3: port side aperture (aft part of forward section).

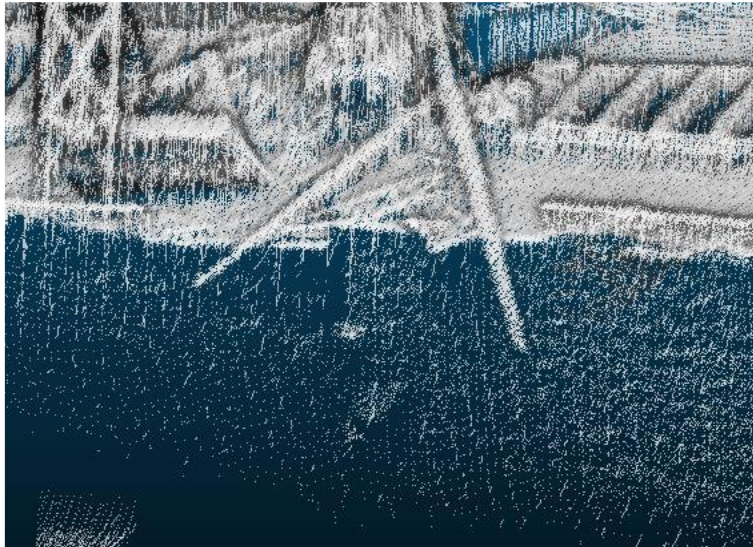
- 4.1.8** Key Area 4, severe splitting of hull (starboard side aft section). “Little if any change is evident between the September 2021 data and the September 2020 data”. (Figure 10)

Figure 10 – Image of Key Area 4: severe splitting of hull (starboard side aft section).

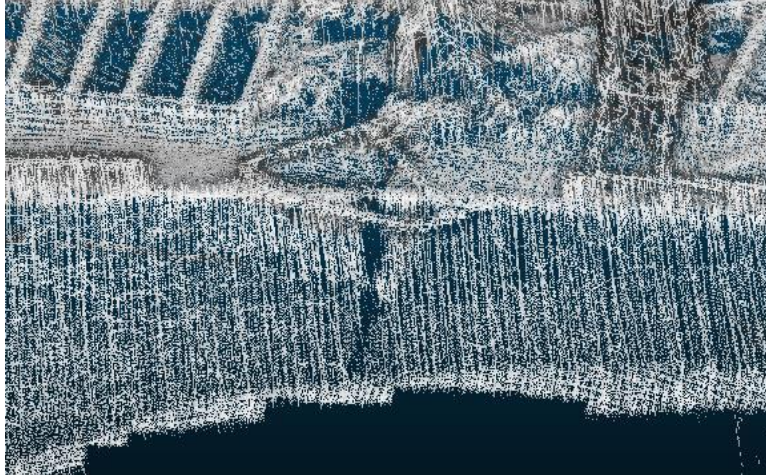
- 4.1.9** Key Area 5, split in deck and hull plating (port side aft section). “This split was clearly observed in the August 2019 dataset and September 2021. Although this split had shown some evidence of increasing in size between the January and August 2019 surveys, little difference is evident between the September 2020 and September 2021 surveys”. (Figure 11).

Figure 11 – Key Area 5: split in deck and hullplating (starboard side, aft section).

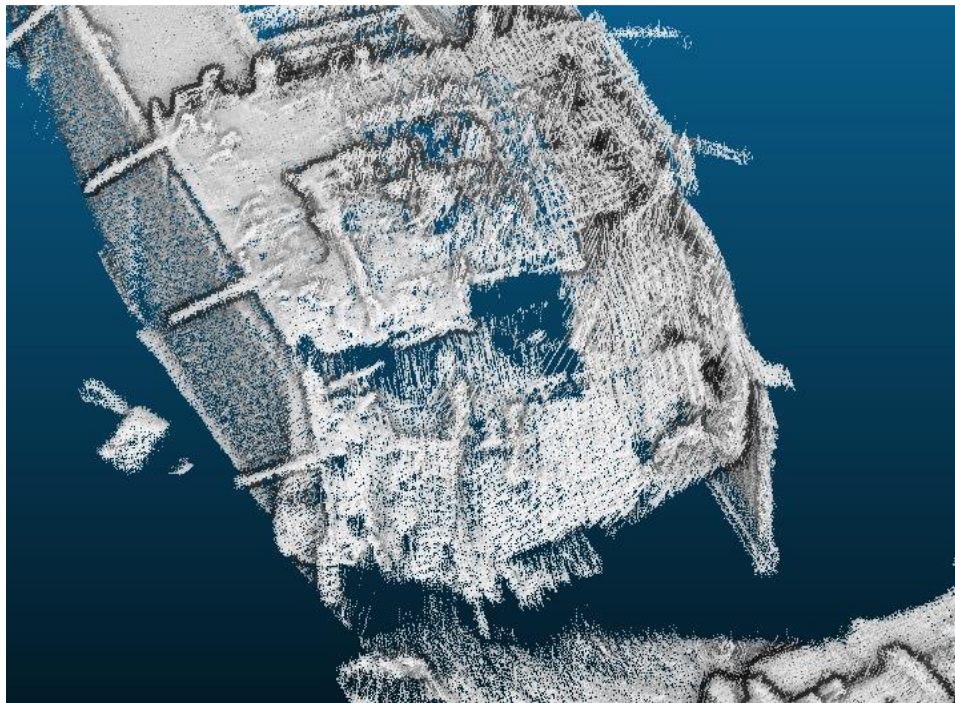
- 4.1.10** Key Area 6, collapsing bridge deck area. “This section of the vessel was identified in 2015 to have seen the greatest amount of degradation since the previous annual survey. The speed of change was not apparent between the January and August 2019 surveys and similarly, little change is immediately evident between the September 2021 survey and the September 2020 survey” (Figure 12).

Figure 12 – Key Area 6: collapsing bridge deck area.

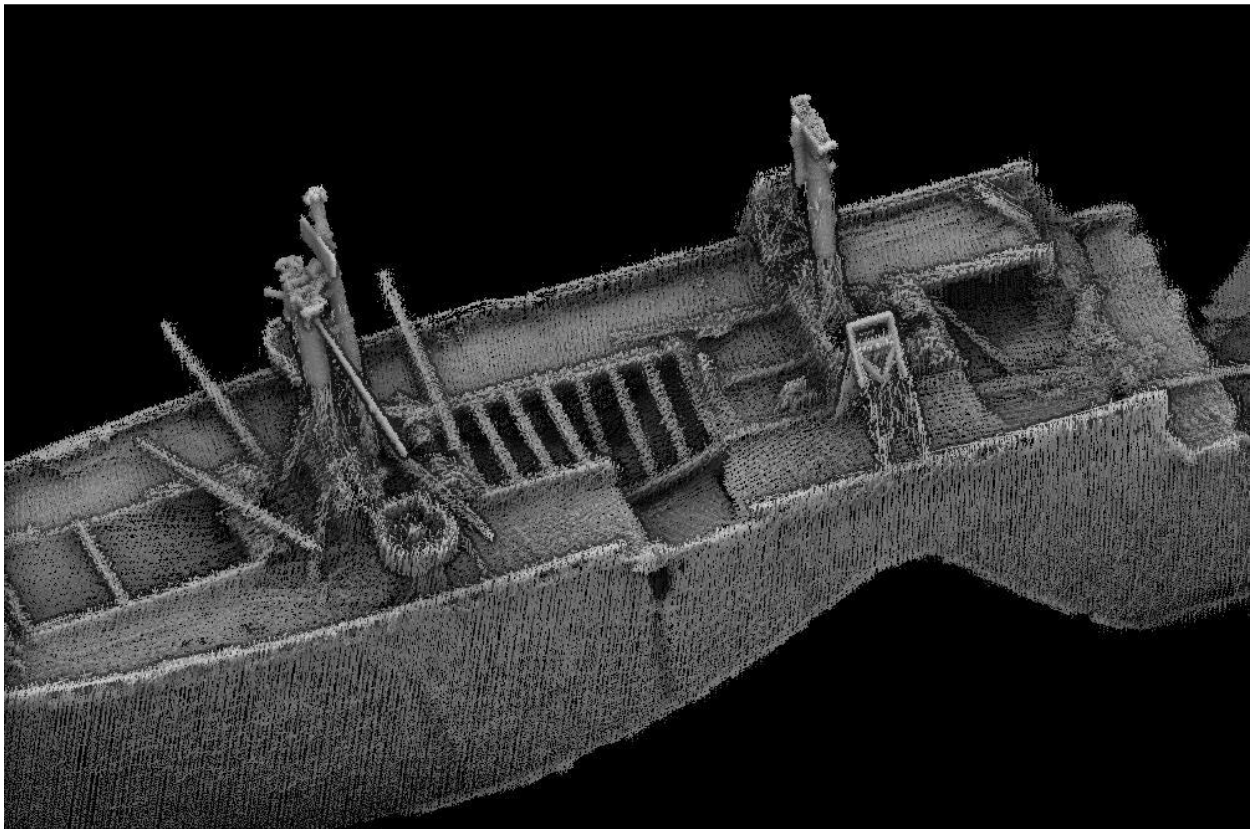
4.2.4 The crack in the hull is at the location shown in Figure 14. Of note is the sediment to the left (port side) that appears to extend deeper in the hull than the second deck level indicating that the second deck has been breached in this area – not surprisingly since the hull has split here and hence a tear in the second deck would be expected. How much sediment has entered the lower hold cannot be determined from this image. As above, there is no discernible changes in Key Area 2.

Figure 14 – Crack in Hull September 2021

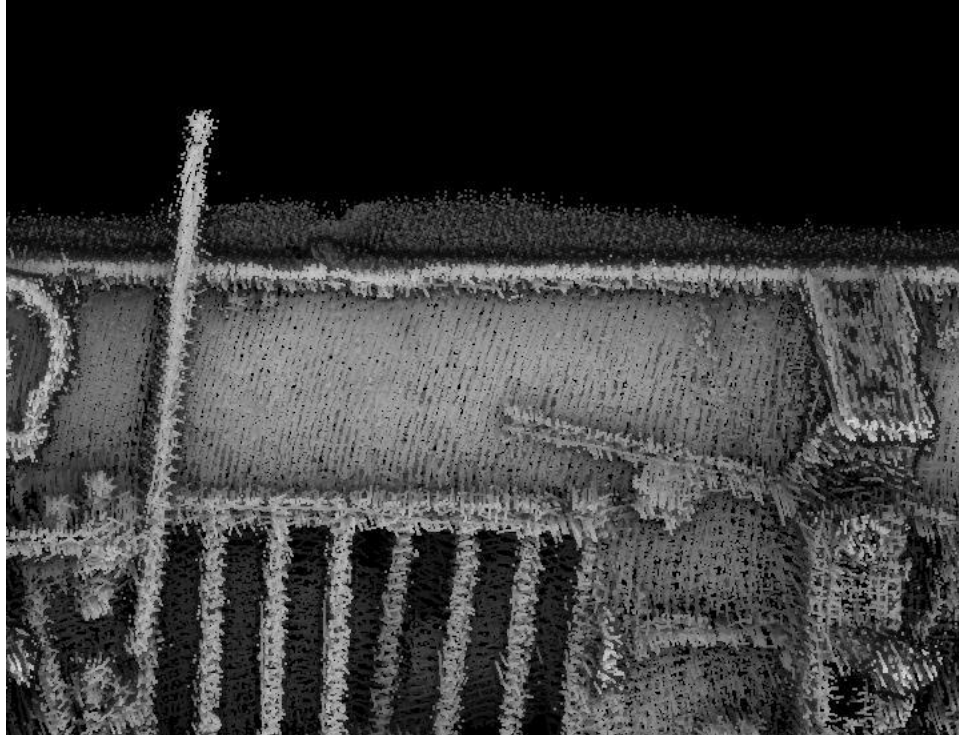
4.2.5 Note the extreme bulging outward of the hull plates on the starboard side although this bulging does seem to have remained stable over the last few surveys (Figure 15). The bulge is limited to hold 2 and the form of the hull returns to normal at the bulkheads at either end – potentially due to the greater strength afforded to the hull by the presence of the bulkheads.

Figure 15 – Bulging in Hull Plating at hold 2

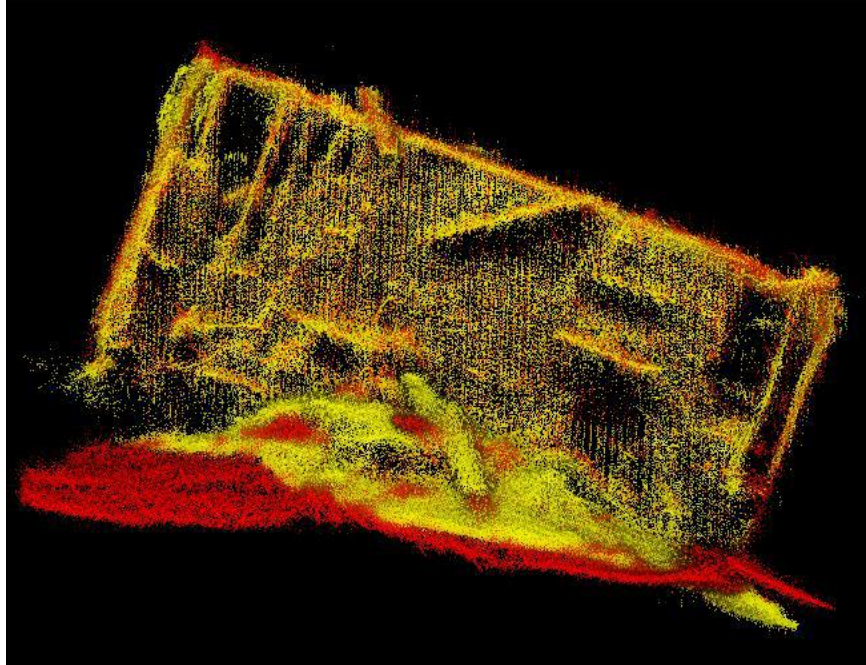
4.2.7 The apertures on the bulkhead at frame 88 at the aft end of the forward section are clearly visible in the 2021 dataset although there is no appreciable difference between this survey and that from September 2020 (Figure 16).

Figure 16 – Key Area 3: Apertures on Bulkhead 88 (Port Side).

- 4.2.8** The poor quality of returns of objects obtained through the aperture mean it is not possible to identify them. The data collected during this survey shows very similar dimensions to what was gathered during the survey of September 2020. However, whether the returns are from cargo in the hold or sediment surrounding them cannot be ascertained.

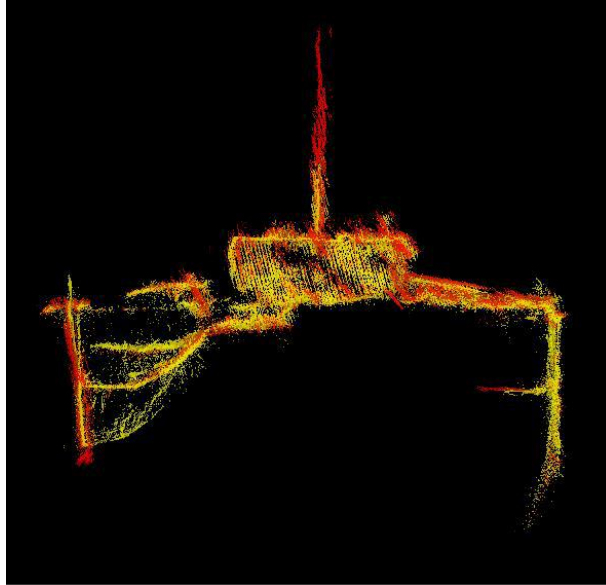
- 4.2.9** **Key Areas 4 & 5 (ID22 and ID24 & ID25)– Splitting of hull, and split in deck and hull**
- 4.2.10** Key Areas 4 and 5 represent the two ends of the same feature, namely a transverse crack across the rear hull section at about frame 134, the bulkhead between holds 4 and 5. Like the forward section, the rear section is hogging and potentially breaking in two about halfway along its length. The split appears to be occurring just forward of the mast, with the mast remaining upright with respect to the stern part, as it drops away from the forward part (Figure 17).

Figure 17 – Cross-section through split hull (Yellow: 2020 survey and red 2021 survey).

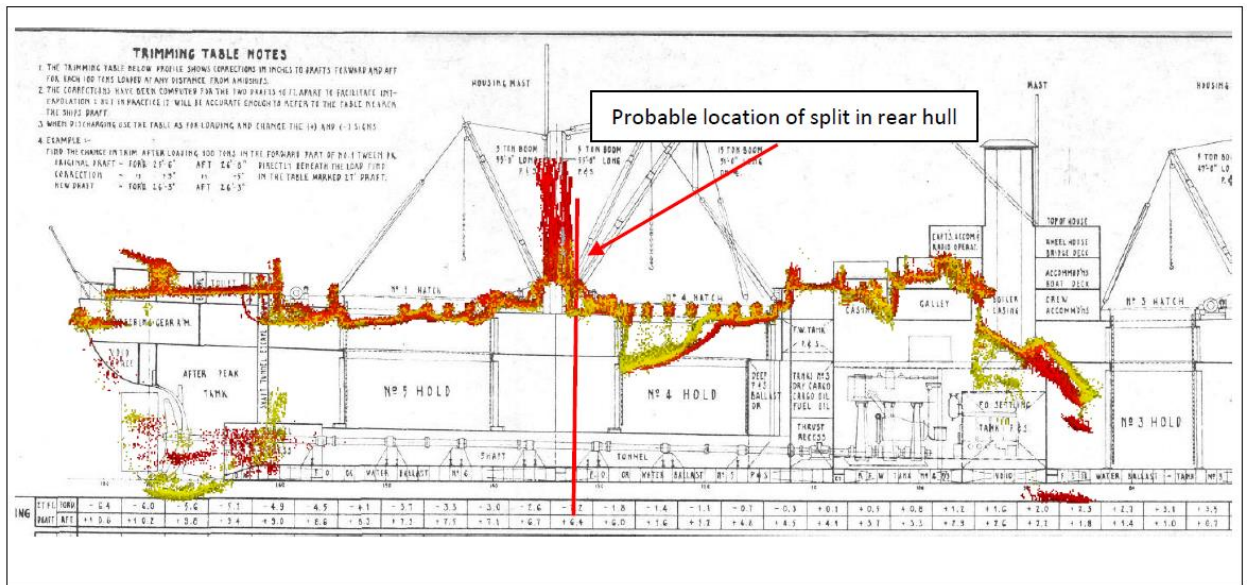
4.2.11 No noticeable change has occurred to the angles or orientation of the wreck although, some variation is apparent to the sediment in hold 4 and the collapsing bridge deck. In Figure 18, the ship's plan has been positioned and orientated so the forward part of the stern aligns with the survey data showing how far below the plan the rear of the data lies.

Figure 18 - Longitudinal profile through the stern section. Yellow: 2020 survey and red 2021 survey.

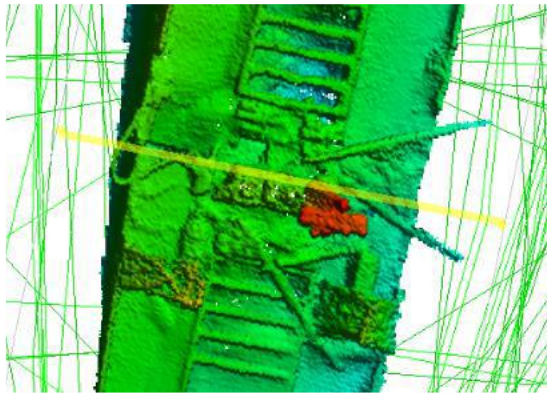
4.2.13 This area was left unsupported when the ship broke in two in 1944. Consequently, it has been adversely affected by wave and current action and is steadily collapsing and falling into the gap between the two halves of the vessel. This area has showed significant degradation in earlier surveys but there is only minor change between the 2020 and the 2021 surveys.

4.2.14 Key Area 6 is particularly difficult to survey as the numerous angular protrusions can affect the returning data, which is why the results cannot be entirely conclusive (Figure 19). However, the upper deck is more robust, and for that reason is used to measure the possible deflection.

Figure 19 – Key Area 6: orientation of split deck.

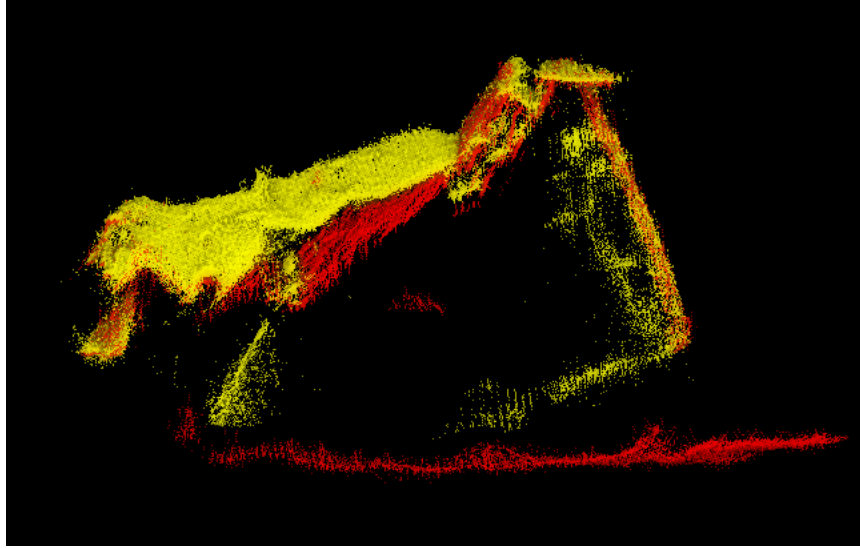
4.2.15 The lack of change on the wreck is evident from the good agreement of the 2020 and 2021 surveys. One change that is apparent is the slight raise in the seafloor to the east (port side) of the wreck. In Figures 20 and 21 below, yellow (2020) and red (2021) points along the long unsupported section of deck agree very well at the top but, vary significantly towards the right where it appears that the deck has collapsed to the lower floor level. This does not seem to have altered the general level of that section of wreckage, but it is possible that this structure may fail completely in the future and fall into the gap between the two halves of the ship.

Figure 20 – Profile through bridge deck area (yellow: 2020 survey, red: 2021 survey)

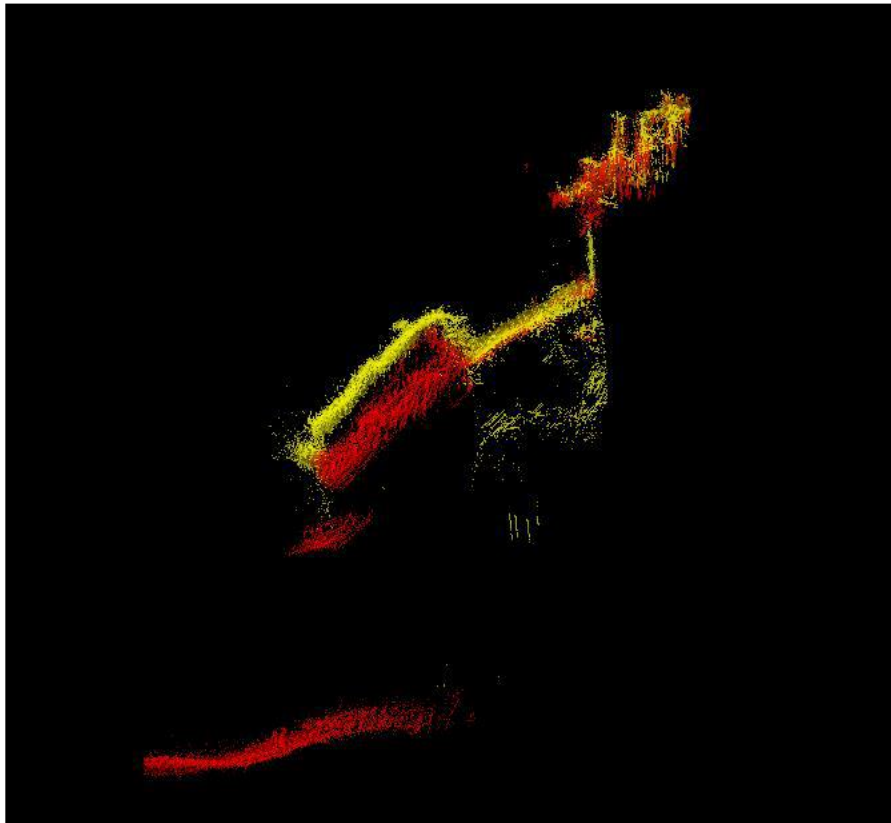
Figure 21 – Longitudinal cross-section showing area of continued change (yellow: 2020 survey, red: 2021 survey)

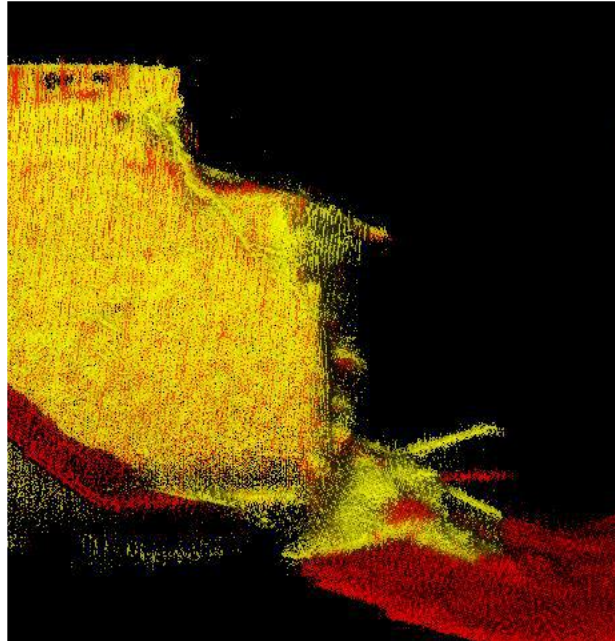
- 4.3.1** There has been no appreciable difference in the debris between the bow and stern section. In Figure 22 below the only appreciable difference is the pipe (or similar structure) sticking out from the debris pile at the base of the front section which has rotated so that its free end is now some 2m lower than it was a year ago. The pipe is identified in the image below by a yellow circle with the 2020 position in yellow and the 2021 position in red.

Figure 22 - Side view of rear of forward section of the SSRM showing the downward rotation of the pipe extending from the debris pile. (yellow: 2020 survey, red 2021 survey)

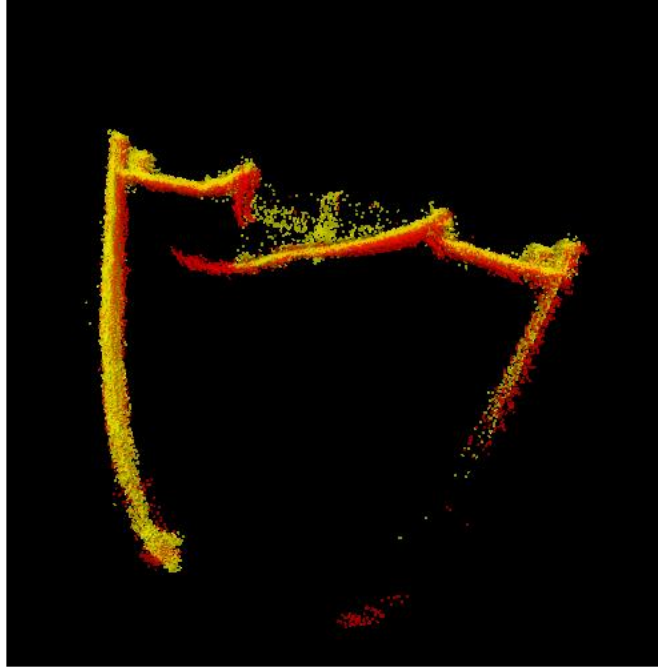
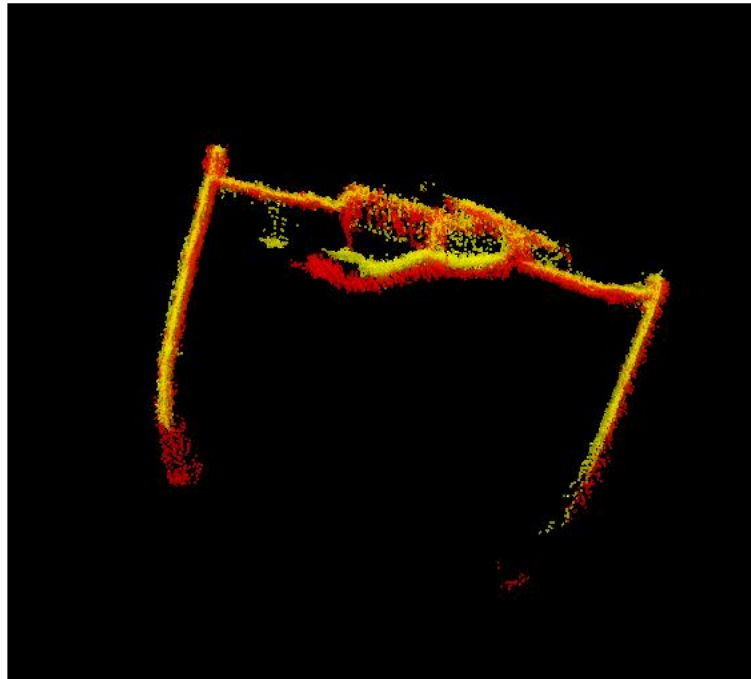
4.4.5 The hatch cover is missing as are all but one of the hatch cover supports. Sediment has settled in the 'tween deck space to a considerable depth, filling the starboard side to the top of the starboard side hatch coaming. The port side remains clear above the horizontal from the starboard hatch coaming. Apart from some undulations in the sediment surface this is indicative of all the sediment visible in the data as imaged through the open hatch. (Figures 23 and 24).

4.4.6 Notably there is no indication that the Second Deck has collapsed. There is no indication that the Second Deck hatch covers have collapsed, although it is an unlikely possibility, they have and the sediment has filled both the 'tween deck area and the lower hold. There has been a slight erosion of the sediment in the rear of the hatch area. However, this is likely to be cyclical event with sediment being washed in and out of the open hatch area possibly daily.

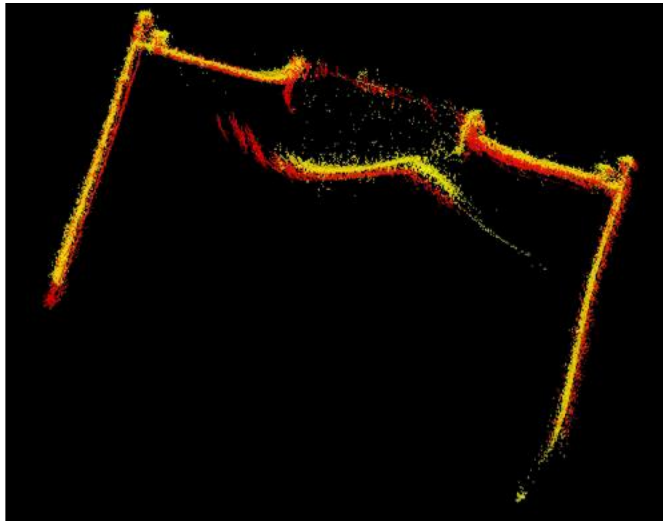
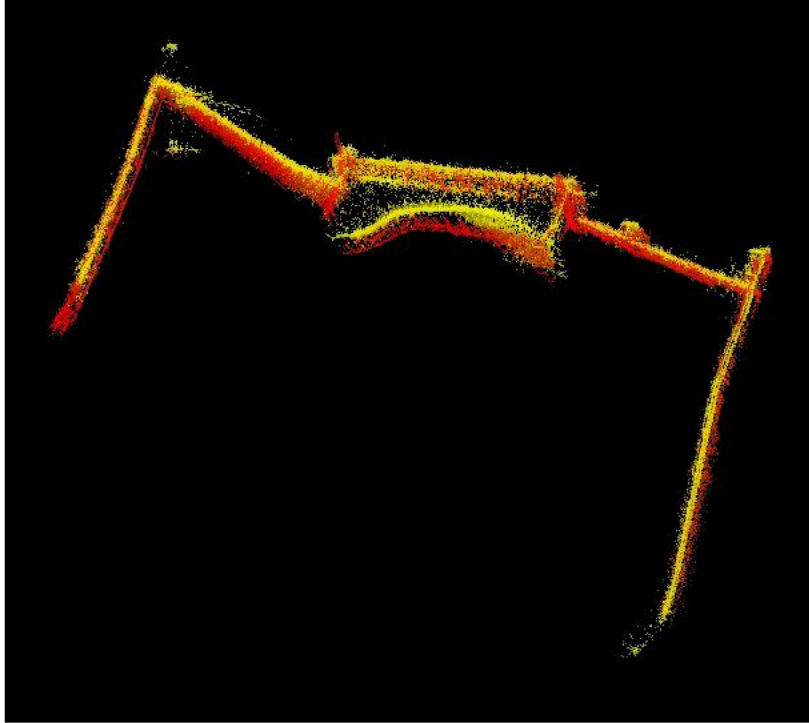
4.4.7 As with hold 1, the outer hatch cover of Hold 2 is missing although all the cover supports are in place. The forward section of the wreck is splitting at frame 54, nearly mid-way along No. 2 Hatch, and this has resulted in part of the Upper Deck collapsing into the 'tween deck space. Sediment is visible through the open No. 2 Hatch and similarly to hold 1, the sediment has filled the 'tween deck space to a considerable depth although, unlike hold 1, it appears that the starboard side is not filled. Again, there is no indication that the second deck or the lower hatch covers have failed as there is no slump in the sediment. (Figures 25 and 26).

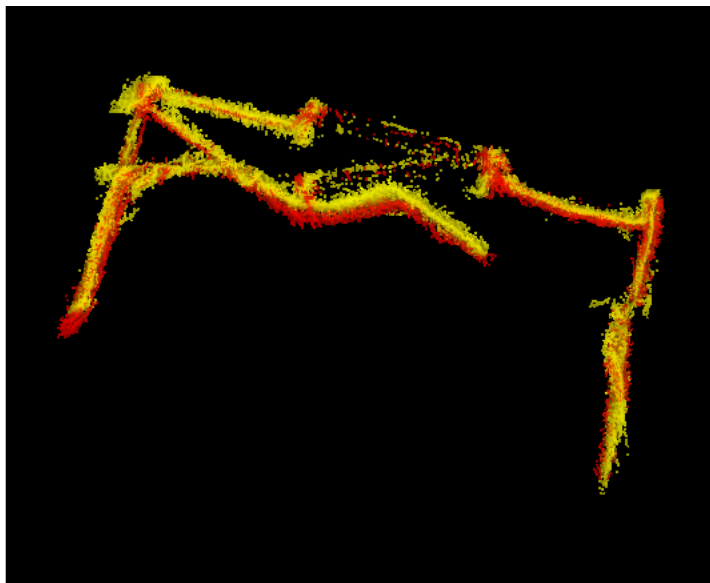
4.4.8 In Figure 27 the sediment in the 'tween deck space of hold 2 is visible. In this area, unlike the forward and aft ends of No. 2 Hatch, the sediment does not fill the 'tween deck space. This may be due to the cracks in the hull sides at this location, which could allow water to flush through and so remove the upper most sediment layers. It is also possible that the Second Deck has partially collapsed where it joins the port hull – see the data as collected through the split in the hull in Figure 27, although this could also be the result of data inaccuracies caused by poor acoustic properties of the sound passing through the narrow gap.

Figure 27 – Cross-section of hull at frame 54 where forward section of hull is breaking in two (yellow: 2020 survey, red: 2021 survey).

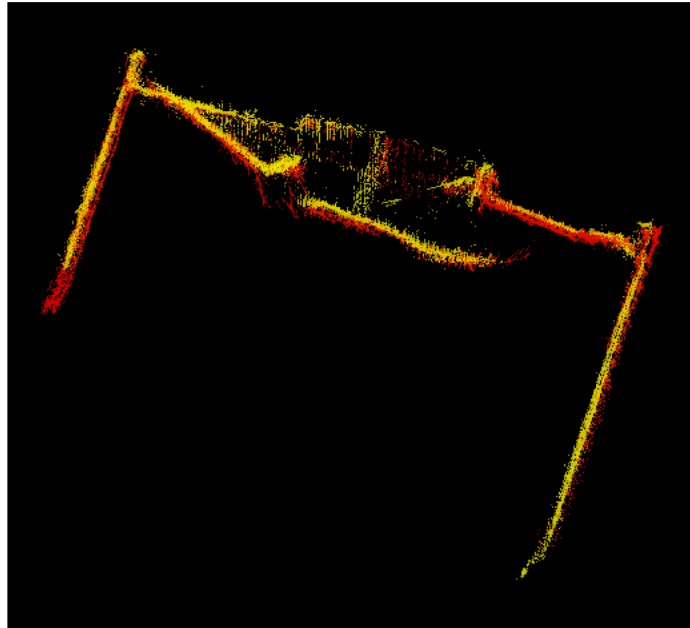
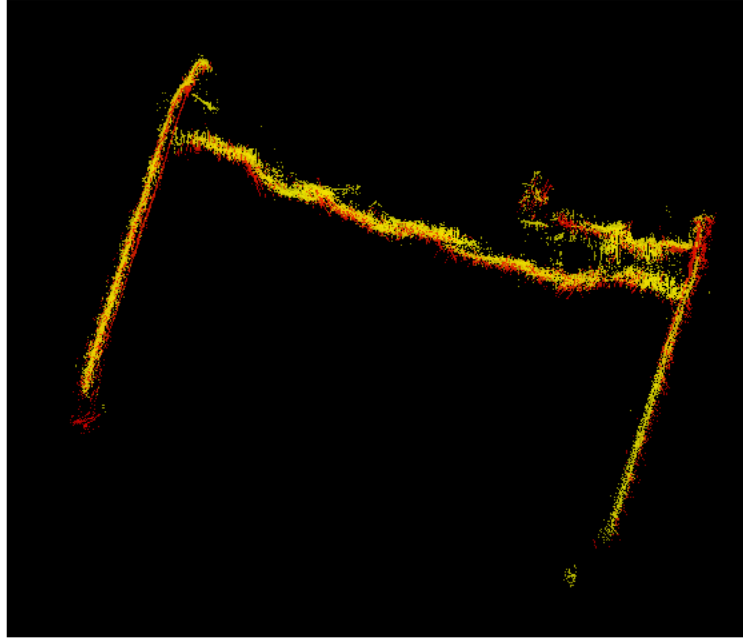
- 4.4.9** The rearmost hold of the forward section. The rear bulkhead of this hold forms the rearmost part of the forward section, the vessel having broken in two immediately aft of that bulkhead. Although the lower hold remained with the forward section, the bulkhead at the rear of the ‘tween deck space and the section of the upper deck above it were carried away leaving this area open. The outer hatch cover has gone as have all the cover supports although there is a beam – possibly a cover support or part of the coaming lying on the starboard side. (Figures 28 and 29).

- 4.4.10** Sediment accumulation is largely limited to the forward part that still retains the protection of the Upper Deck and, in common with all the forward holds there is no evidence that the Second Deck or the cover leading to the lower Hold have collapsed. All sediment layers are higher than the second deck with no indicative slumps.

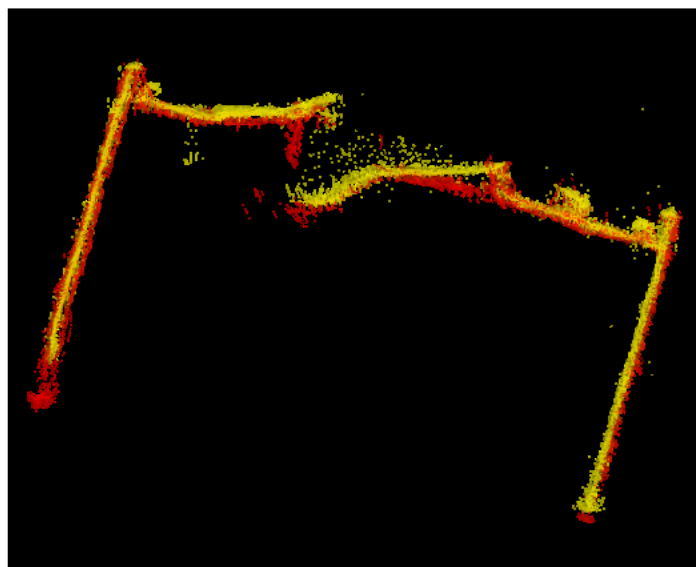
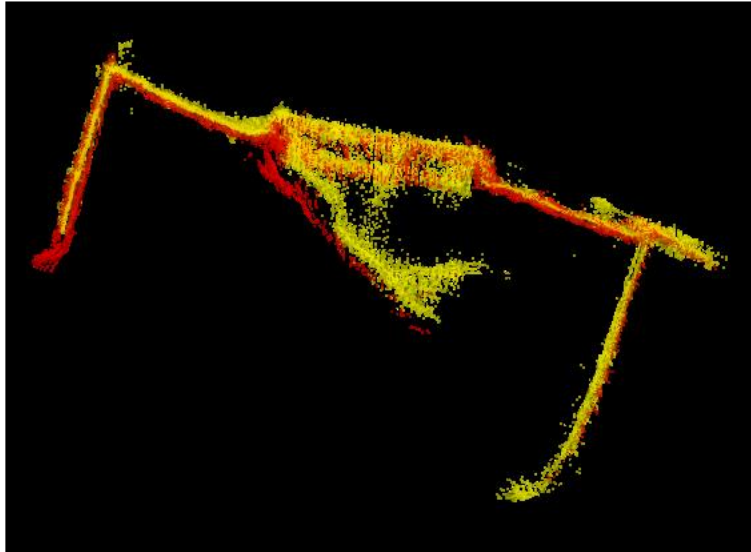
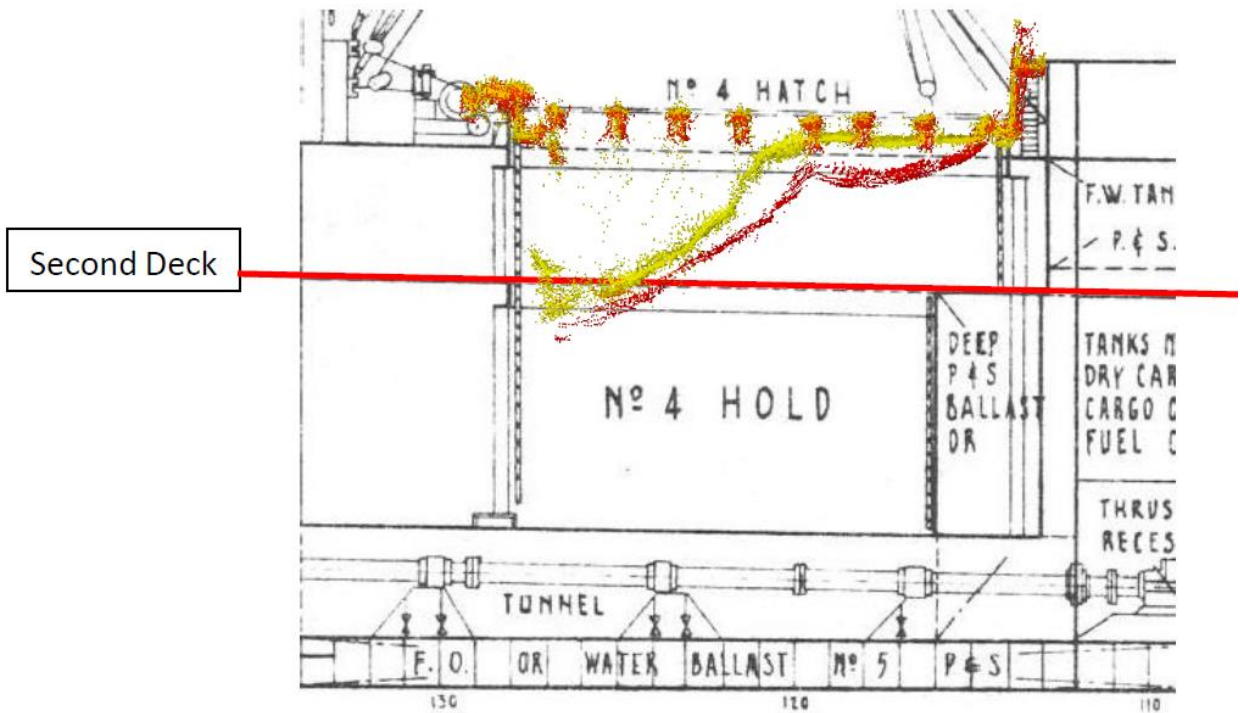
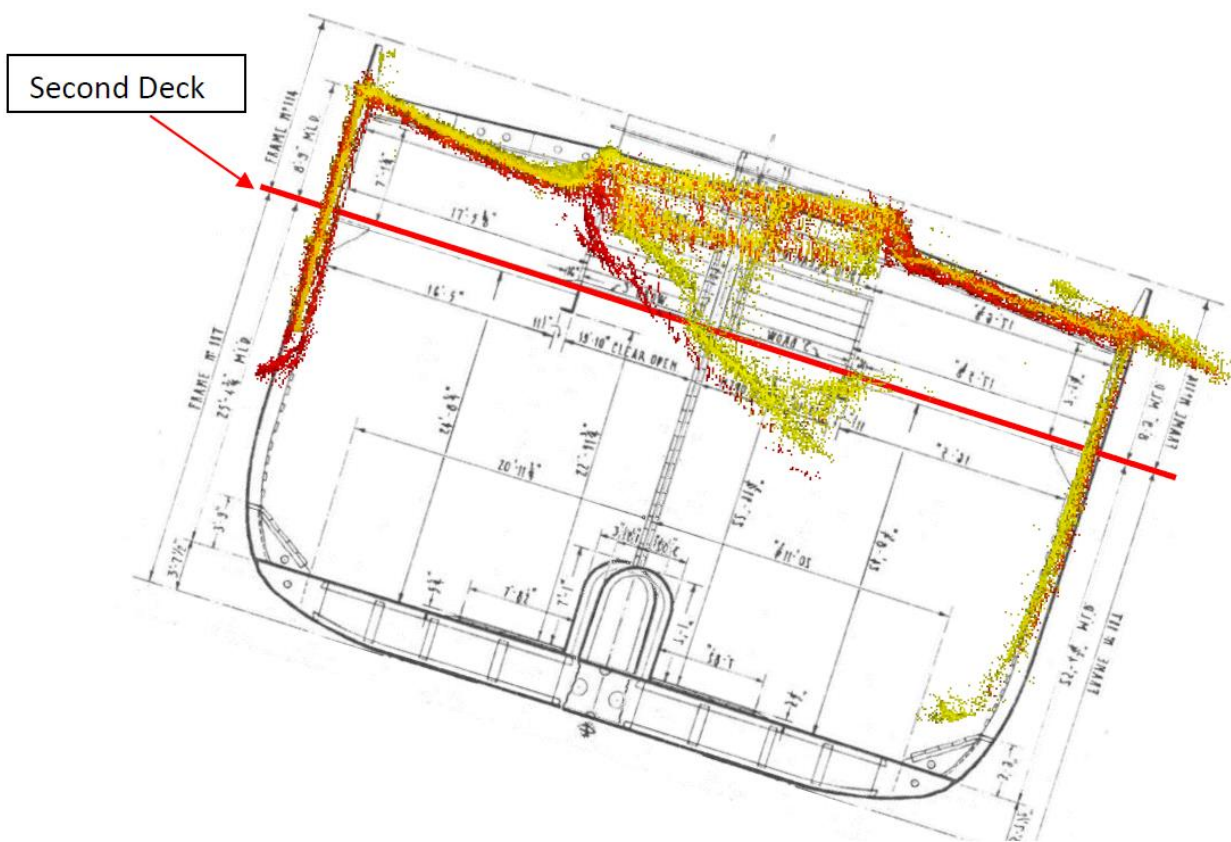
- 4.4.11** The most forward of the two holds in the aft section. Since the two stern holds are reported to have been emptied during salvage operations conducted soon after the grounding it is not known if the lower hatch covers were replaced. However, since the upper hatch supports are in place, it seems likely that the salvors did replace the covers once they were finished. (Figures 30, 31, 32 and 33).

4.4.12 The sediment in the forward part of No. 4 Hatch shows distinct similarities with that in No 1 Hatch, with the starboard side of the ‘tween deck space being filled, and the port side remaining clear above the horizontal to the top of the hatch coaming. However, the rear of the hatch area shows a different story with the first (and only) indication that the Second Deck or the lower hatch covers have failed. Here the sediment layer descends below the level of the Second Deck confirming some form of collapse, probably a partial collapse of the lower hatch cover. This has happened at some time between 2010 (where the survey showed the sediment above the Second Deck) and the 2017 survey where the sediment was just below the Second Deck. The sediment has deepened slightly between 2020 and September 2021, but this does not seem to indicate any major further collapse. More likely a redistribution of the sediment by currents.

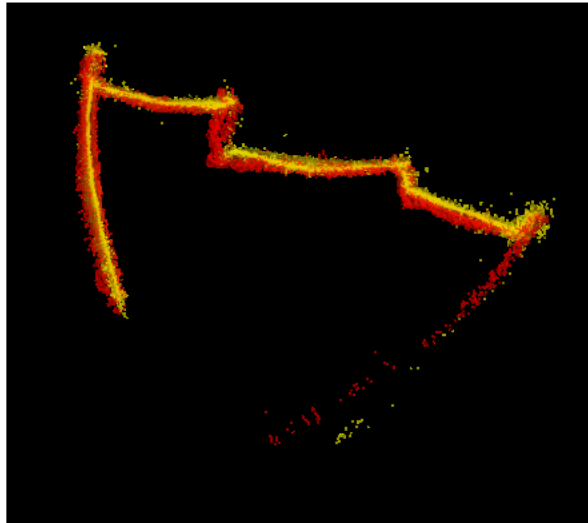
4.4.13 The rear most hold. The forward four of the six hatch cover supports remain in place. Sediment levels in the 'tween deck space again follow the pattern of the other mainly intact holds, in that the starboard side is filled while the port side remains clear above the level of the horizontal from the top of the hatch coaming. As with the other holds, except No. 4 Hold, there is no indication that the second deck or the lower hatch cover have collapsed.

Figure 34 – Cross-section through hull at frame 154 (yellow: 2020 survey, Red: 2021 survey).

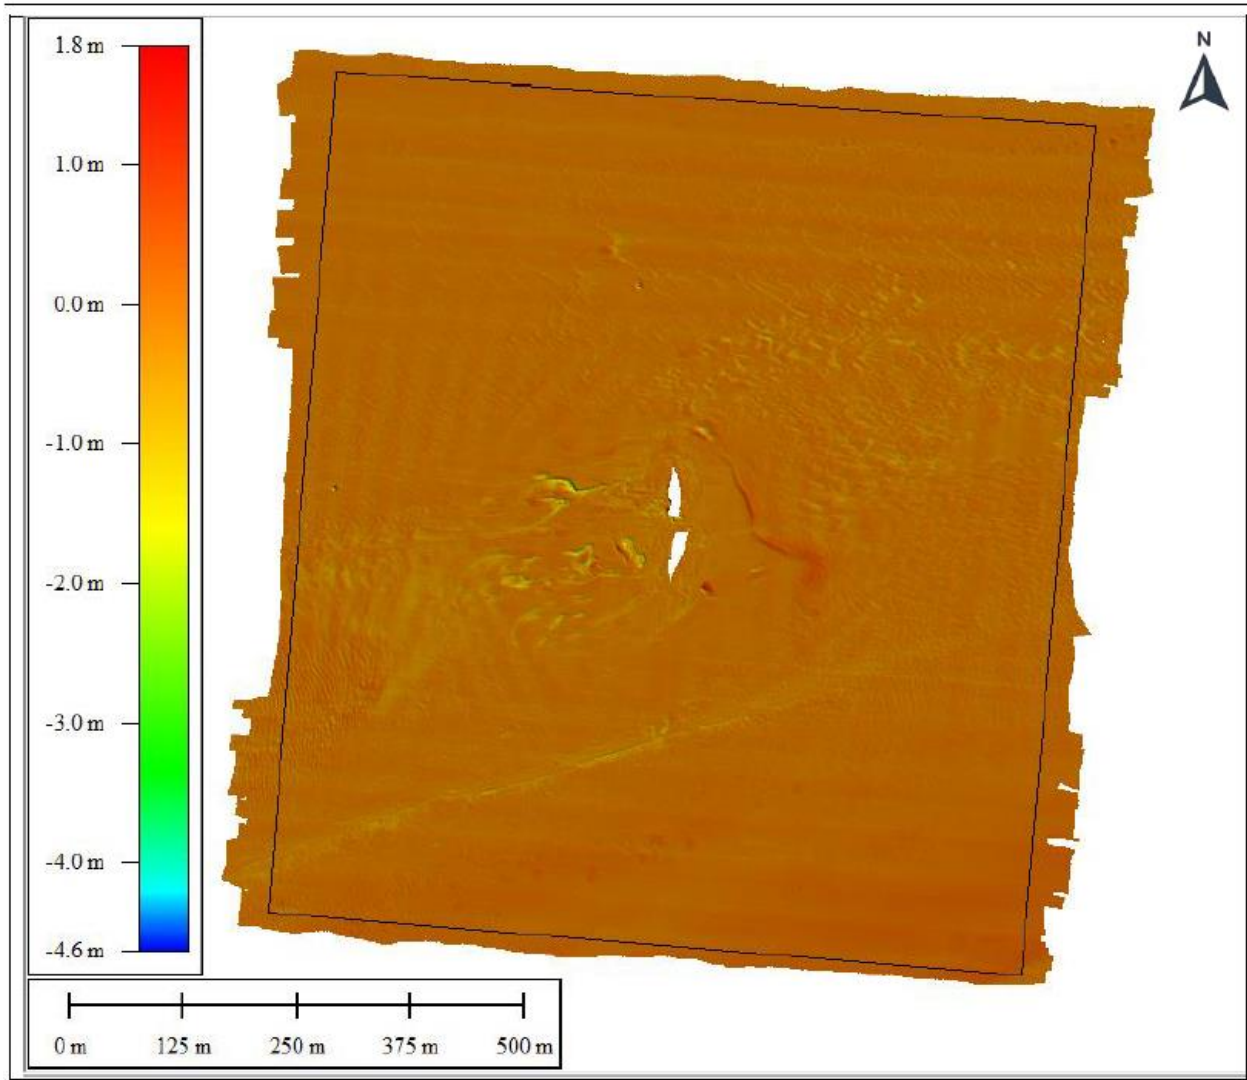
5.1.2 Across the site, a difference plot was made between the 2020 and 2021 surveys. The results of this are shown in Figure 36 below. In general, there are only minor changes in the depths. However, the edge of the scour pit that extends to the east of the SSRM has migrated about 5m westwards as

indicated by the line of accretion to the east of the wreck. Similarly, a small hollow lying to the southeast of the wreck has been filled. Other changes are small movements to the edges of the scour pit to the west of the wreck and the migration of several sand waves. None of the seabed changes are considered to be significant.

Figure 36 – Comparison of seabed surveys between 2020 and 2021.

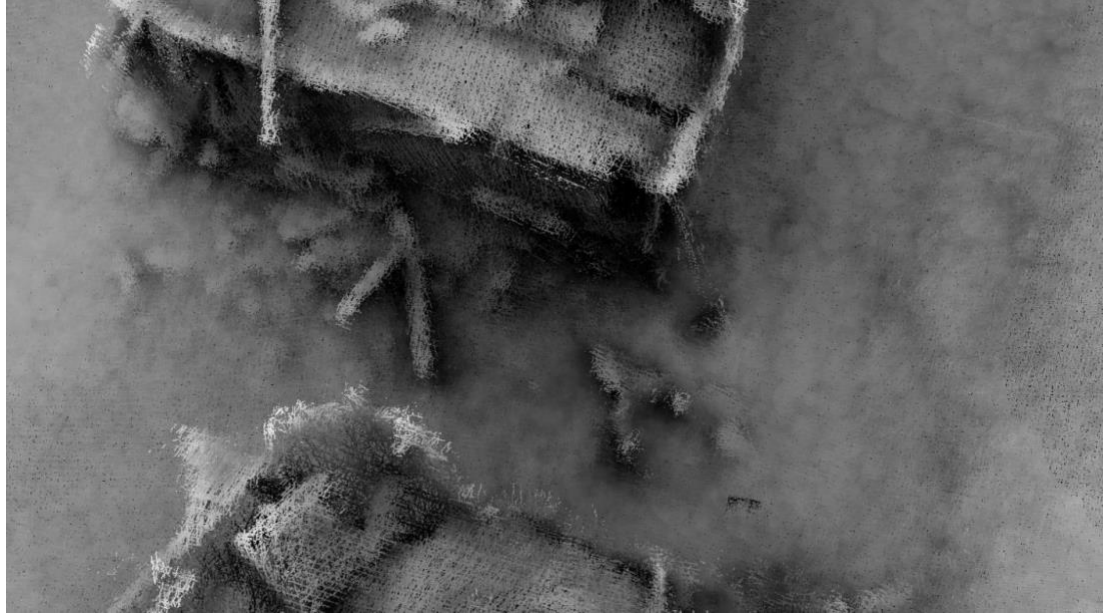
5.2.1 A surface difference plot shows evidence of a minor loss of material in the gap between the two sections. Whilst not immediately clear in the 3D point cloud data, a profile view in CARIS shows elevated debris that was previously overhanging but now has now broken off leading to a loss of elevation.

Figure 38 – Scan Between the Forward and Aft Hull Sections 2021
