Defence
Safety Authority

Service Inquiry

Loss of Hawk T Mk1 XX189
from 736 Naval Air Squadron,
RNAS Culdrose

SERVICE INQUIRY INVESTIGATION INTO THE LOSS OF HAWK T MK1 AIRCRAFT XX189 FROM 736 NAVAL AIR SQUADRON, RNAS CULDROSE, ON 25 MARCH 21

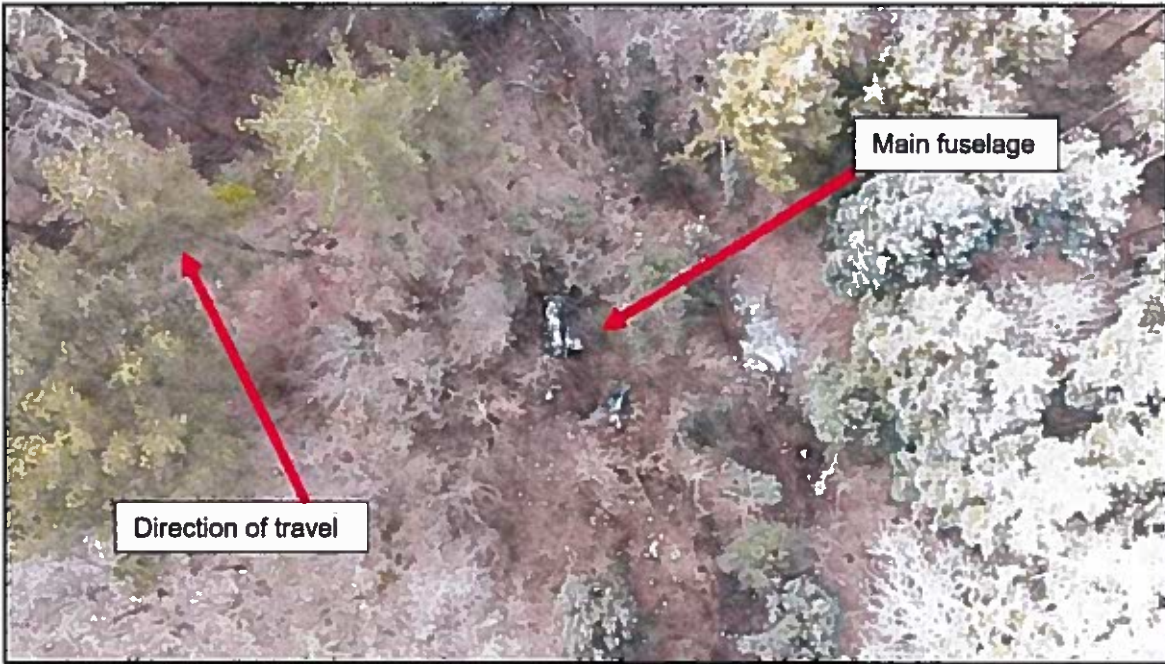
Figure 1.3.4 - XX189's resting place post impact with the Cornish Hedge.

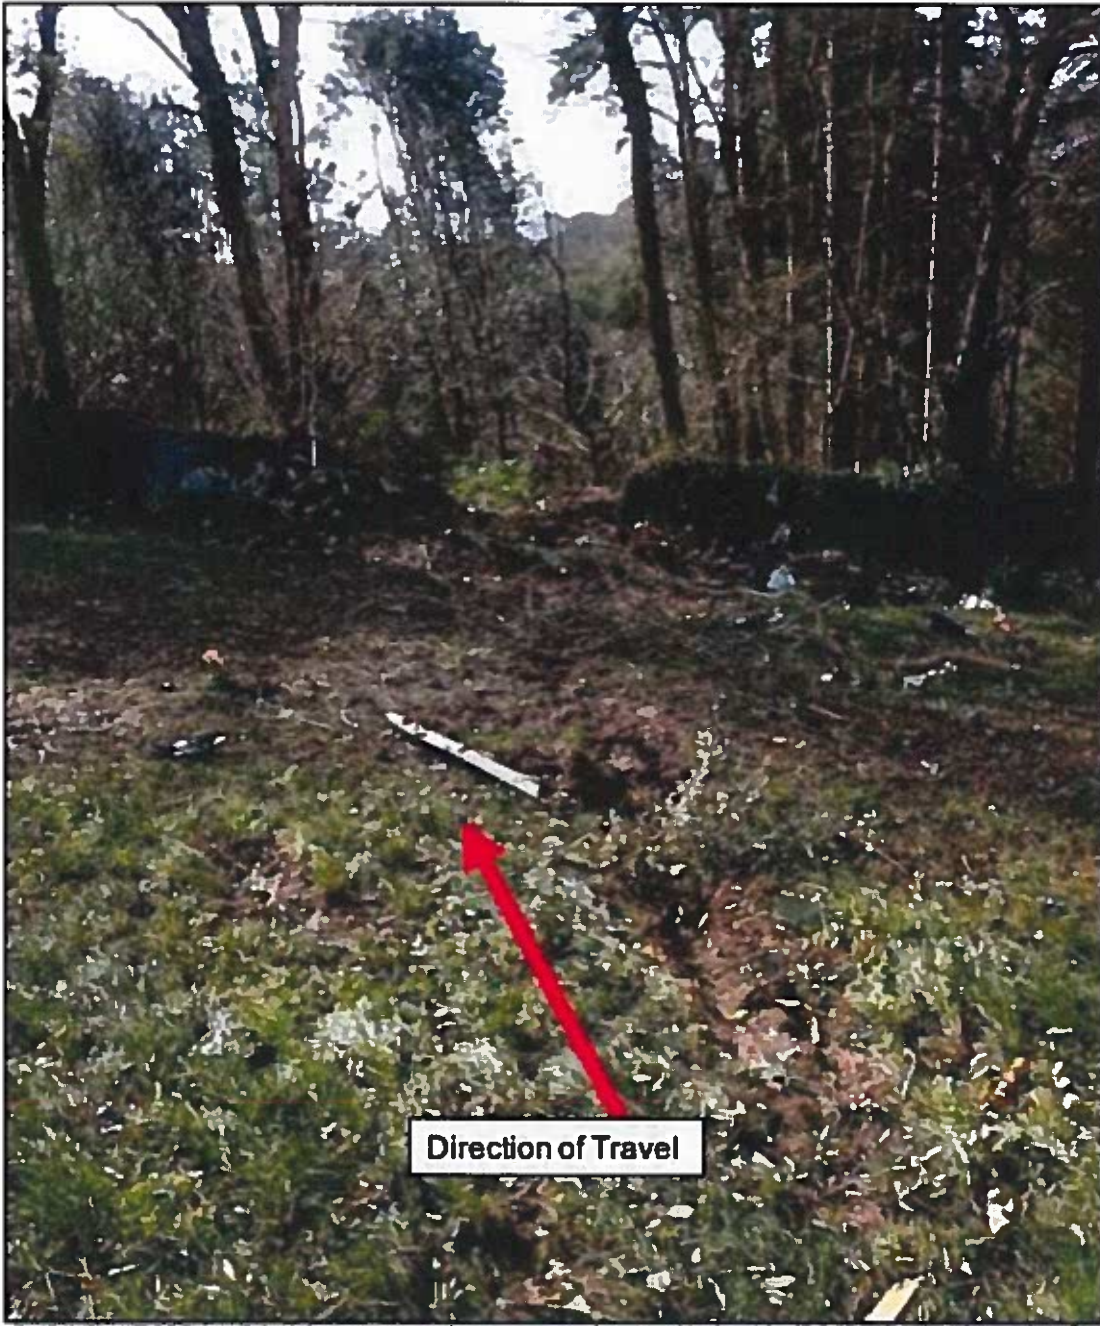
1.4.64. The collision with the Cornish Hedge³⁷ (Figure 1.4.9 and Figure 1.4.10) significantly reduced the velocity of the aircraft and caused substantial damage to the airframe.

Figure 1.4.9 - Initial ground strike marks with direction of travel.

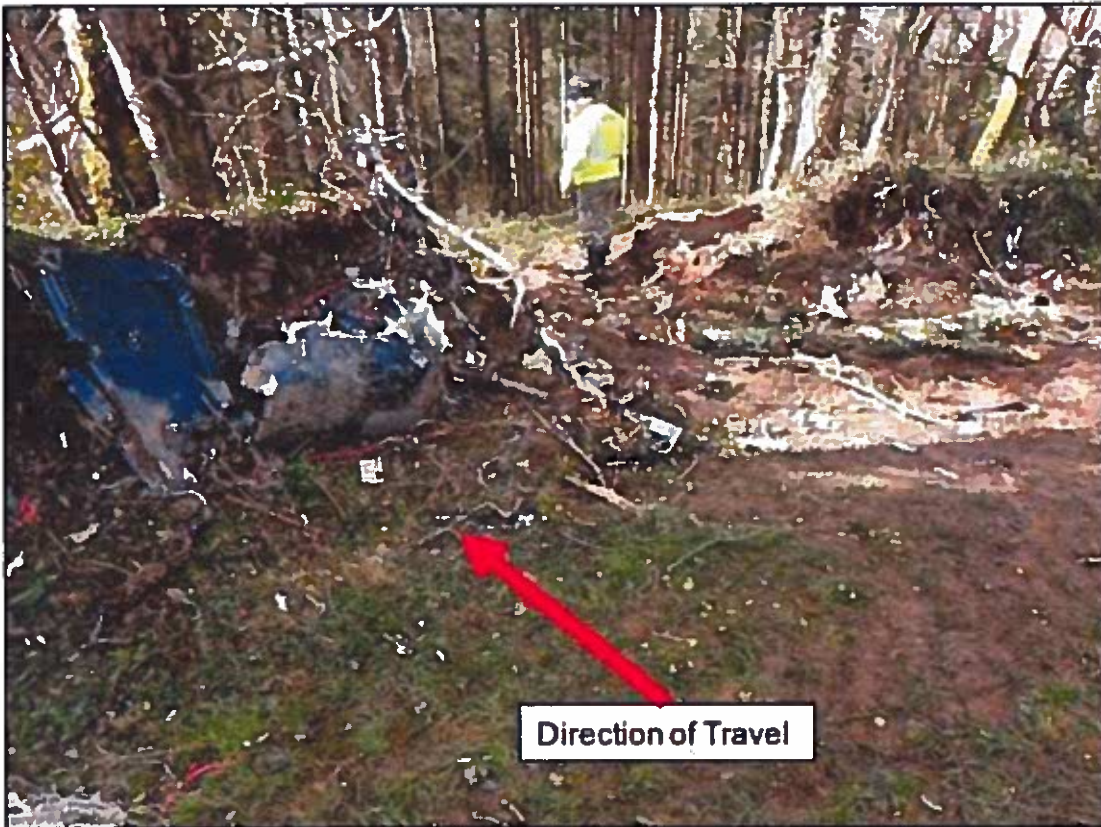
Figure 1.4.10 - Damage to the Cornish Hedge with direction of impact.

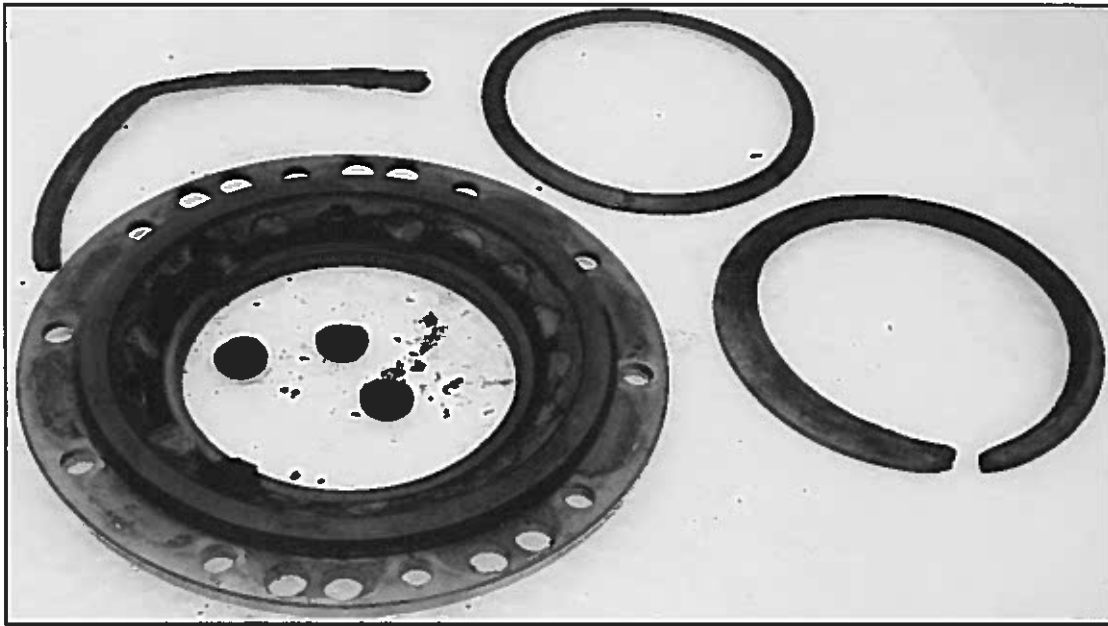
Figure 1.4.15 - Damaged HP Compressor Location Bearing, cage, and race.

1.4.77. Evidence showed that the galling, abrasion, and subsequent overheating, which led to the bearings experiencing a loss of dimensional tolerance, was caused by the loss of cooling and lubrication from the oil system. A rapid loss of oil was indicated by the localised debris from the bearing breakdown. The oil would have been the medium to transport the debris around the oil system. However, as there was a significant and rapid loss of oil, this did not occur.

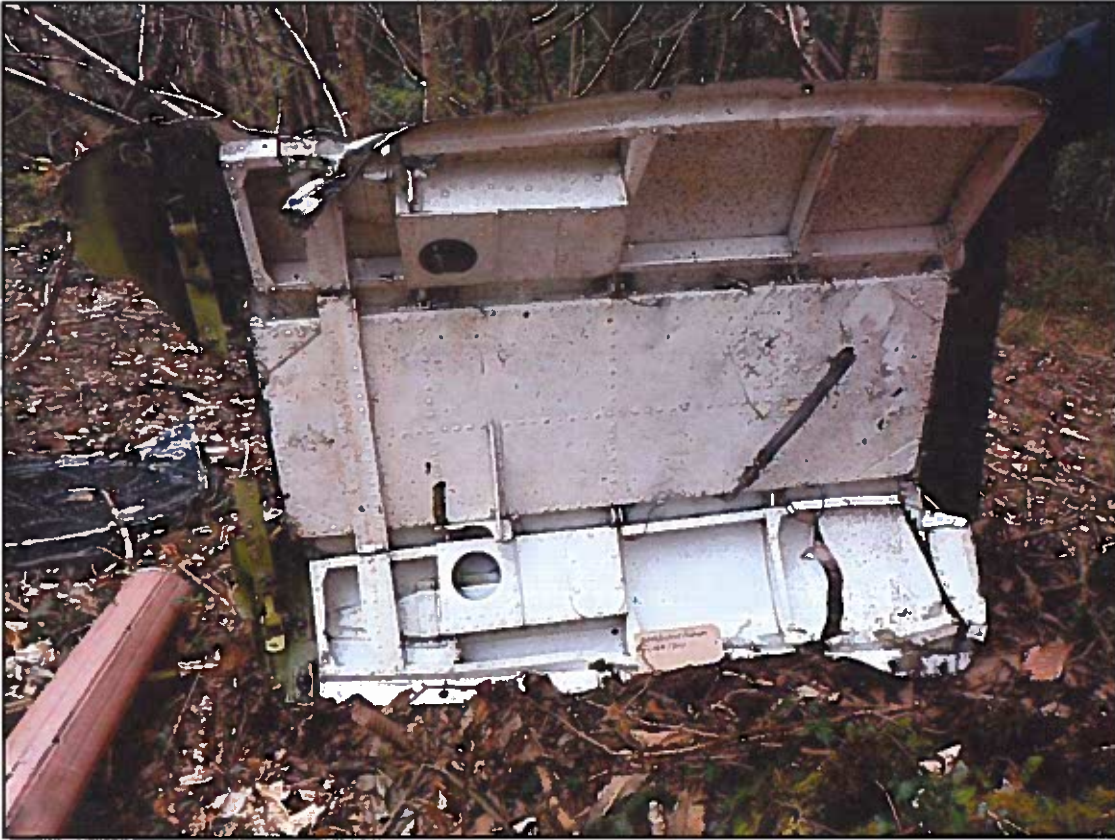
Figure 1.4.16 - Oil splatter visible on the interior of the gull wing doors.

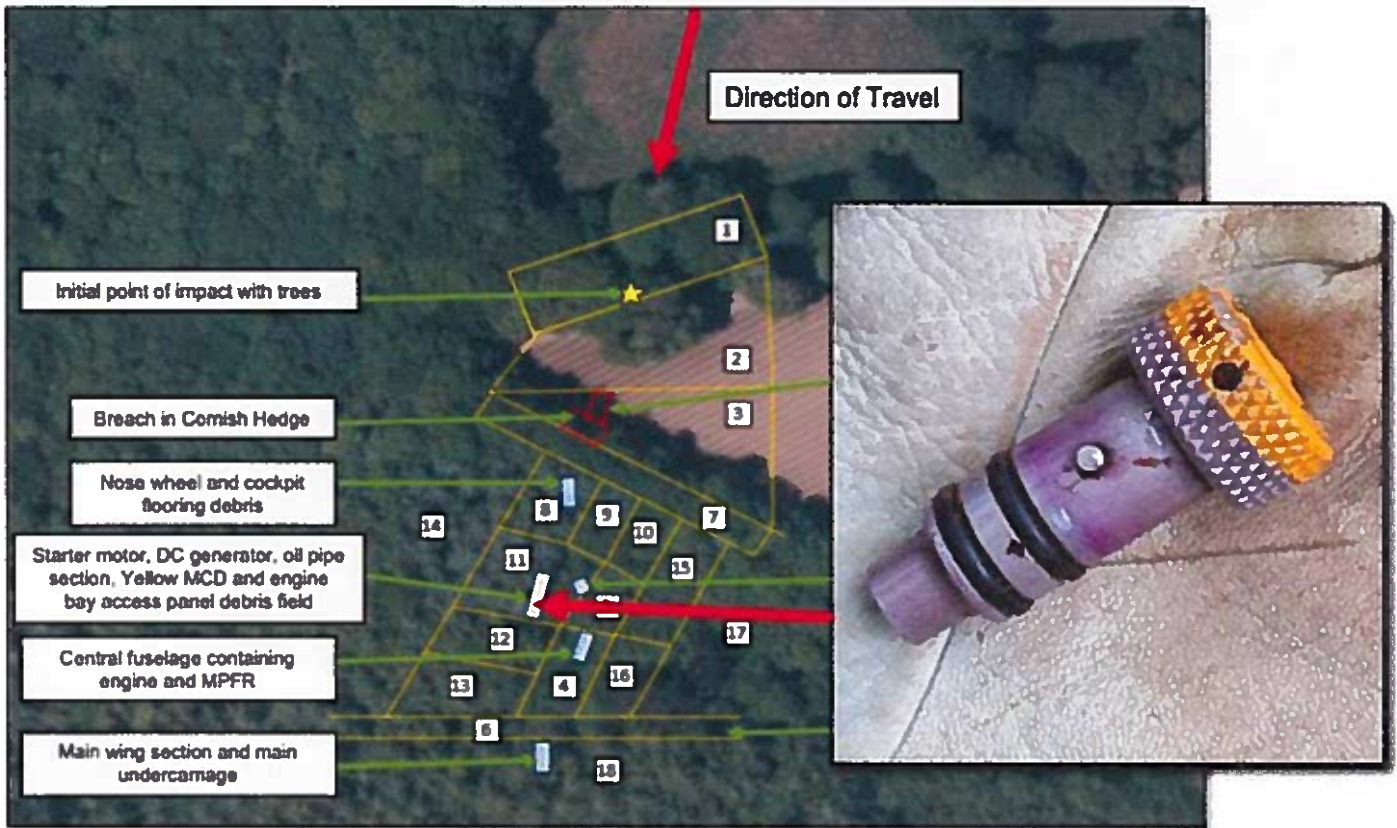
Figure 1.4.17 - Yellow MCD as found at crash site 31 Mar 2021.

1.4.83. The Yellow MCD was discovered approximately 10m west of the engine and main fuselage in the vicinity of the air starter motor, generator and the engine bay access panels that had detached from the airframe and engine during the crash sequence (Figure 1.4.17). Both Red and Blue MCDs were still in their respective housings (Figure 1.4.18).

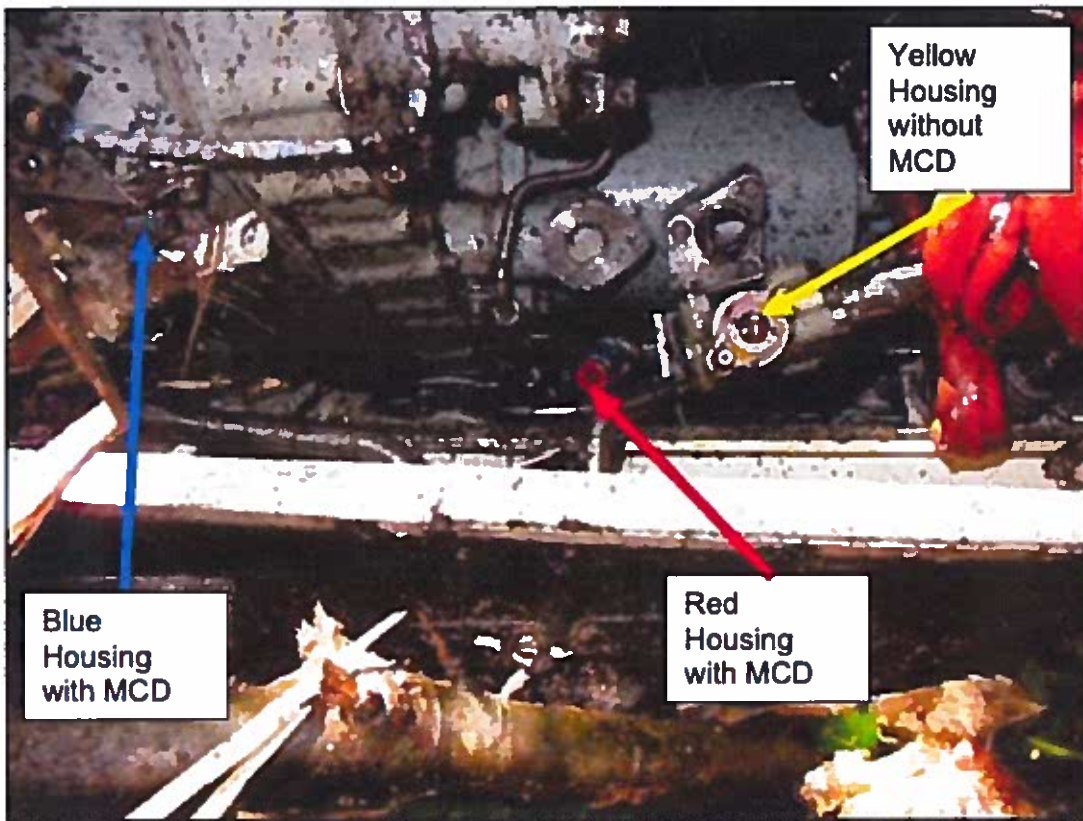
Figure 1.4.18 - MCD configuration on arrival of DAIB to crash site.

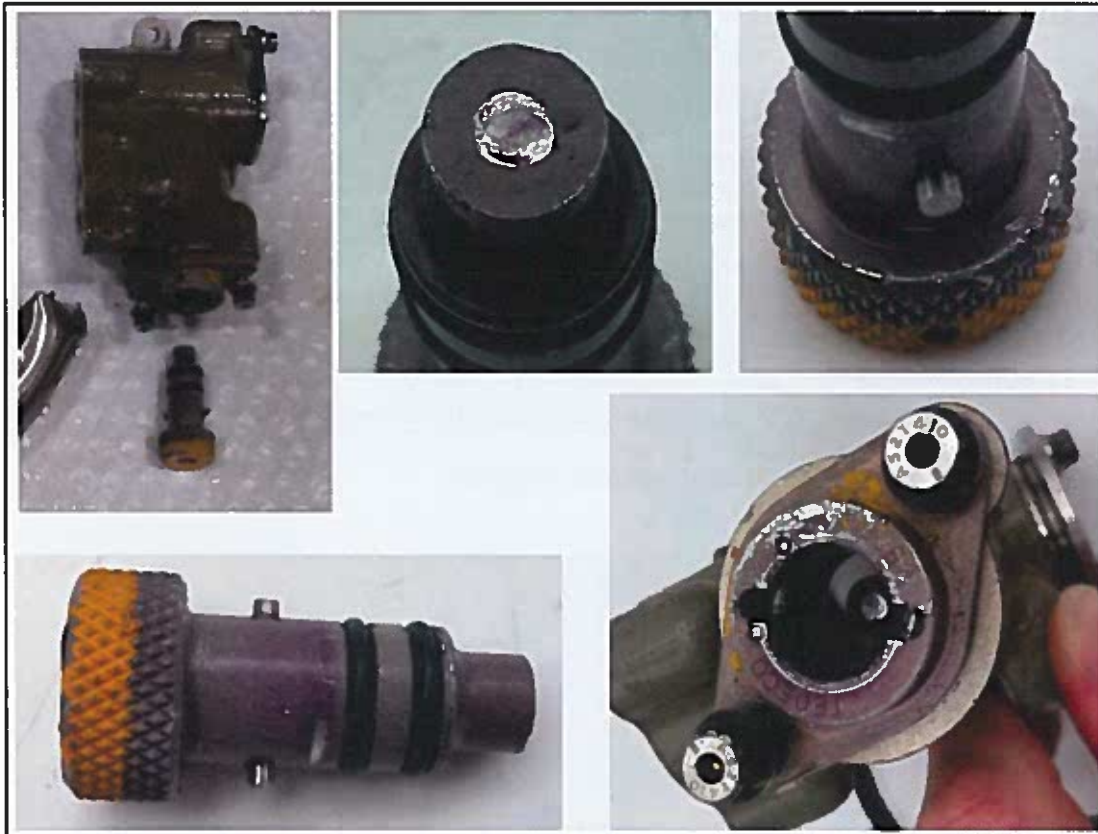
1.4.84. **MCD separation.** Components and surrounding structure (air starter motor, direct current generator, and engine bay access panels) exhibited impact damage consistent with being violently separated from the aircraft during the crash sequence. Detailed analysis of the Yellow MCD and housing did not identify any impact damage. Minor scuffing was evident on the MCD head and housing. However, R-R reported that, had the Yellow MCD been forcibly separated as a result of the crash sequence, significant deformation and damage would have been present on the MCD and its housing⁴² (Figure 1.4.19).

Figure 1.4.19 - Yellow MCD and MCD housing inspection.

1.4.85. Through analysis of the technical evidence presented, the Panel concluded that the Yellow MCD was not fitted in its housing prior to the impact with the ground.

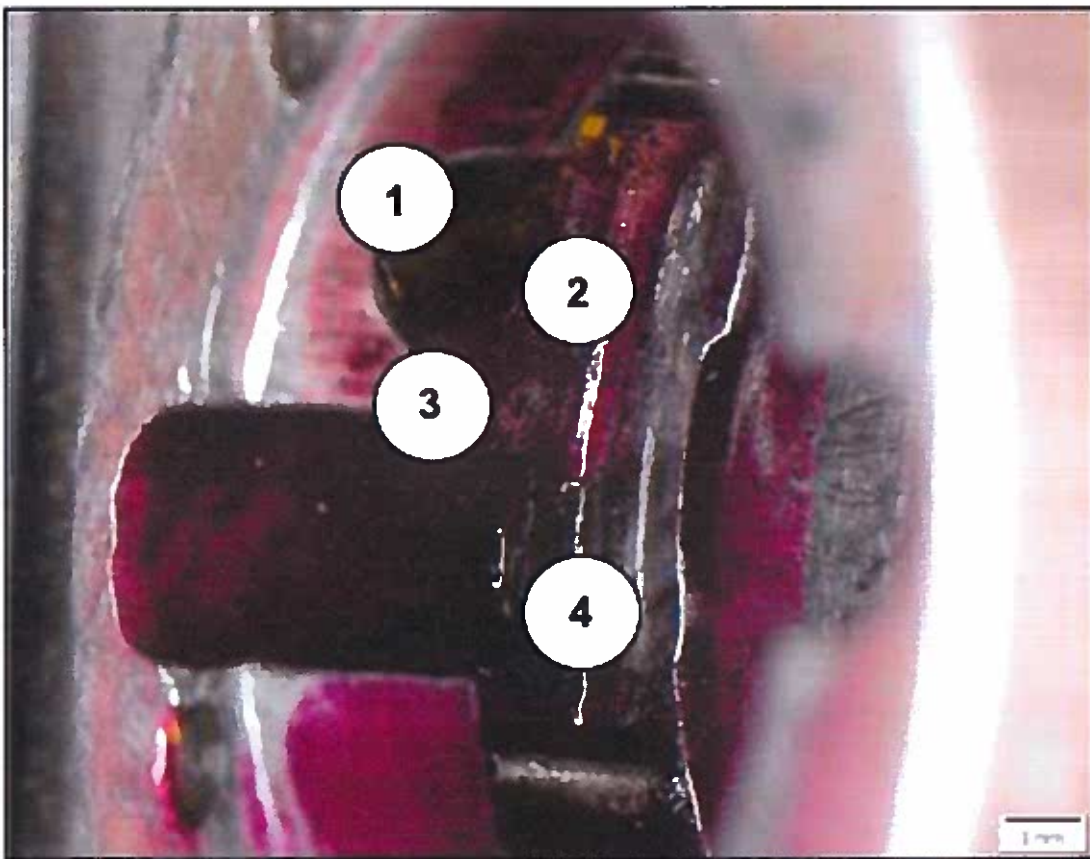
Figure 1.4.20 - MCD test positions as described in Table 1.4.2.

1.4.87. The Panel deduced that the removal of the Yellow MCD did not occur during the crash sequence. The Panel concluded that the separation of the Yellow MCD occurred prior to the impact most likely as a result of the MCD being in either position 3 or 4 post maintenance (Figure 1.4.20).

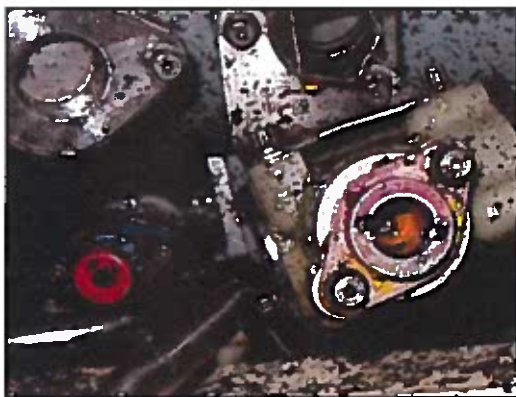
Figure 1.4.22 - Yellow MCD housing as found by DAIB investigators.

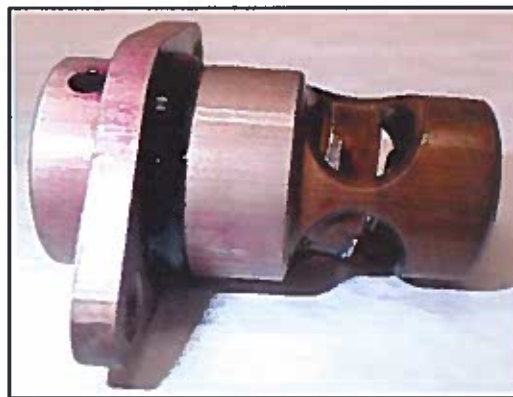
Figure 1.4.23 - Yellow MCD housing as removed for inspection.

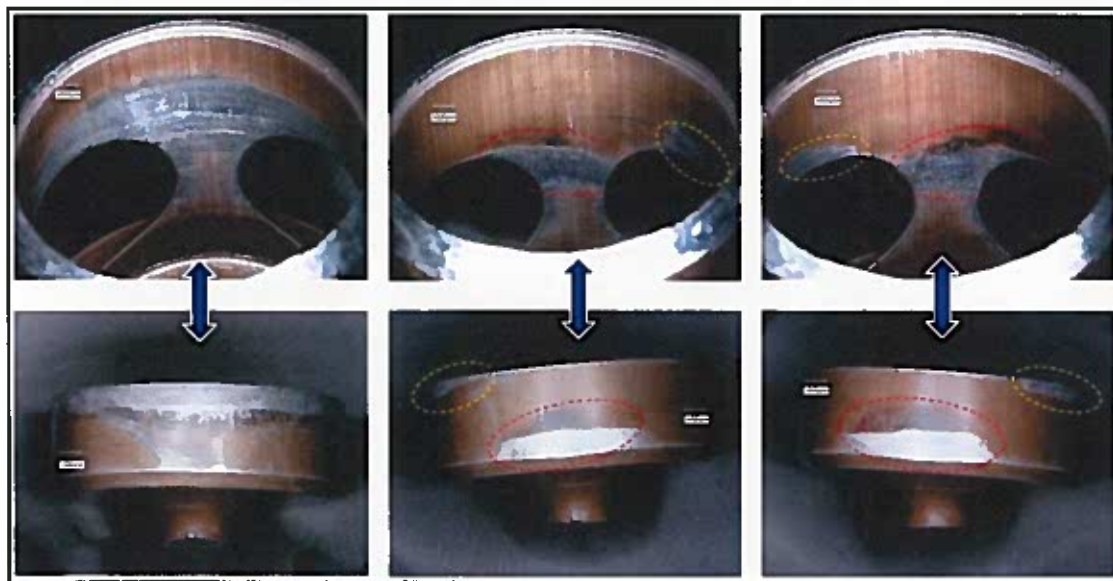
removed for routine sampling. The Panel determined that the MCD housing plunger became jammed leaving the valve in the partially open position. There was no evidence to support a foreign object holding the valve open. The Panel determined that the valve became jammed post MCD maintenance on XX189 on 24 Mar 2021, highly likely due to the wear noted in Figure 1.4.24, otherwise an oil leak would have been apparent during maintenance (when the MCD was out of its housing). When combined with the missing MCD this condition allowed oil to escape from the engine. The resultant lack of oil caused the HP Location Compressor Bearing to overheat and the engine to fail. The Panel concluded that the failure of the MCD self-sealing valve caused the loss of oil which led to the failure of the engine. The Panel finds that the failure within the self-sealing valve was a **Causal Factor**.

Figure 1.4.24 – Wear on inside of housing with corresponding wear on the plunger.

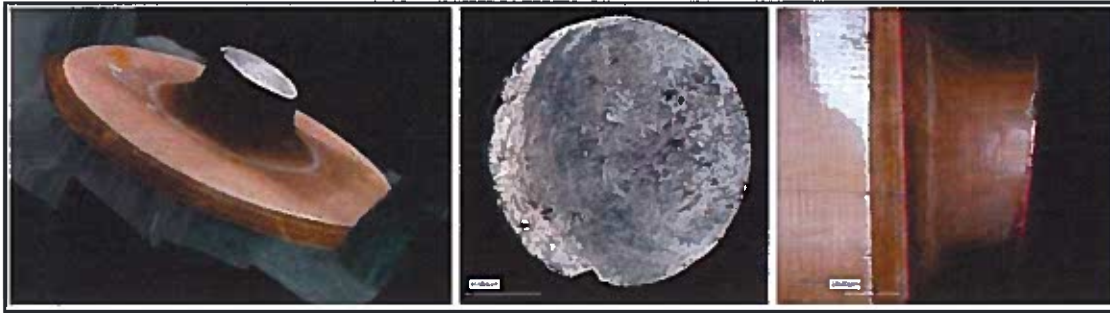
Figure 1.4.25 – Wear to the end face of the plunger from contact with the MCD.

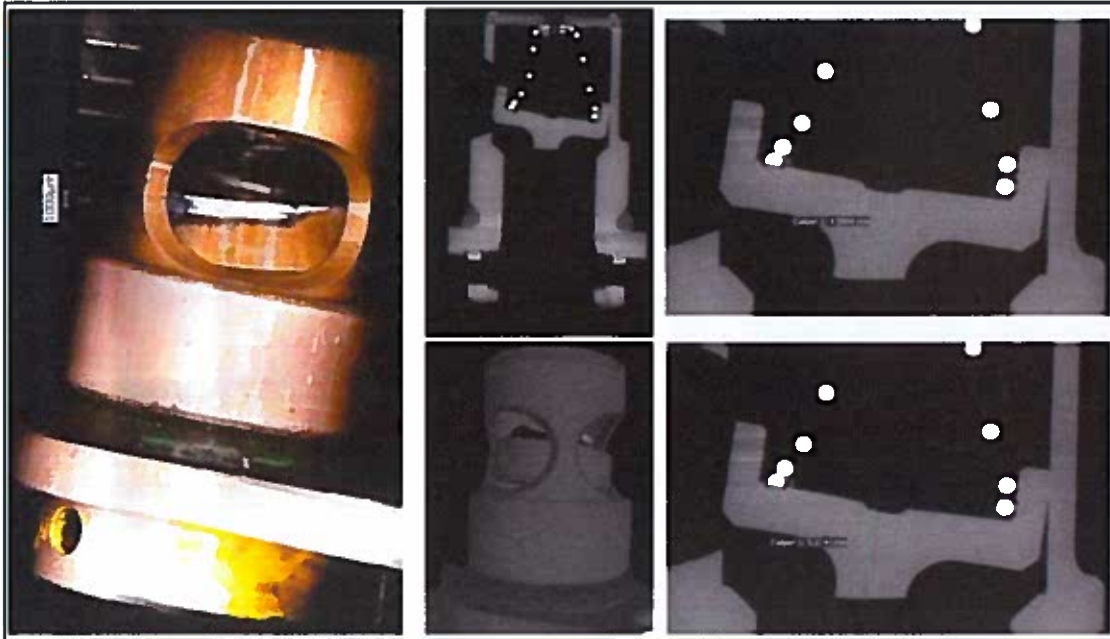
Figure 1.4.26 – Photograph and CT scan of Yellow MCD showing canted angle of the plunger.

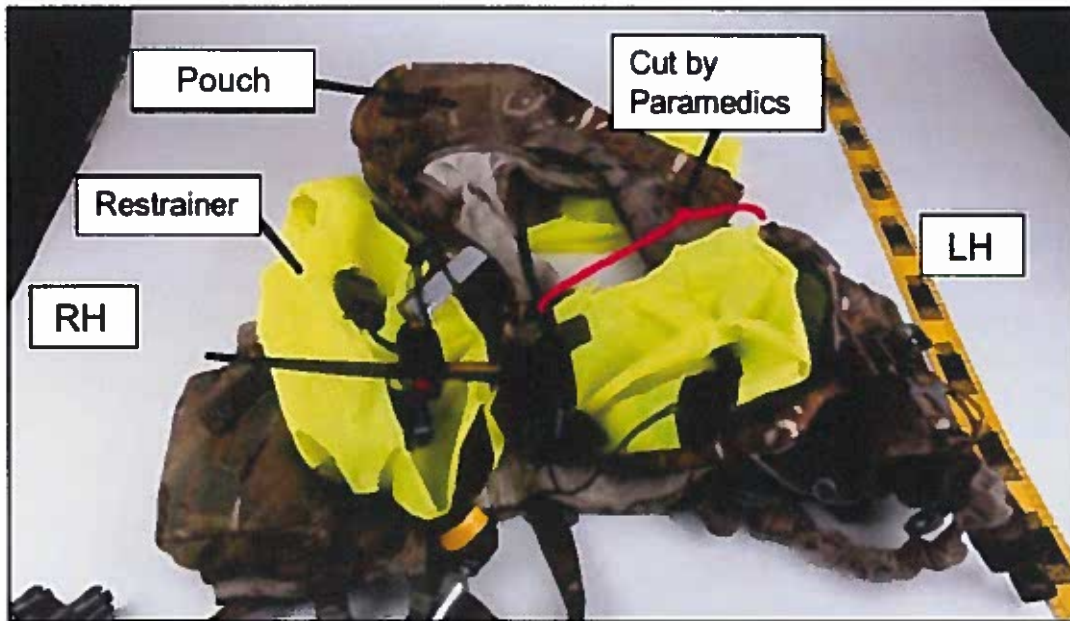
Figure 1.4.37 - Showing as-received (by 1710 NAS) waistcoat and restrainer (in-service failure).

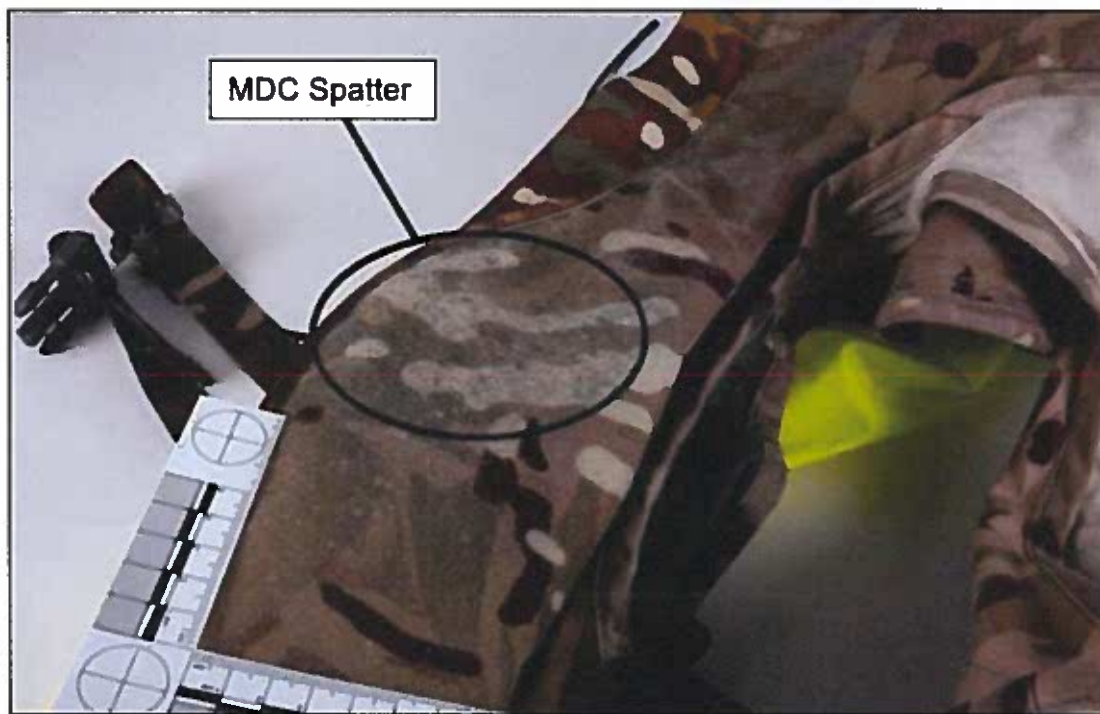
Figure 1.4.38 - Showing MDC spatter on the front face of the waistcoat pouch (in-service failure).

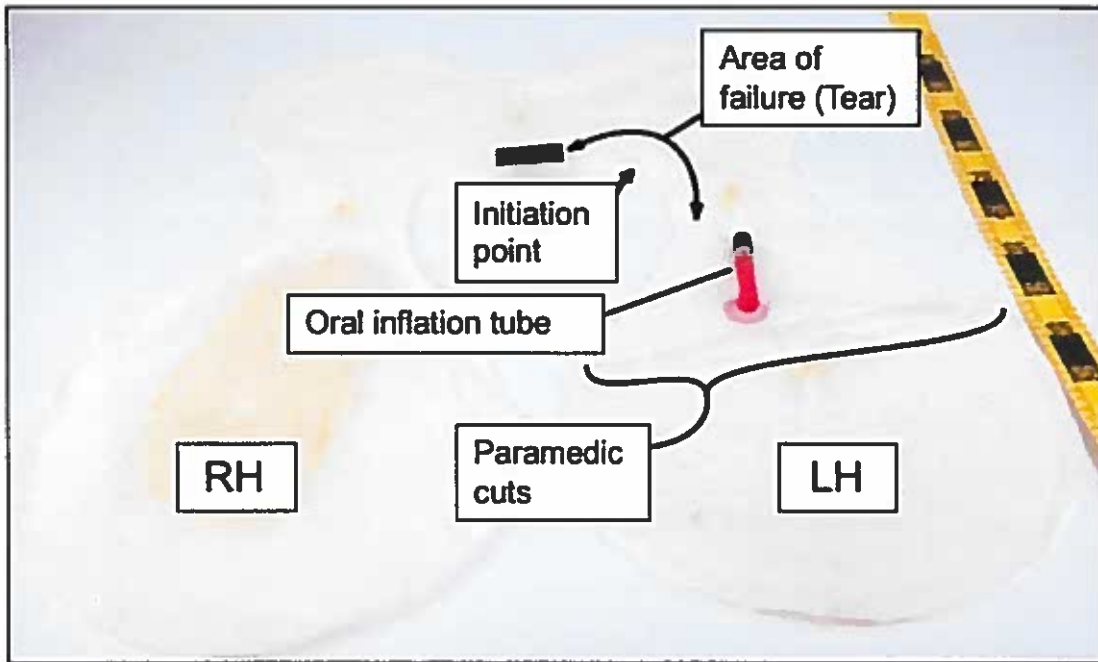
Figure 1.4.39 - Mk42M single stowage container (front view) highlighting findings from 1710 NAS.

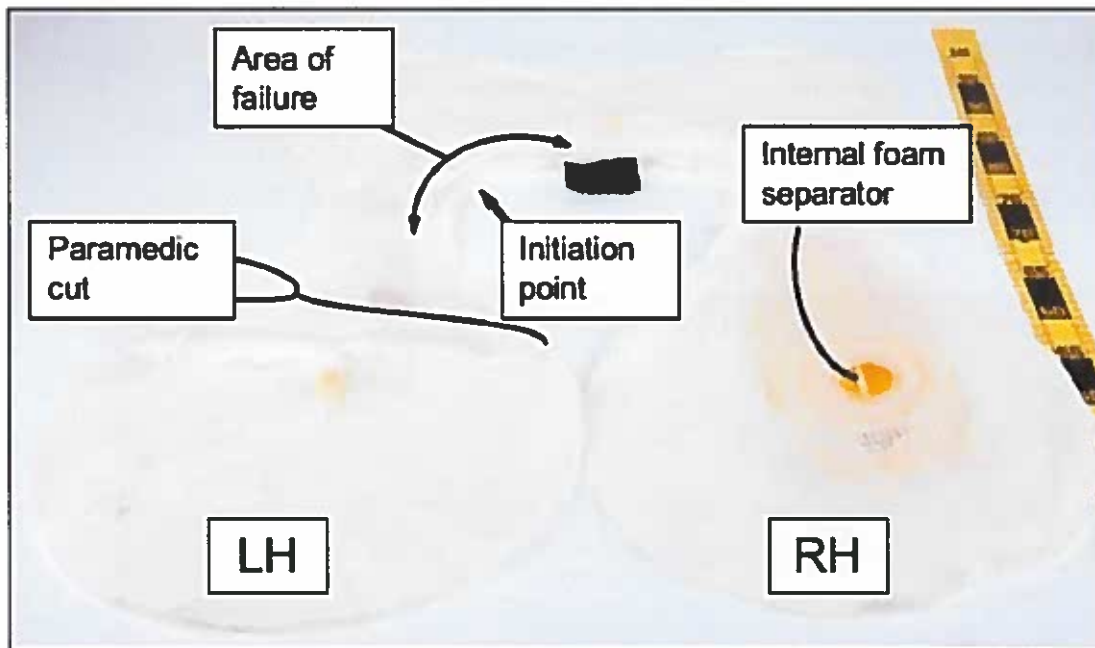
Figure 1.4.40 - Mk42M single stowage container (rear view) highlighting findings from 1710 NAS.

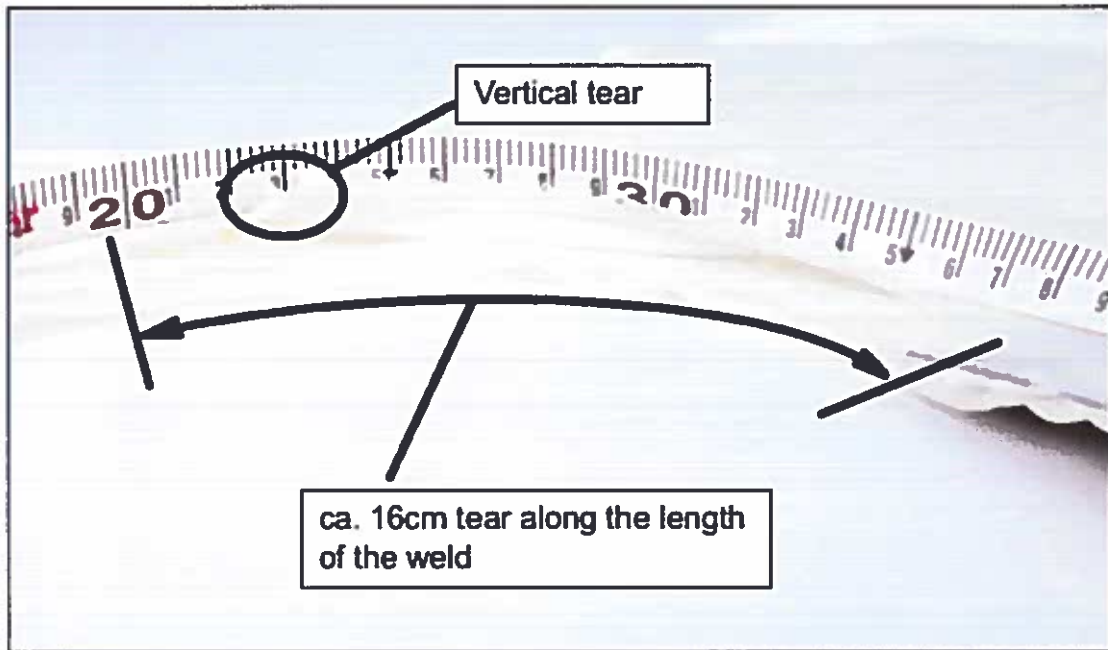
Figure 1.4.41 - Approximate length of the tear to the failed stole.

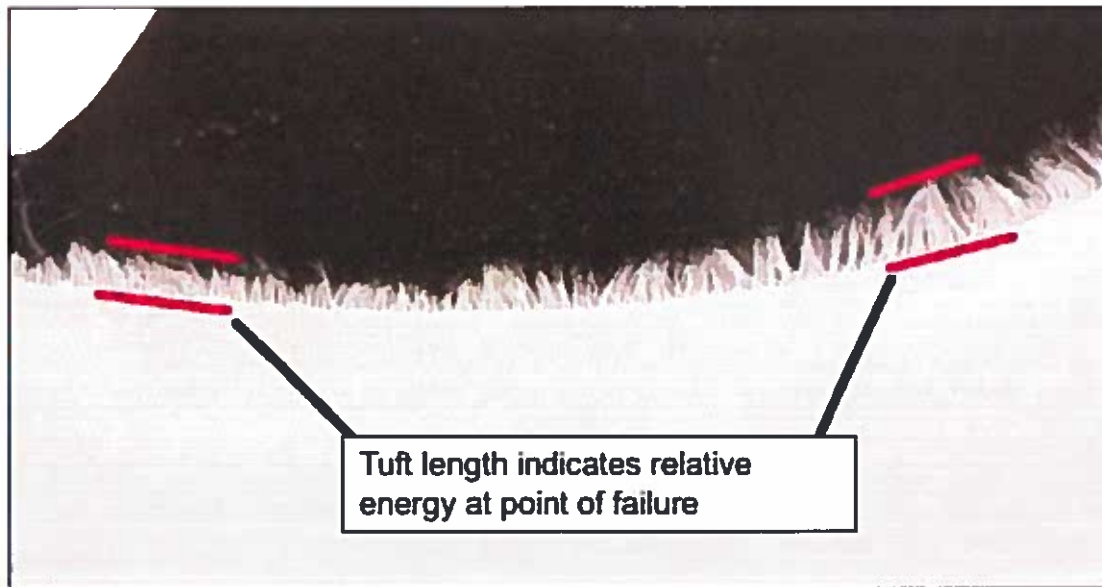
Figure 1.4.42 - Change in degree and depth of the fibre pull on the failed stole.

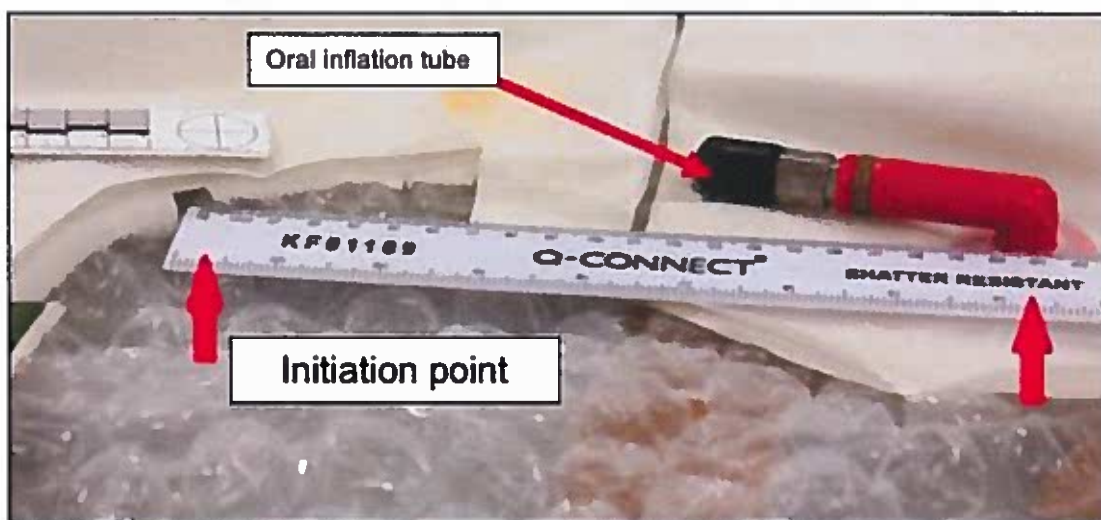
Figure 1.4.43 - Corresponding position measurements for the EPLB antenna on the in-service failed stole.

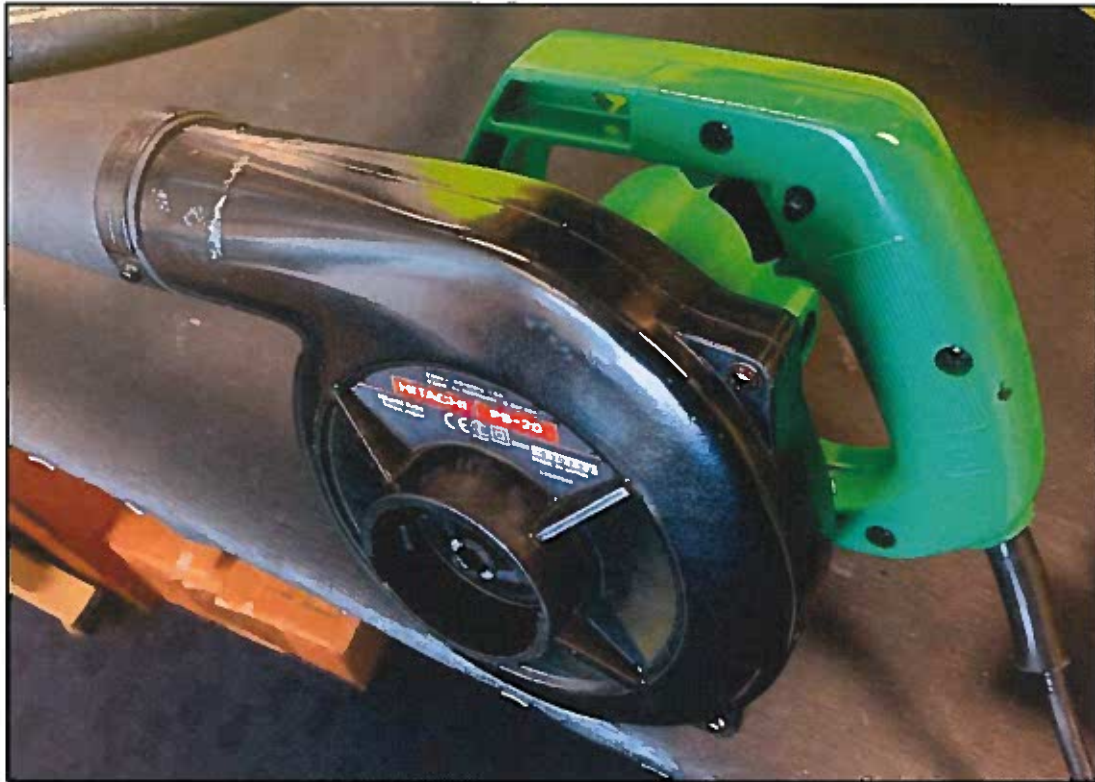
Figure 1.4.45 - Incorrect Inflator / Deflator used by 736 NAS for LSJ inflation tests.

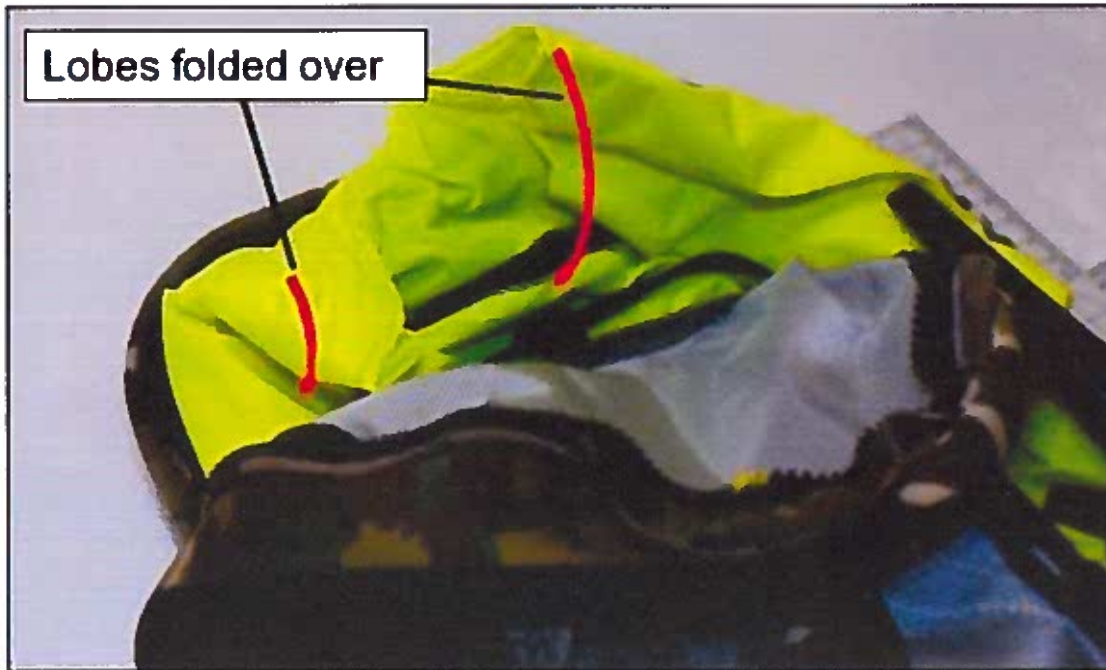
Figure 1.4.47 - Incorrect folding of the lobes on a quarantined 736 NAS LSJ.

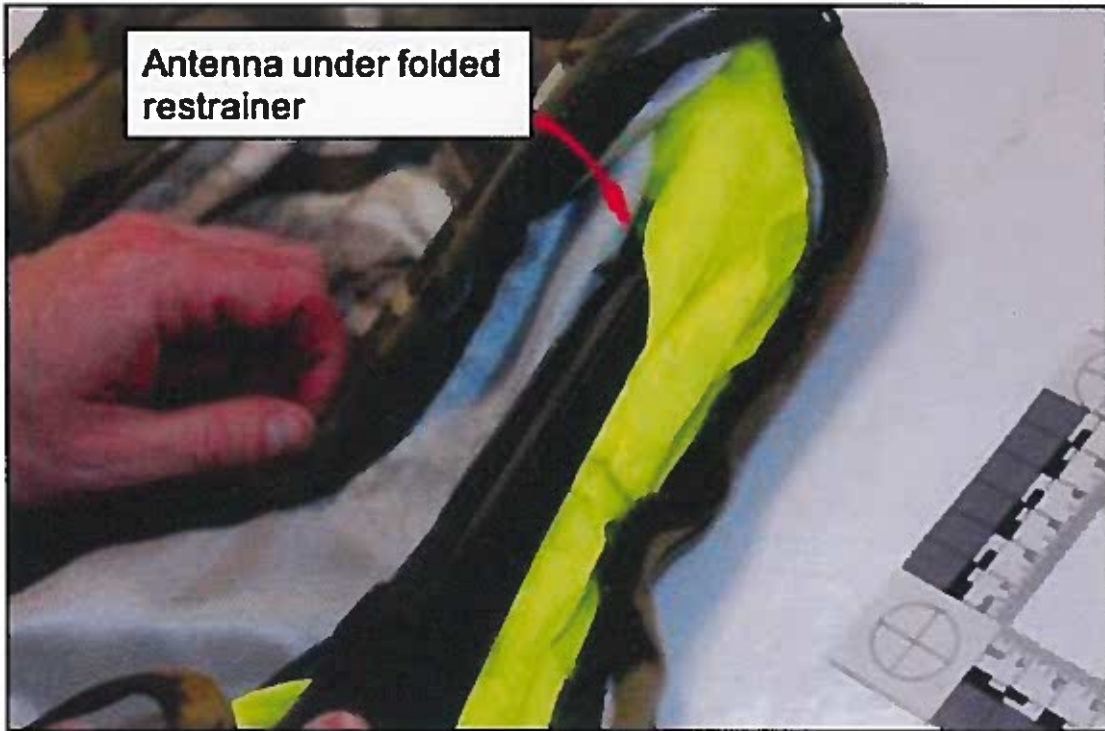
Figure 1.4.48 - Incorrect EPLB antenna positioning on a quarantined 736 NAS LSJ.

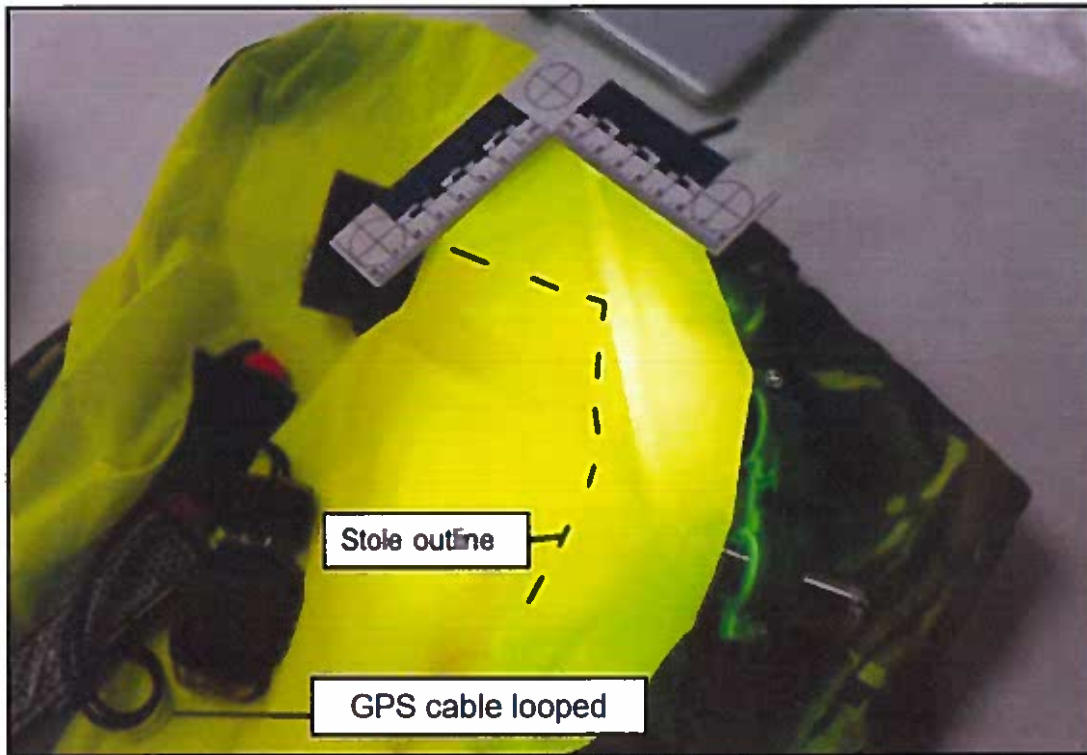
Figure 1.4.49 - Lack of stole extension within the restrainer on a quarantined 736 NAS LSJ.

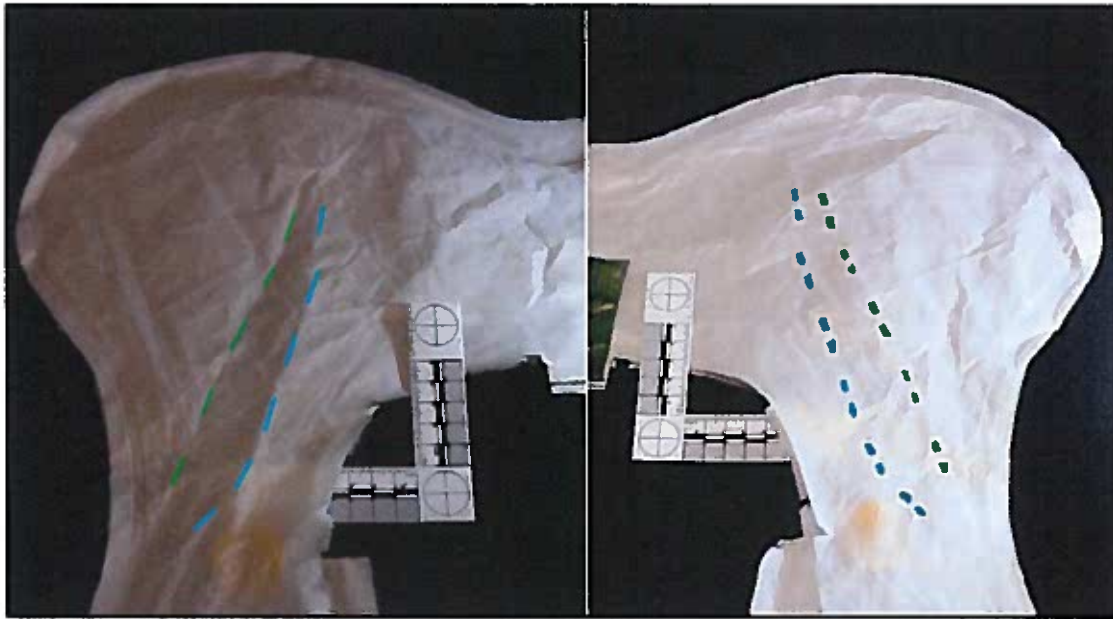
Figure 1.4.50 - Creases on the in-service failed stole; rear surface (left image) transposed to front surface (right image).

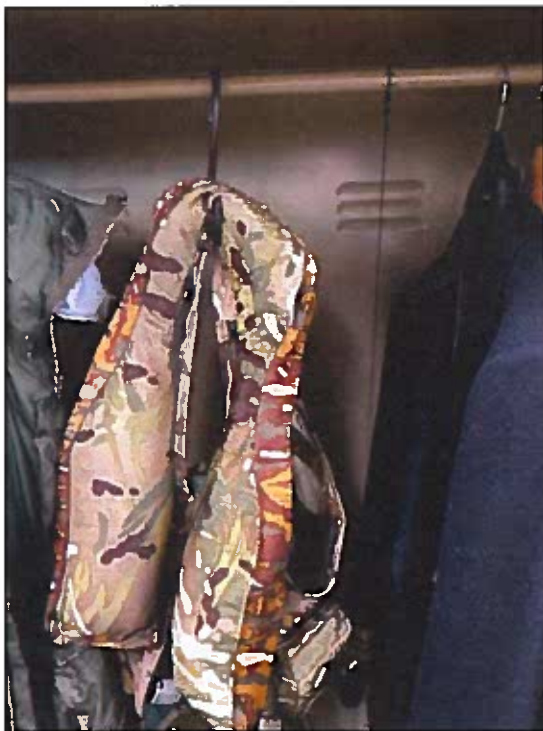
Figure 1.4.52 - LSJ stowed on a non-approved 's hook' as found on 736 NAS.

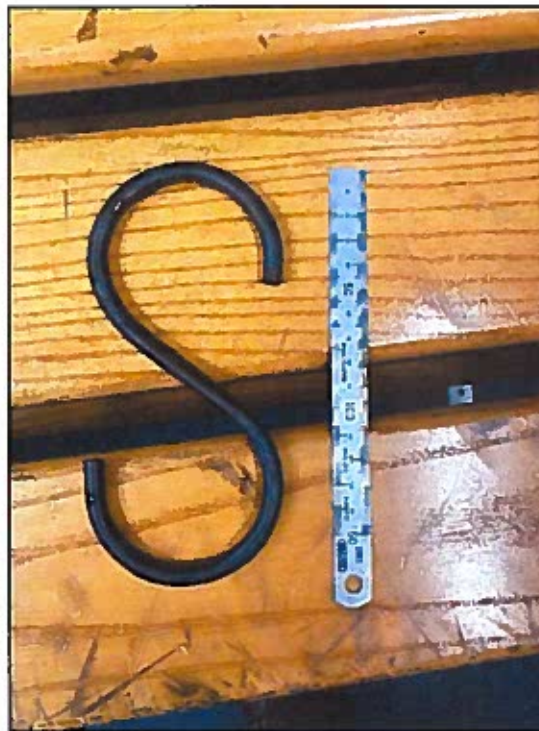
Figure 1.4.53 - Close up of 's-hook' as used for stowage of LSJs on 736 NAS.

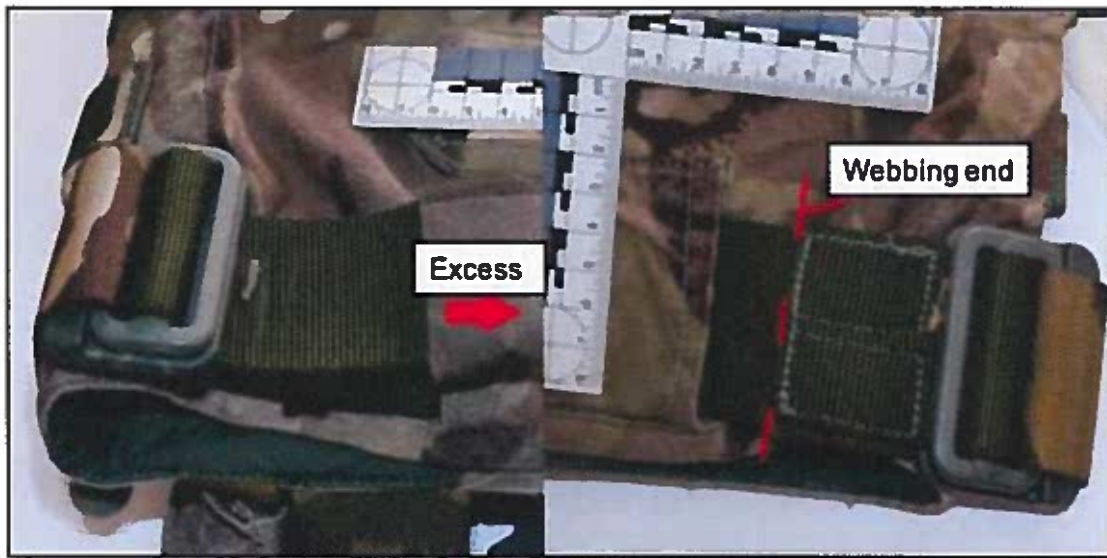
Figure 1.4.54 - Rear adjustment straps on the failed LSJ pulled asymmetrically.

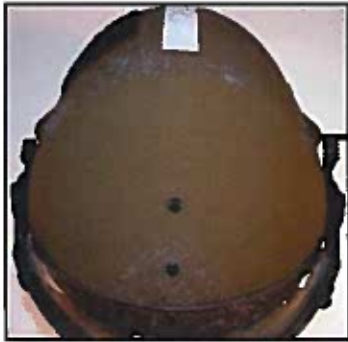
Figure 1.4.57 - MDC spatter.

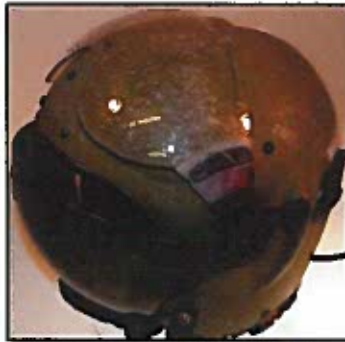
Figure 1.4.58 - MDC visor spatter.
