Rail Accident Investigation Branch

Rail Accident Report

Buffer stop collision at Kirkby, Merseyside 13 March 2021

Report 07/2022
August 2022

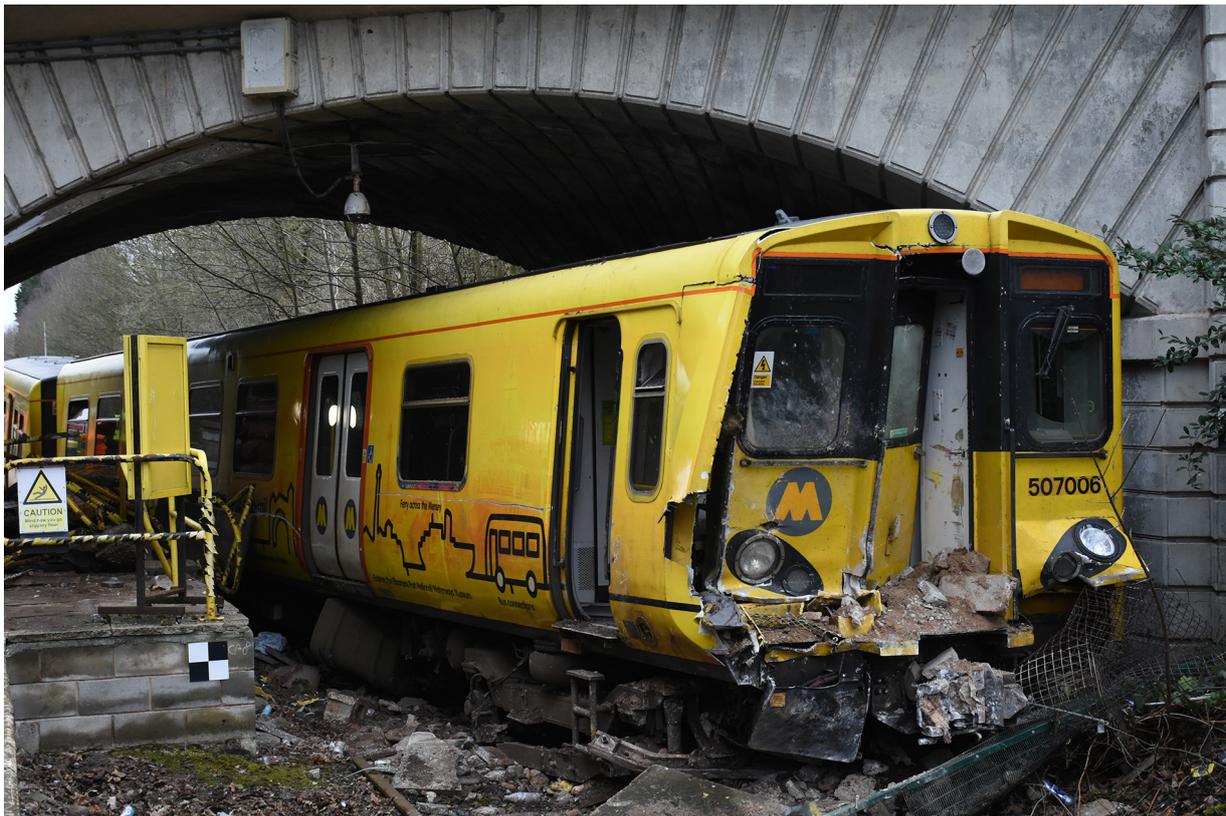
Figure 2: Photograph of the train in its final position after the collision

- 3 At around 18:53 hrs on Saturday 13 March 2021, a Merseyrail train hit the buffer stop at Kirkby station, Merseyside (figure 1). The train was travelling at 41 mph (66 km/h) as it entered the platform. Soon afterwards, the driver made an emergency brake application, but there was insufficient distance remaining to prevent the collision, and the train struck the buffer stop at around 29 mph (47 km/h). The train came to rest under a bridge, around 28 metres beyond the original buffer stop position (figure 2).

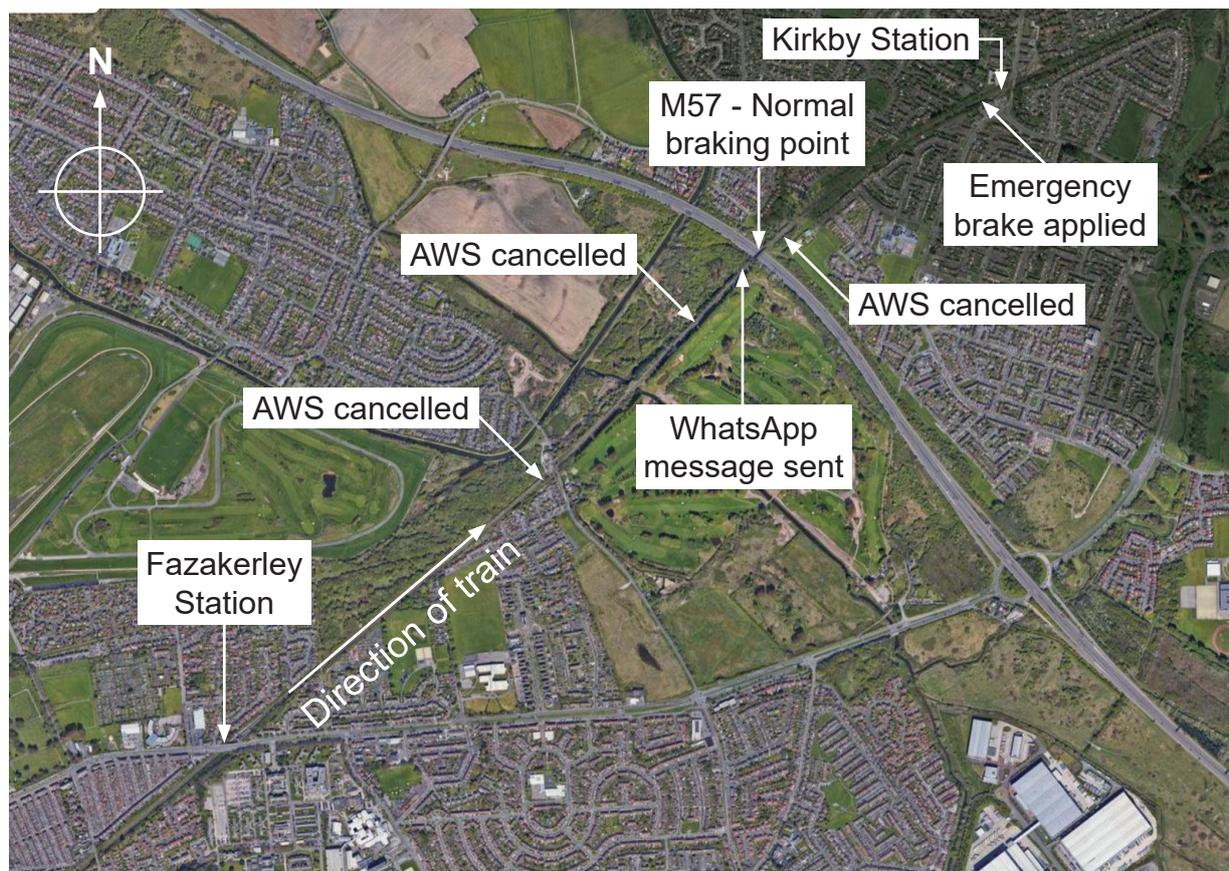
Figure 9: Google Earth image showing important points of the train's journey between Fazakerley and the collision with the buffer stop at Kirkby station

- 58 Merseyrail trains its drivers to begin applying the brakes on the approach to Kirkby station as the train passes over the M57 motorway (paragraph 40). Applying the lowest braking setting at this point typically results in a gradual reduction in a train's speed to around 10 mph (16 km/h) by the time the train reaches the 15 mph (24 km/h) permanent speed restriction sign located at the start of the platform.
- 59 The driver did not apply the brakes as he passed this normal braking point and made no further braking applications until the final emergency brake application which was made within the platform area of the station and on approach to the buffer stop (paragraph 44, figure 9).

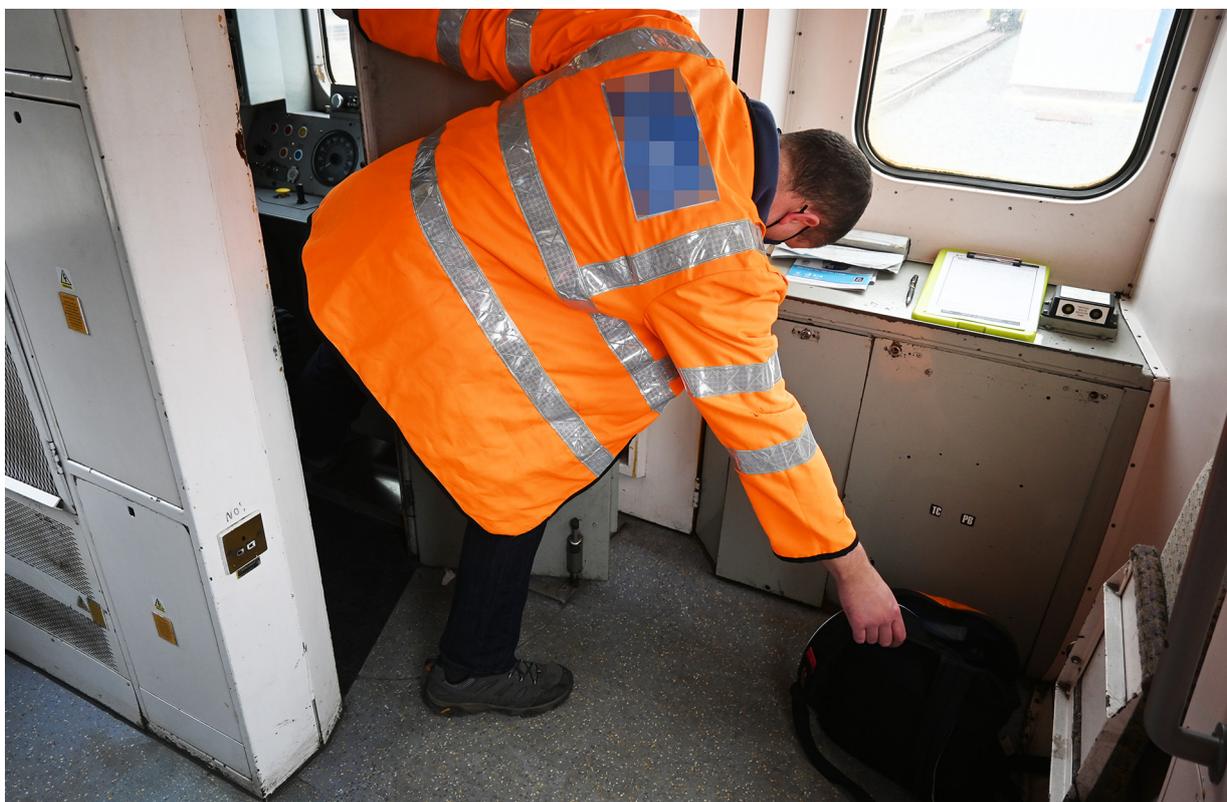
Figure 10: Photograph of a reconstruction showing how the driver could have reached his bag while maintaining pressure on the DSD pedal with his left foot

71 BTP and RAIB undertook a reconstruction of this scenario following the accident with somebody of similar height and build to the driver. This showed that, while reaching for the bag, the driver would lose almost all visibility of the track ahead, as the internal driving cab door shrouded most of the view through the gangway door. It also showed that the driver could reach his bag, even if it fell on the floor close to the tripcock cabinet, while maintaining pressure on the DSD pedal with his left foot (figure 10).

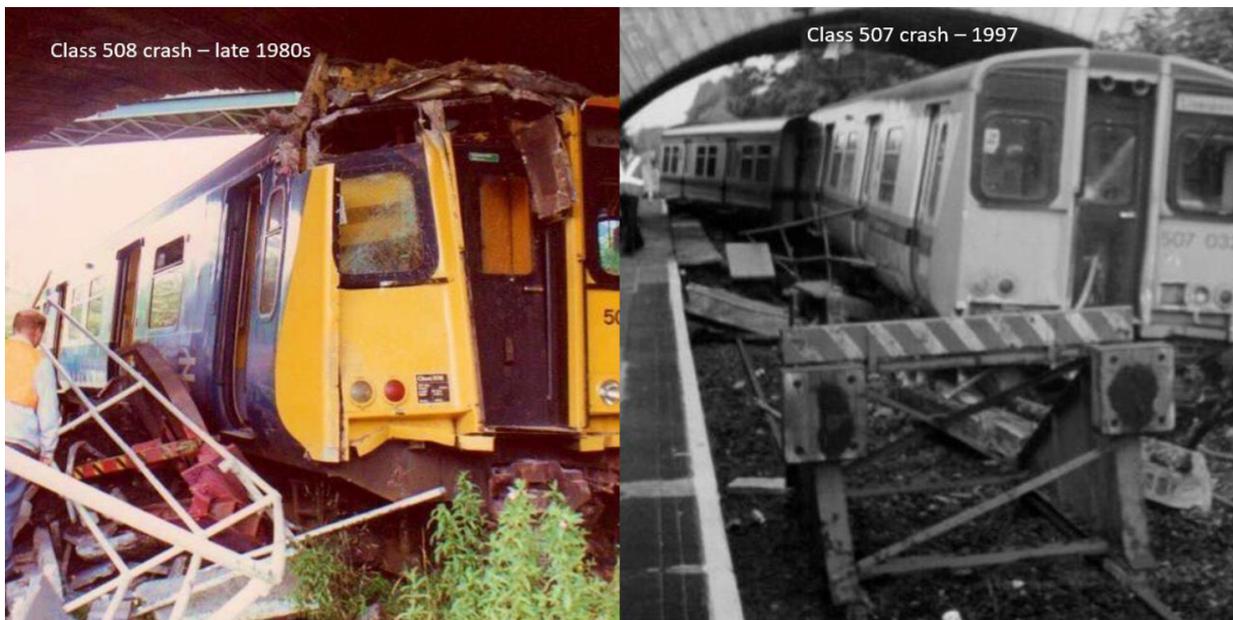
Figure 11: Photographs of buffer stop collisions at Kirkby in a) 1987 and b) 1997 (courtesy of Network Rail)

89 In the 35 years before this accident, there had been at least three previous buffer stop collisions at Kirkby station with photographs and news articles showing collisions in 1987, 1991 and 1997 (figure 11), before the installation of TPWS. The photographs of the aftermath of these collisions suggest that the speed of impact in each accident was likely to have been similar to the speed of impact of the 2021 accident. Witness evidence from some long-serving Merseyrail staff suggests that low adhesion was a causal factor in the 1997 accident.

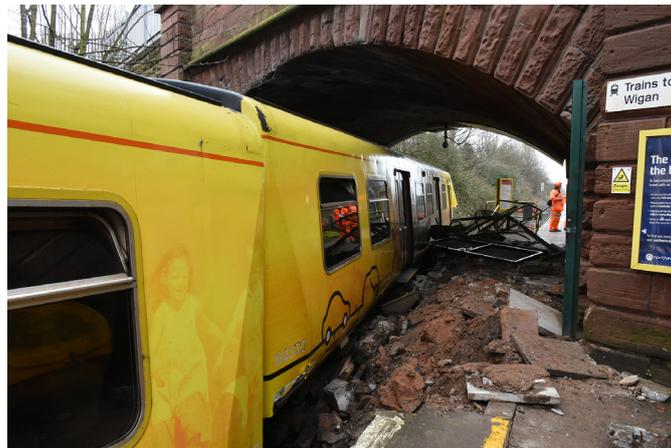
Figure 12: Photograph of the platform extension walkway the day after the accident

- 99 Due to the impact speed and design of the buffer stop, the train demolished the buffer stop and much of the platform extension walkway (figure 12). This walkway was open to pedestrians at the time of the accident. However, most of the footfall over this walkway occurs immediately before and after the arrival of a Northern service into platform 2. As no such service was present at the time of the accident, nobody was on the platform extension walkway when the collision occurred. If passengers had been present on the walkway it is likely that the consequences of the accident could have been much more serious.

⁹ Global System for Mobile Communications – Railway.
