AAIB Bulletin

9/2022

SERIOUS INCIDENT

Aircraft Type and Registration:	Airbus A350-1041, G-XWBC	
No & Type of Engines:	2 Rolls-Royce Trent XWB-97 turbofan engines	
Year of Manufacture:	2019 (Serial no: 362)	
Date & Time (UTC):	2 January 2022 at 1430 hrs	
Location:	London Heathrow Airport	
Type of Flight:	Commercial Air Transport (Passenger)	
Persons on Board:	Crew - 12	Passengers - 326
Injuries:	Crew - None	Passengers - None
Nature of Damage:	Damage to aircraft skin, toilet waste panel and tailstrike sensor	
Commander's Licence:	Airline Transport Pilot's Licence	
Commander's Age:	49 years	
Commander's Flying Experience:	17,305 hours (of which 652 were on type) Last 90 days - 141 hours Last 28 days - 48 hours	
Information Source:	AAIB Field Investigation

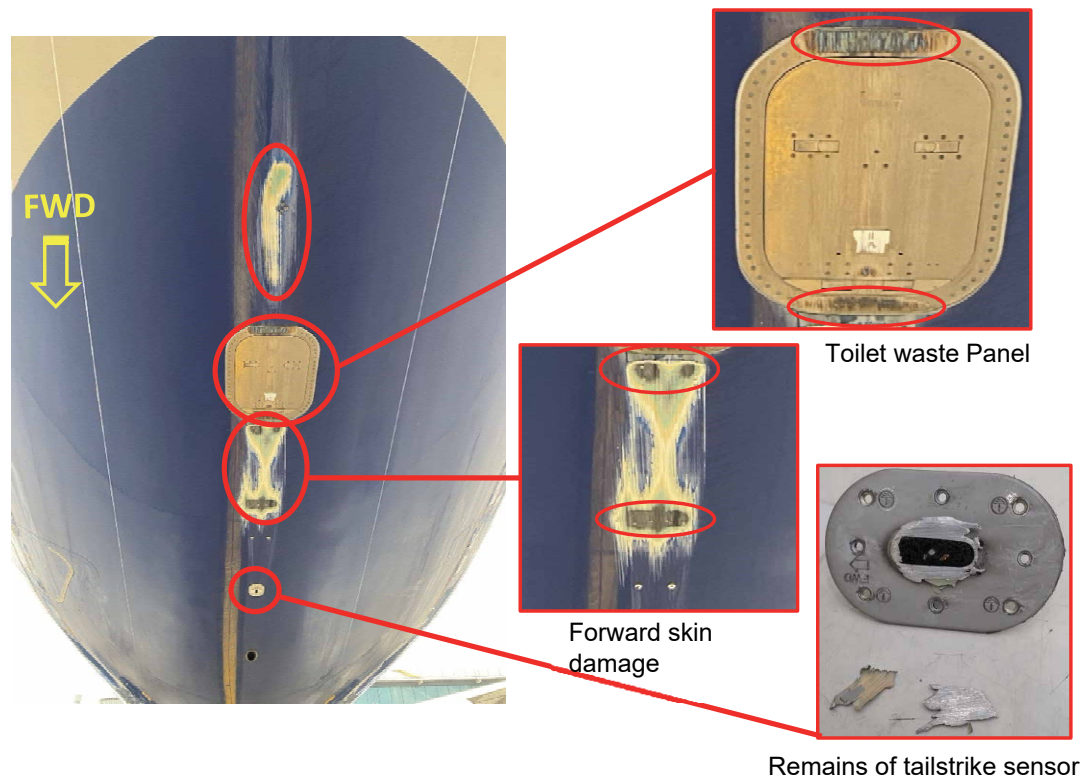
Figure 2

An initial damage assessment found two areas of skin damage on the aircraft tail lower fuselage, one each end of the toilet waste panel aft of the tailstrike sensor. While the rearmost skin damage area was assessed as surface finish damage, the forward area appeared to have penetrated through the paint, copper mesh lightning protection layer and up to five carbon fibre reinforced plastic layers.

Rear lower fuselage damage to skin, toilet waste panel and tailstrike sensor

The leading and trailing edges and rivets on the toilet waste panel were also abraded by the runway surface, although the damage to the panel was believed to be repairable during the initial damage assessment.

As designed, the tailstrike sensor had fractured on impact (Figure 2).

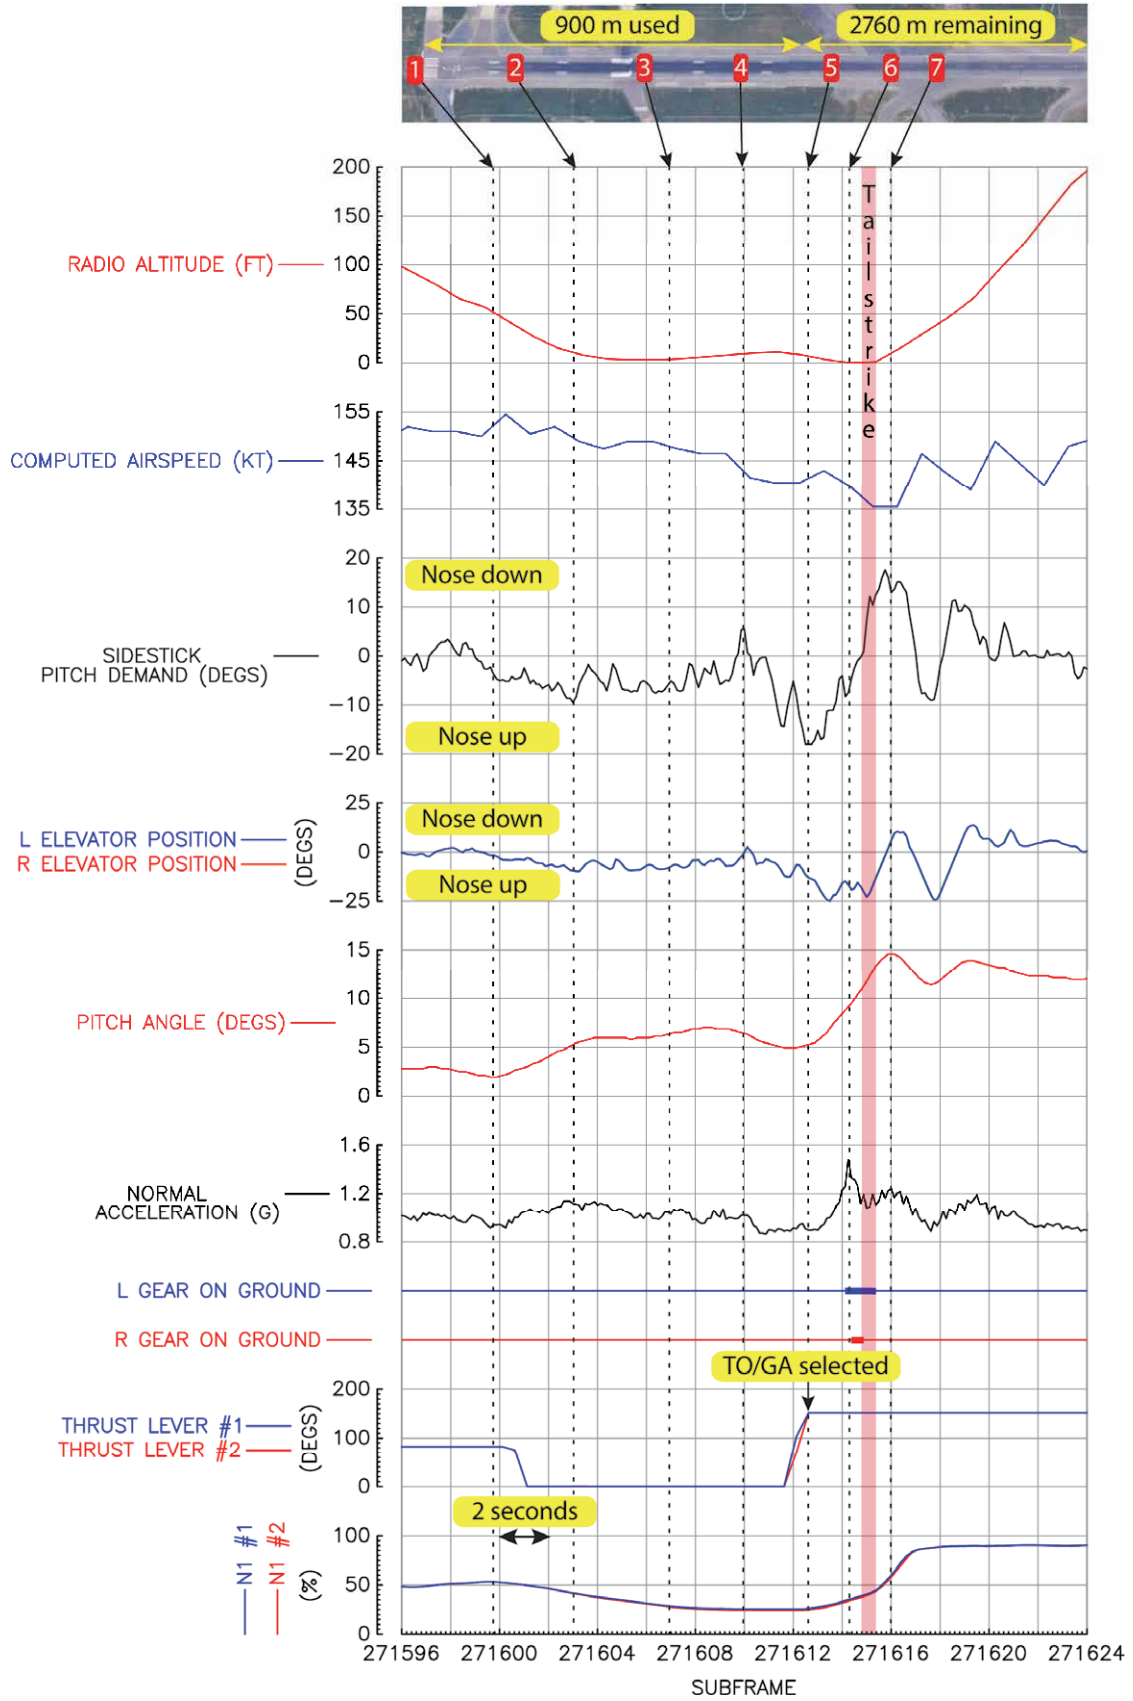
Figure 3

G-XWBC's descent from 100 ft radio altitude and the initial part of the go-around

Over the next three seconds, as G-XWBC descended through 10 ft, progressively more nose-up sidestick was applied, reaching 3/5 of maximum sidestick deflection at point 2. In response, G-XWBC's pitch attitude increased and then stabilised at around 6° nose-up, and the aircraft 'floated' 5 ft above the runway but did not touchdown.

Four seconds later, at point 3, G-XWBC began to climb and the pitch attitude increased slightly. At point 4, a sharp nose-down sidestick input (of approximately 1/3 of maximum deflection) was made. The sharpness of this input is seen in the distinct reduction of normal acceleration at point 4.

G-XWBC then descended, the pitch attitude reduced towards 5° nose up, and an increasing amount of nose-up sidestick was applied which reached full travel. In response, the elevators reached 4/5 of their full nose-up travel. At point 5, having used 900 m of runway and with the aircraft at the end of the TDZ, a go-around was initiated and the thrust levers were moved to the TOGA detent. At this point, 2,760 m of runway remained ahead of the aircraft.

The nose-up sidestick command was then reduced, although it was still maintained in the nose up sense, and the pitch attitude, which had risen rapidly because of the large elevator deflections, approached 10° nose up. At the same time, G-XWBC's airspeed had substantially decreased and, before the engines had time to significantly spool up, the aircraft briefly touched down at point 6.

Between points 6 and 7, as G-XWBC became airborne again, the airspeed reached a minimum of 135 kt and the tailstrike occurred. Although nose-down sidestick inputs were made, G-XWBC's pitch attitude continued to increase before the elevators moved to reduce the pitch attitude. A maximum pitch attitude of 16° nose-up was recorded at point 7.

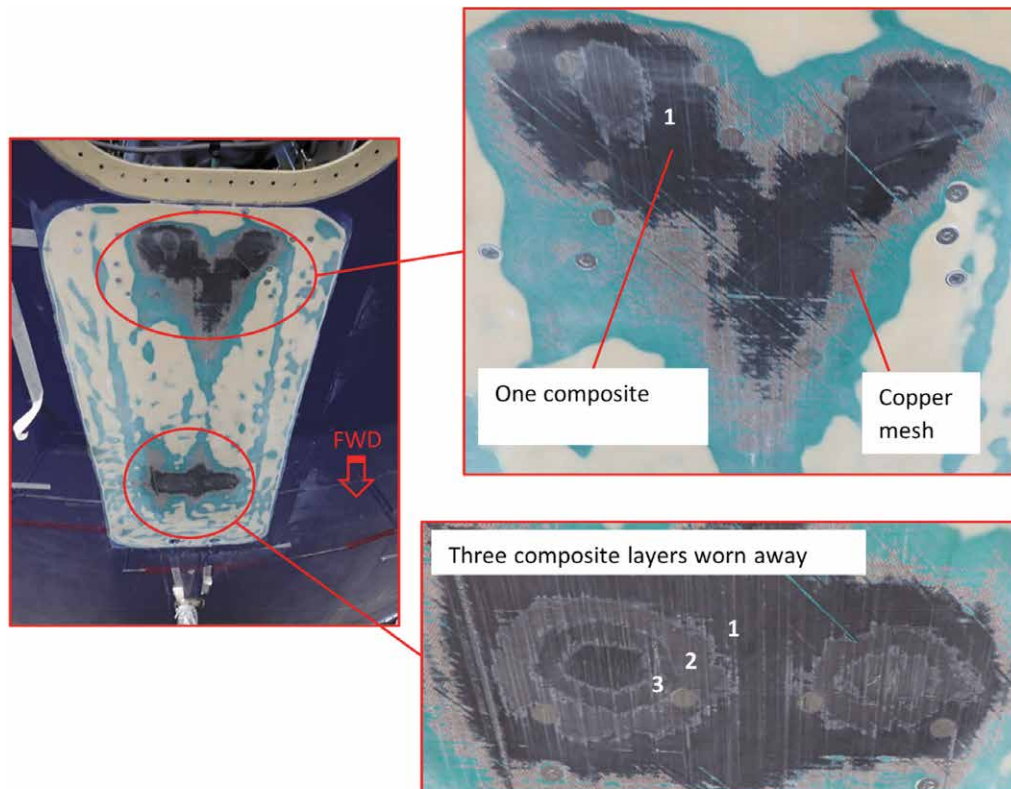
Figure 5

Inspection of the external skin area forward of the toilet waste panel found the painted surface, copper mesh layer and up to three composite layers had been worn away in small patches (Figure 5). The damage was within the capability of the operator's aircraft structures maintenance team to repair. The toilet waste panel was damaged beyond repair because the

Damaged skin composite layers

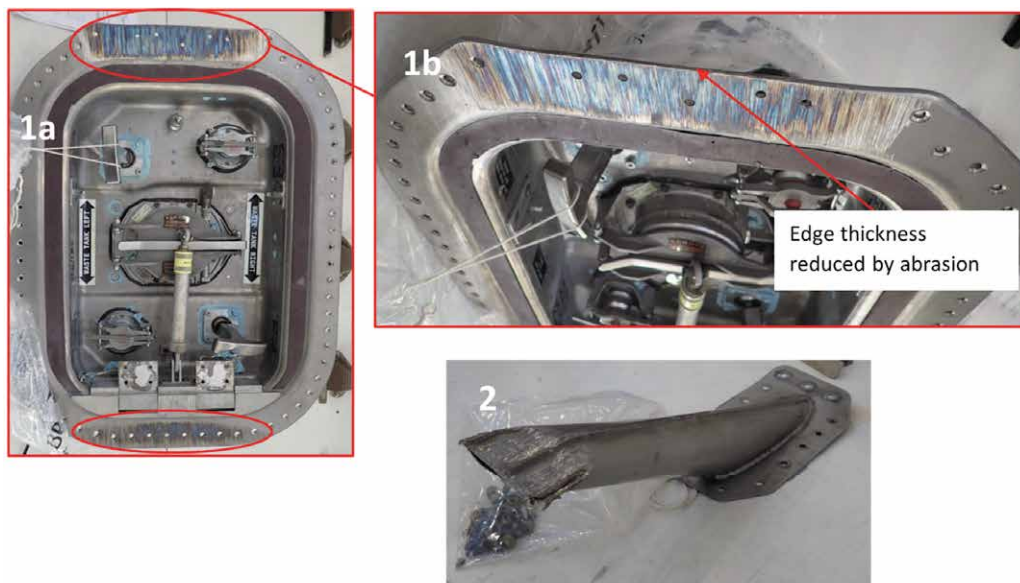
Figure 6

abraded leading and trailing edges had thinned the material and compromised the strength of the panel. Three vent pipes positioned along the rear of the fuselage had also been bent and abraded as the aircraft tail struck the ground and had to be replaced (Figure 6).

Toilet waste panel (1a) damaged beyond repair (1b) and damaged vent pipe (2)

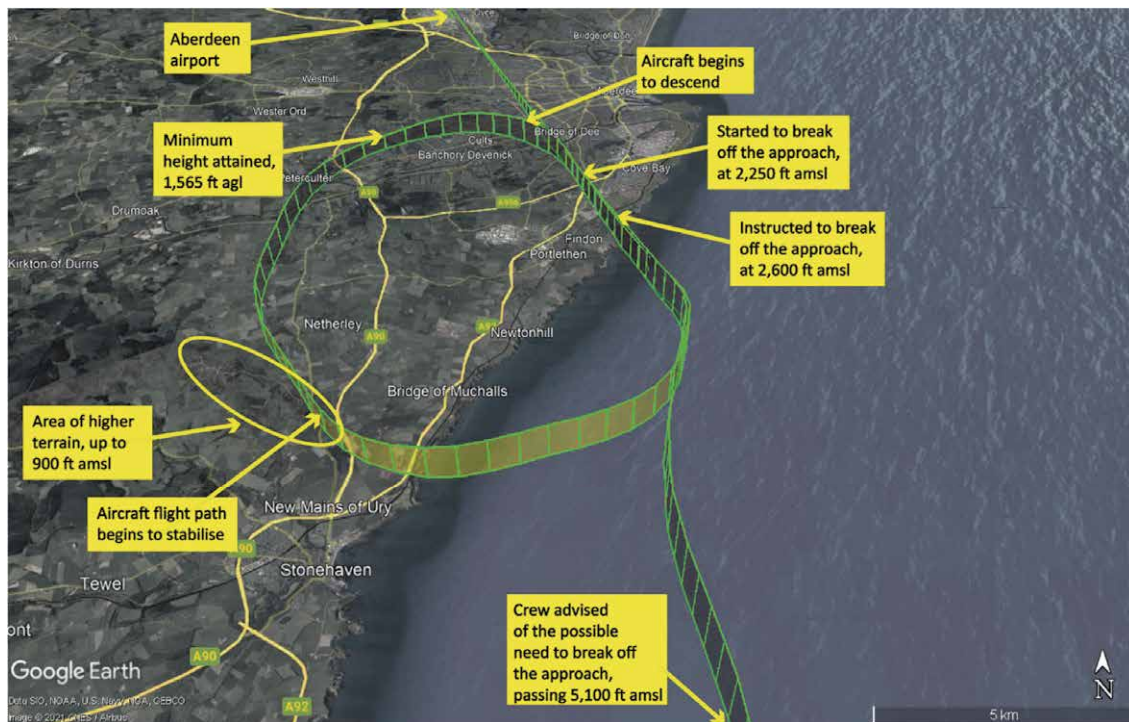
Figure 1

G-FDZF's flightpath into Aberdeen and the unintended descent

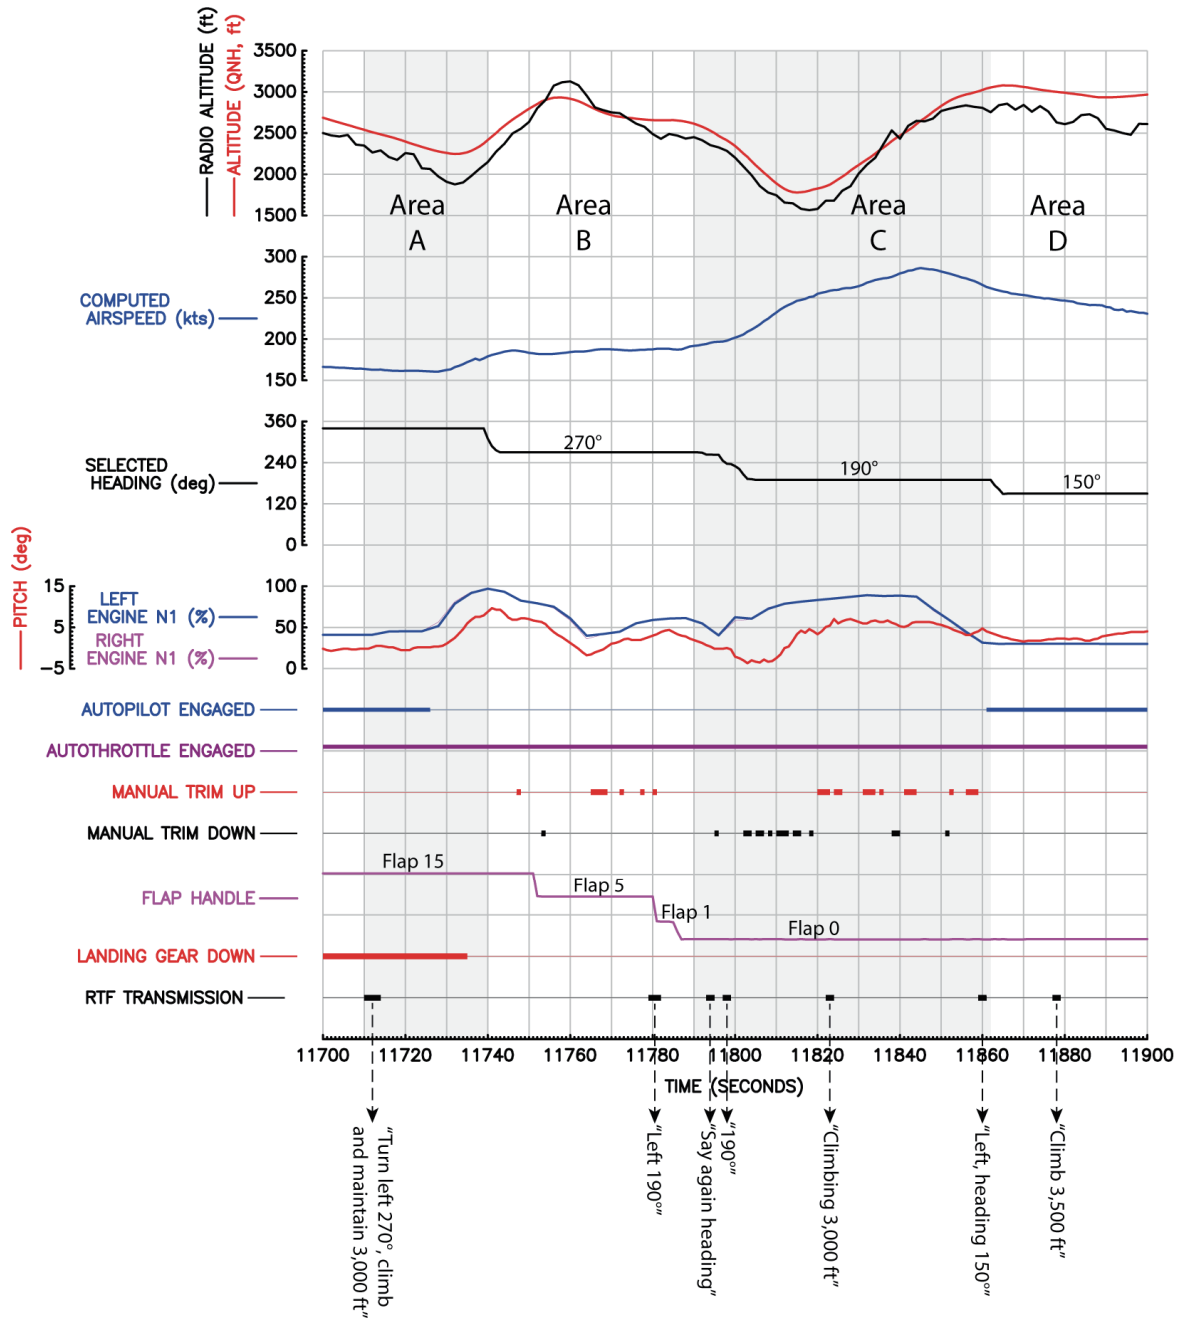
Figure 2

Area A shows the flightpath from when the crew responded to the ATC instruction to break off the approach and shows the disconnection of the autopilot, whilst the autothrottle remained engaged. It shows that the thrust increased automatically towards 97% N_1 , the landing gear was retracted, and the aircraft's pitch attitude increased. The aircraft climbed and turned left towards a heading of 270°. The data shows a strong correlation between the engine power setting and changes in the pitch of the aircraft, noting that the flap setting did not change, and that no manual pitch trim inputs are recorded in Area A.

Area B shows that as the aircraft, which was being manually flown, approached the selected altitude of 3,000 ft, the autothrottle reduced the engine power setting and the pitch of the aircraft decreased as the flight director began to command the level-off. As the aircraft passed 2,850 ft amsl, the flaps were retracted from flap 15 to flap 5, and after reaching 2,930 ft amsl the aircraft began to descend. G-FDZF then briefly levelled at 2,650 ft amsl and the flaps were further retracted from Flap 5 to Flap 1. Four seconds later, the flaps were fully retracted and G-FDZF again started to descend.

Flight data for the approach and subsequent unintended descent
