**ACCIDENT**

<b>Aircraft Type and Registration:</b>	1) Cessna 182B, G-OMAG 2) Boeing Stearman A75N1(PT17), N68427
<b>No &amp; Type of Engines:</b>	1) 1 Continental Motors Corp O-470-R piston engine 2) 1 Continental Motors Corp W670 piston engine
<b>Year of Manufacture:</b>	1) 1959 (Serial no: 52214) 2) 1942 (Serial no: unknown)
<b>Date &amp; Time (UTC):</b>	20 August 2021 at 1332 hrs
<b>Location:</b>	Dunkeswell Aerodrome, Devon
<b>Type of Flight:</b>	1) Private 2) Private
<b>Persons on Board:</b>	1) Crew - 1                      Passengers - None 2) Crew - 1                      Passengers - None
<b>Injuries:</b>	1) Crew - 1 (Serious)      Passengers - N/A 2) Crew - None              Passengers - N/A
<b>Nature of Damage:</b>	1) Damage to wings and control surfaces, windscreen, window, cabin structure and engine cowling. Fin and rudder tops chopped off, and damage to elevators.  2) Damage to propeller and shock load to engine. Cuts in fabric of fuselage and damage to right wing root.

**Synopsis**

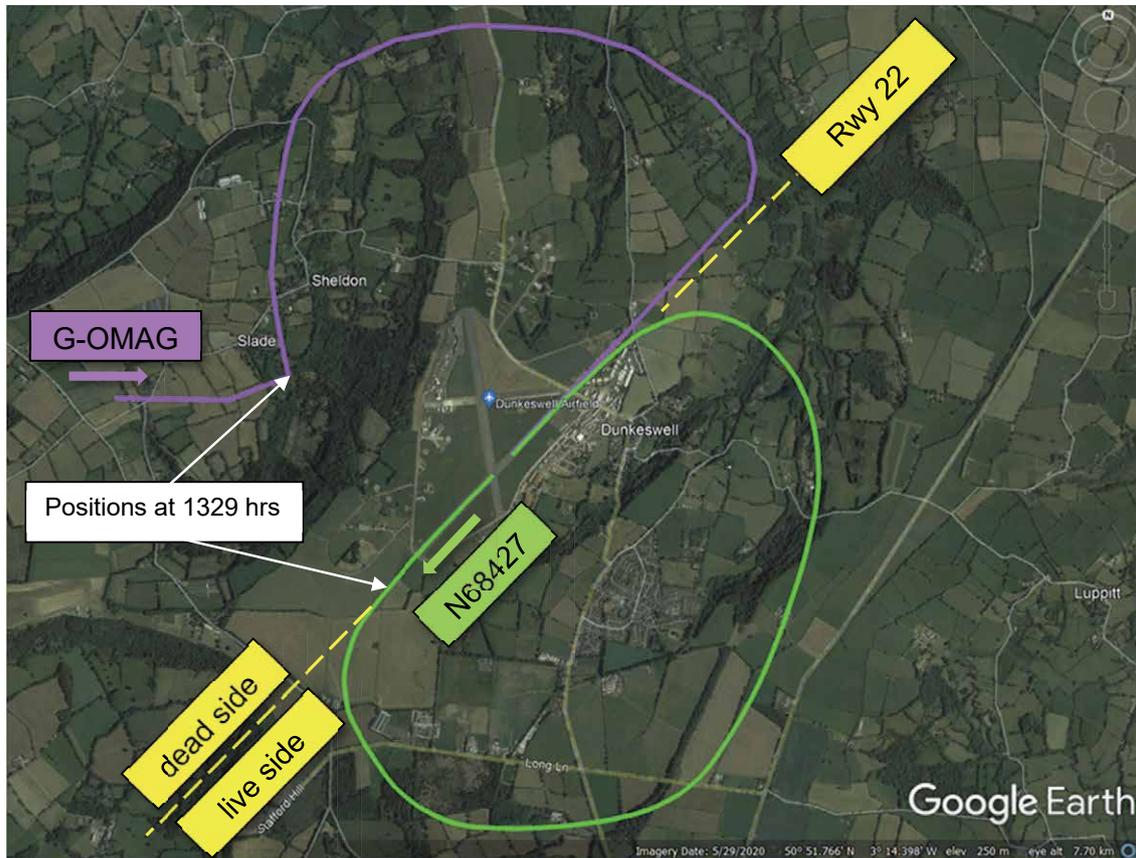
**Figure 1**

At 1329 hrs, the Stearman completed a touch-and-go landing and continued into the left-hand visual circuit, achieving a downwind height of 750 ft. The Cessna was now approximately one nautical mile to the west and the pilot made a track change to the left, onto a northerly heading, to arc around the aerodrome to position to join the circuit from the dead side<sup>1</sup> onto a right base for Runway 22 (Figure 1).

Tracks of G-OMAG joining the circuit and N68427 touch-and-go circuit sourced from recorded data

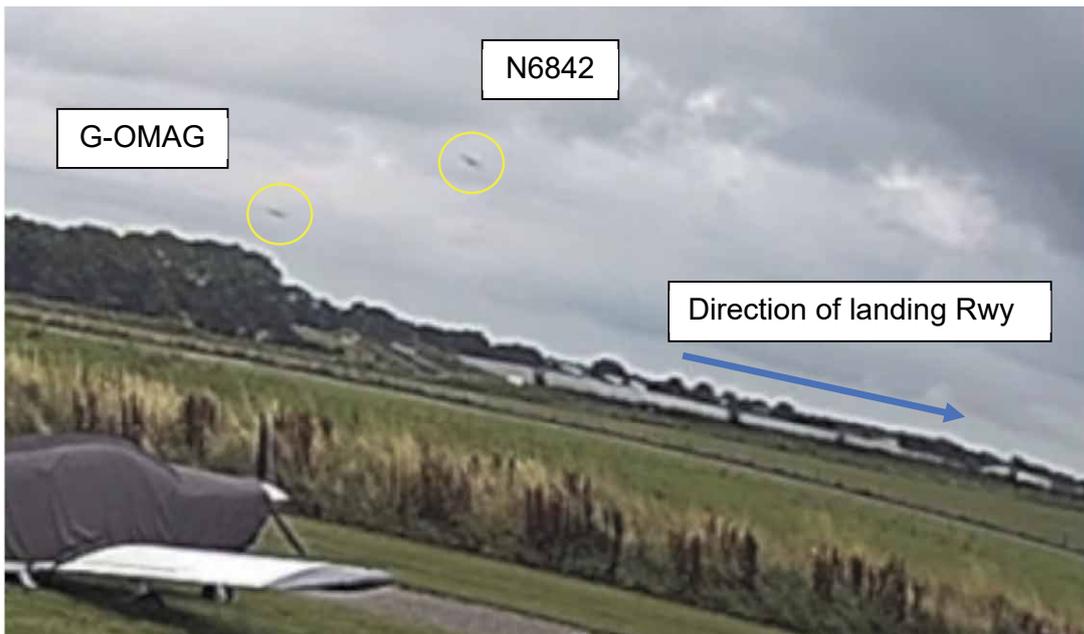
**Figure 2**

At the point the Cessna was approximately one nautical mile from the runway threshold, CCTV footage (Figure 2) showed the Stearman flying a curving left base leg, descending from downwind. The pilot was not aware that the Cessna had joined the circuit and had heard no radio transmissions.

Still from CCTV footage of the approach to Runway 22  
(image used with permission)

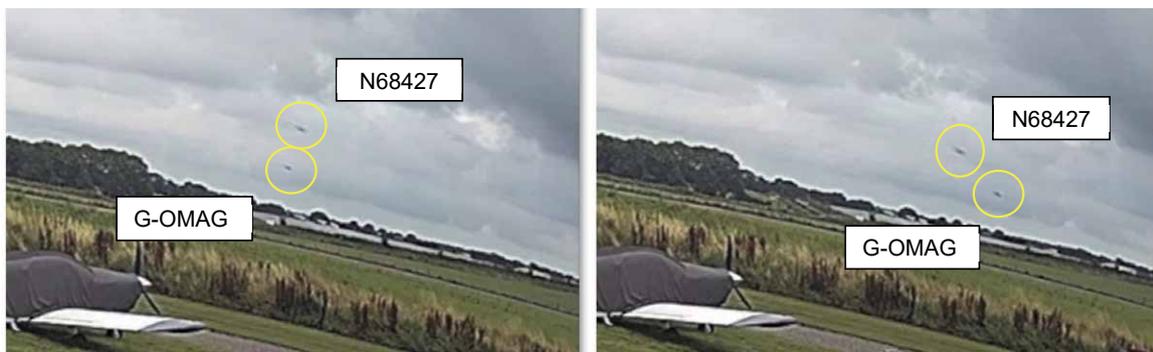
**Figure 3**

Stills from CCTV footage of the approach to Runway 22  
(image used with permission)

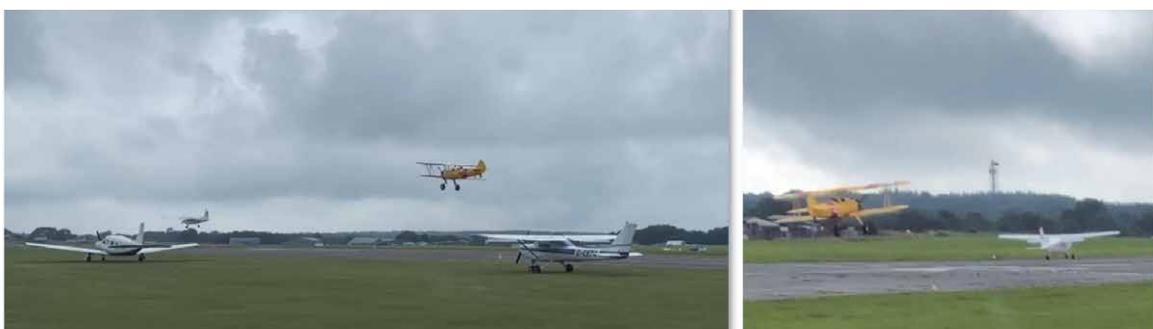
**Figure 4**

The pilot reported that he made a radio transmission as he started the base leg, then again when established on final. He then heard a final call from another aircraft and, assuming it was an aircraft positioning behind him, made an information call: “November 27 final, close to threshold”. There was no response from the other aircraft, so he continued with the approach. CCTV footage (Figure 3) showed that the Cessna had passed ahead of, and below, the Stearman before the Stearman had completed the base turn. Various witnesses reported seeing both aircraft on the final approach in very close proximity, “as though they were in formation” (Figure 4).

Aircraft on final approach  
(images used with permission)

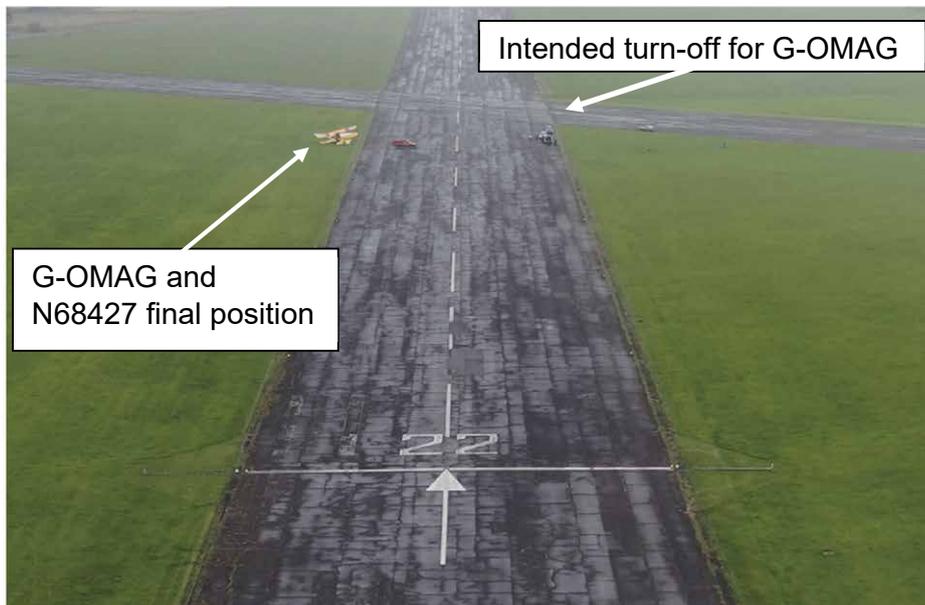
**Figure 5**

The pilot reported that the landing “didn’t feel right” and that the aircraft was not responding to control inputs. He applied power to correct what he felt was a drift to the left, then reduced power to idle. The aircraft continued to swing further to the left, off the runway and onto the grass (Figure 5).

Facing inset threshold of Runway 22  
(image used with permission)

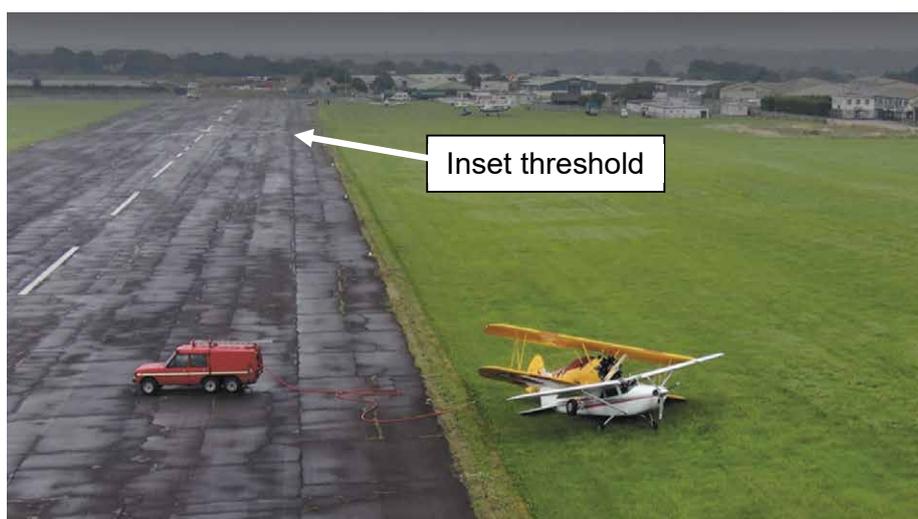
**Figure 6**

The pilot believed that the left landing gear had failed. Once the aircraft stopped, he looked down and saw that his aircraft was straddled on top of another aircraft, the Cessna (Figure 6).

Looking back to threshold of Runway 22  
(image used with permission)
