**SERIOUS INCIDENT**

<b>Aircraft Type and Registration:</b>	BAe ATP, SE-LPS	
<b>No &amp; Type of Engines:</b>	2 Pratt and Whitney Canada PW126A turboprop engines	
<b>Year of Manufacture:</b>	1991 (Serial no: 2043)	
<b>Date &amp; Time (UTC):</b>	9 April 2021 at 0519 hrs	
<b>Location:</b>	Ronaldsway Airport, Isle of Man	
<b>Type of Flight:</b>	Commercial Air Transport (Cargo)	
<b>Persons on Board:</b>	Crew - 2	Passengers - None
<b>Injuries:</b>	Crew - None	Passengers - N/A
<b>Nature of Damage:</b>	None reported	
<b>Commander's Licence:</b>	Airline Transport Pilot's Licence	
<b>Commander's Age:</b>	54 years	
<b>Commander's Flying Experience:</b>	5,415 hours (of which 2,964 were on type) Last 90 days - 44 hours Last 28 days - 20 hours	
<b>Information Source:</b>	AAIB Field Investigation

**Synopsis**

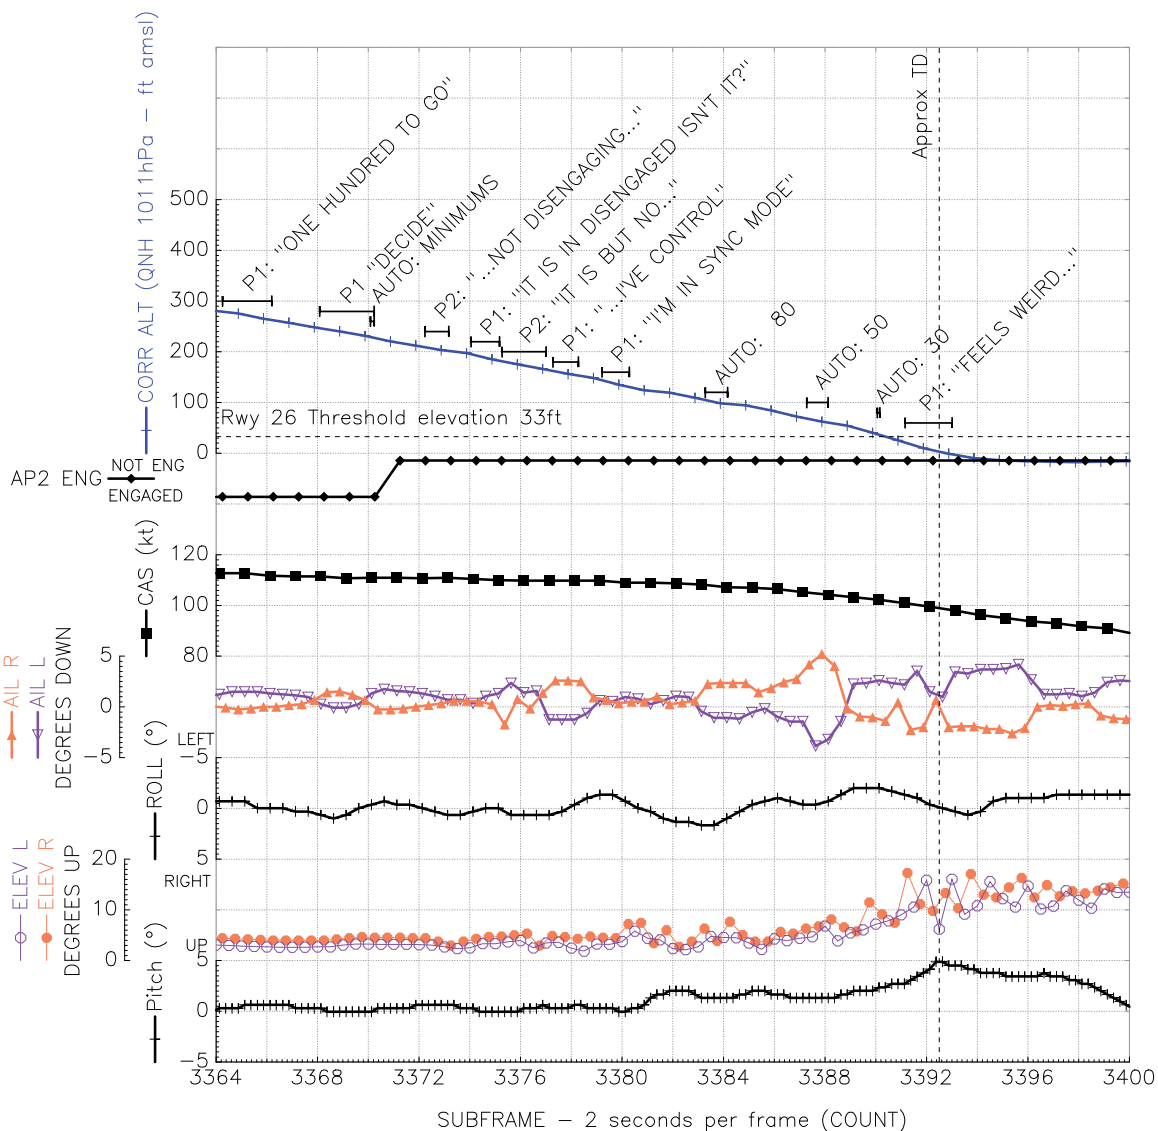
**Figure 1**  
QAR and partial CVR extracts

The co-pilot was the PF during the descent. Passing through 250 ft amsl the commander called "DECIDE" and the automatic "MINIMUMS" call was triggered. The data shows that AP2 disengaged, followed by the co-pilot stating that it was "...NOT DISENGAGING..." No cavalry charge audio, normally associated with an autopilot disengagement, was captured by the CVR. This was followed by a brief discussion between the flight crew, during which the PF commented that he felt the AP had not disengaged. Passing approximately 150 ft amsl, the commander stated that he had control, and that he was "IN SYNC MODE". The descent continued and the aircraft landed normally. The commander stated that the aircraft "FELT WEIRD" but that he was in control.

The only other anomalous system behaviour identified in the recordings were that the altitude alerts recorded by the CVR during the flight were approximately 12 seconds long, which was significantly longer than the expected duration of approximately one second.

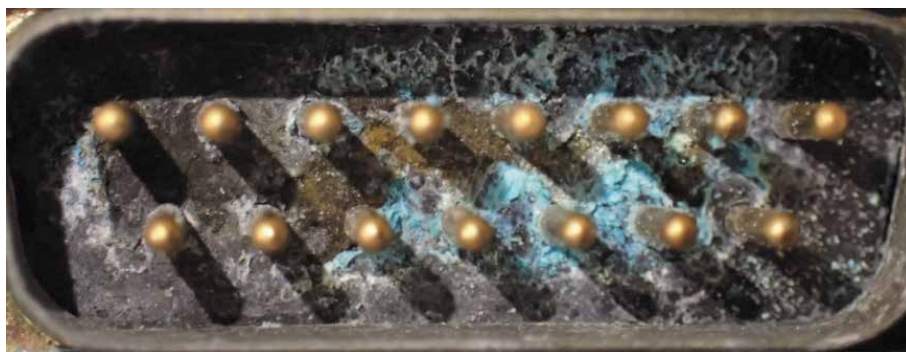
**Figure 4**

The electrical connector was found to be corroded when the audio warning unit was disconnected (Figure 4). The unit is located in the area beneath the DV window and the operator advised that moisture (water) ingress through the DV windows was a known problem with ATP aircraft.

Contamination and corrosion on the audio warning unit connector

The investigation concluded that the anomalies with the audio warnings were probably associated with corrosion and moisture caused by water ingress through the DV windows.

- Install the extended side trim panels on all their ATP aircraft and repair any damaged panels.
- Waterproof the side-console switches on all their ATP aircraft.
- Check the rigging of every ATP DV window to make sure that they close correctly.
- Investigate the feasibility of remounting the audio warning unit and installing a drip shield to avoid moisture entering the unit from the top.

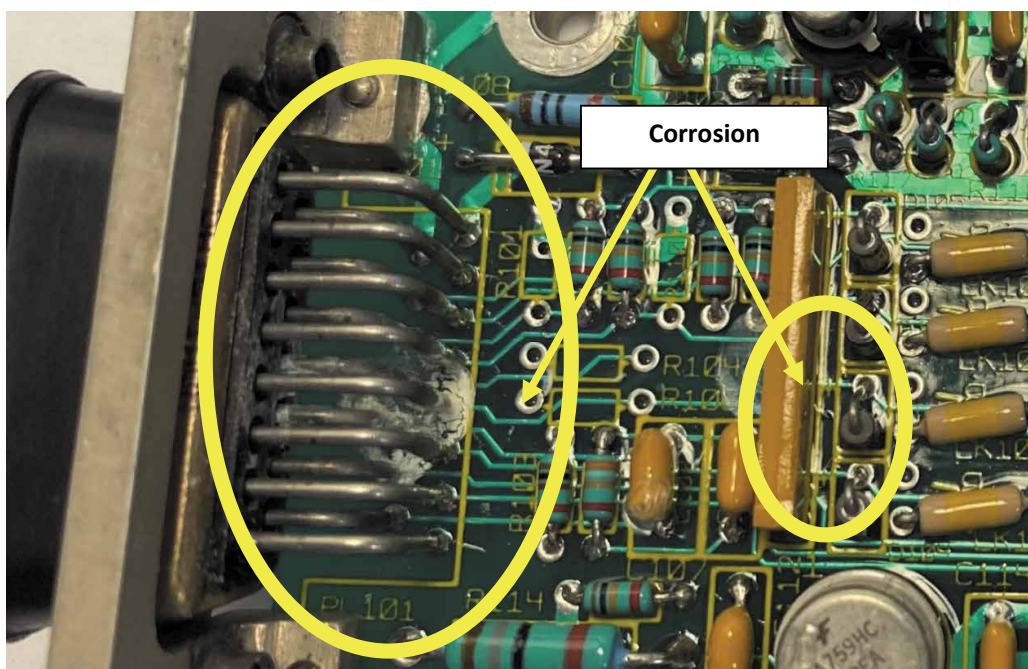
**Figure 5**

No faults were found when the warning unit was tested. It was dry when disassembled, but corrosion deposits were found on one of the three printed circuit boards (PCBs). Most of

the corrosion was in the area where the external electrical connector was soldered to the PCB, but deposits were also found on other areas of the circuit board (Figure 5).

Corrosion deposits inside the audio warning unit

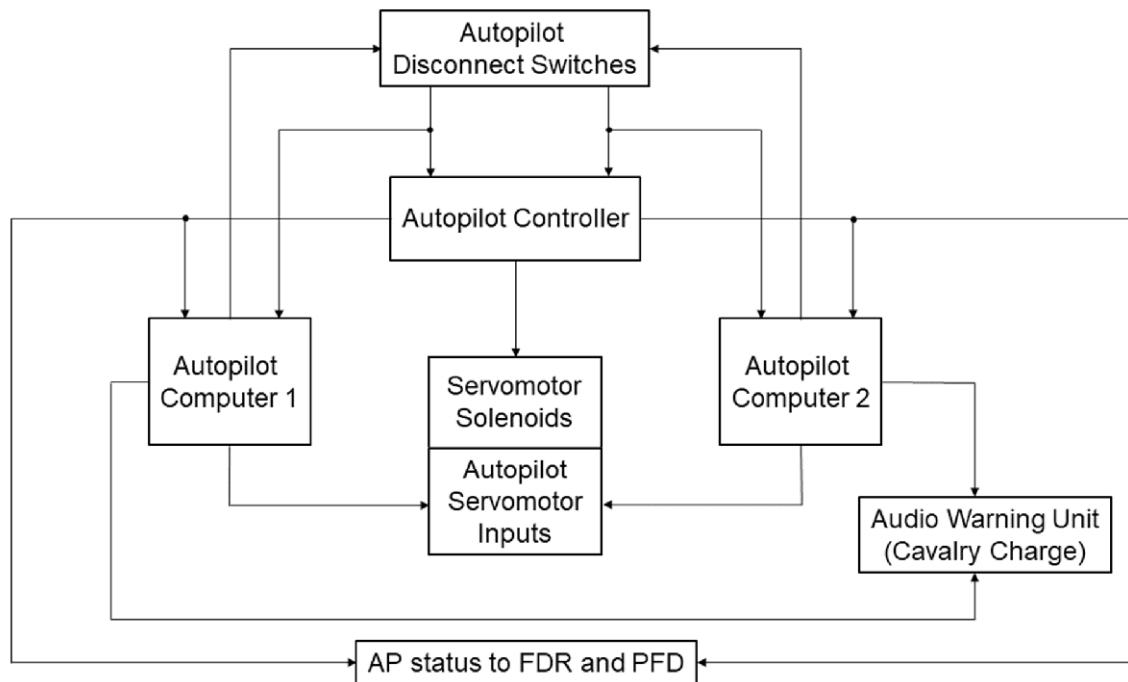
**Figure 6**

The manufacturer responsible for the design of the autopilot<sup>6</sup> reviewed the engagement logic and identified a possible scenario where an intermittent failure could result in the autopilot computer disengaging whilst the autopilot servo solenoids remain energised.

If the debounce circuit was ineffective, multiple electrical pulses could be produced very rapidly. This phenomenon could be intermittent and could be caused by degradation of electrical components in the debounce circuit or the push button mechanism and contacts.

The autopilot manufacturer identified additional testing to substantiate their theoretical failure scenario. If successful, this could result in changes to minimise the future arising rate. Safety action was taken by the CAA to include the proposed testing as part of the ongoing continued airworthiness of the ATP fleet.

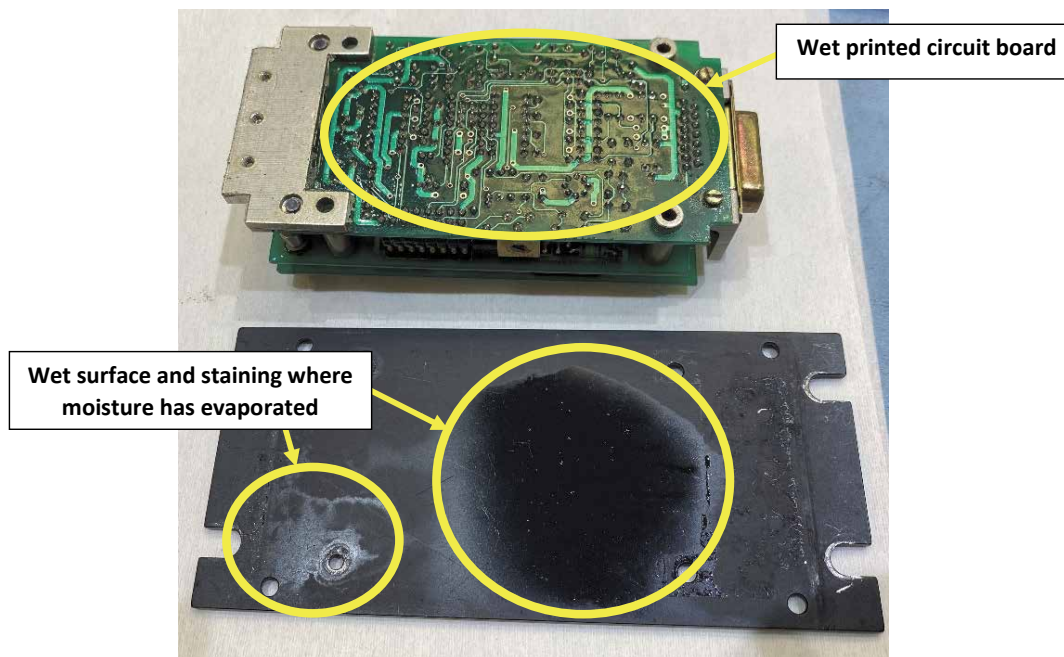
**Figure 7**

As the audio irregularities on SE-MAJ were very similar to those on SE-LPS, the audio warning unit from SE-MAJ was returned to the AAIB for further investigation. Visual examination found the external condition to be good but when the external cover was removed the internal components were found to be wet and corrosion was seen on one of the PCBs (Figure 7). This examination was carried out seven days after the occurrence of 2 December 2021, so it is possible that the unit had partially dried out in the intervening time.

Visible moisture in the audio warning unit

Corrosion was also found within the warning unit fitted to SE-MAJ and the PCBs inside were wet. The combined effect of the corrosion and moisture cannot be readily assessed. However, given the similarities between the symptoms on both aircraft, it is likely that this contributed to, or caused, the extended duration of the altitude alerts and the repeated cavalry charge warnings on SE-LPS after it landed. The DV windows, which can be opened when the aircraft is on the ground, are known to be susceptible to water ingress. Previous SBs have been issued to reduce the likelihood of aircraft equipment being affected by

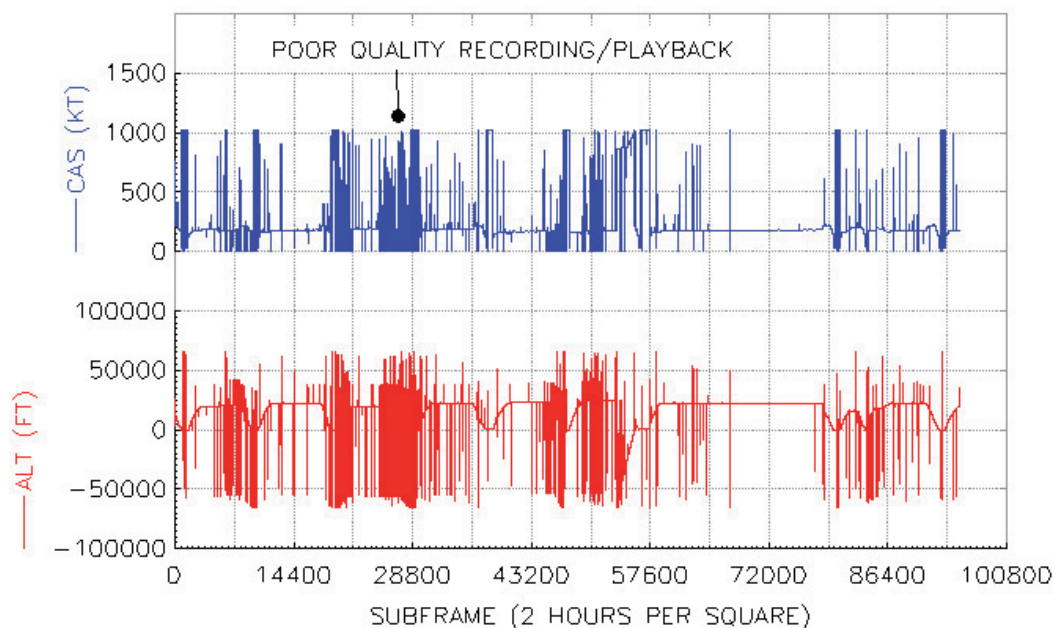
**Figure 8**

The FDR fitted to SE-LPS was a model PV1584 which records the data on a magnetic tape. These recorders can suffer from quality issues, resulting in parameter error rates that vary throughout the recording (Figure 8). Errors are expected to occur when recorders

Example parameters illustrating quality issues of magnetic tape FDR recording from SE-LPS

It is recommended that the Civil Aviation Authority review the use of magnetic tape flight data recorders used in aircraft operated by UK Air Operator Certificate holders and establish if there is a practical way to comply with the ICAO requirement to cease their use.

It is recommended that the Civil Aviation Authority require that magnetic tape flight data recorders, used in aircraft operated by UK Air Operator Certificate holders, comply with the Civil Aviation Authority Specification No 10, regarding the error rate requirements, by checking the complete recording rather than by undertaking a sample check.
