TITLE: **Arboricultural Survey &
Constraints Advice:**
Henham Road, Elsenham

DATE: 02/03/2022

REF: HWA10767_APIII

Prepared For
Countryside Properties

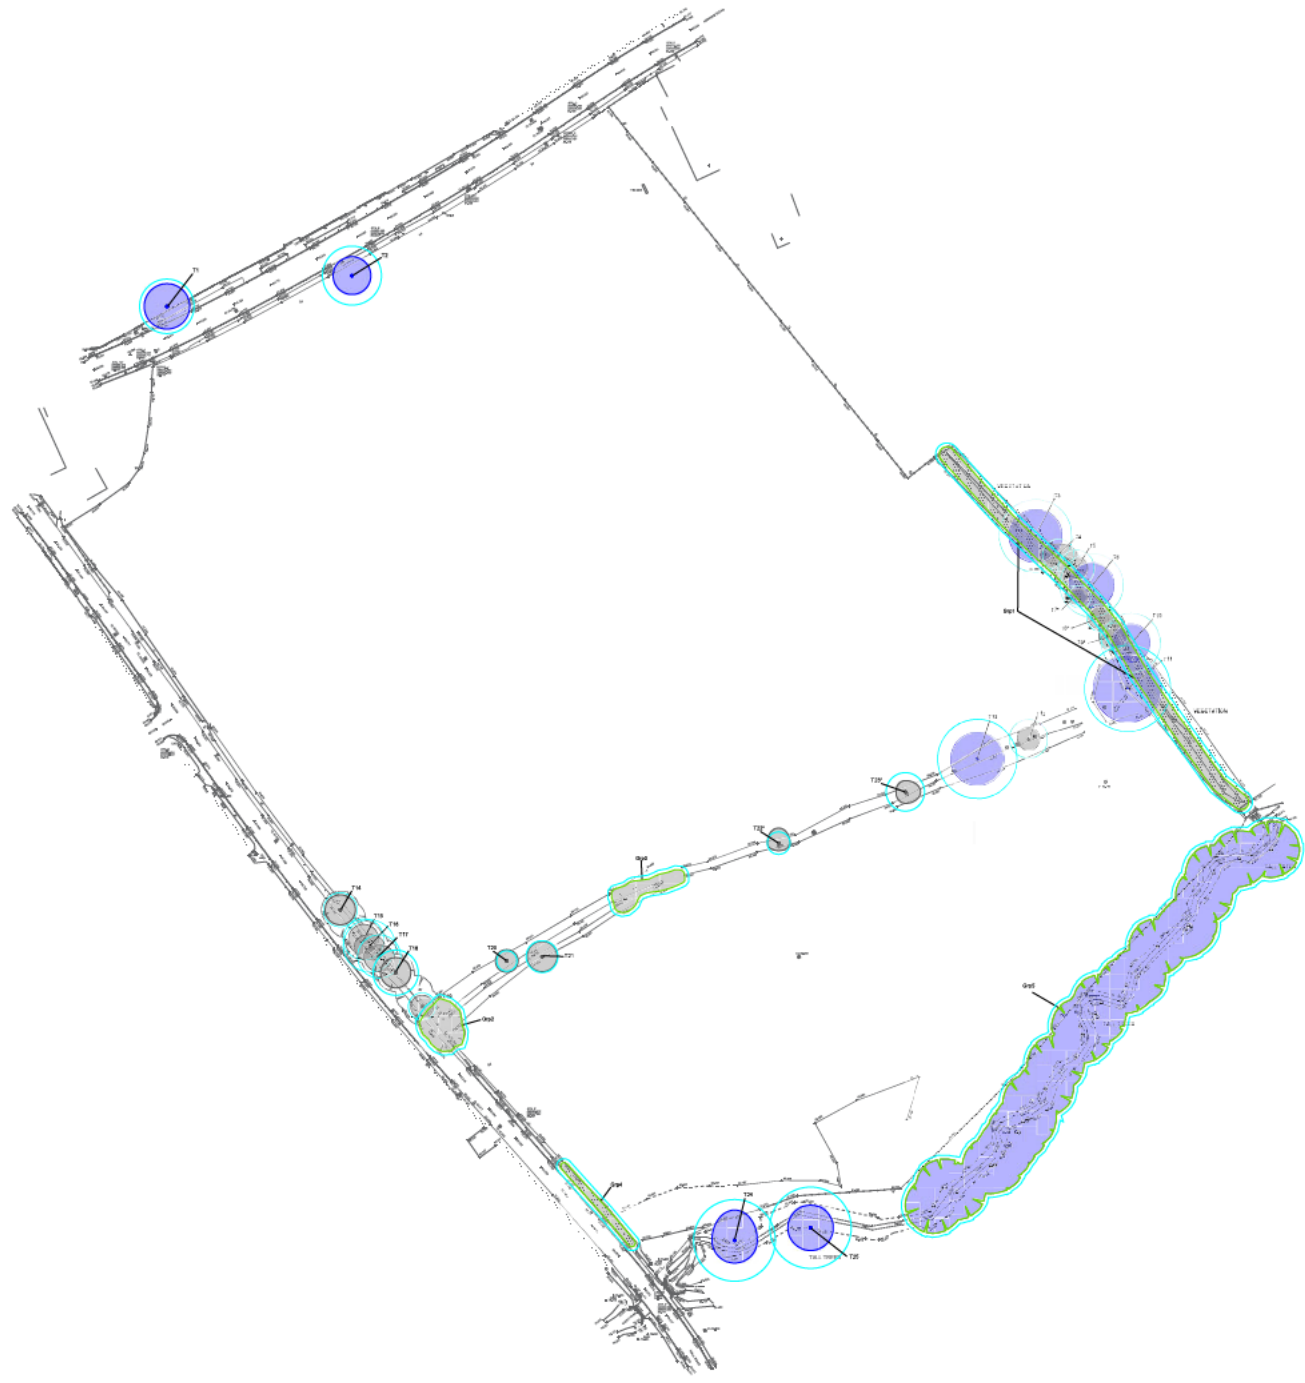
Figure 1: Tree Constraints Plan (TCP)

- 4.2 **Above ground constraints:** The second constraint is the amount of space required around a tree(s) in order for it to be successfully retained once development is finished and the pressures of human occupation come to bear. This area would not normally be suitable for occupied accommodation, but un-occupied structures or hard surfacing may be feasible. This is represented by a separate polygon on figure 1 in appendix C (TCP).
