## Flooding and sinking of the survey workboat *Bella* in the approaches to Lynmouth, England on 6 July 2021

### SUMMARY

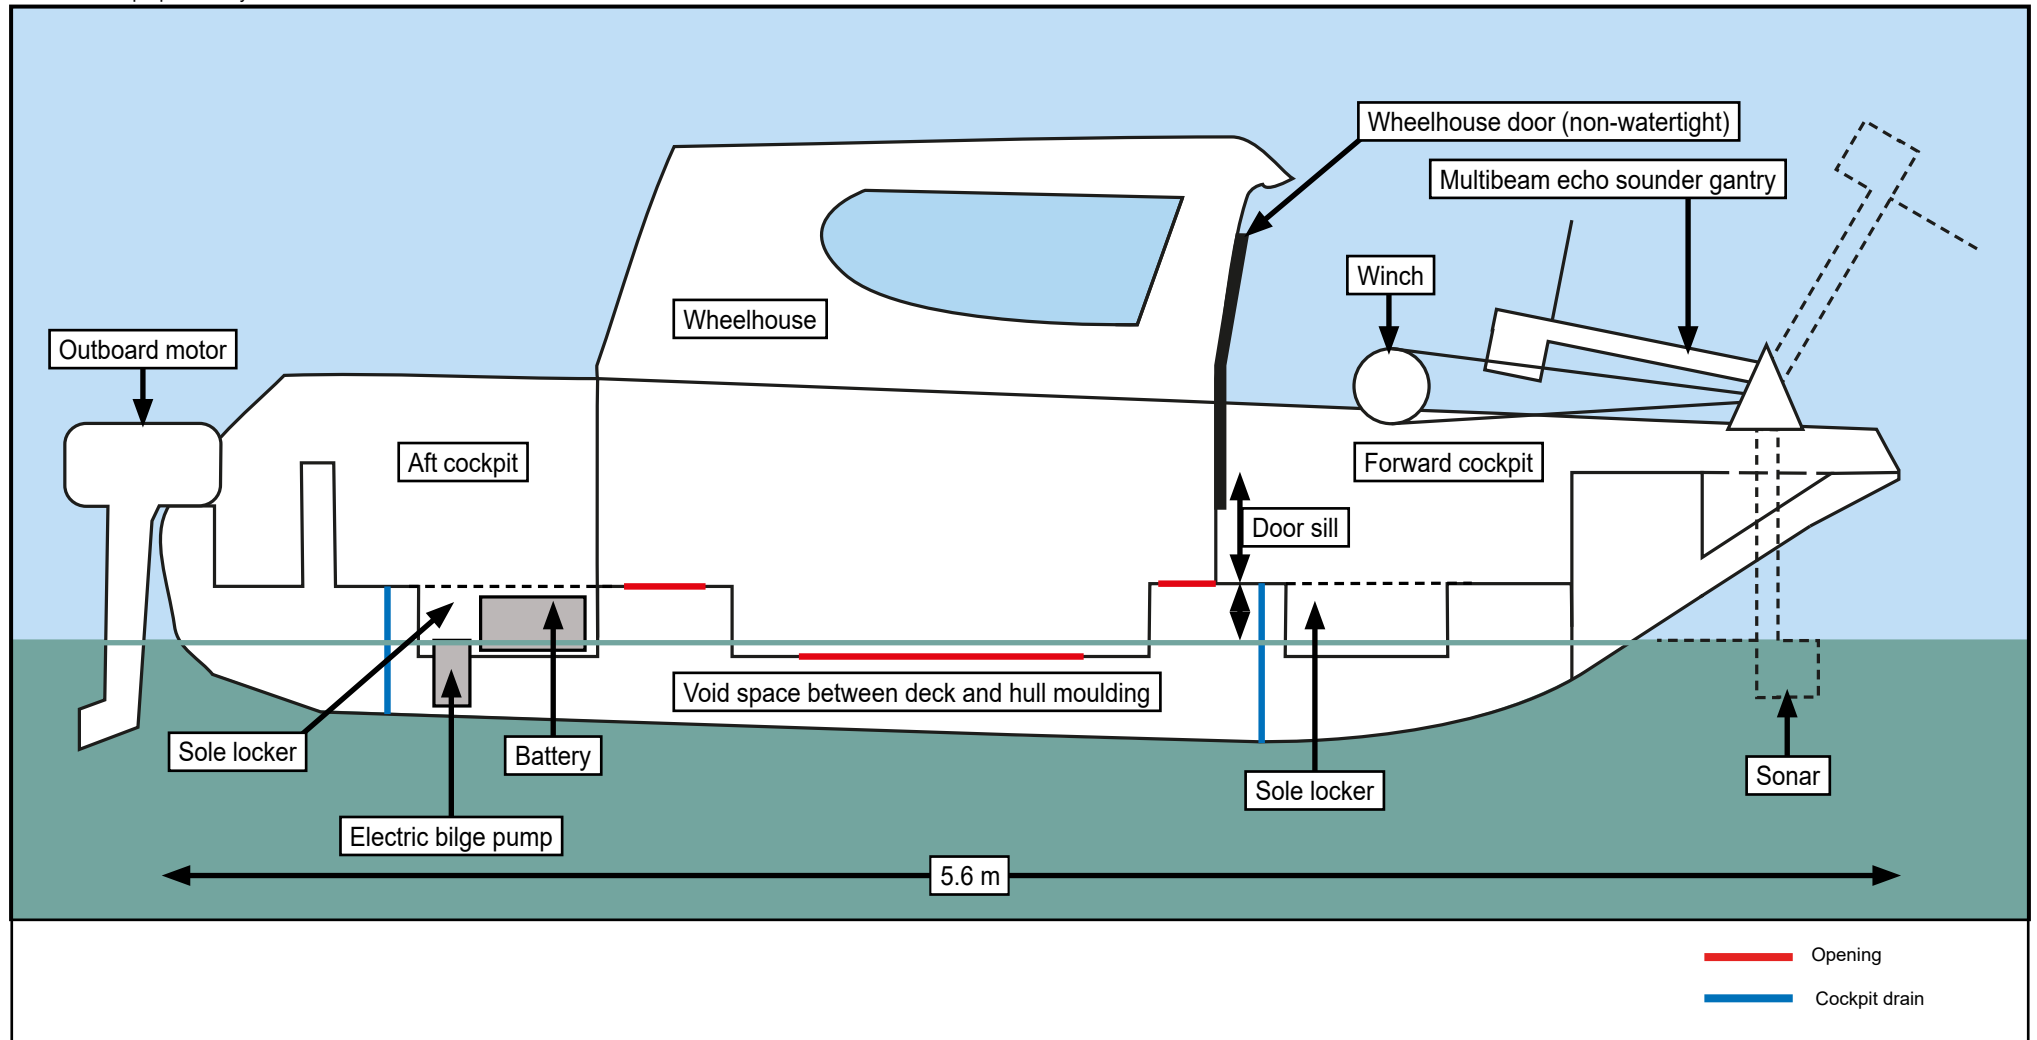
In 2016, a Finnish survey company modified *Bella* by fitting a 100kg MBES system, comprised of a steel winch, gantry and MBES transducer, near the bow for hydrographic surveys (**Figure 3**). The survey company did not have *Bella* certified as a commercial vessel and only operated it in sheltered waters.

Figure 3: *Bella's* layout
