ACCIDENT

Aircraft Type and Registration:	Escapade, G-CGNV	
No & Type of Engines:	1 Rotax 912-UL piston engine	
Year of Manufacture:	2011 (Serial no: LAA 345-14901)	
Date & Time (UTC):	14 November 2021 at 1204 hrs	
Location:	Brighton Airfield, Selby, North Yorkshire	
Type of Flight:	Private	
Persons on Board:	Crew - 1	Passengers - None
Injuries:	Crew - 1 (Fatal)	Passengers - N/A
Nature of Damage:	Aircraft destroyed	
Commander's Licence:	Private Pilot's Licence (Aeroplanes)	
Commander's Age:	66 years	
Commander's Flying Experience:	945 hours (of which 4 were on type) Last 90 days - 9 hours Last 28 days - 3 hours	
Information Source:	AAIB Field Investigation

Synopsis

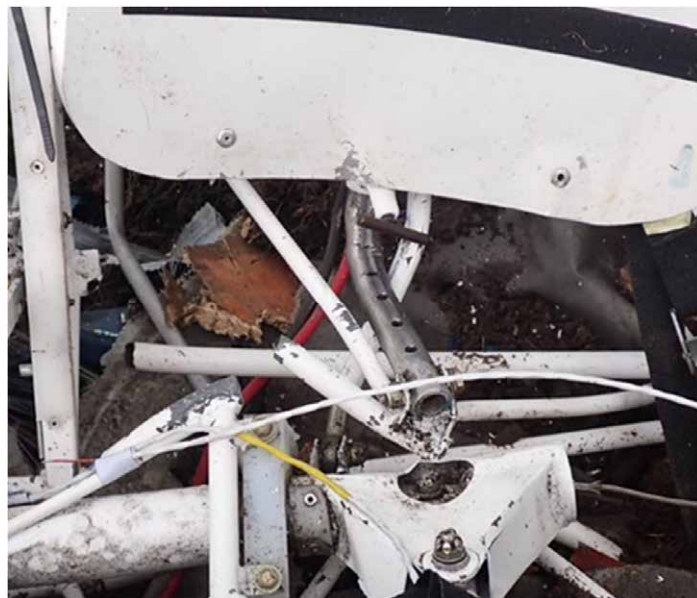
Figure 2

Damage to the pilot's seat adjustment rail

The pilot's seat (Figures 1 and 2 earlier) had been forced downwards between its runners and there was a severe bend in the seat adjuster rail. There was a distinctive score mark running along the upper face of the adjuster rail tube which was offset with the centre line of the pin location holes. There was also evidence of burrs similarly offset on the edges of the holes. Figure 9 shows the score mark and burrs. This mark and the hole burrs extend from the forwardmost hole in the adjuster rail to the fourth hole. The severe bend in the tube had distorted the remaining holes further back, to the extent that holes five and six were 'closed-up' and hole seven was hidden within the seat guide tube which ran along the rail.

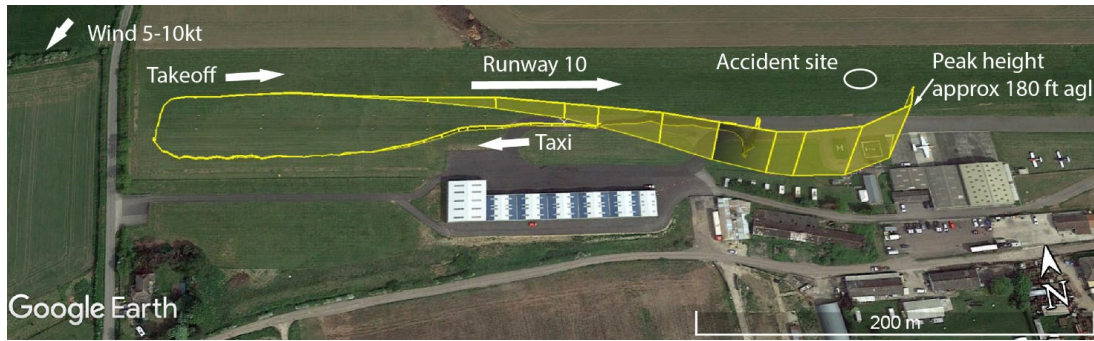
**Figure 3**

The recorded flight path of the accident flight is shown in Figure 3. The acceleration to takeoff was comparable with other recorded flights associated with this aircraft at the same airfield (some on the opposite runway). One of the CCTV cameras captured the takeoff roll and initial climb but there was insufficient contrast to calculate the aircraft orientation until the aircraft had climbed above the tree line in the background, at roughly 20 ft agl. As soon as it was visible, it was apparent that there was left roll and a left drift with the aircraft tracking to the right of the runway (Figure 4).

Track of G-CGNV using PilotAware ATOM GRID Network data
(Satellite imagery courtesy of Google Earth)

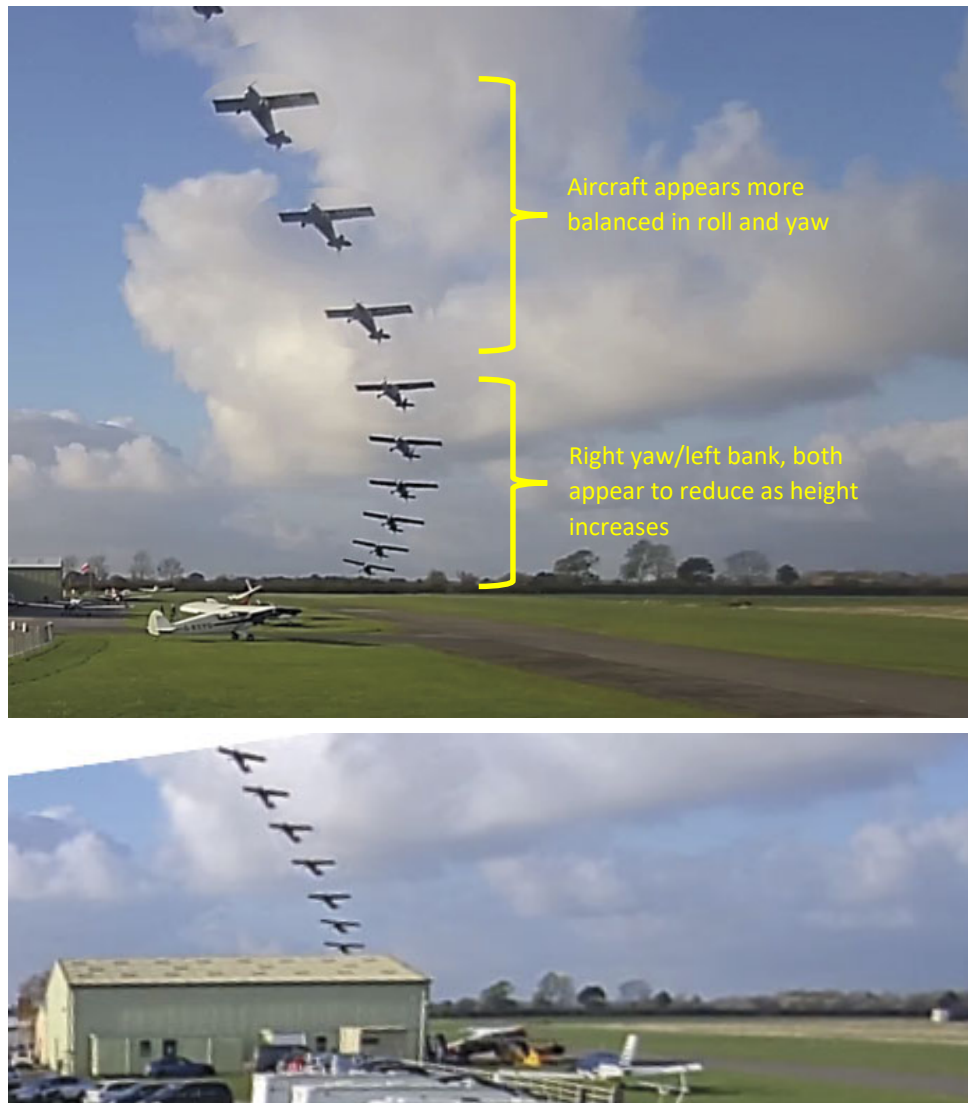
**Figure 4**

Cropped and combined snapshots of one of the CCTV recordings to show the aircraft flight path and orientation during a large part of the climb

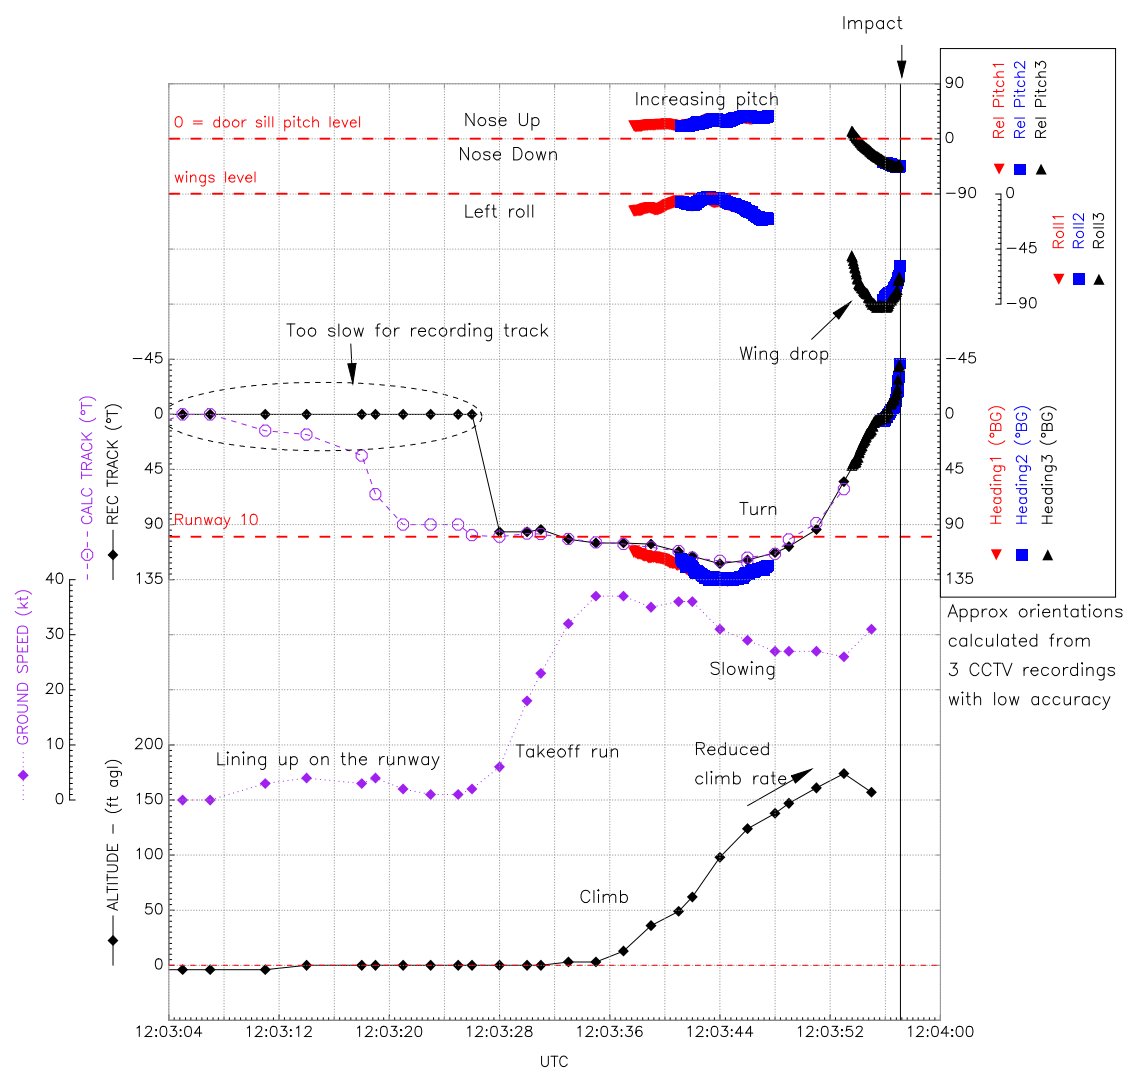
Figure 5

Data recorded by the Pilot Aware network and approximate orientation data derived from the CCTV recordings

The climb rate briefly reduced at about 40 ft agl but increased again at about 50 ft agl. Approaching 100 ft agl, the left roll had reduced to approaching wings level, but it started increasing again in conjunction with a turn to the left, a reduction in ground speed, and a reduction in climb rate.

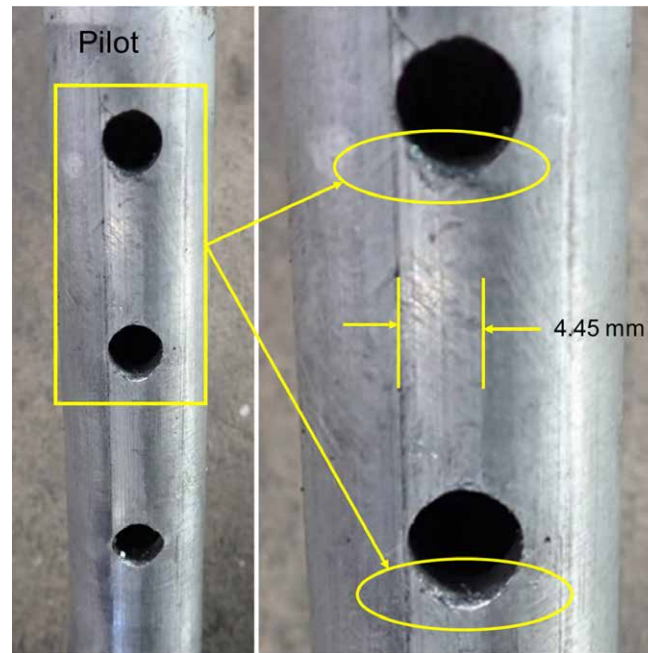
Figure 9

Score mark and burrs on the hole edges on the pilot's seat adjuster rail

The aluminium alloy seat adjuster rail tube was 19.0 mm in diameter with a tube wall thickness of 3.3 mm. Where possible, measurements were taken of the visible holes which were found to have a diameter variation between 6.37 and 6.41 mm. The mark on the tube was 4.45 mm wide and offset against the hole centre line to the left by 0.43 mm. The pin was damaged and slightly bent but its engagement end could be accurately measured. The pin diameter was 6.30 mm and was chamfered leaving an end face diameter of 4.45 mm. The pin end is shown in Figure 11 and a schematic cross-sectional diagram of the dimensions and offset are shown in Figure 12. The offset shown in the diagram, represents the pin as it would naturally sit based on the dimensional evidence. The tolerance within the pin guide, plus any wear, allows the pin to advance further downwards such that the chamfer just engages in any of the adjuster rail holes against their edges. The evidence for this is shown in the preceding Figure 9.

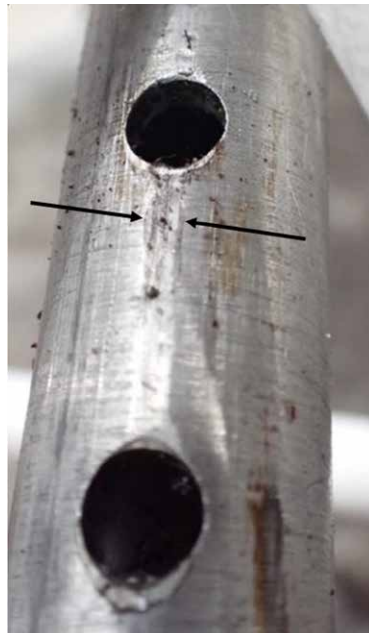
Figure 10

Passenger seat adjuster rail marks (highlighted)

The witness mark in the passenger seat adjuster rail, although faint, tracked the centre line of the holes. There was also some burr damage on the edges of the holes but without any significant offset.

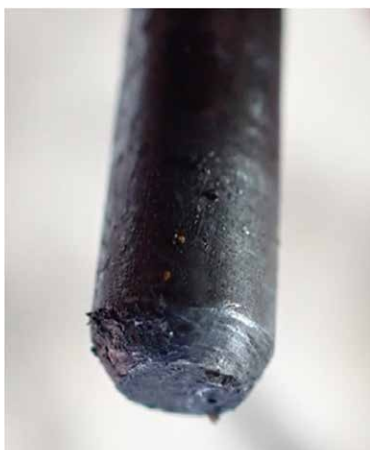
Figure 11

Pilot's seat pin chamfered end

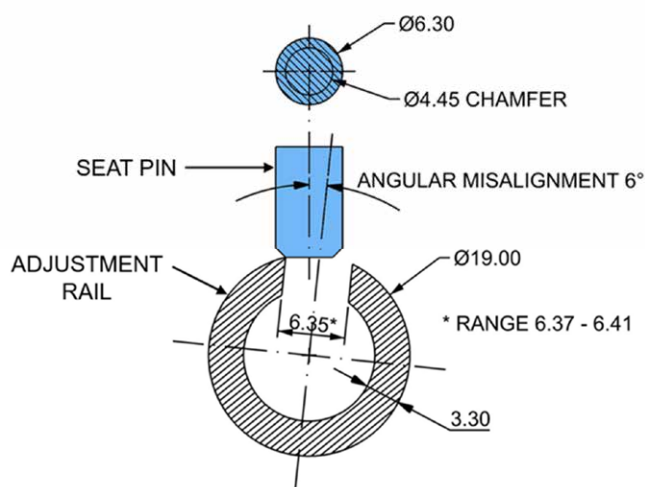
Figure 12

Schematic cross-sectional diagram of the adjuster rail dimensions and pin offset
(not to scale)

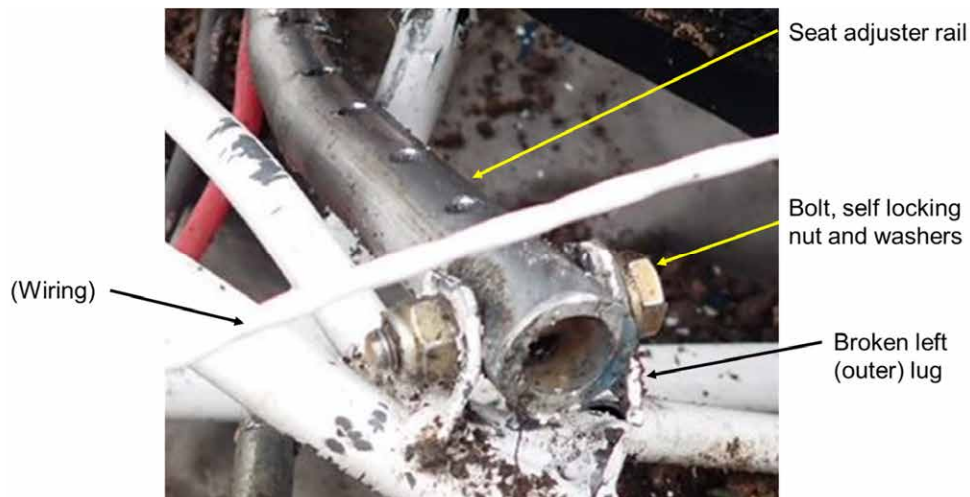
The forward attachment fitted to the cross frame had distorted and the left lug had broken away from the frame. The attachment bolt and nut were still in place but were not particularly tight. Figure 13 shows the pilot's seat adjuster rail front mounting assembly. The rear mounting point was in a similar condition to the front.

Pilot's seat adjuster rail front mounting assembly

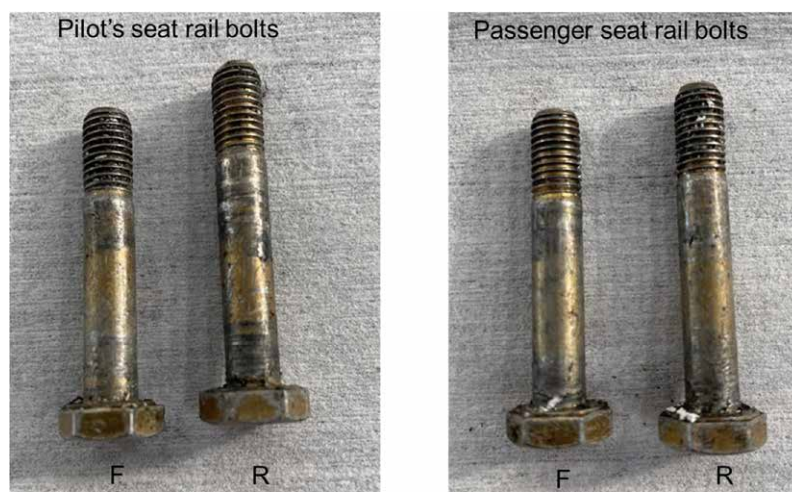
Figure 14

The front and rear lug holes were 6.49 mm diameter, the bolts were 6.2 mm diameter. The adjuster rail front mounting holes were 6.48 mm diameter. However, the rear mounting hole on the left side of the adjuster rail was slightly larger at 7.0 mm diameter. These measurements were standard clearance holes and when the bolt was loosened, allowed a play of between 0.28 mm and 0.29 mm, except in the case of the rear 7.0 mm hole, where the play was 0.8 mm. The mounting bolts on both adjuster rails showed evidence of wear, movement and fretting. The pilot's adjuster rail bolts appeared to be more worn than the passenger adjuster rail bolts (Figure 14).

Pilot's and passenger seat adjuster rail mounting bolts

The damage to the aircraft prevented accurate seat and airframe alignment checks. During disassembly the stiff nuts holding the bolts in place were found not to be particularly tight. Examination of the bolts found wear marks on their surface plating on areas of the bolts in direct contact with the rail and its mounting lugs. Similar bolts removed from other parts of the structure through tubing and lugs, did not exhibit the same wear marks. This suggests there had been some movement or fretting over time between the adjuster rail and its bolts.

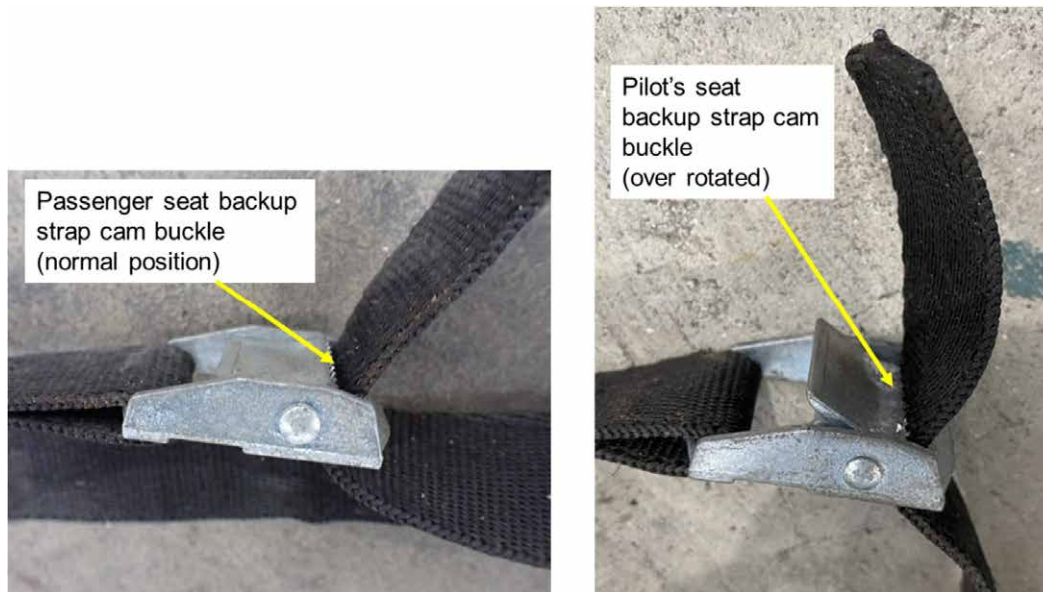
Figure 15

The pilot's seat backup strap was fitted in the same way as the passenger seat backup strap. Its cam buckle was over rotated and jammed because the webbing strap had been placed under significant tension⁴ (Figure 15).

Backup strap buckle condition

The pilot's backup strap had been subjected to a high tensile load during the accident which had caused the buckle to jam. This was caused by the downwards bend to the adjuster rail and it caused the backup strap to create additional distortion of the cockpit frame which it was looped around. The backup strap was pulled downwards very sharply, which caused the buckle cam to over centre and jam.

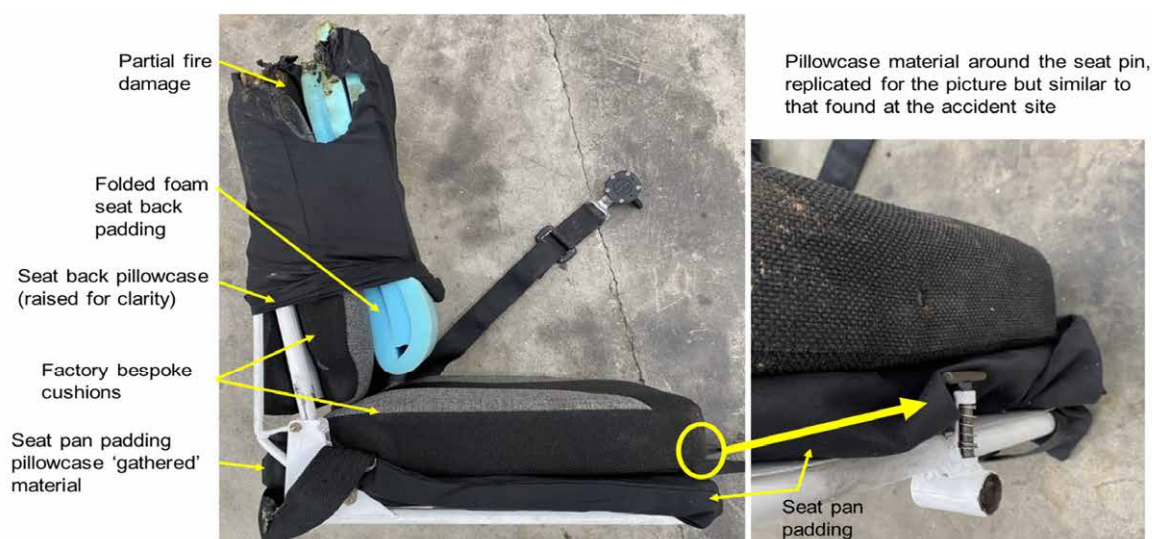
The seat pan foam padding was loosely placed under the factory-made cushion but was not fitted with the hook and loop strips positioned to attach the factory cushion to the seat pan. The seat back padding was fitted on the face of the factory-made seat back and the whole thing enclosed in a pillowcase and then slid over the seat back. Figure 16 shows the seat frame fitted with the padding and factory-made cushions.

Seat cushion and padding modifications

Interaction of the additional seat pan padding and loose pillowcase material with the pin was considered. It is plausible that the pilot's weight and movement on the seat pan caused the padding to squash outwards, act on the pin enough to dislodge its chamfer edge from where it was resting against the adjuster rail hole. Therefore, interaction between the additional seat pan padding and the pin in its sensitive position could not be ruled out.

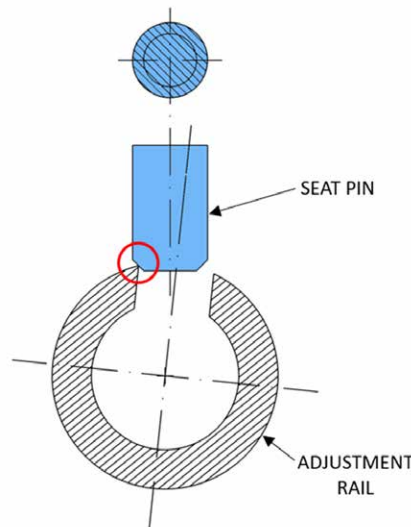
Figure 17

If the seat pin had been correctly located in the adjuster rail, the seat would have remained in its selected position. The examination and measurements of the seat adjuster rail and seat pin show that they were incorrectly aligned which hindered positive engagement of the pin in the location holes. Marks on the rail and the offset location of burrs made by the pin on the edge of the holes also suggest that the misalignment has been present for some time. This is supported by witness testimony that indicated difficulties had been experienced by the pilot in positively setting the seat position. It is therefore likely that on some occasions when the seat had felt secure, it was being held in place only by the edge of the chamfered end of the pin partially entering the hole as shown in the schematic in Figure 17.

Illustration of partial seat pin engagement (not to scale)

The pin was not correctly located in the adjustment rail hole due to a misalignment between the centre line of the pin and the centre line of the adjuster rail holes. It was not possible to determine the exact cause of the misalignment of the seat pin and adjuster rail.
