SERIOUS INCIDENT

Aircraft Type and Registration:	Bombardier Challenger CL-600-2B16 (601-3A), 2-PAPA	
No & Type of Engines:	2 General Electric Aviation CF34 turbofan engines	
Year of Manufacture:	1993 (Serial no: 5125)	
Date & Time (UTC):	29 March 2022 at 1638 hrs	
Location:	On approach to Oxford Airport	
Type of Flight:	Private	
Persons on Board:	Crew - 3	Passengers - 2
Injuries:	Crew - None	Passengers - None
Nature of Damage:	None	
Commander's Licence:	Airline Transport Pilot's Licence	
Commander's Age:	50 years	
Commander's Flying Experience:	8,550 hours (of which 2,000 were on type) Last 90 days - 59 hours Last 28 days - 36 hours	
Information Source:	Aircraft Accident Report Form submitted by the commander and further enquiries by the AAIB

Synopsis

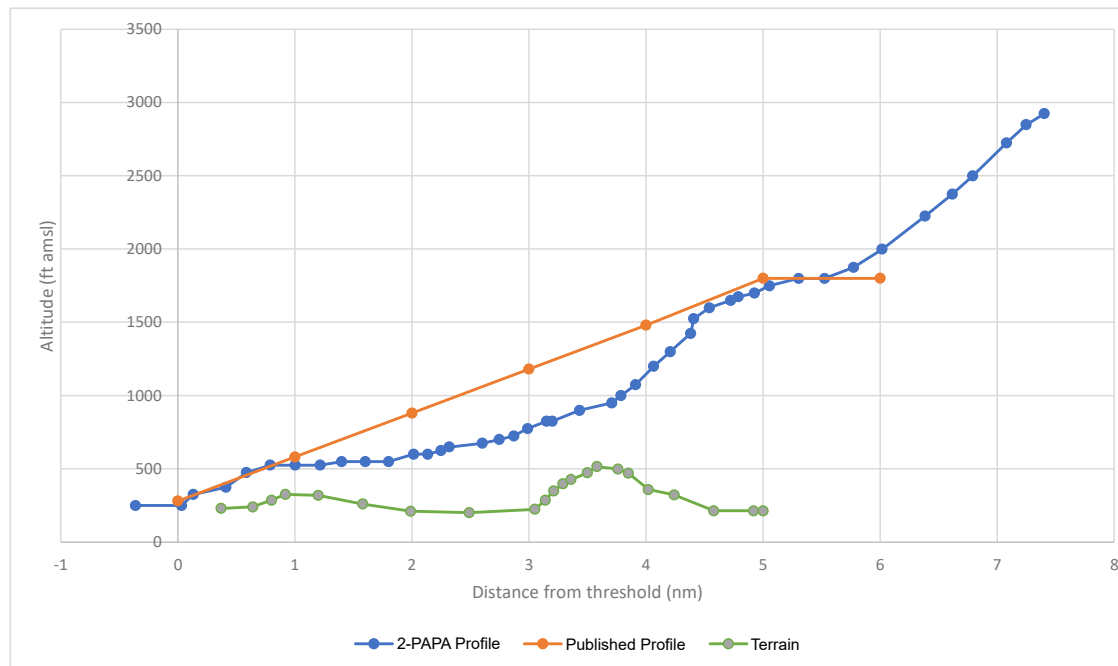
Figure 1

The aircraft was fitted with a FDR but no data was recovered from it. Data broadcast by the aircraft was used to create Figure 1. The profile flown by 2-PAPA is shown in blue and the published NDB/DME approach profile is shown in orange. The terrain under the approach path is shown in green.

Profile flown by 2-PAPA compared to the published profile and terrain
