SERIOUS INCIDENT

Aircraft Type and Registration:	Saab 340B, G-NFLB	
No & Type of Engines:	2 General Electric Co CT7-9B turboprop engines	
Year of Manufacture:	1998 (Serial no: 340B-456)	
Date & Time (UTC):	14 September 2021 at 1125 hrs	
Location:	6 nm east of the Isle of Islay, Argyll and Bute	
Type of Flight:	Training	
Persons on Board:	Crew - 4	Passengers - None
Injuries:	Crew - None	Passengers - N/A
Nature of Damage:	Failed Generator	
Commander's Licence:	Airline Transport Pilot's Licence	
Commander's Age:	59 years	
Commander's Flying Experience:	14,894 hours (of which 7,208 were on type) Last 90 days - 92 hours Last 28 days - 25 hours	
Information Source:	Aircraft Accident Report Form submitted by the pilot and subsequent enquiries made by the AAIB

Synopsis

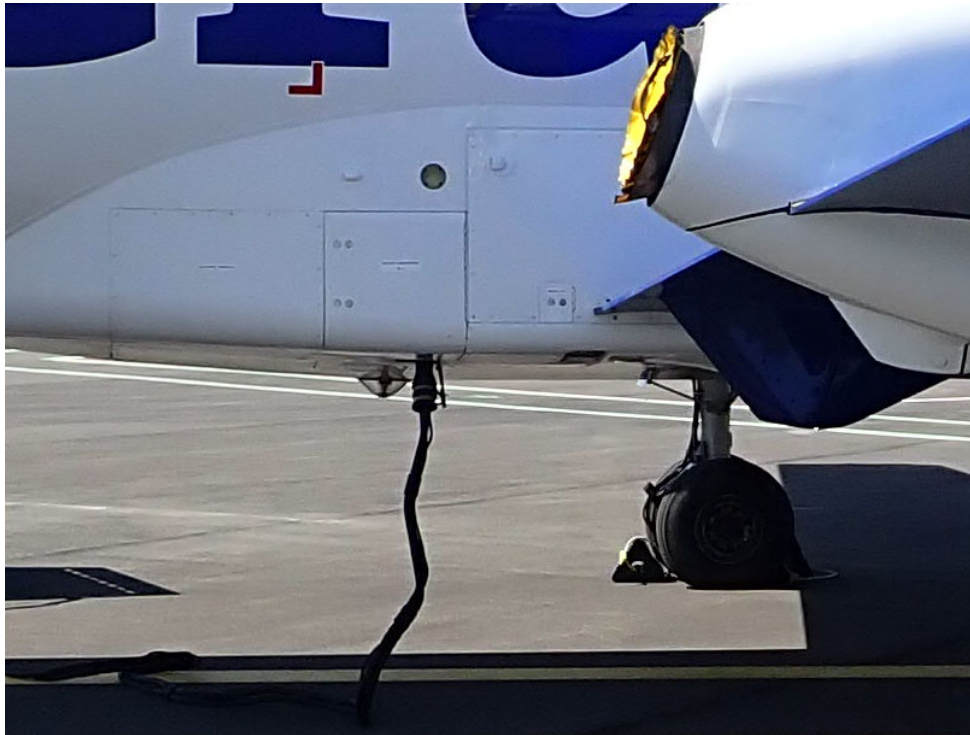
Figure 1

External power connection rear of right wing

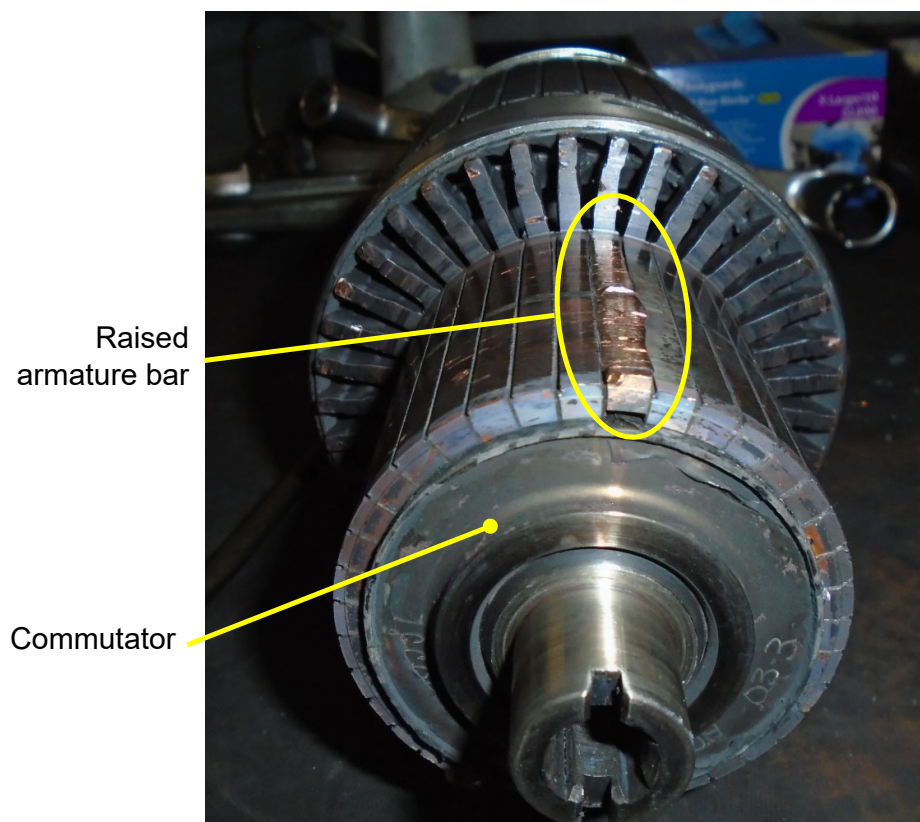
Figure 2

The starter/generator, which had accrued 261 hours since its last overhaul, was removed from the right engine and sent to a component repair organisation for investigation. The examination revealed that the generator armature had two raised bars (Figure 2) and damage to the brushes. This resulted in arcing and subsequent failure to generate current.

The maintenance organisation suggested that the most likely cause of the damage was repeated starts with insufficient cooling time between them. It identified this is a known failure mode attributed to current being applied to the stationary armature during the start sequence, which heats it and results in the commutator bar lifting.

Starter Generator Armature showing lifted raised and damaged bar on the commutator

During the 31 hours of operation by the operator, there had been no repeat starts carried out. It was therefore considered likely that if insufficient time between starts had been the cause of the issue, this occurred whilst the aircraft was operated by its previous owner, the damage remaining dormant until the generator was heavily loaded during the in-flight engine start of the opposite engine.

An examination of the right engine starter/generator found that it had failed and could not provide any power to allow a cross start of the left engine. The failure of the generator was considered by the component overhaul organisation to be the result of multiple starts with insufficient time between them to allow the unit to cool. The operator reported that there were no starts of this nature during the time that aircraft had been operated by them. It is therefore likely that, if the cause of the generator failure was insufficient cooling between successive starts, these starts occurred whilst the aircraft was operated by the previous owner. The damage sustained by the generator then became apparent when operated under high load during engine start.

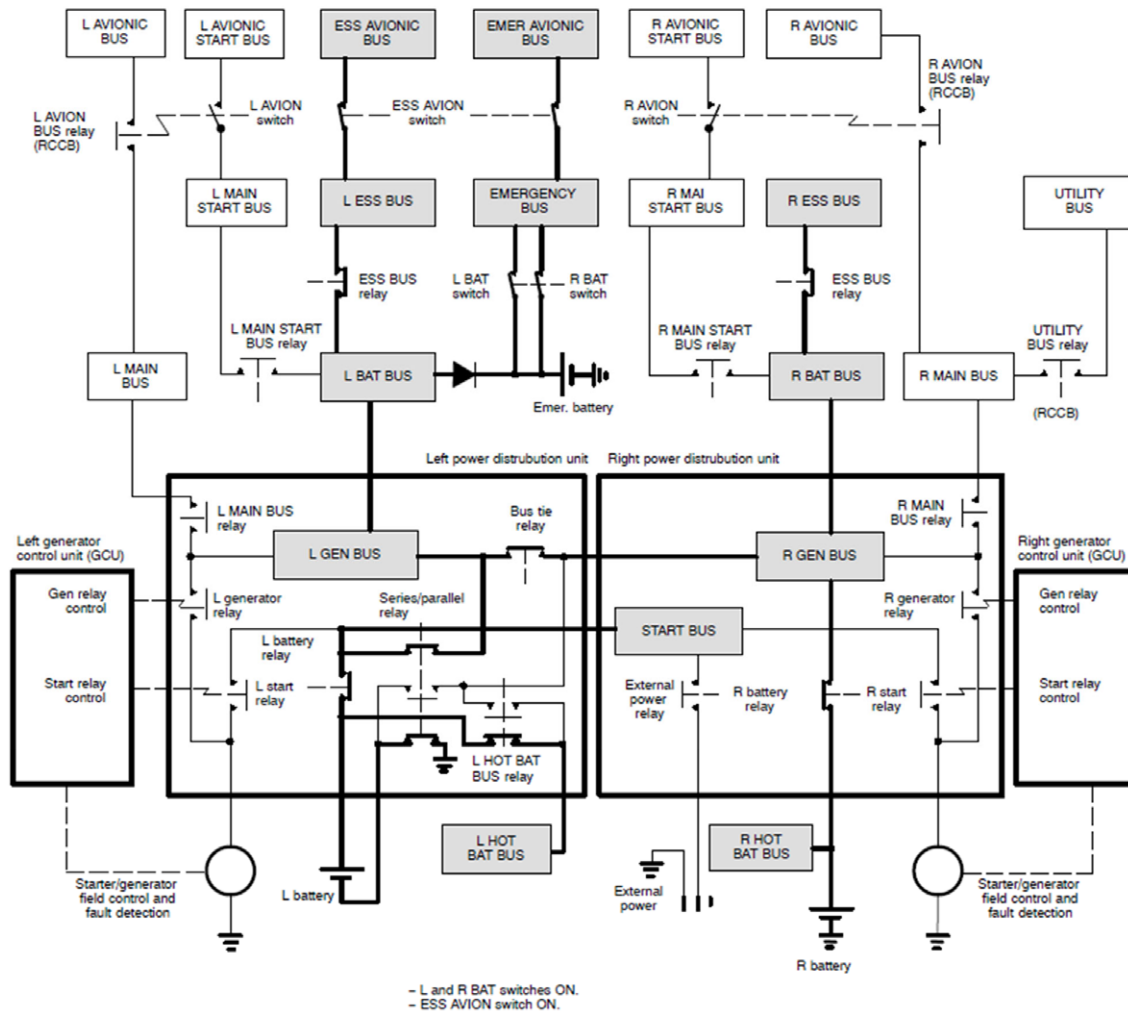
Figure 5

The GEN busses are connected automatically by the closing of the bus tie relay, thereby connecting the batteries when the aircraft is on battery power only (Figure 5). The bus tie relay is open when both generators are operating, but close following the loss of a single generator.

Electrical system showing busses (shaded) powered by battery power only
