## ACCIDENT

<b>Aircraft Type and Registration:</b>	Piper PA-28-181, G-BFSY	
<b>No &amp; Type of Engines:</b>	1 Lycoming O-360-A4M piston engine	
<b>Year of Manufacture:</b>	1977 (Serial no: 28-7890200)	
<b>Date &amp; Time (UTC):</b>	25 June 2022 at 1740 hrs	
<b>Location:</b>	Chatteris Airfield, Cambridgeshire	
<b>Type of Flight:</b>	Private	
<b>Persons on Board:</b>	Crew - 1	Passengers - 1
<b>Injuries:</b>	Crew - None	Passengers - None
<b>Nature of Damage:</b>	Damage to left wing and nosewheel spat	
<b>Commander's Licence:</b>	Airline Transport Pilot's Licence	
<b>Commander's Age:</b>	33 years	
<b>Commander's Flying Experience:</b>	1,800 hours (of which 130 were on type) Last 90 days - 90 hours Last 28 days - 35 hours	
<b>Information Source:</b>	Aircraft Accident Report Form submitted by the pilot and further enquiries by AAIB

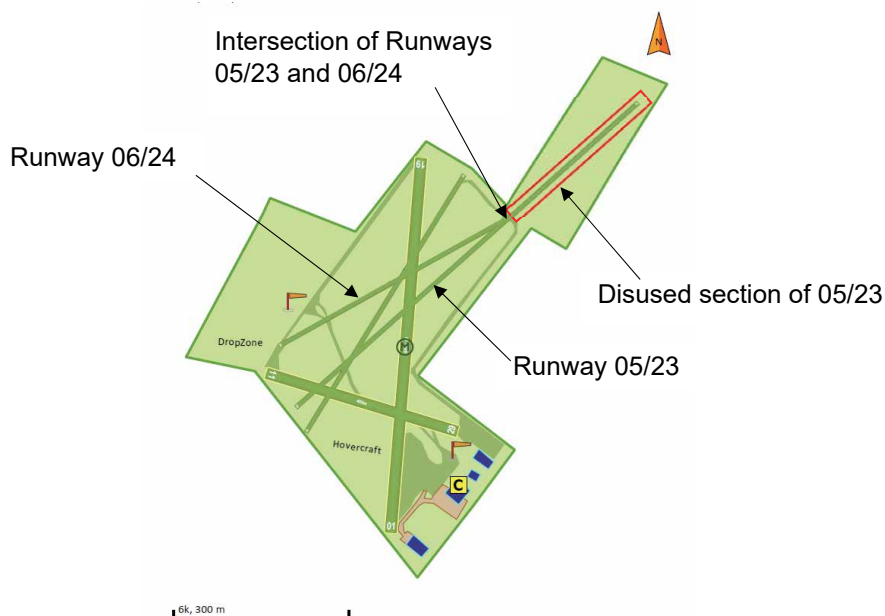
**Figure 2**  
Example Chatteris Airfield plate

The pilot used an online flight planning tool providing basic airfield information, including an airfield plan (Figure 2) known as a 'plate'. The plate for Chatteris did not mark the disused section of Runway 05/23. More detailed airfield plates are available, via subscription, within the tool which the pilot had a subscription for. These showed the disused section marked with white crosses and contained a warning; however, on this occasion, this detailed airfield plate did not display when the pilot was planning the flight.

Visiting pilot information on the airfield's flying club's website shows an older airfield plate without disused runway markings, advising Runway 05/23 is under construction and to check availability. Whether PPR was obtained by the pilot is disputed between pilot and airfield.

- The airfield management team have taken action to cut the grass of the disused section of Runway 05/23 so that the white crosses are more visible.
- The flight planning tool provider have updated their airfield plate to show the disused section of Runway 05/23.
- The flying club's website is updating their visiting pilot information to display the latest airfield plate showing the disused section of Runway 05/23.
