ACCIDENT

Aircraft Type and Registration:	EV-97 Teameurostar UK, G-CFNW	
No & Type of Engines:	1 Rotax 912-UL piston engine	
Year of Manufacture:	2008 (Serial no: 3317)	
Date & Time (UTC):	5 March 2022 at 1100 hrs	
Location:	A6105, 1.5 Miles East of Duns, Scottish borders	
Type of Flight:	Private	
Persons on Board:	Crew - 1	Passengers - None
Injuries:	Crew - 1 (Minor)	Passengers - N/A
Nature of Damage:	Damaged beyond economical repair	
Commander's Licence:	National Private Pilot's Licence	
Commander's Age:	60 years	
Commander's Flying Experience:	950 hours (of which 499 were on type) Last 90 days - 7 hours Last 28 days - 6 hours	
Information Source:	Aircraft Accident Report Form submitted by the pilot

Synopsis

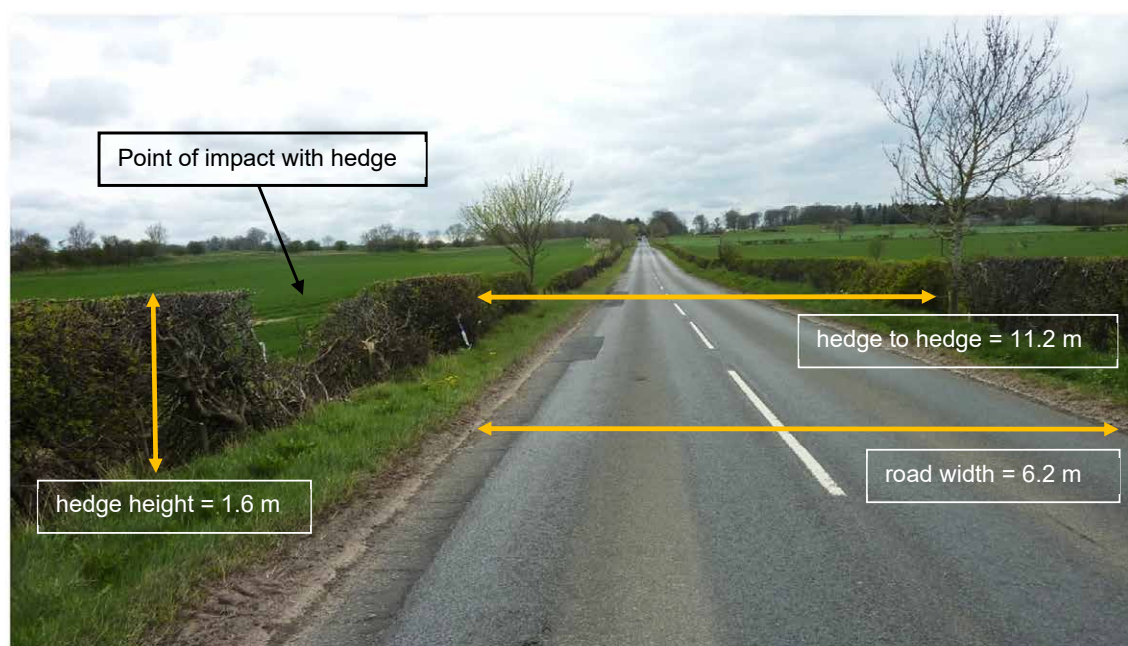
Figure 2

The A6105 connects the village of Earlston to Berwick-upon-Tweed, passing through Duns. It is single carriageway and the police reported that it is often busy with local traffic. For road and obstacle dimensions see Figure 2.

A6105 looking south-west towards Duns along the takeoff path
(image used with permission)

The EV-97 Teameurostar UK has a wingspan of 8.1 m giving a clearance on each wing tip of 1.55 m from the hedges at the side of the road.

The accident occurred because the pilot was unable to maintain sufficient directional control of the aircraft during the takeoff to prevent the left wing colliding with the hedge. The pilot believed this was because of an unexpected gust of wind. The hedges were 1.6 m high and the clearance on each wing tip was 1.55 m. Both the width of the road and the distance between the hedges lining the road were significantly less than the minimum dimensions recommended by the CAA in CAP 793: that the runway width should be 10 m and that there should be no vertical obstructions within 25 m of the centreline.
