**ACCIDENT**

<b>Aircraft Type and Registration:</b>	MA Scale F4 Phantom	
<b>No &amp; Type of Engines:</b>	1 Turbine engine	
<b>Year of Manufacture:</b>	2021 (Serial no: N/A)	
<b>Date &amp; Time (UTC):</b>	16 September 2021 at 1430 hrs	
<b>Location:</b>	Near Kenyon Hall Farm Airfield, Warrington, Cheshire	
<b>Type of Flight:</b>	Private	
<b>Persons on Board:</b>	Crew - N/A	Passengers - N/A
<b>Injuries:</b>	Crew - N/A	Passengers - N/A
<b>Nature of Damage:</b>	Destroyed	
<b>Commander's Licence:</b>	Other	
<b>Commander's Age:</b>	72 years	
<b>Commander's Flying Experience:</b>	Unknown hours (of which unknown were on type) Last 90 days - unknown hours Last 28 days - unknown hours	
<b>Information Source:</b>	Aircraft Accident Report Form submitted by the pilot and further AAIB enquiries

**Synopsis**

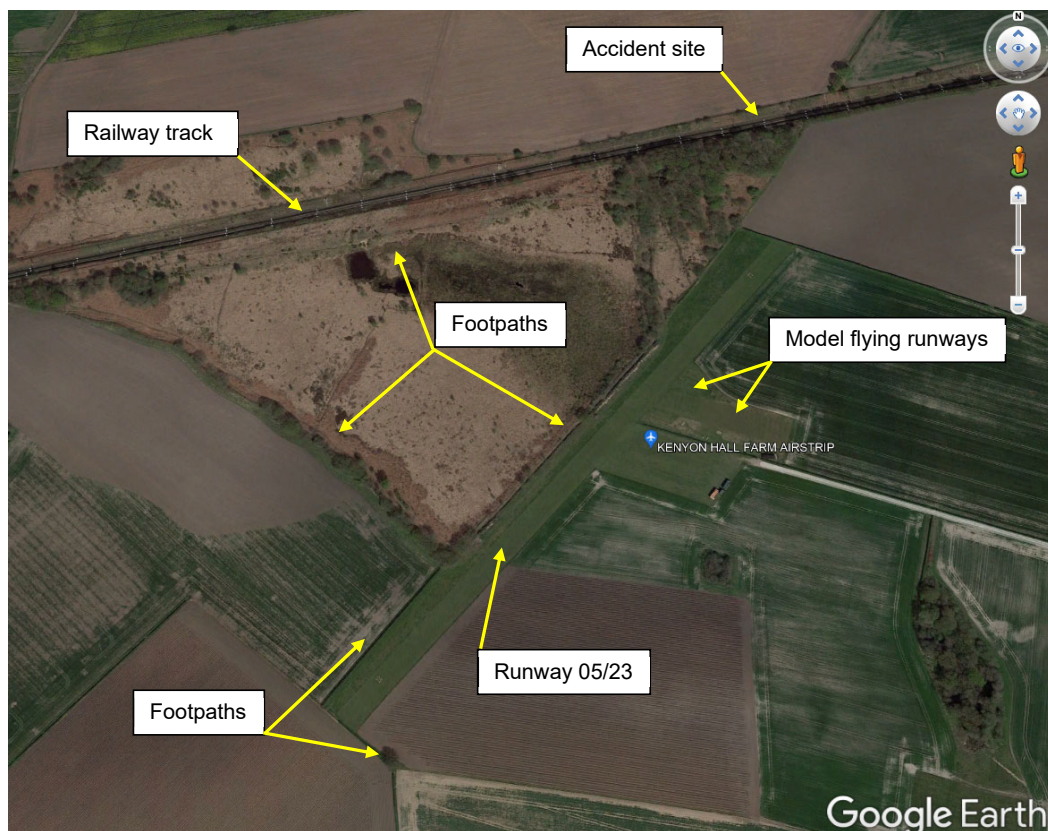
**Figure 1**  
Airfield overview

The model flying club is based at Kenyon Hall Farm Airstrip (Figure 1), which is an unlicensed airfield with a grass Runway 05/23 for full size aircraft. There are two runways for model flying, a 75 m strip adjacent and parallel to 05/23 and a 110 m strip, which runs in an east-west direction. A railway track passes to the north of the site. There are several public footpaths which run along the north-west boundary of the airfield, and in the area between the airfield and railway track.

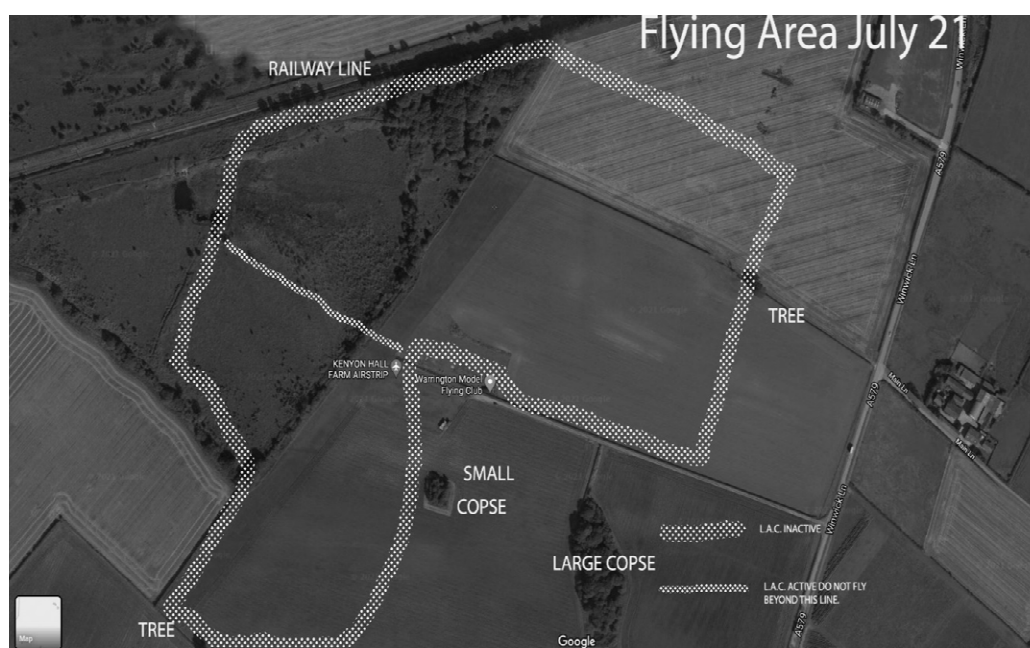
**Figure 2**

The model flying club was affiliated with the BMFA. The club procedures contained an airfield diagram depicting the approved overfly zone (Figure 2) and advised that members should ‘avoid flying at distance’ in the direction of the railway track.

Airfield overfly area from model flying club procedures

The club procedures required members to avoid intentionally flying their aircraft in the direction of the railway track, but its risk assessment did not include the hazard of an inflight loss of control resulting in an aircraft crashing beyond visual line of sight, including on or close to the railway. There was consequently no guidance on alerting Network Rail to the potential threat of an object on the track and no guidance to members about the hazards of entering an active railway track.

After the accident the club amended its procedures to require any turbine powered model to be approved by the club committee before it can be flown at the site, so that its suitability can be assessed. Following this investigation the club added a section to its procedures relating to retrieval of models that land outside the airfield boundary, which directly references the Network Rail 24-hour emergency telephone number.
