AAIB Bulletin S2/2022

SPECIAL

SERIOUS INCIDENT

Aircraft Type and Registration:	Bombardier CL-600-2B16 (604 variant), D-AAAY	
No & Type of Engines:	2 General Electric CF34-3B turbofan engines	
Year of Manufacture:	2004 (Serial no: 5602)	
Date & Time (UTC):	10 August 2022 at 1640 hrs	
Location:	In the climb after departing from Farnborough Airport, Hampshire	
Type of Flight:	Commercial Air Transport (Passenger)	
Persons on Board:	Crew - 3	Passengers - 7
Injuries:	Crew - None	Passengers - None
Nature of Damage:	Still under assessment	
Commander's Licence:	Airline Transport Pilot's Licence	
Commander's Age:	56 years	
Commander's Flying Experience:	13,091 hours (of which 5,655 were on type) Last 90 days – 102 hours Last 28 days – 41 hours	
Information Source:	AAIB Field Investigation

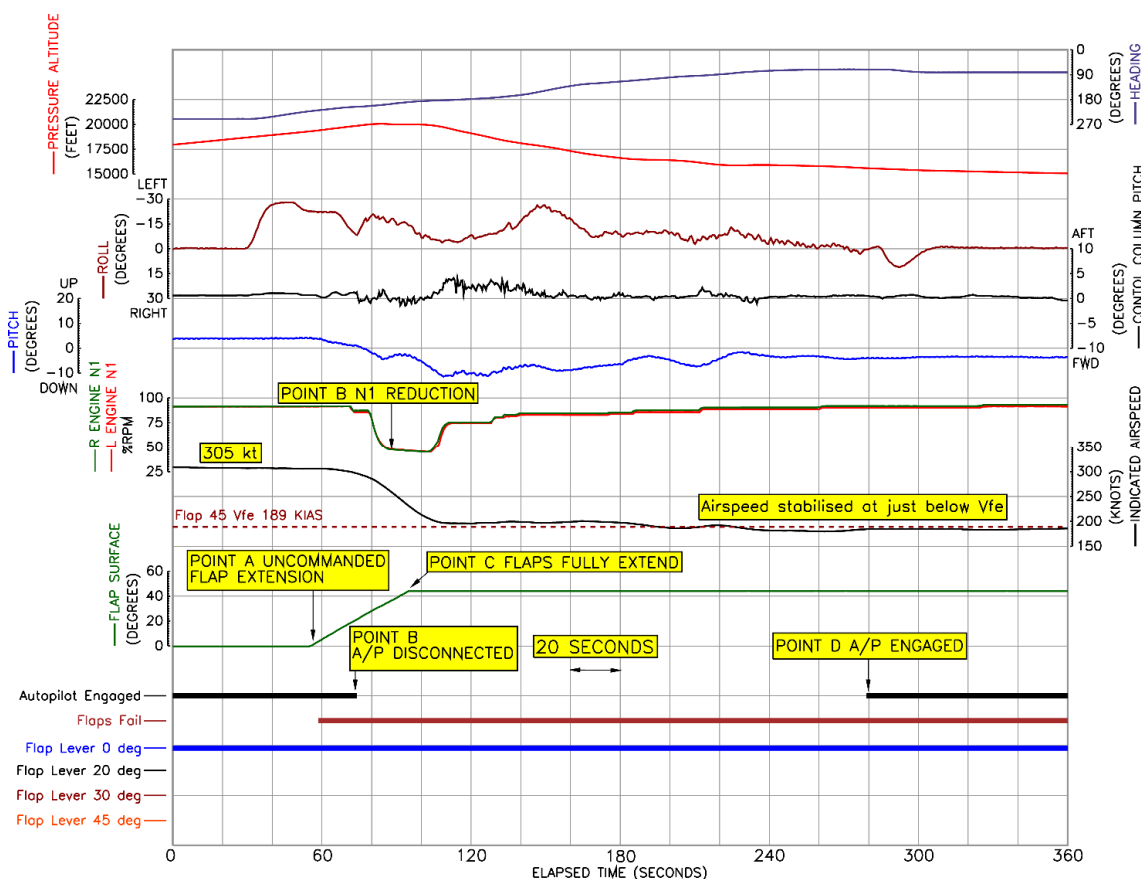
Figure 2

to extend whilst the flap control lever remained in the flap 0 position (Figure 2, Point A). The rate at which the flaps extended was about 1.1°/sec, which was about half the normal extension speed. The autopilot remained engaged, and the aircraft's speed started to progressively reduce whilst also pitching down from 4° nose up. Shortly after, a flap failure message was recorded, which occurred when the flaps had extended by about 3°.

As the flaps reached 20°, the airspeed was 296 KIAS, which was 65 kt above flap 20 VFE. This coincided with the flight crew disconnecting the autopilot and reducing engine thrust from 91% to 47% N1 (Figure 2, Point B). The flaps continued to extend over the next 21 seconds until reaching 45° where they stopped, at which point the airspeed was 234 KIAS, 45 kt above flap 45 VFE (Figure 2, Point C).

FDR data of uncommanded flap extension

170 seconds, which was the time between the flaps starting to extend from 0°, and the airspeed having been stabilised at just below 189 KIAS with the flaps at 45°. During this period, the maximum flap overspeed was about 103 KIAS.

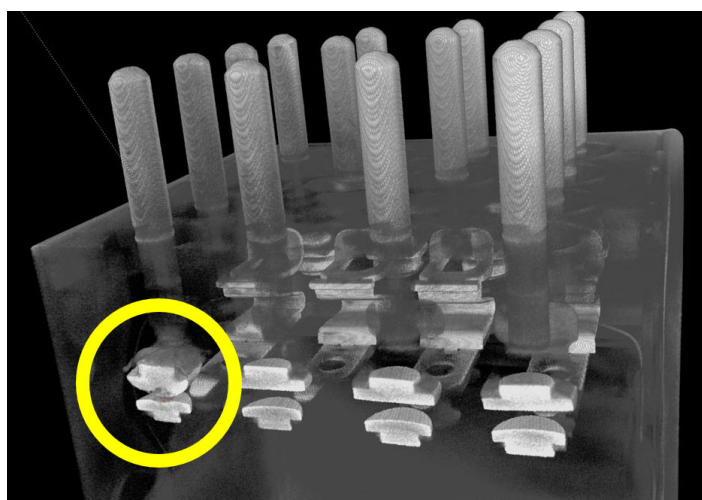
The testing and inspection identified that the No 1 motor retract relay was not working as expected.

All four of the flap extend / retract relays were taken to a specialist facility and were scanned using a computerised tomography (CT) scanner. Figure 4 is an image of the No 1 motor retract relay from the scan showing a contact anomaly. This anomaly is being investigated further, along with discrepancies in the operation of the relay.

CT scan image of a contact anomaly in No1 motor retract relay

The fault with the No 1 retract relay meant the No 1 motor continued to operate and the wing tip brakes did not engage. The No 2 relays worked as expected and the No 2 motor was unpowered. Consequently, the flaps continued to extend uncommanded at half speed, driven by the No 1 motor, until they reached the limit stop.

5. Fault finding identified an anomaly with the operation of the electrical contacts inside the No1 retract relay. The result of this anomaly was that as the flaps were only being driven by one of the two motors, they retracted at half-speed.

By 20 October 2022, Bombardier will advise operators, through an Advisory Wire, of the existing maintenance tasks that will identify if the flaps are operating at half speed.

Transport Canada have advised that Bombardier and Transport Canada will determine any appropriate actions to ensure that the protection system on the Challenger 600 series of aircraft will stop an uncommanded flap extension and the system operates as intended. Transport Canada will mandate such actions as necessary for the continued safe operation of the aircraft.
