INCIDENT

Aircraft Type and Registration:	Leonardo AW189, G-MCGT	
No & Type of Engines:	2 General Electric Co CT7-2E1 turboshaft engines	
Year of Manufacture:	2014 (Serial no: 92006)	
Date & Time (UTC):	30 July 2021 at 1530 hrs	
Location:	Near Heads of Ayr, South Ayrshire	
Type of Flight:	Training	
Persons on Board:	Crew - 4	Passengers - None
Injuries:	Crew - None	Passengers - None
Nature of Damage:	None	
Commander's Licence:	Airline Transport Pilot's Licence	
Commander's Age:	41 years	
Commander's Flying Experience:	5,276 hours (of which 1,228 were on type) Last 90 days – 78 hours Last 28 days – 14 hours	
Information Source:	AAIB Field Investigation

Synopsis

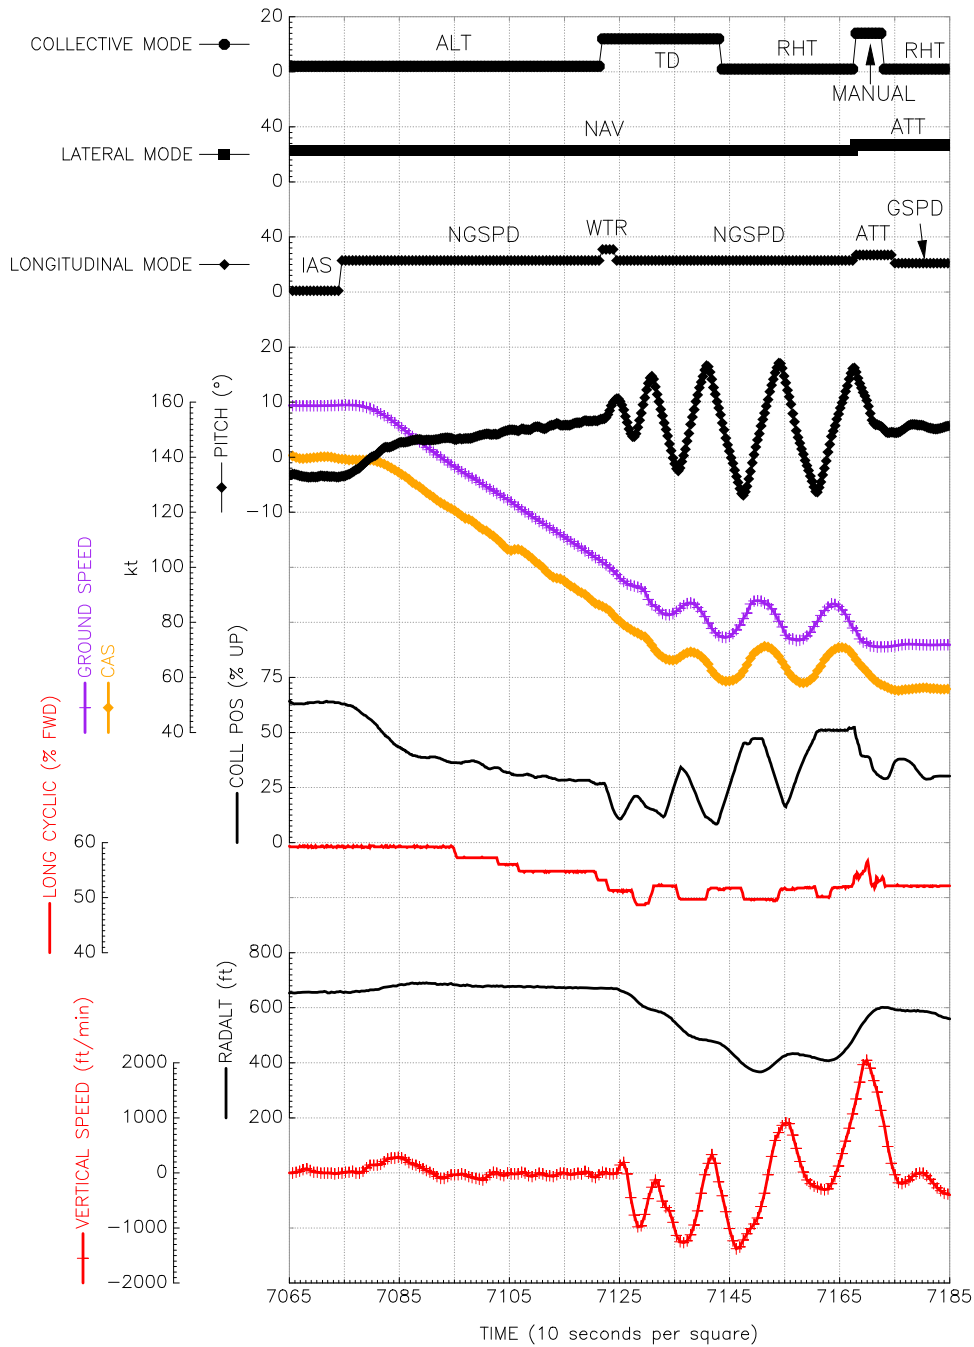
Figure 4
 Pertinent extracts of FDM data from the 5 July 2021 incident

The sequence shown in Figure 4 started with AFCS collective mode ALT captured, maintaining a selected altitude, lateral NAV mode captured, following an FMS path, and longitudinal IAS, holding approximately 140 KCAS. The longitudinal mode switched to NGSPD indicating that a search pattern had been activated. The helicopter pitched up slowly to decelerate to a target groundspeed associated with the search pattern.

The collective mode switched from ALT to TD to descend the helicopter from its radio height of about 670 ft to an updated radio height datum of 200 ft. Under these conditions, TD is associated with the IAS longitudinal mode to target 80 KCAS. The longitudinal mode recording showed a change to WTR mode, which was shortly followed by the helicopter pitching up. The criteria for capture of WTR were not met and information from the manufacturer (discussed later in this report) shows that it was not in fact captured and that the WTR indication was erroneous. The recorded longitudinal mode then switched back to NGSPD. The helicopter entered a cycle of pitching up and down manoeuvres, with the biggest transition being from 6.9° nose down to 17.1° nose up about 6.5 seconds later.

The collective mode was recorded to switch to RHT as the helicopter descended through a radio height of 470 ft with an increasing descent rate. This would have been triggered by pressing the collective FTR. At this point the helicopter pitch was approximately 8° nose up but with a nose-down pitch rate of 4.1°/s. The radio height datum updated to helicopter height as the RHT mode captured. During the following oscillation, the height reduced to 367 ft before recovering, and further radio height datum adjustments were made. This deviation was after more than two complete cycles of pitch oscillations.

The pitch oscillations continued for more than 40 seconds before the upper AFCS modes were deselected, and the crew took manual control of the helicopter using the primary ATT modes.

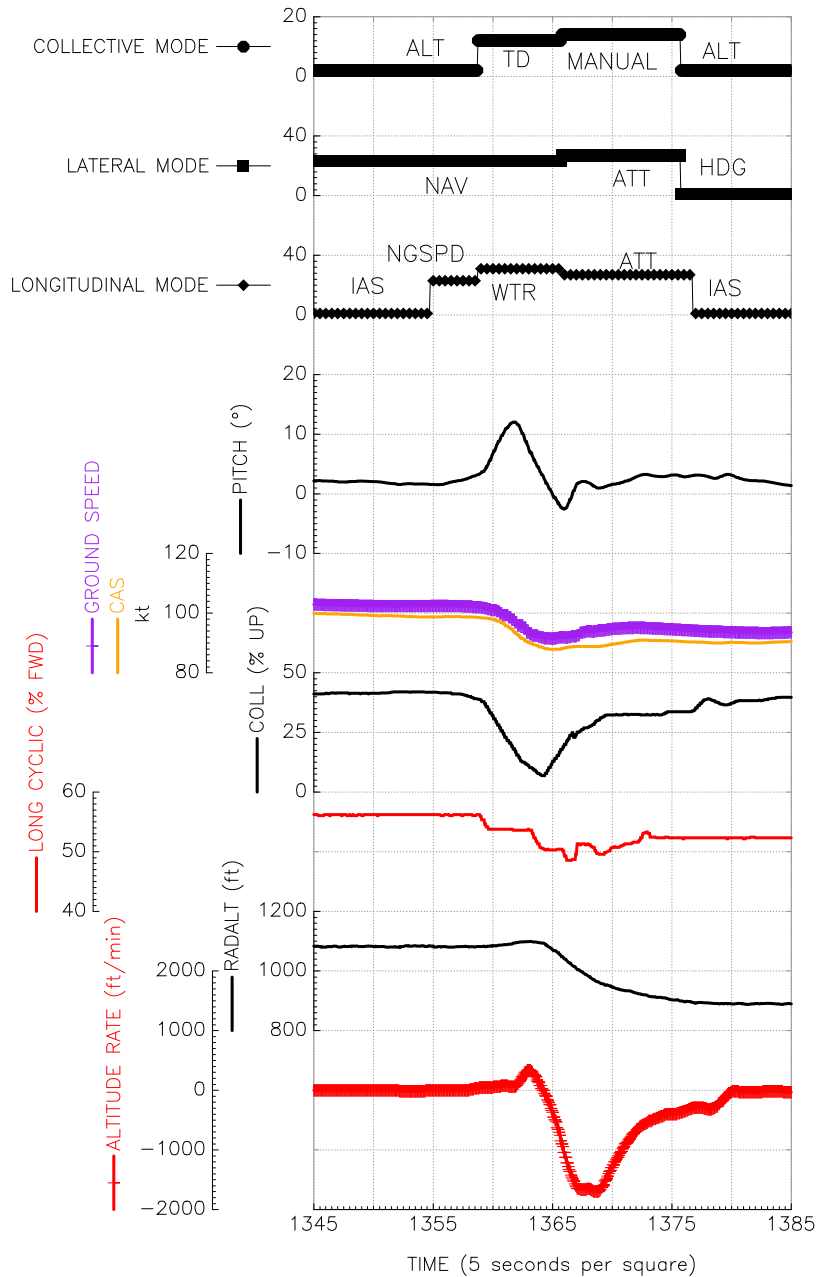
Figure 5
 Pertinent extracts of flight recorder data from the 30 July 2021 incident

This event started with the helicopter flying at approximately 1,100 ft agl and 100 KCAS, with the AFCS collective ALT mode captured, along with the NAV and IAS modes. The longitudinal mode switched to NGPSD indicating the activation of an FMS directed search pattern. The helicopter started pitching up to reduce speed. The collective TD mode was selected to initiate a descent, and the recorded longitudinal mode switched to WTR. This

was the same behaviour as observed on the 5 July 2021 incident and resulted in the same erroneous indication that WTR was captured. The switch to TD resulted in an increased rate of pitching up. The helicopter reached a peak of approximately 12° nose up and then started pitching down. As the pitch reached approximately 3° nose down, the AFCS upper modes were deselected, and the crew took manual control.

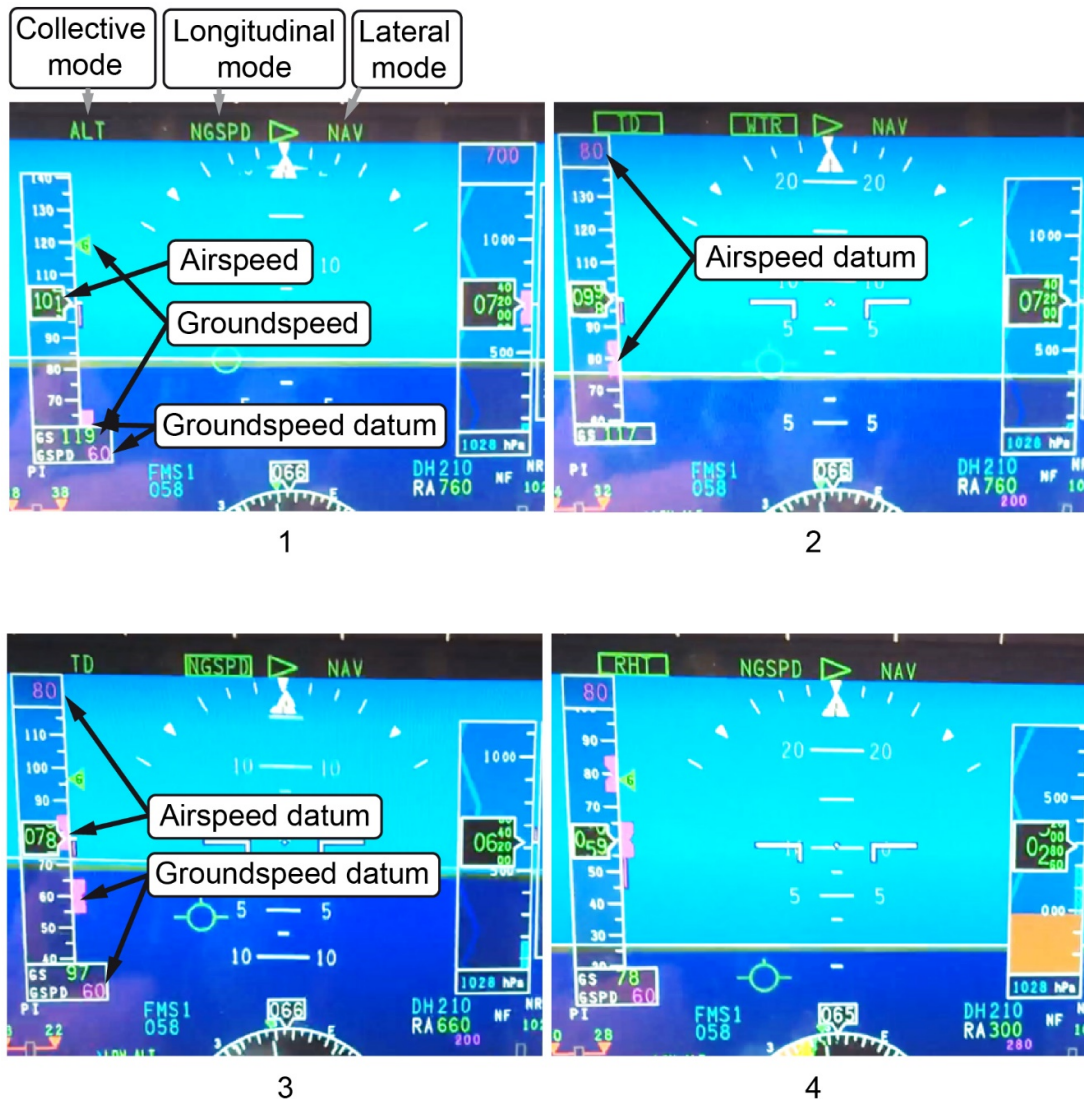
Figure 6

- 1 NGSPD active.
- 2 TD activated, longitudinal mode WTR annunciated, pitch oscillations start.
- 3 Slowed through 80 KIAS, longitudinal mode of TD switch to IAS, annunciation change to NGSPD, both groundspeed and airspeed datums.
- 4 FTR triggered height datum change, collective mode change to RHT, two speed datums persist, pitch oscillations persist until NGSPD deselected.

PFD mode annunciations and speed targets during reproduced sequence

- The trigger to the behaviour was the selection of TD mode before the search speed datum had been achieved, ie during the deceleration phase to capture the demanded GS.

- The oscillation typically ranged between a pitch attitude of 17° nose up and 8° nose down. However, the oscillation would remain within those limits and not become divergent.
- The behaviour could be replicated irrespective of whether there was a tailwind or a headwind. However, the oscillations were greater when flying into wind with either a rate of climb of 2,250 fpm or a rate of descent of 1,950 fpm.
- WTR was annunciated on the PFD Annunciator. However, the corresponding button on the APCP did not illuminate, indicating WTR was not captured. This was confirmed by a crewman monitoring his station in the rear of the aircraft.

The behaviour would stop temporarily while cyclic FTR was depressed, and completely on selection of GSPD on the APCP, or on the deselection of the upper modes. It was noted that the behaviour could not be replicated when RHT was captured prior to the selection of TD.

In October 2021, following the conclusion of the above tests, the operator issued an FSI to crews restricting the use of NGSPD in conjunction with TD. The operator also included information on this issue in the ground school training as part of its Operator Proficiency Check programme which all of its SAR AW189 crews have received.
