AAIB Bulletin

10/2022

Aircraft Type and Registration:	BAe ATP, SE-LPS	
No & Type of Engines:	2 Pratt and Whitney Canada PW126A turboprop engines	
Year of Manufacture:	1991 (Serial no: 2043)	
Date & Time (UTC):	9 April 2021 at 0519 hrs	
Location:	Ronaldsway Airport, Isle of Man	
Type of Flight:	Commercial Air Transport (Cargo)	
Persons on Board:	Crew - 2	Passengers - None
Injuries:	Crew - None	Passengers - N/A
Nature of Damage:	None reported	
Commander's Licence:	Airline Transport Pilot's Licence	
Commander's Age:	54 years	
Commander's Flying Experience:	5,415 hours (of which 2,964 were on type) Last 90 days - 44 hours Last 28 days - 20 hours	
Information Source:	AAIB Field Investigation

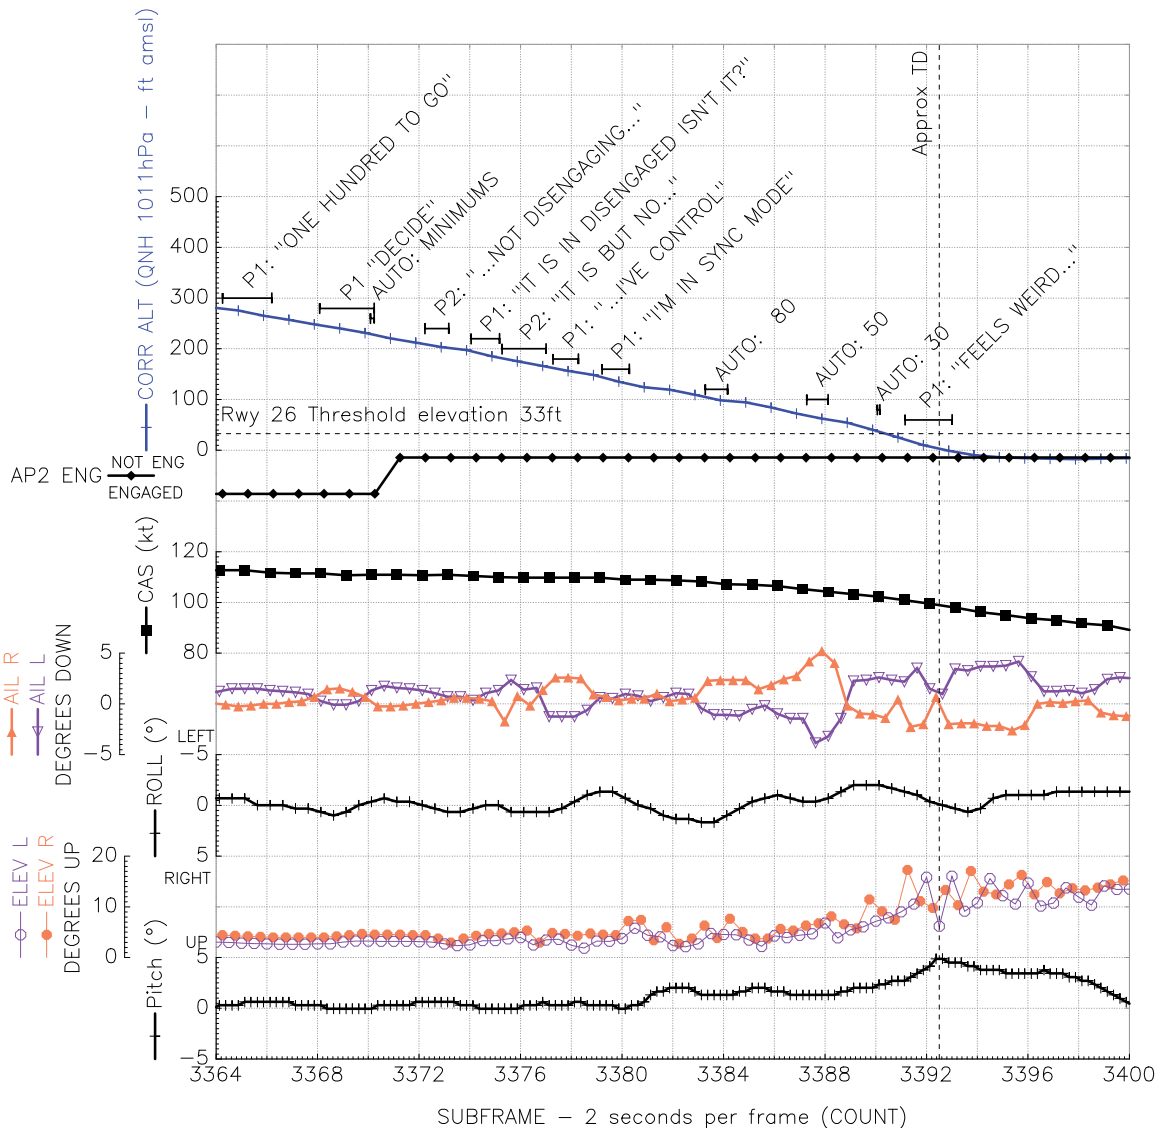
Figure 1
QAR and partial CVR extracts

The only other anomalous system behaviour identified in the recordings were that the altitude alerts recorded by the CVR during the flight were approximately 12 seconds long, which was significantly longer than the expected duration of approximately one second.

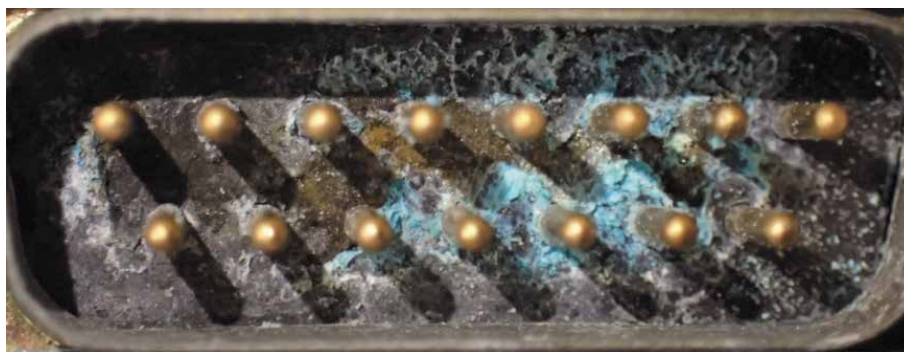
Figure 4

The electrical connector was found to be corroded when the audio warning unit was disconnected (Figure 4). The unit is located in the area beneath the DV window and the operator advised that moisture (water) ingress through the DV windows was a known problem with ATP aircraft.

Contamination and corrosion on the audio warning unit connector

- Install the extended side trim panels on all their ATP aircraft and repair any damaged panels.
- Waterproof the side-console switches on all their ATP aircraft.
- Check the rigging of every ATP DV window to make sure that they close correctly.
- Investigate the feasibility of remounting the audio warning unit and installing a drip shield to avoid moisture entering the unit from the top.

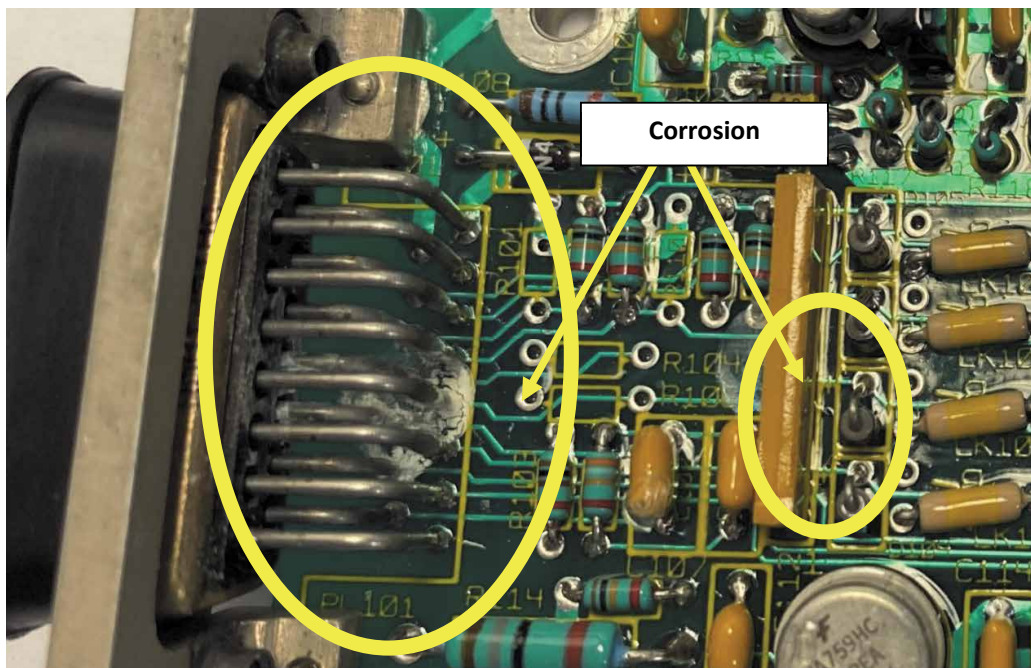
Figure 5

No faults were found when the warning unit was tested. It was dry when disassembled, but corrosion deposits were found on one of the three printed circuit boards (PCBs). Most of

the corrosion was in the area where the external electrical connector was soldered to the PCB, but deposits were also found on other areas of the circuit board (Figure 5).

Corrosion deposits inside the audio warning unit

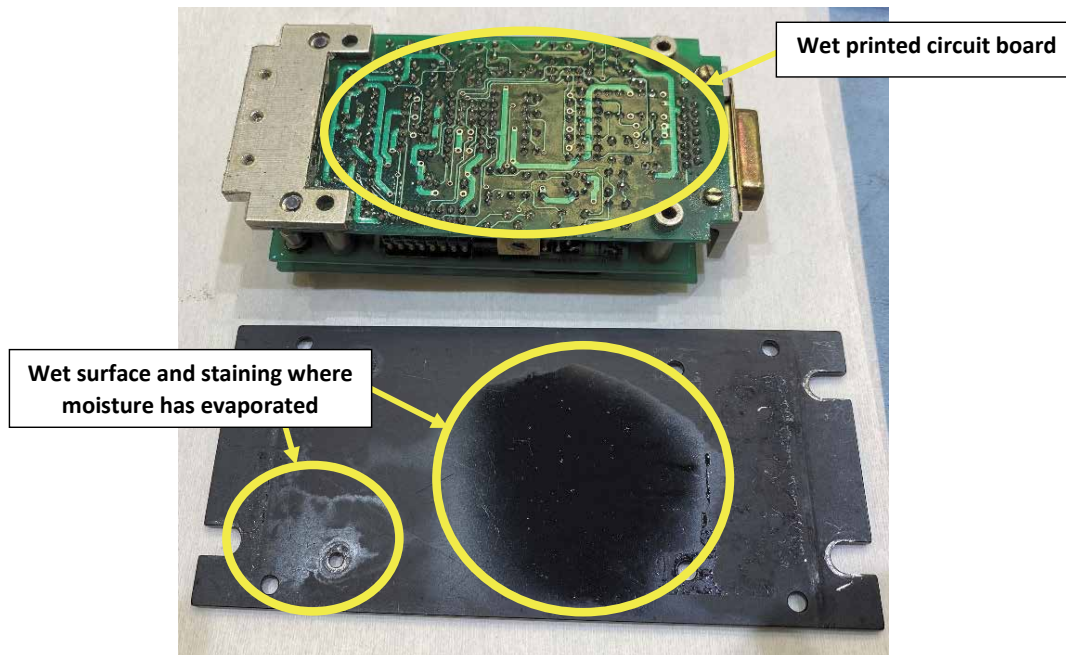
Figure 7

As the audio irregularities on SE-MAJ were very similar to those on SE-LPS, the audio warning unit from SE-MAJ was returned to the AAIB for further investigation. Visual examination found the external condition to be good but when the external cover was removed the internal components were found to be wet and corrosion was seen on one of the PCBs (Figure 7). This examination was carried out seven days after the occurrence of 2 December 2021, so it is possible that the unit had partially dried out in the intervening time.

Visible moisture in the audio warning unit

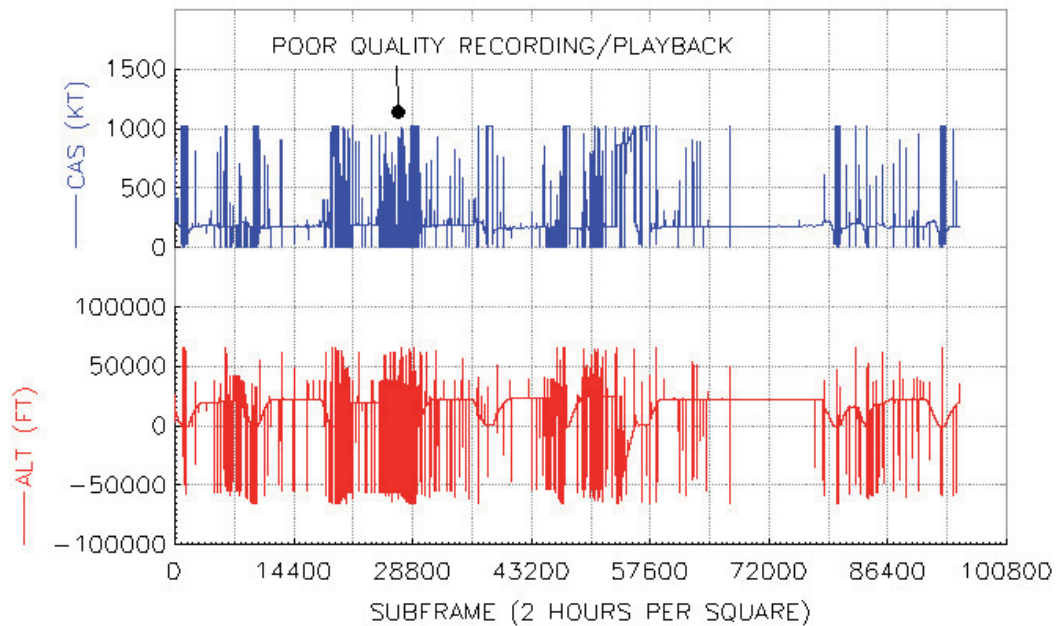
Figure 8

stop and start between flights. Additional errors are likely to occur even on a good quality installation.

Example parameters illustrating quality issues of magnetic tape FDR recording from SE-LPS

It is recommended that the Civil Aviation Authority review the use of magnetic tape flight data recorders used in aircraft operated by UK Air Operator Certificate holders and establish if there is a practical way to comply with the ICAO requirement to cease their use.

It is recommended that the Civil Aviation Authority require that magnetic tape flight data recorders, used in aircraft operated by UK Air Operator Certificate holders, comply with the Civil Aviation Authority Specification No 10, regarding the error rate requirements, by checking the complete recording rather than by undertaking a sample check.

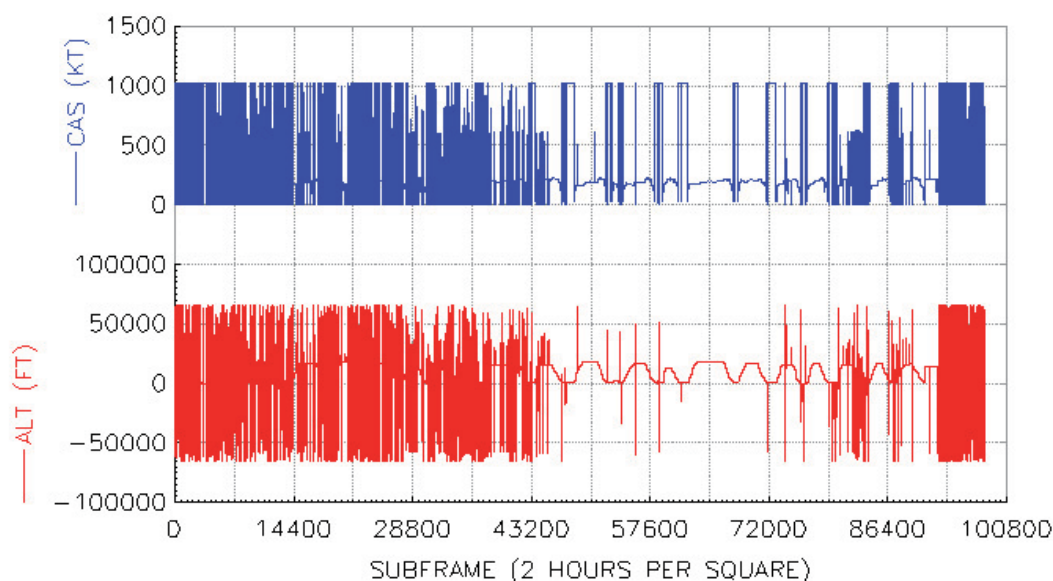
Figure 9

SE-MAJ was also fitted with the same model of FDR as SE-LPS, and the recording from its occurrence flight also had significant quality issues (Figure 9).

Example parameters illustrating quality issues of magnetic tape FDR recording, from SE-MAJ

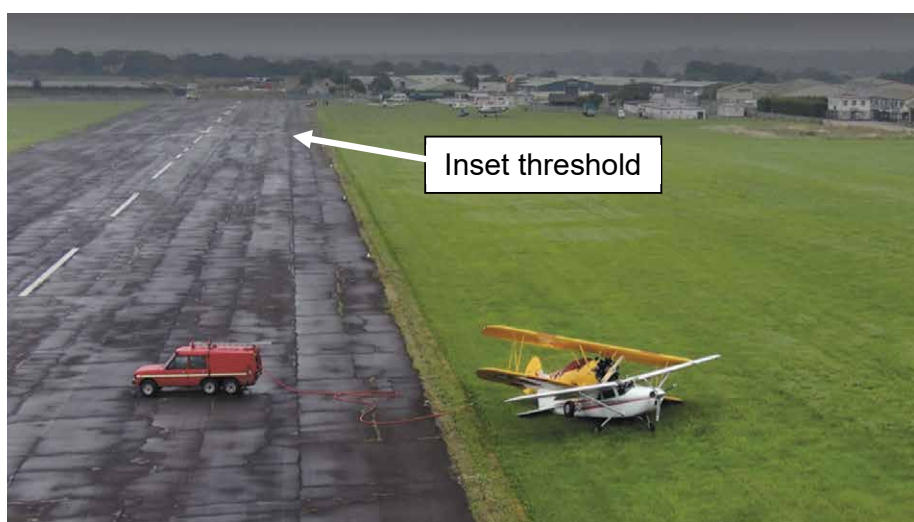
Figure 6

The pilot believed that the left landing gear had failed. Once the aircraft stopped, he looked down and saw that his aircraft was straddled on top of another aircraft, the Cessna (Figure 6).

Looking back to threshold of Runway 22
(image used with permission)

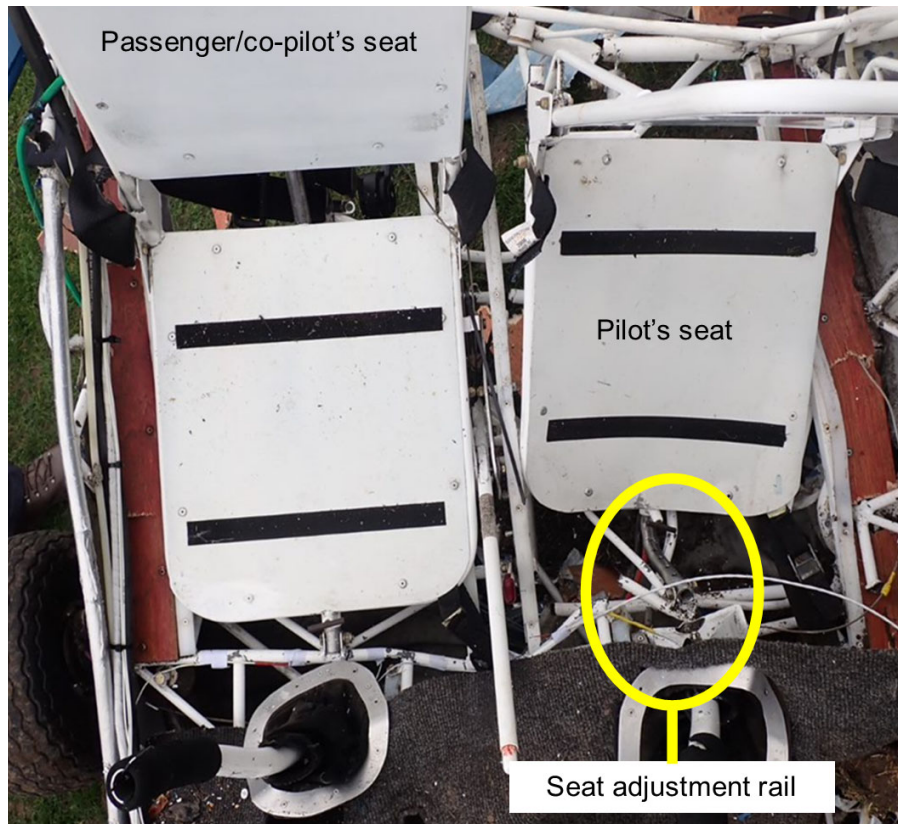
Figure 1

Seat as found at the accident site (cushions removed)

The pilot's seat (Figures 1 and 2 earlier) had been forced downwards between its runners and there was a severe bend in the seat adjuster rail. There was a distinctive score mark running along the upper face of the adjuster rail tube which was offset with the centre line of the pin location holes. There was also evidence of burrs similarly offset on the edges of the holes. Figure 9 shows the score mark and burrs. This mark and the hole burrs extend from the forwardmost hole in the adjuster rail to the fourth hole. The severe bend in the tube had distorted the remaining holes further back, to the extent that holes five and six were 'closed-up' and hole seven was hidden within the seat guide tube which ran along the rail.

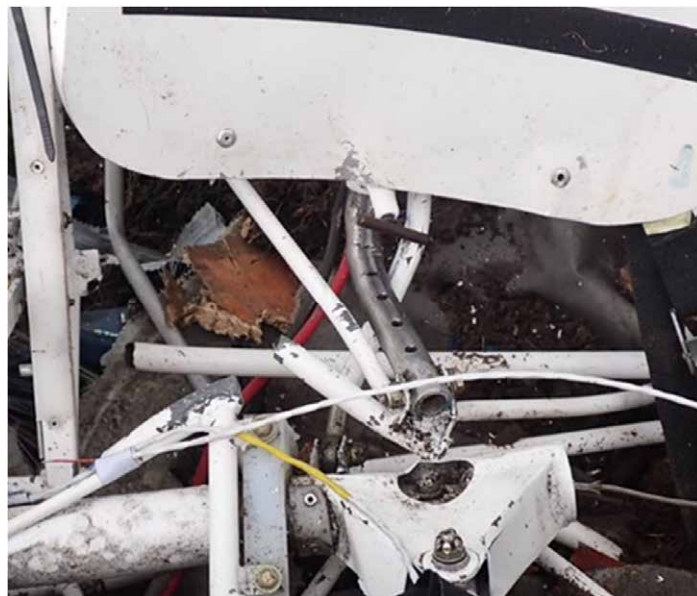
Figure 2

Damage to the pilot's seat adjustment rail

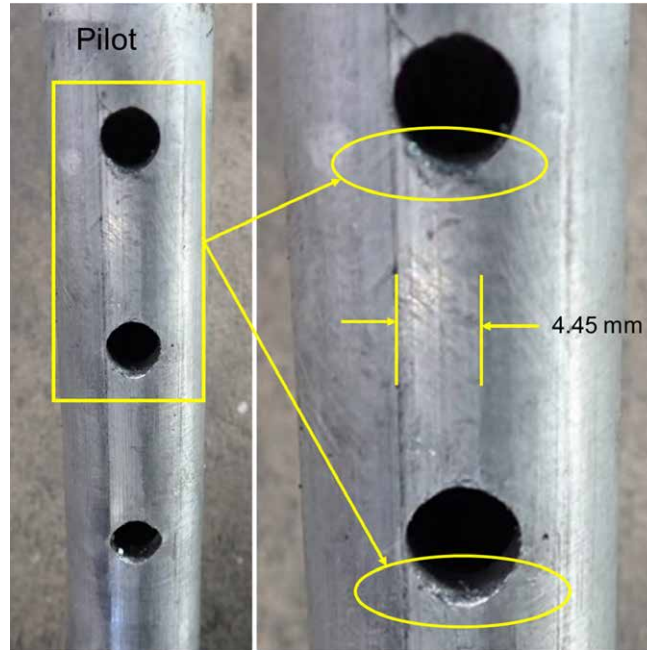
Figure 9

The aluminium alloy seat adjuster rail tube was 19.0 mm in diameter with a tube wall thickness of 3.3 mm. Where possible, measurements were taken of the visible holes which were found to have a diameter variation between 6.37 and 6.41 mm. The mark on the tube was 4.45 mm wide and offset against the hole centre line to the left by 0.43 mm. The pin was damaged and slightly bent but its engagement end could be accurately measured. The pin diameter was 6.30 mm and was chamfered leaving an end face diameter of 4.45 mm. The pin end is shown in Figure 11 and a schematic cross-sectional diagram of the dimensions and offset are shown in Figure 12. The offset shown in the diagram, represents the pin as it would naturally sit based on the dimensional evidence. The tolerance within the pin guide, plus any wear, allows the pin to advance further downwards such that the chamfer just engages in any of the adjuster rail holes against their edges. The evidence for this is shown in the preceding Figure 9.

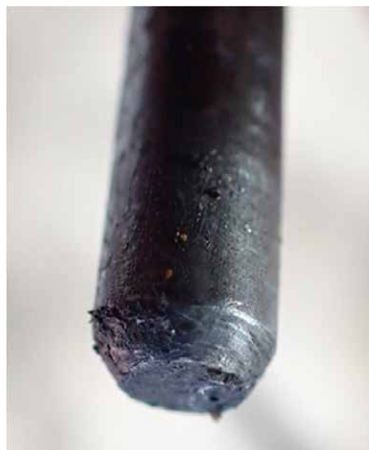
Figure 11

Pilot's seat pin chamfered end

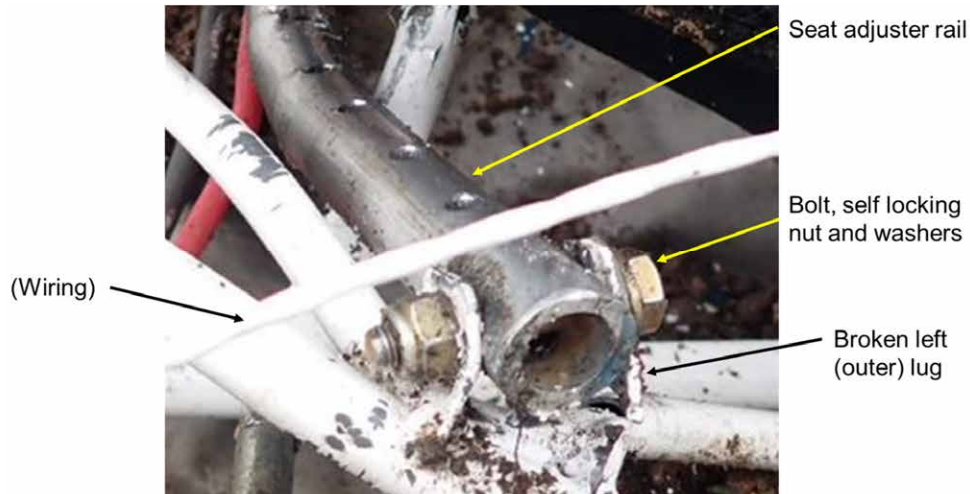
The forward attachment fitted to the cross frame had distorted and the left lug had broken away from the frame. The attachment bolt and nut were still in place but were not particularly tight. Figure 13 shows the pilot's seat adjuster rail front mounting assembly. The rear mounting point was in a similar condition to the front.

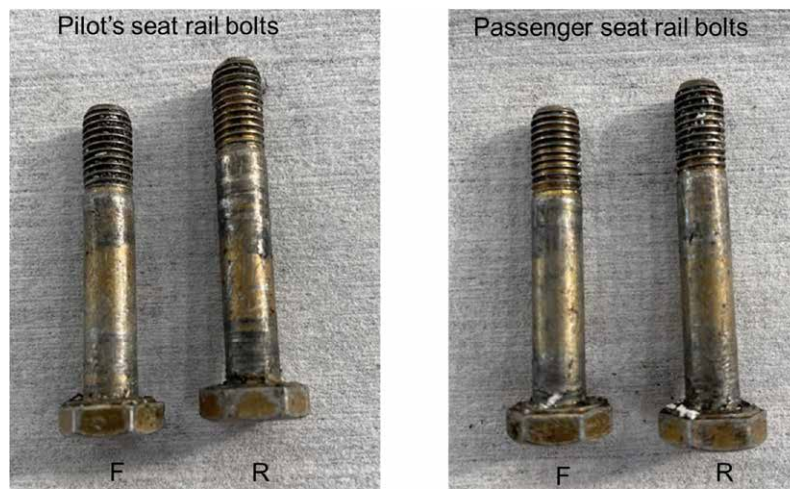
Figure 14

The front and rear lug holes were 6.49 mm diameter, the bolts were 6.2 mm diameter. The adjuster rail front mounting holes were 6.48 mm diameter. However, the rear mounting hole on the left side of the adjuster rail was slightly larger at 7.0 mm diameter. These measurements were standard clearance holes and when the bolt was loosened, allowed a play of between 0.28 mm and 0.29 mm, except in the case of the rear 7.0 mm hole, where the play was 0.8 mm. The mounting bolts on both adjuster rails showed evidence of wear, movement and fretting. The pilot's adjuster rail bolts appeared to be more worn than the passenger adjuster rail bolts (Figure 14).

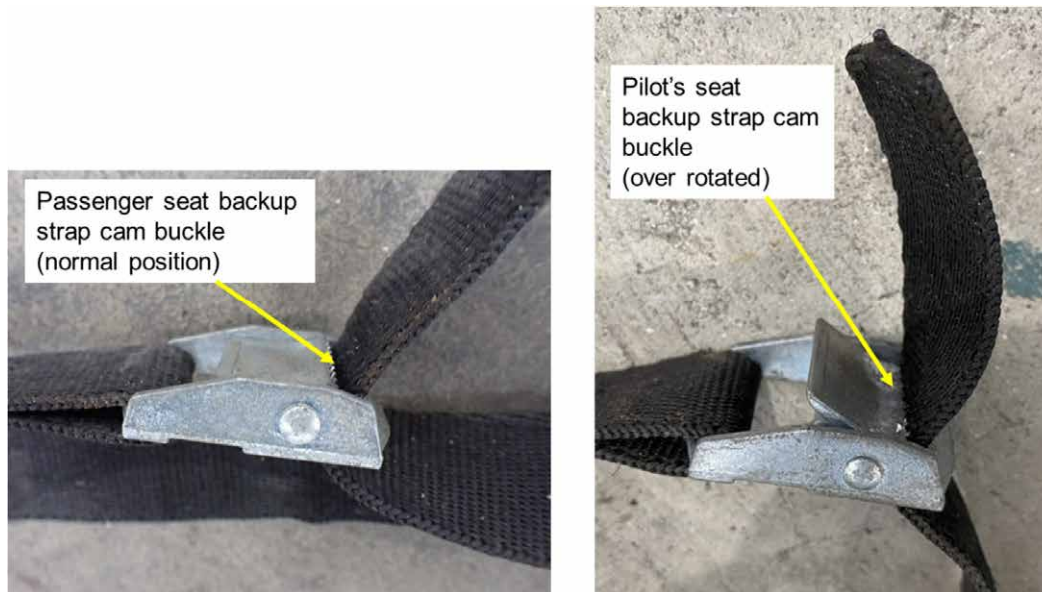
Figure 15

The pilot's seat backup strap was fitted in the same way as the passenger seat backup strap. Its cam buckle was over rotated and jammed because the webbing strap had been placed under significant tension⁴ (Figure 15).

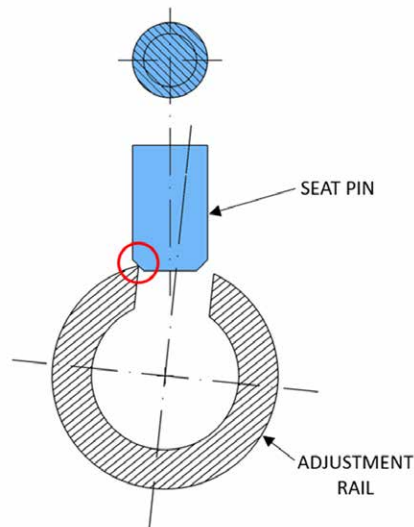
Figure 17

If the seat pin had been correctly located in the adjuster rail, the seat would have remained in its selected position. The examination and measurements of the seat adjuster rail and seat pin show that they were incorrectly aligned which hindered positive engagement of the pin in the location holes. Marks on the rail and the offset location of burrs made by the pin on the edge of the holes also suggest that the misalignment has been present for some time. This is supported by witness testimony that indicated difficulties had been experienced by the pilot in positively setting the seat position. It is therefore likely that on some occasions when the seat had felt secure, it was being held in place only by the edge of the chamfered end of the pin partially entering the hole as shown in the schematic in Figure 17.

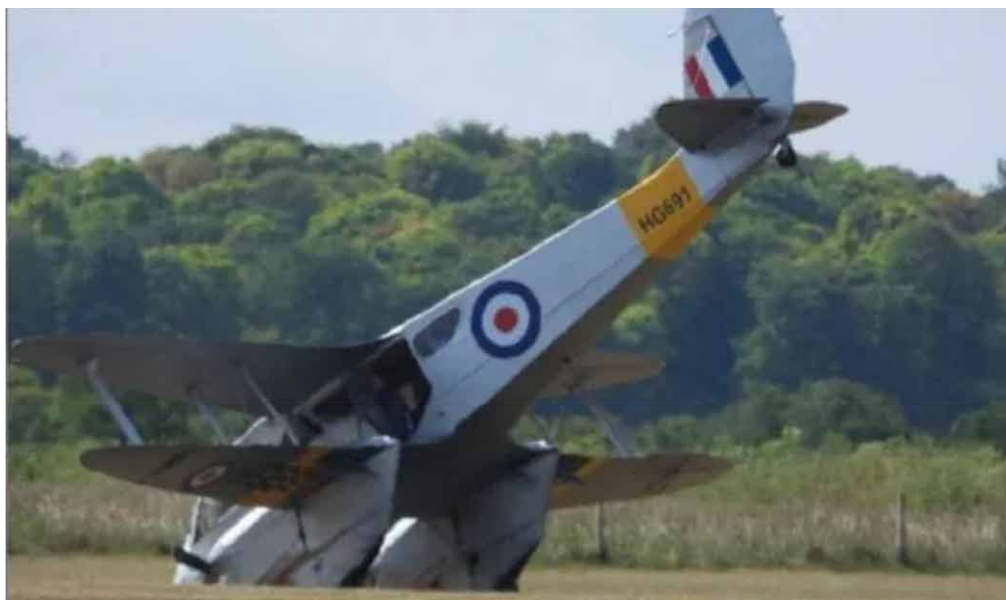
Figure 1

nose down. He described the landing as a “not particularly heavy touchdown though with a bit of a skip”. The tips of both propellers struck the runway followed by the underside of the aircraft nose. The aircraft slid with its nose touching the ground and gradually veered to the right. The aircraft departed the paved surface to the right and stopped on the grass with the nose on the ground (Figure 1).

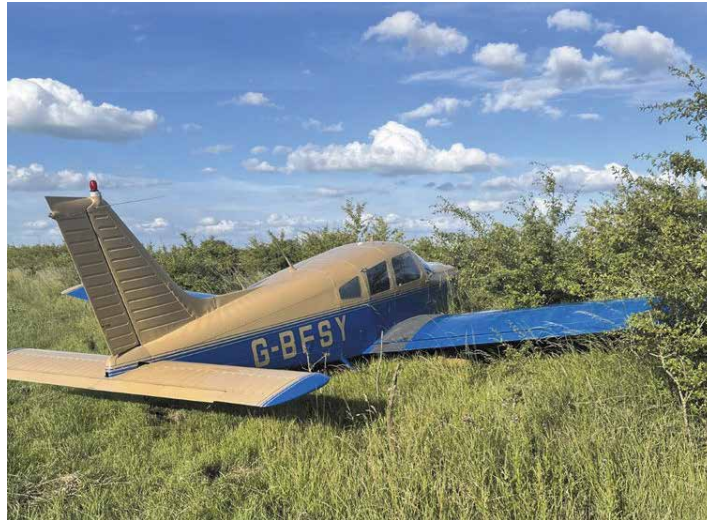
Figure 1
Accident site

The pilot reported that he did not see the white crosses during either overflight or approach, due to overgrown grass.
