SERIOUS INCIDENT

Aircraft Type and Registration:	Boeing 737-800, G-JZHL	
No & Type of Engines:	2 CFM CFM56-7B26E turbofan engines	
Year of Manufacture:	2016 (Serial no: 63568)	
Date & Time (UTC):	1 December 2021 at 1452 hrs	
Location:	Kuusamo Airport, Finland	
Type of Flight:	Commercial Air Transport (Passenger)	
Persons on Board:	Crew - 6	Passengers - None
Injuries:	Crew - None	Passengers - N/A
Nature of Damage:	None	
Commander's Licence:	Airline Transport Pilot's Licence	
Commander's Age:	44 years	
Commander's Flying Experience:	7,459 hours (of which 3,344 were on type) Last 90 days - 204 hours Last 28 days - 47 hours	
Information Source:	AAIB Field Investigation

Synopsis

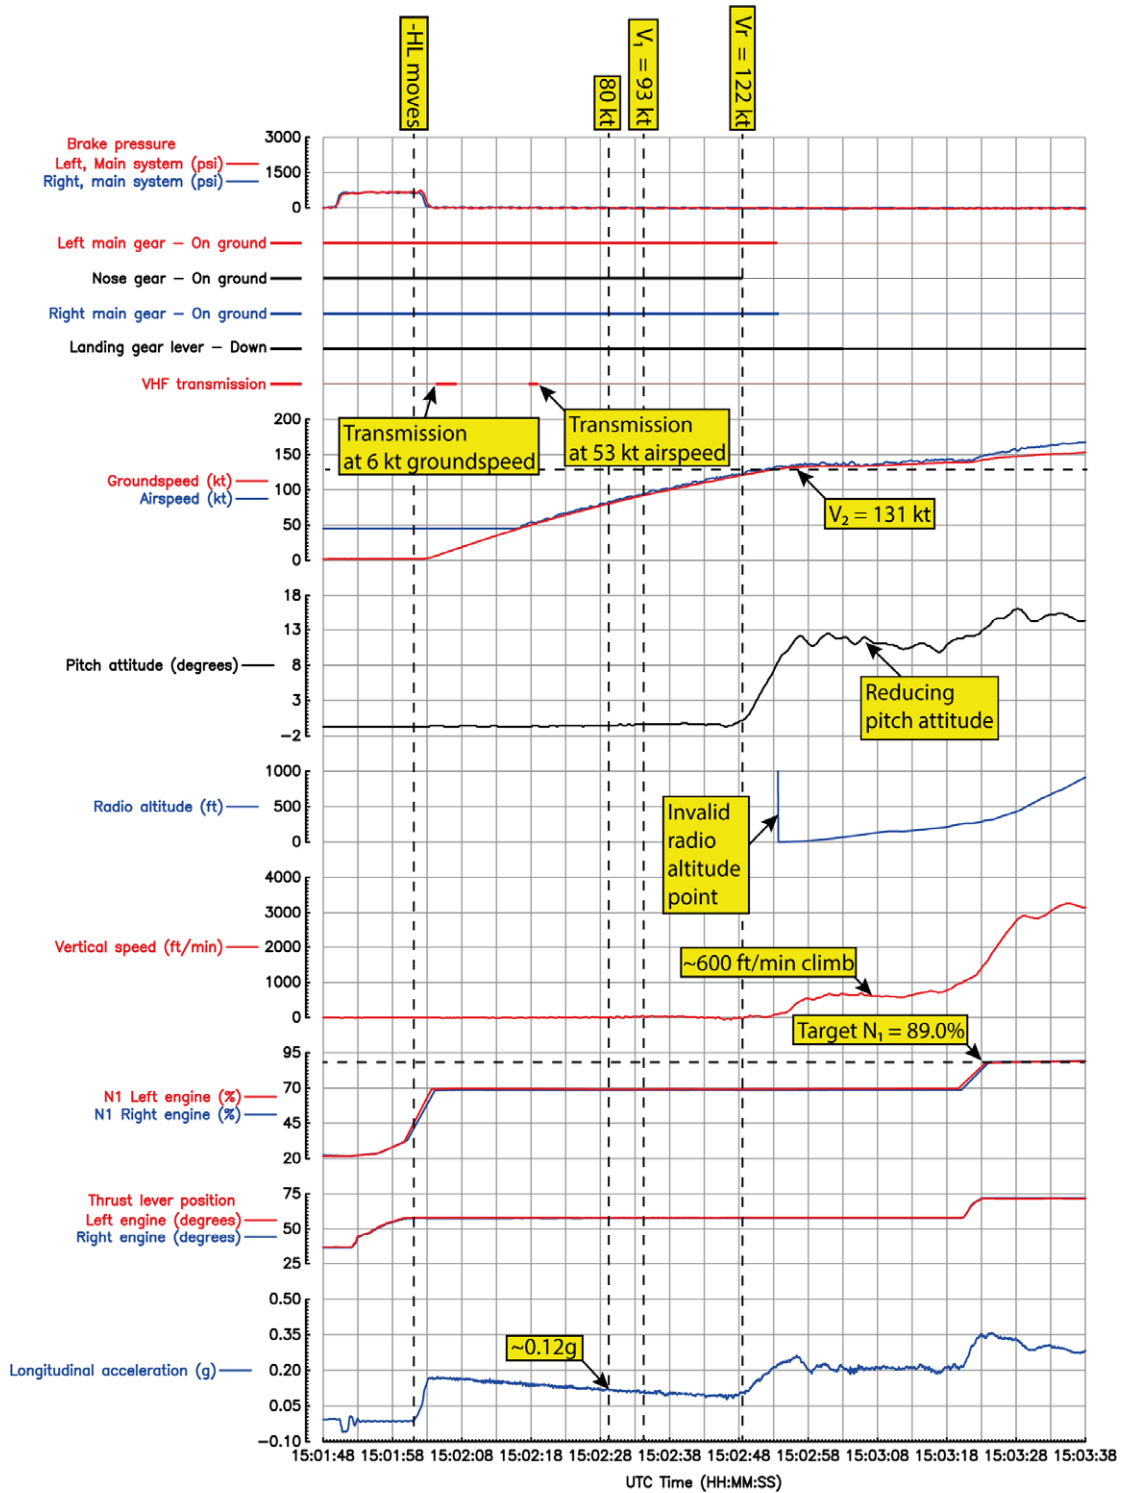
Figure 2 shows salient data from the FDR for the takeoff and second segment climb. It shows that, although the maximum system braking pressure is 3,000 psi, a brake pressure of only 600-700 psi was applied before the thrust levers were slowly advanced for the pre-takeoff engine run-up. Twelve seconds later, as the engines were spooling up towards 70% N_1 , and with 600-700 psi brake pressure still applied, the recorded longitudinal acceleration shows that G-JZHL began to move. The brakes were then released, and the engines stabilised at 70% N_1 . G-JZHL accelerated and, on passing 6 kt groundspeed, a radio transmission was made from the aircraft, followed by another transmission at 53 kt airspeed. At 80 kt airspeed, G-JZHL was accelerating at approximately 0.12g, or 2.25 kt/second, and attained V_1 , with the engines still at 70% N_1 , 32 seconds after brake release. At V_R , the aircraft was rotated for takeoff, leaving the ground six seconds later and establishing a 600 ft/min rate of climb in which the airspeed settled around V_2 . However, G-JZHL did not accelerate any further, despite the pitch attitude of the aircraft being reduced and the retraction of the landing gear, until 250ft agl when the thrust levers were advanced to 89% N_1 , the correct power setting for the takeoff.

FDR data for G-JZHL's takeoff and second segment climb

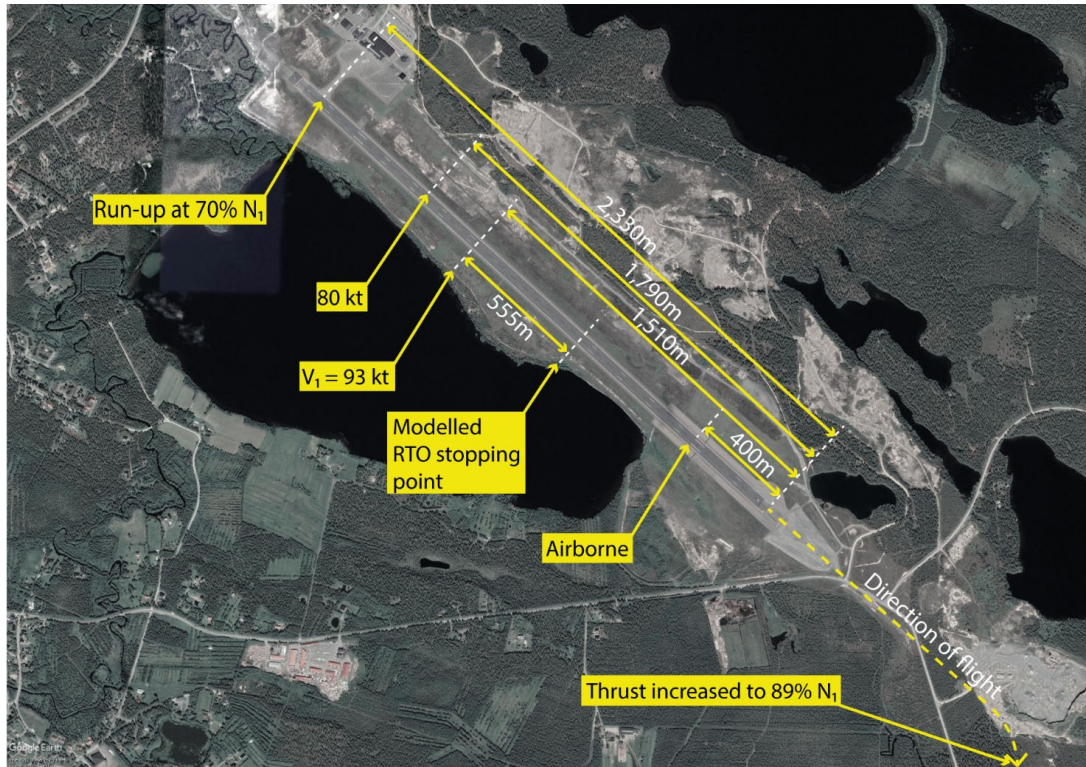
Figure 3 shows the takeoff and second segment climb in plan view. The distance from where G-JZHL performed the pre-takeoff engine run-up until the end of the runway is 2,330 m. G-JZHL passed 80 kt with 1,790 m of runway remaining ahead of the aircraft and, at V_1 , 1,510 m remained ahead of the aircraft. G-JZHL became airborne 400 m from

the end of the runway, and the thrust was restored to 89% N_1 approximately 1,800 m after G-JZHL lifted off.

Plan view of G-JZHL's takeoff and second segment climb

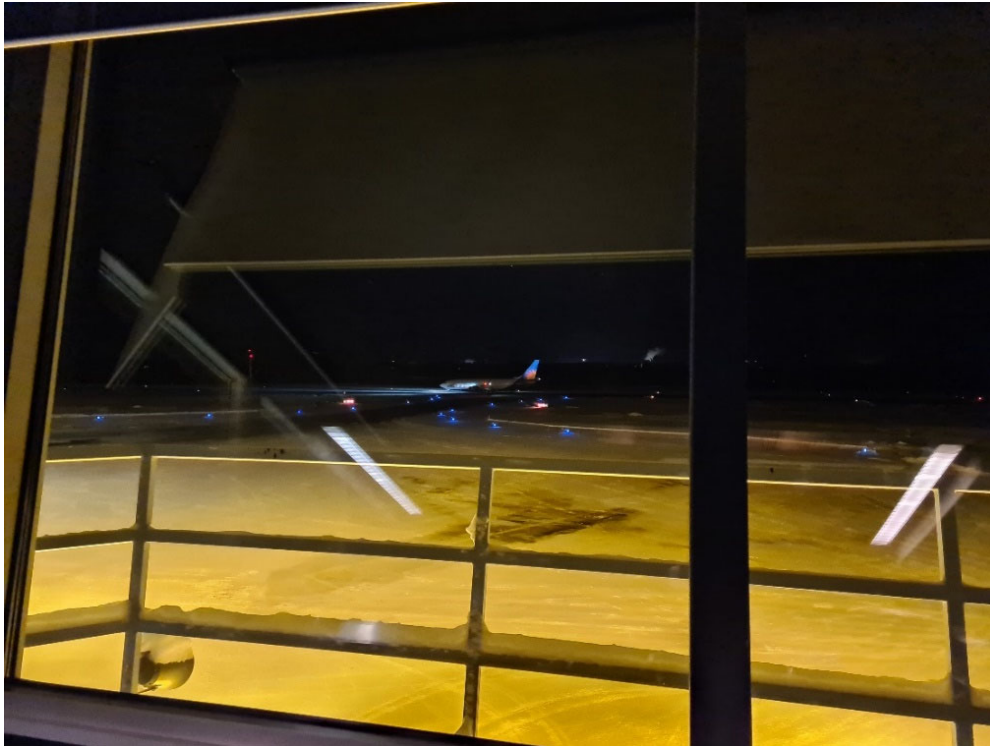
Figure 6

The FISO reported that they could see that the aircraft had commenced its takeoff roll (view from the tower at a similar time of day is shown in Figure 6).

View from the ATC Tower

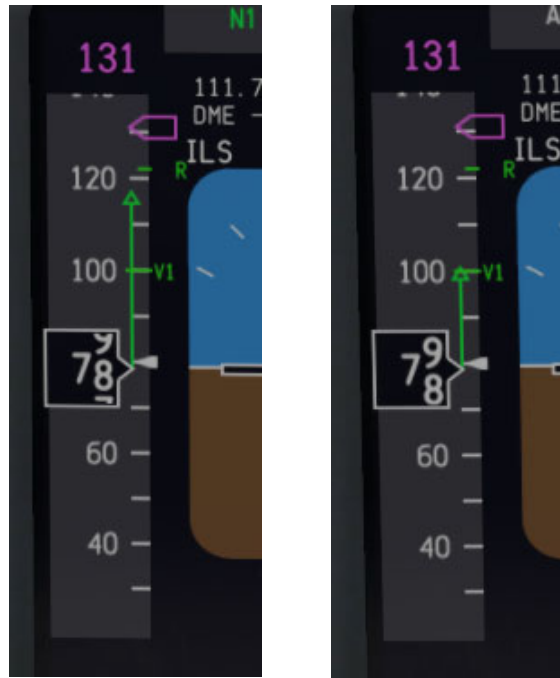
The PFD speed tape shows a trend arrow, and the top of the arrow predicts what the speed will be in 10 seconds at the current acceleration rate. Figure 10 shows the difference in the trend arrow with 89% N_1 set and 70% N_1 set.

PFD Speed Tape trend arrow (left image with 89% N_1 , right image with 70% N_1)
(images captured in a simulator)

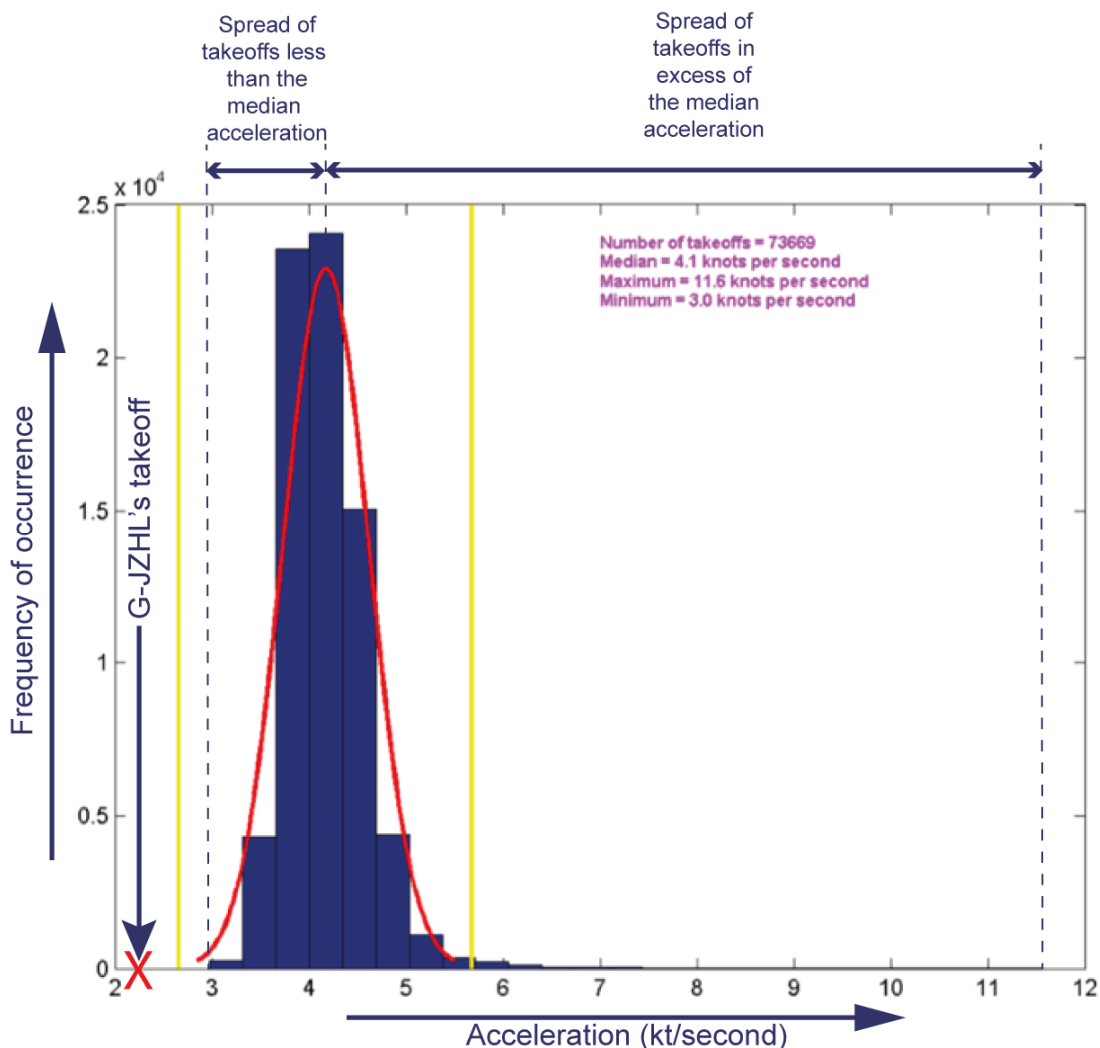
Figure 11

G-JZHL's acceleration on takeoff compared with other 737-800 takeoffs.
Used with permission
